SC-8628  
SC-8628

## SECHELT ROBERTS 0.75km

2025 Inspection

Structure Class Temporary Bridge

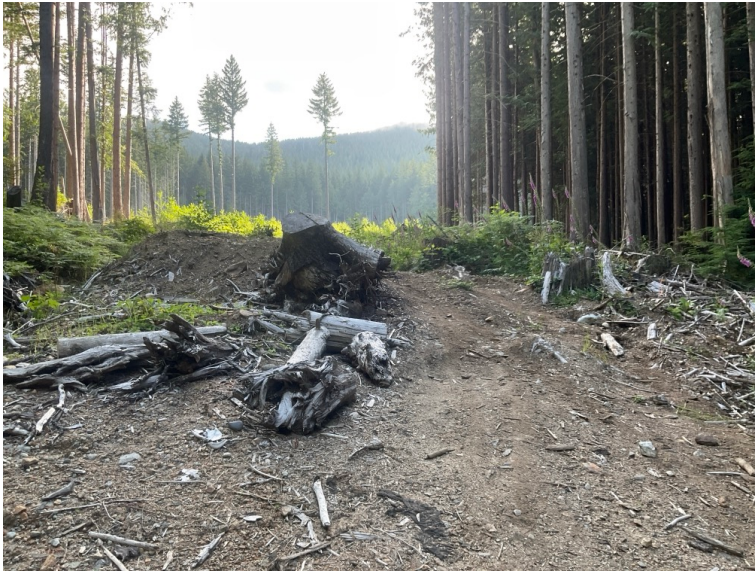
Approach from Left Bank when facing downstream
