SC-8630  
SC-8630

## SECHELT ROBERTS 1.12km

2025 Inspection

Structure Class Temporary Bridge

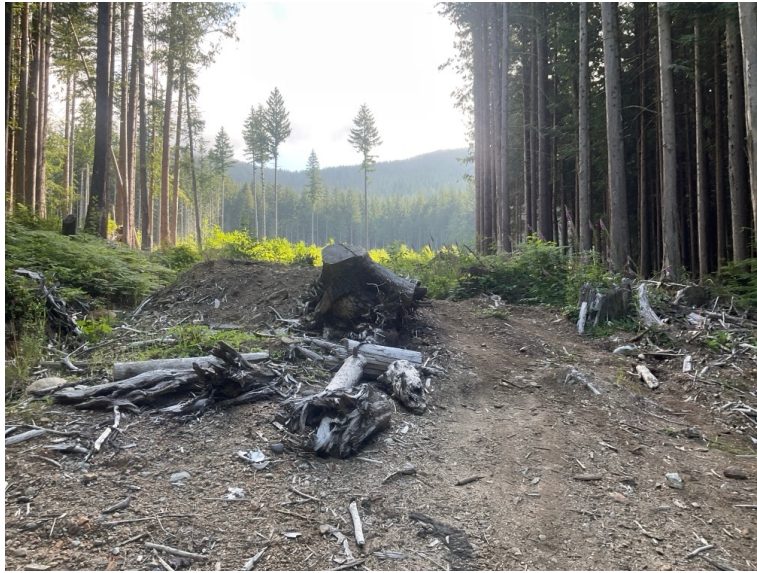
Approach from Left Bank when facing downstream
