SC-8638  
SC-8638

## SECHELT ROBERTS 0.85km

2025 Inspection

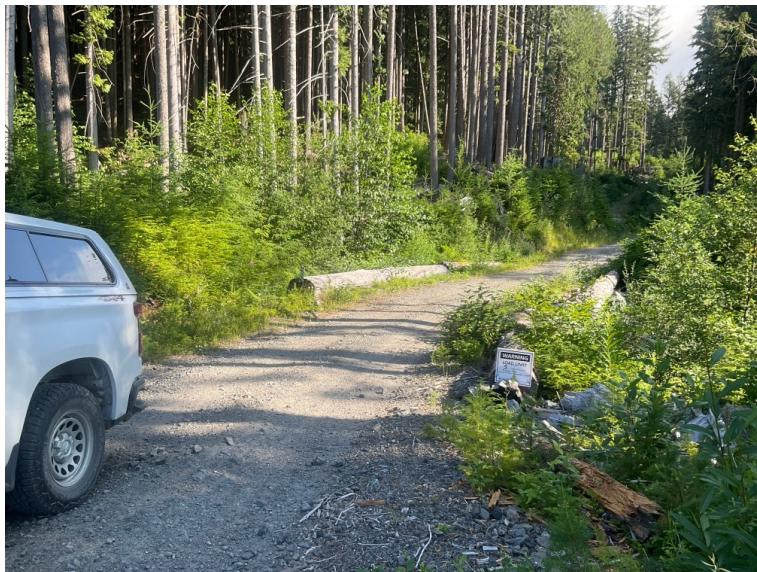
Approach from Right Bank when facing downstream

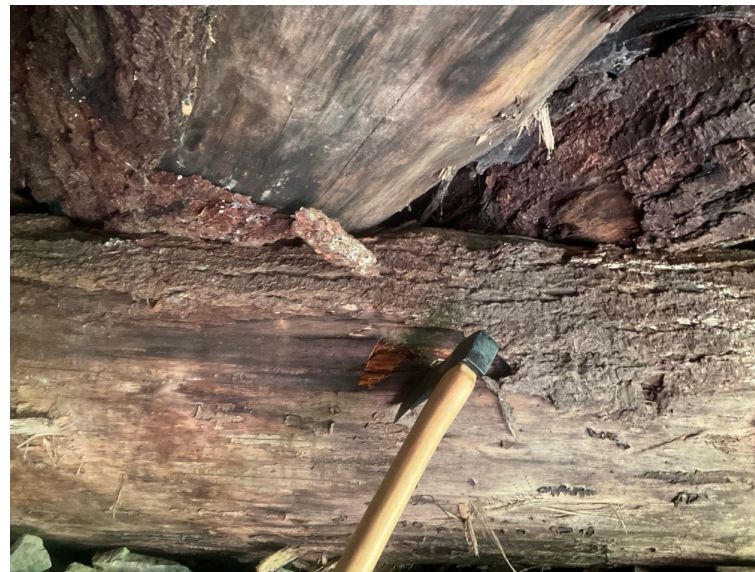
Bearing
