SC-8639  
SC-8639

SECHELT ROBERTS 1.06km

2025 Inspection

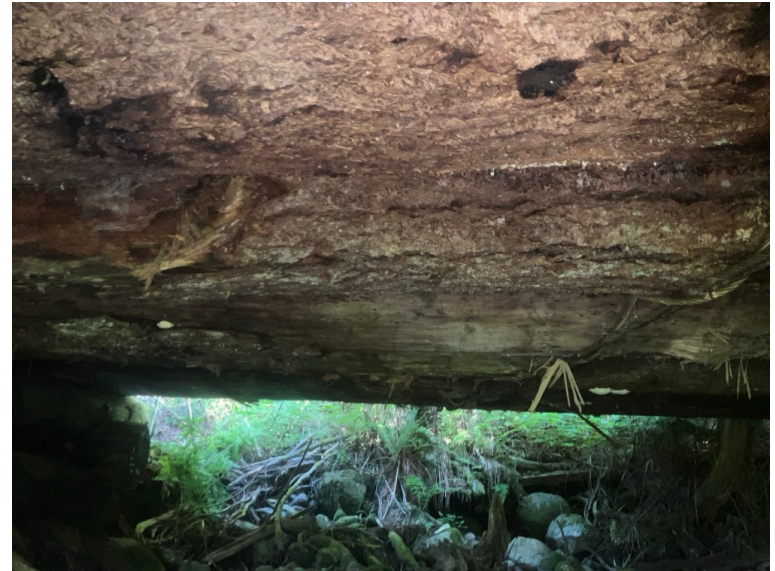
No apparently change since past inspection. Stringers 3,5,8,9 have konk, est 100mm sap rot. Lashing tight. Established closure date 3 years.

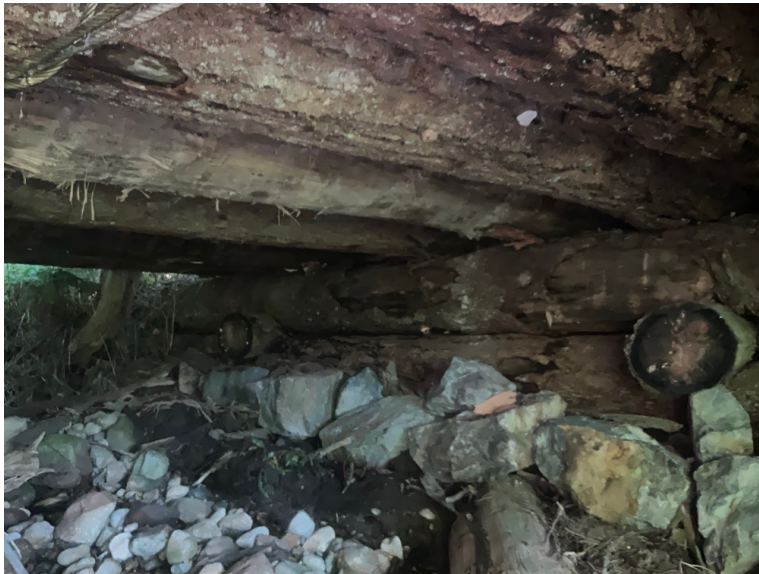
Left Bank Abutment when facing downstream

Log/Timber Cribs Poor Conk

Tie Backs Poor Conk
