SC-8640  
SC-8640

## SECHELT ROBERTS 1.12km

2025 Inspection

Structure Class Temporary Bridge

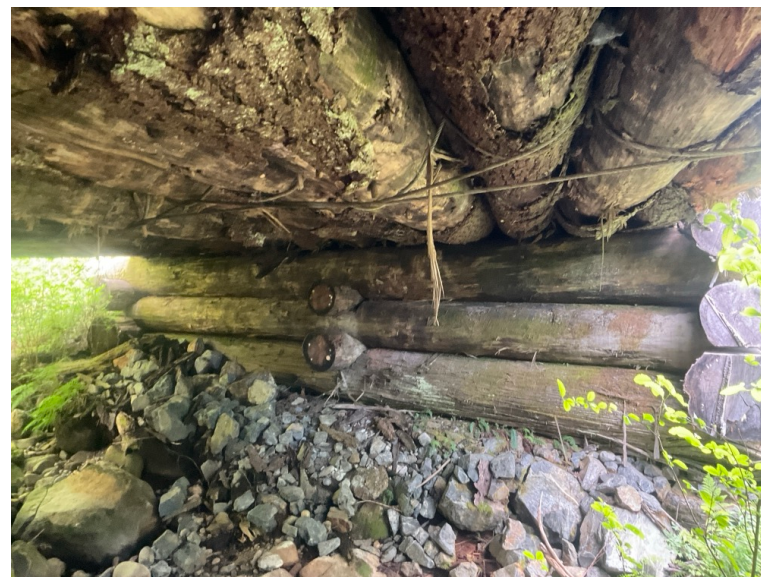
Left Bank Abutment when facing downstream

Log/Timber Cribs Poor 30mm sap rot. conk.

Tie Backs Poor 30mm sap rot

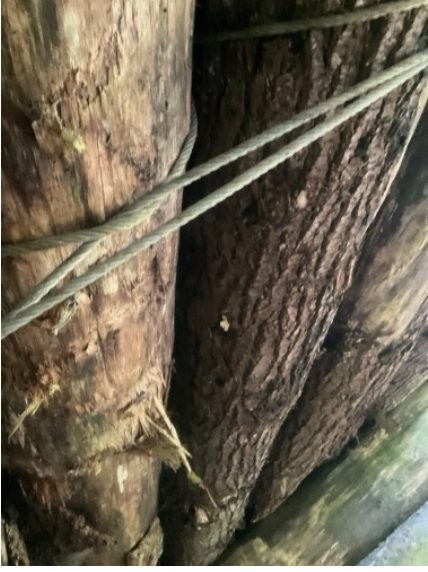
No apparent change last inspection. 5 tonnes posted rating. Stringers 3 and 7 have small conk. 20-30mm average sap rot. Lashing is tight. Estimated closure 3 years.
