SC-8655  
SC-8655

LOIS FSR 8133 BR01 9.83km

2025 Inspection

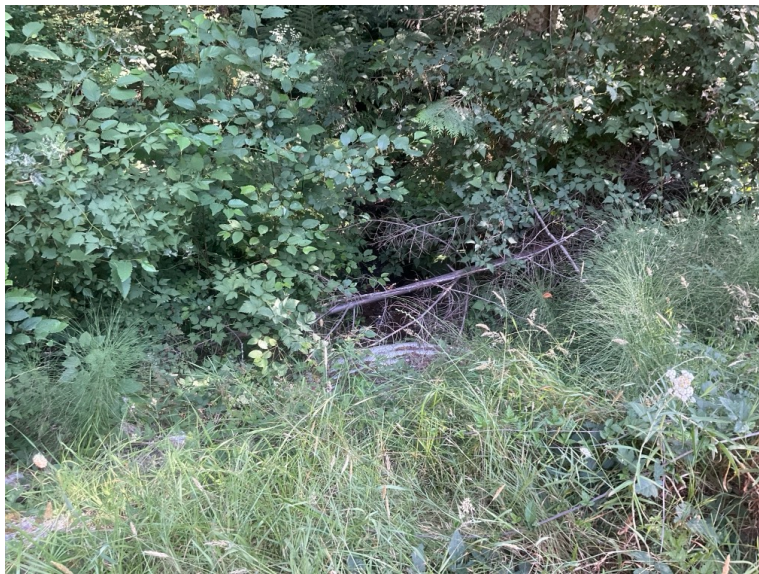
Outlet      Good

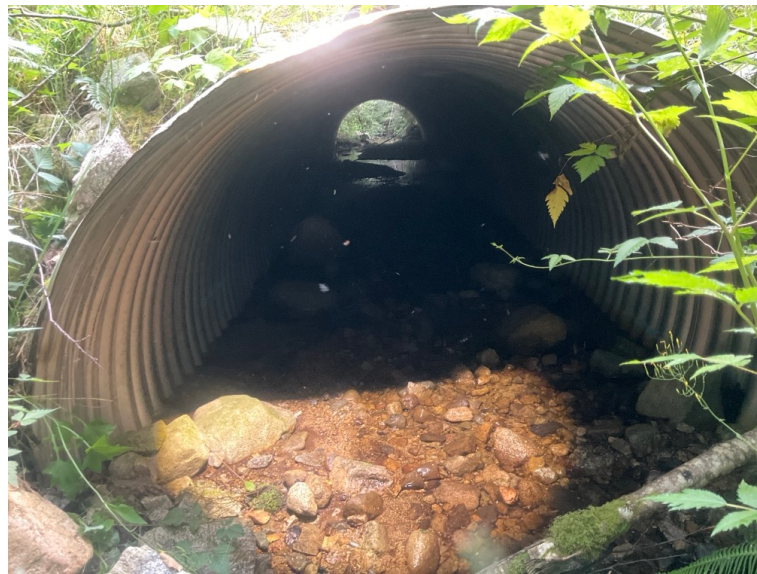
Inlet      Good
