SC-8662  
SC-8662

RAINY RIVER 0.66km

2025 Inspection

Ministry of Forests Reviewing Engineer: Richard Mills P.Eng.  
Review Date: Jan 26, 2026  
Load Rating: L165 or 150 tonnes  
Recommended Next Inspection: 2028  
Comments: Remove rubber matting from deck.

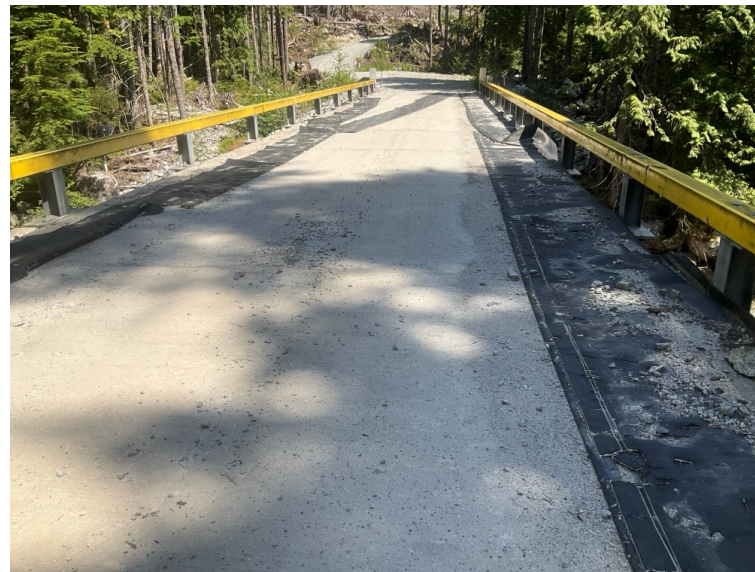
Deck

Running Surface      Fair

1 Structure. Clean Deck. # of Rubber matting should be removed from deck  
delineators. Priority:Low
