Highway 91/17 Upgrade Project

Submittal No.	PGC-SUB-001947	Document No.	H9117-EV-MRP-0026
Title	Environmental Monthly Report June 2022	Revision:	1
Date Submitted to MoTI		July 14, 2022	
Prepared by:	Nuzhat Beig, M. Eng, EIT (MESL)

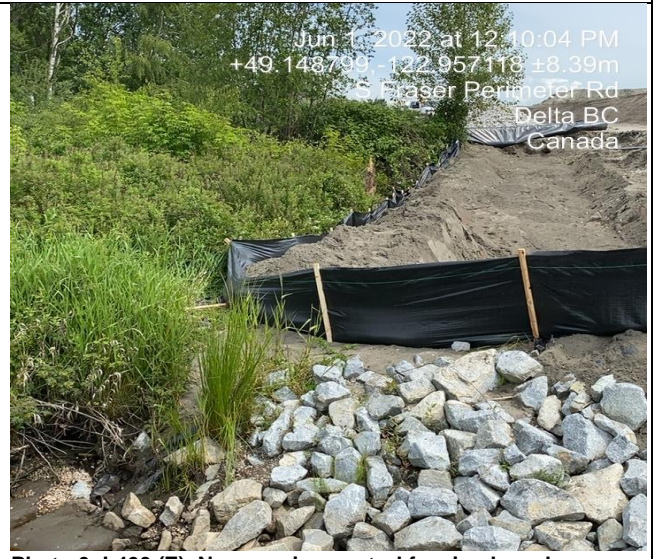
Photo 6: L400 (E). New erosion control fencing keyed.

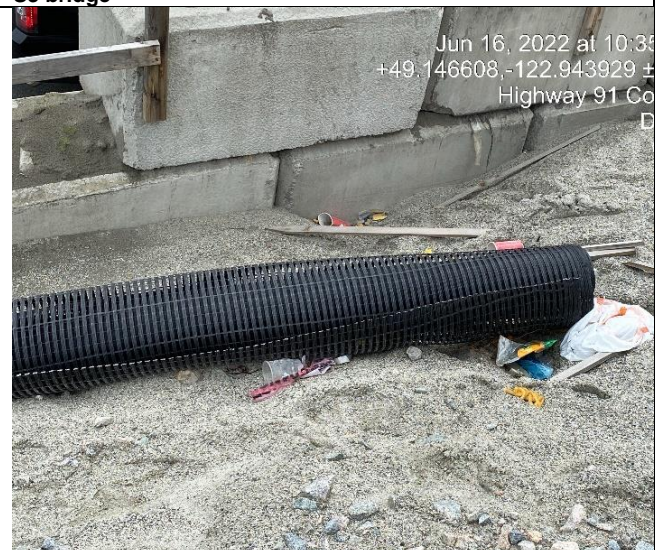
Photo 32: L1150 (F). S3 bridge littering

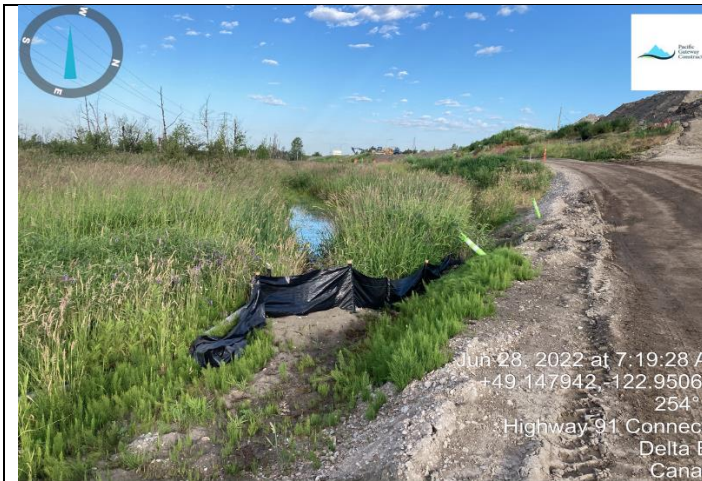
Photo 39: L500 (F). Fixed ESC fencing.

03 June 2022: L550/L100 ESC Fencing – Sand removed and fencing repaired.

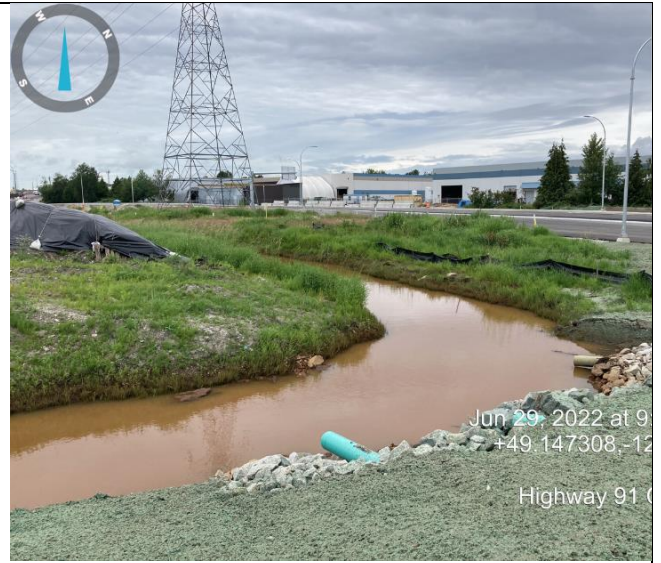
Photo 52: L1300 (H). Upstream Silda ditch.

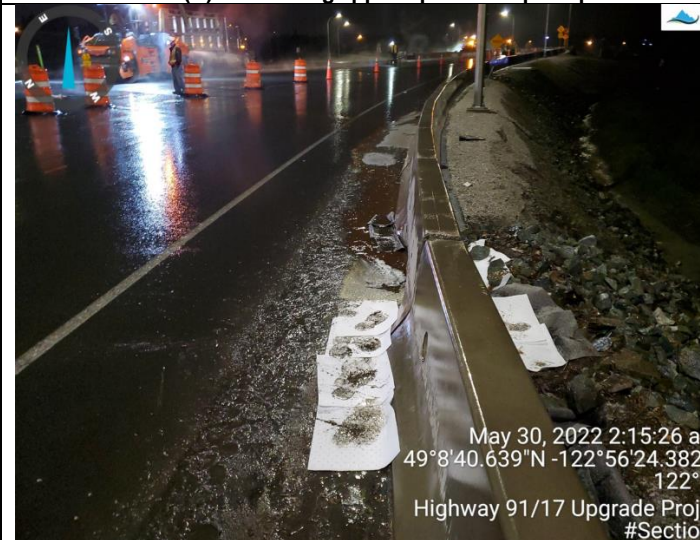
Photo 55: L600 (I). Tack spill.

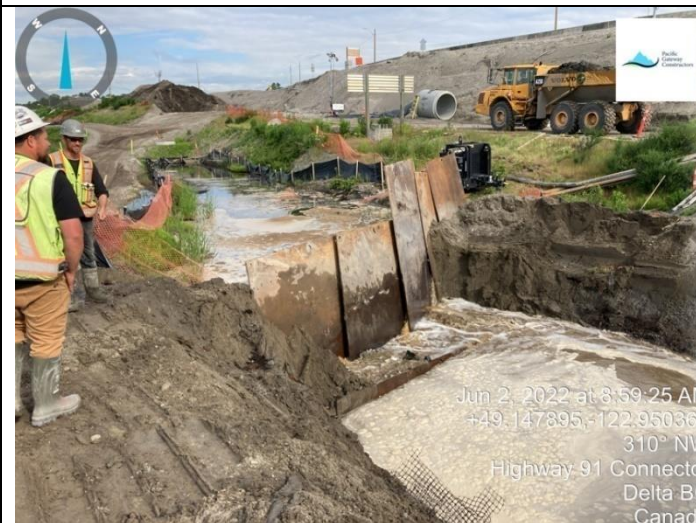
On 01 June 2022, water was being pumped from the western portion S3 L500 pond to Silda Ditch under the supervision of PGC environmental representatives to draw down water levels in preparation for culvert connection. Water quality monitoring was ongoing during pumping and at approximately 16:00 the pumps were turned off due to observed elevated turbidity at the discharge location. Pumps remained off overnight.

Photo 77: Isolation failure at L500 pond.

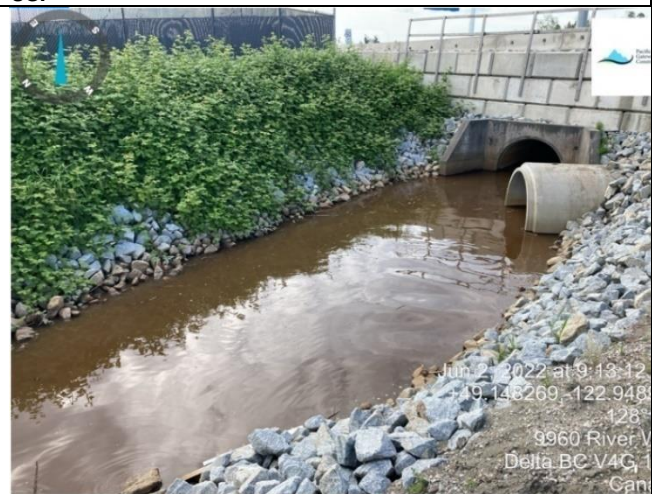
- **08 June 2022:** PGC provided follow-up reporting on conditions at Silda Ditch following the 02 June 2022 high turbidity water release. Elevated turbidity was observed due to re-suspended sediments and reduced flow at the Silda Ditch culvert discharge location and Silda Ditch midstream monitoring location.

PGC conducted follow-up monitoring on 07 and 08 June 2022 and continued to observe elevated turbidity and very low water levels in the culvert discharge and midstream locations. Silda Ditch downstream water quality impacts are minimal (approximately 10 NTU above background, including tidal influence from the river), indicating stagnant water in the culvert discharge and midstream locations with very minimal flow moving downstream. Water quality information was reported to MoF as follow-up to the reported high-turbidity release and in accordance with WSA approval conditions (see **Section 3.2**).

Photo 78: Culvert discharge location in Silda Ditch, 2 June 2022 at 09:13 (240 NTU)

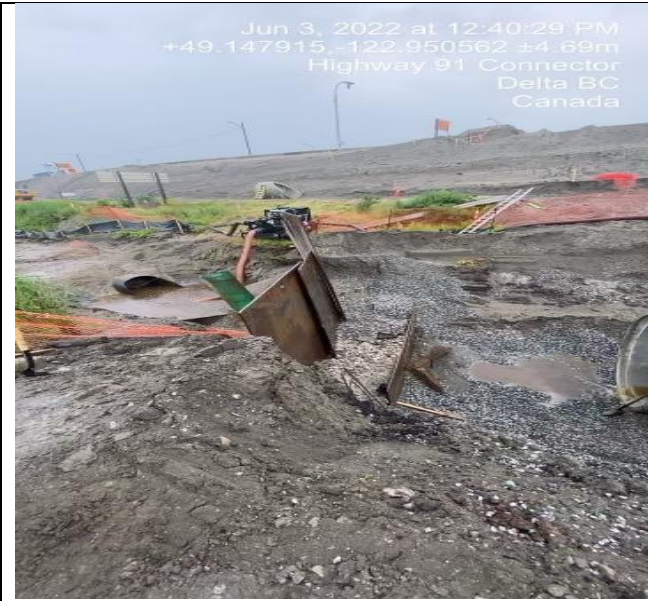
Photo 81: Re-established isolation at L500 pond.

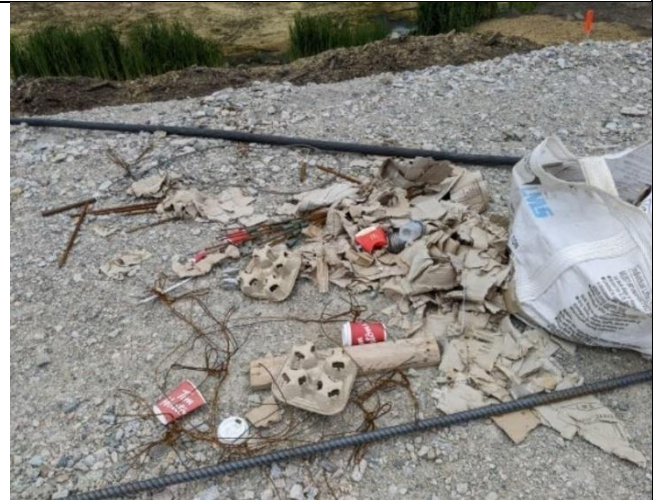
- **16 June 2022:** During an inspection by Province representatives, an excess of garbage and inadequate general housekeeping were observed in the work area at the S3 bridge. Wildlife-proof receptacles for food waste were not available at the work area. Deficiencies were recorded for action and PGC opened NCR 129 for failure to comply with Wildlife and Waste Management BMPs as stated in the CEMP. Toolbox training for subcontractors was completed 22 June 2022.

Photo 84: S3 Bridge - Waste and food garbage observed without appropriate containment/disposal.

JBs – S3 Garbage/House keeping	Complete	High	06/16/2022	06/24/2022	06/24/2022	On time	Issue: Inadequate garbage disposal on site, garbage not being sorted, no wildlife-proof bins for food waste. Corrective Action: Comment: Additional toolbox training completed 22 June clean-up complete
JBs – S2 Garbage/House keeping	Complete	High	06/16/2022	06/24/2022	06/24/2022	On time	Issue: Inadequate garbage disposal on site, garbage not being sorted, no wildlife-proof bins for food waste. Corrective Action: Comment: Additional toolbox training completed 22 June clean-up complete
JBs – S2 Bridge Concrete Waste	Complete	High	06/16/2022	06/24/2022	06/24/2022	On time	Issue: Waste concrete remaining on site without adequate containment Corrective Action: Additional crew training, additional inspection, working with structures team to reinforce subcontractor requirements. Comment: Additional toolbox training completed 22 June clean-up complete

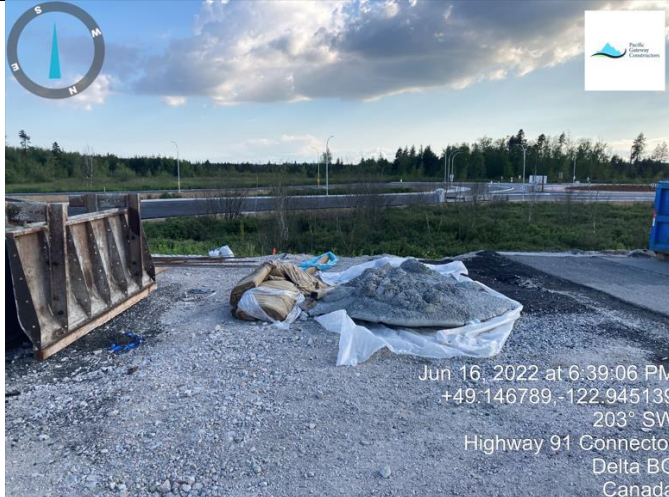
- **16 June 2022:** During an inspection by Province representatives, evidence of concrete equipment washing on site and without adequate containment/washout receptacles was observed in the work area at the S3 bridge. Uncured concrete waste was observed on the south abutment without adequate containment. Deficiencies were recorded for action and PGC opened NCR 128 for failure to comply with Environmental Work Plan 0043 for the S3 bridge and Concrete and Hazardous Waste Best Management Practices (BMPs) as stated in the CEMP. Toolbox training for subcontractors was completed 22 June 2022.

Photo 85: S3 Bridge - waste concrete left on site, inadequate containment.

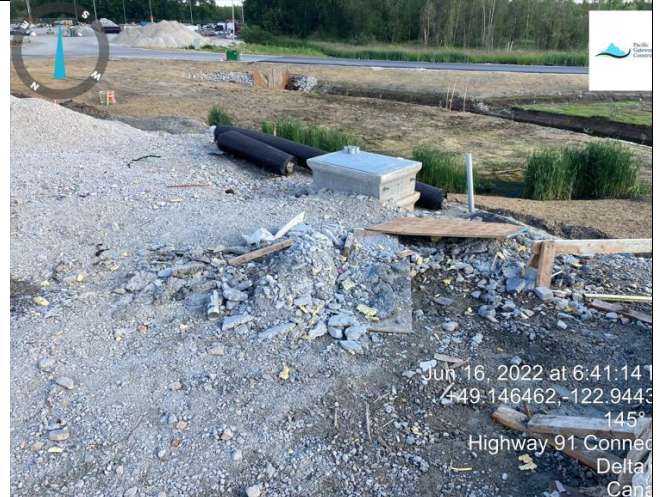
Photo 86: S2 Bridge - waste concrete and garbage not disposed of properly.

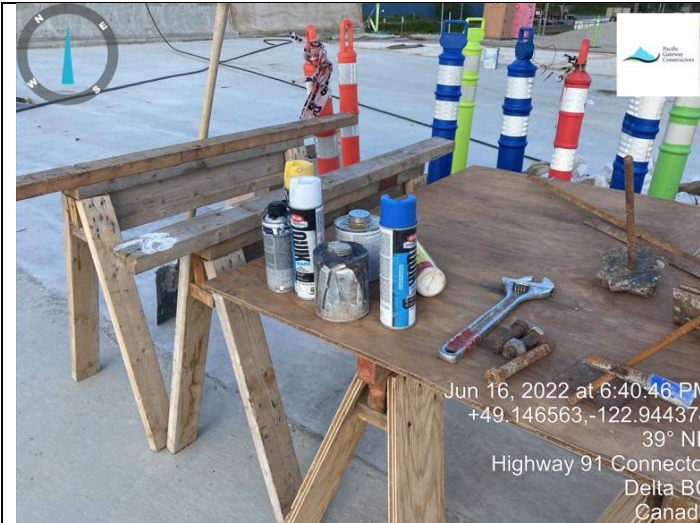
Photo 87: S2 Bridge – hazardous materials without secondary containment.

JBs – S2 Bridge Secondary Containment	Complete	High	06/16/2022	06/24/2022	06/24/2022	On time	Issue: Hazardous materials (chemicals, fuel) observed on site without adequate secondary containment. Corrective Action: Additional crew training, additional inspection, working with structures team to reinforce subcontractor requirements. Comment: Additional toolbox training completed 22 June clean-up complete
JBs – S3 Bridge Secondary Containment	Complete	High	06/16/2022	06/24/2022	06/24/2022	On time	Issue: Hazardous materials (chemicals, fuel) observed on site without adequate secondary containment. Corrective Action: Additional crew training, additional inspection, working with structures team to reinforce subcontractor requirements. Comment: Additional toolbox training completed 22 June clean-up complete

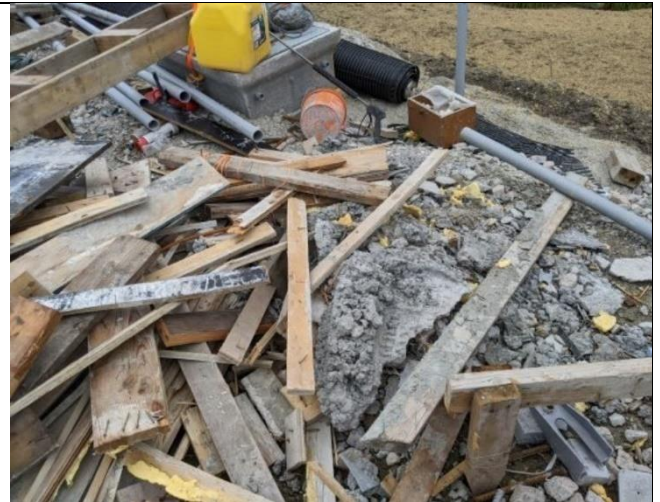
- **16 June 2022:** During an inspection by Province representatives, a jerry can of suspected diesel fuel was observed placed on a concrete box above an embankment at the S3 bridge without secondary containment. A portable generator was also observed without secondary containment at the S2 bridge; however, it was not confirmed that the generator was remaining in place (i.e., whether it should be considered stationary equipment). Deficiencies were recorded for action for both observations, and PGC opened OFI 103 for providing additional training on secondary containment measures and hazardous waste handling. Toolbox training for subcontractors was completed 22 June 2022.

Photo 88: S3 Bridge – jerry can with diesel fuel without secondary containment. Waste concrete and garbage not disposed of properly.

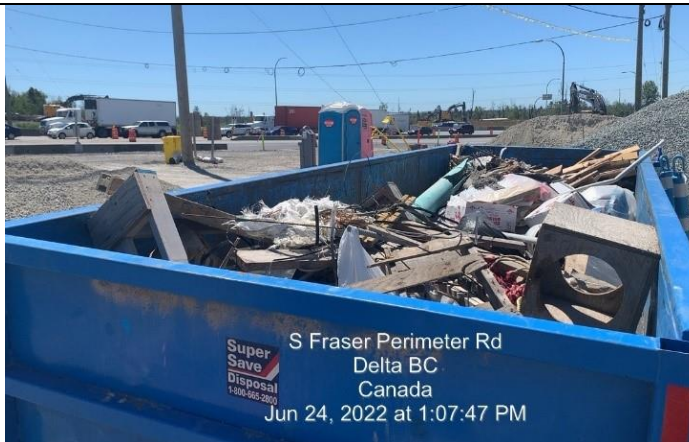
Photo 91: Jacob Brothers S2 Bridge worksite cleanup – general waste sorted into appropriate receptacle.
