Shoreline Cleanup Assessment Technique (SCAT) and the Silvertip Incident

Gary S. Mauseth/Greg Challenger – Polaris Applied Sciences Kirkland, WA Andrew Milanes – ES2 Denham Springs, LA Tyson O'Brien – General Eng. and Env. Baton Rouge, LA

Silvertip Pipeline Incident

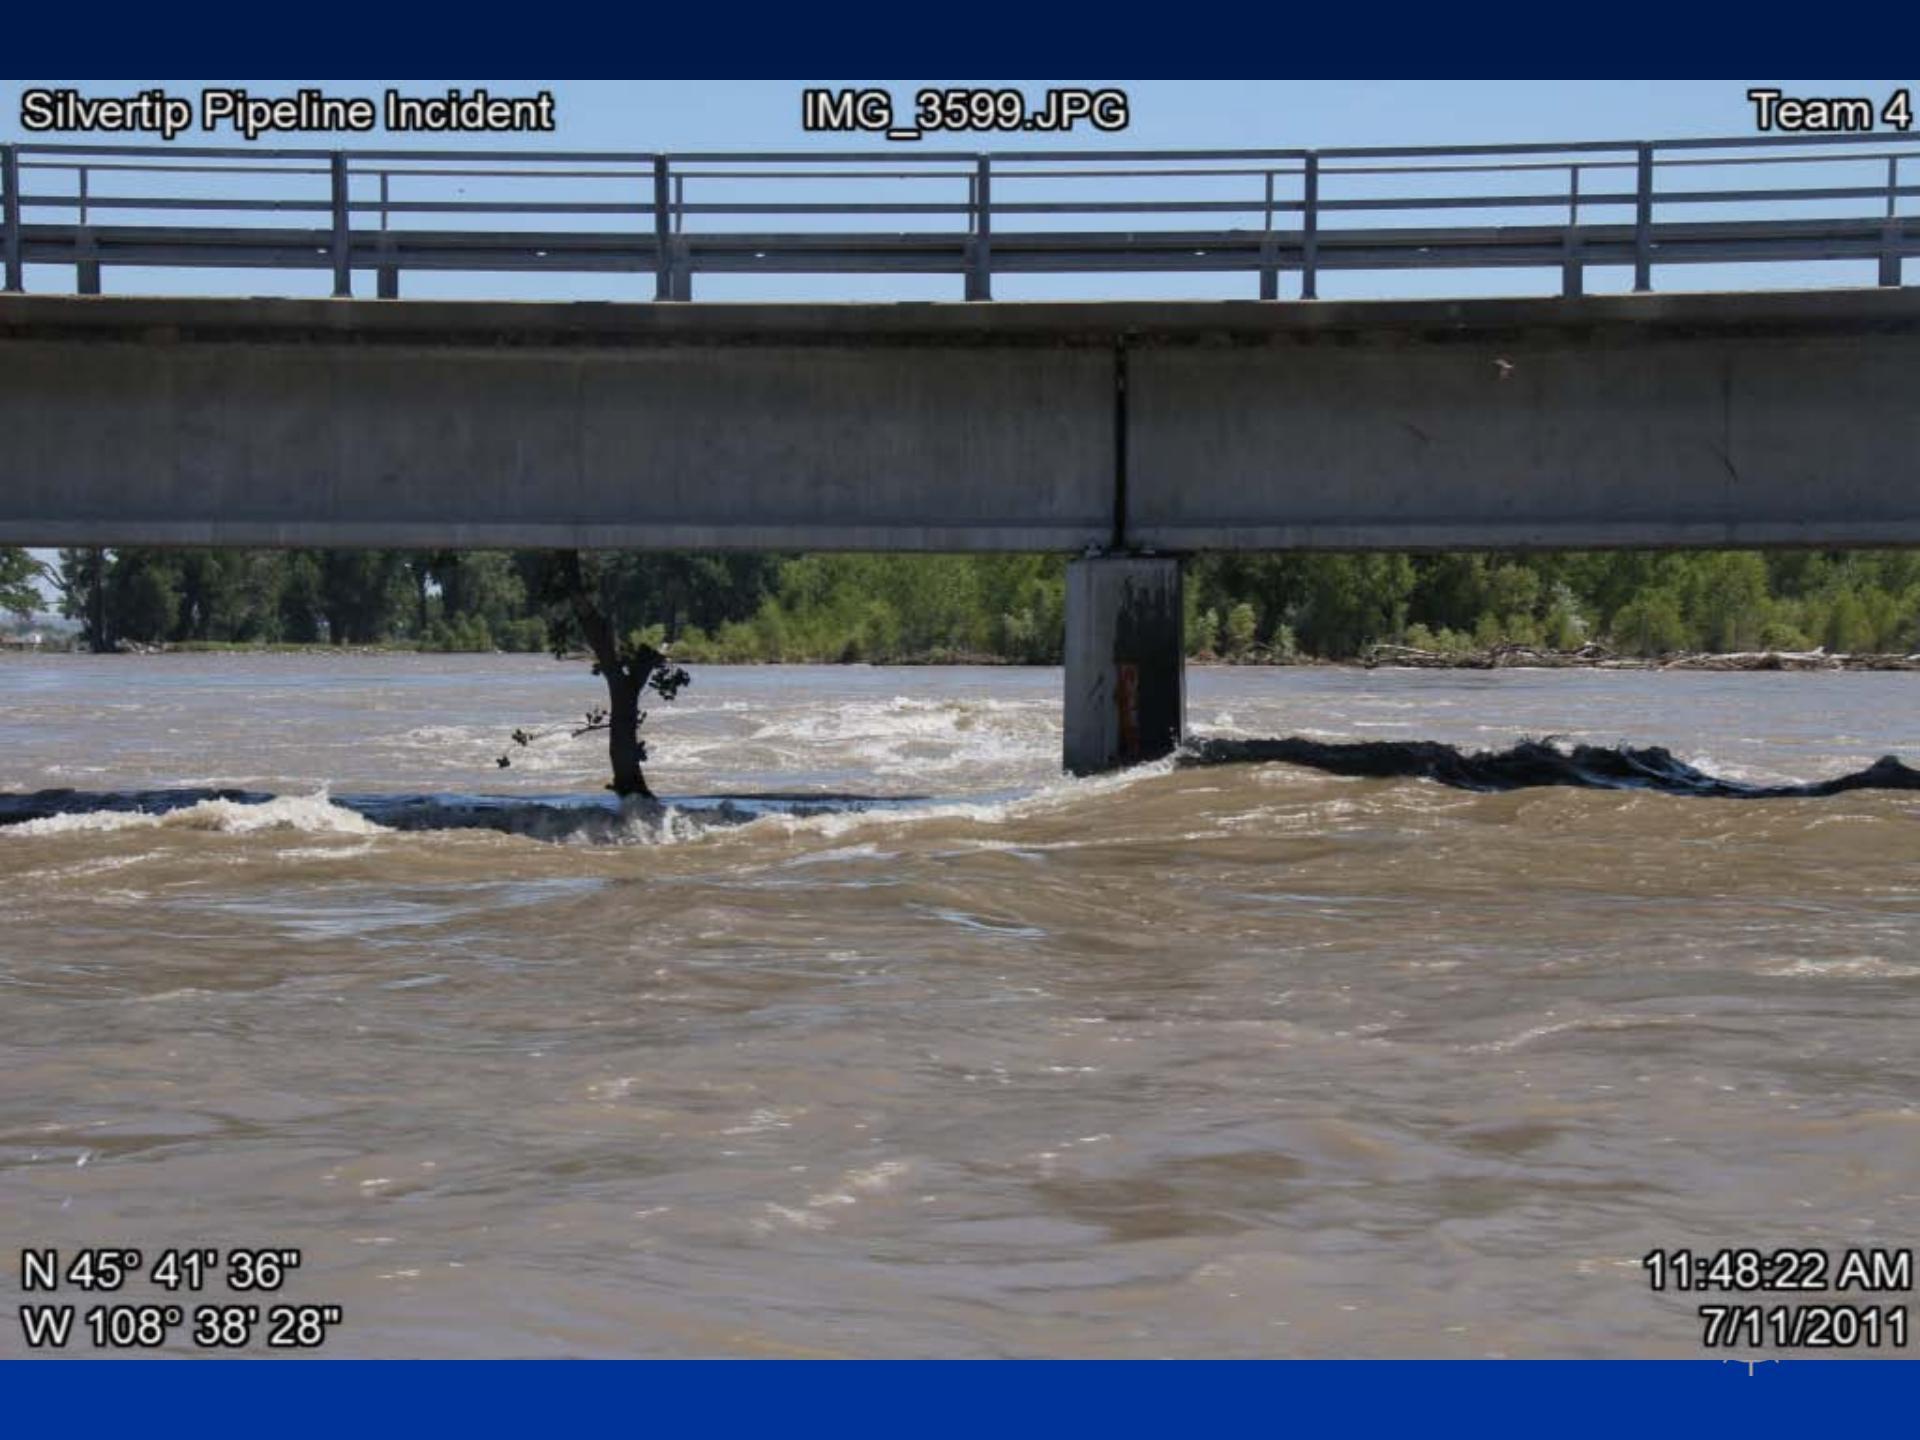
DSC02796.JPG

Record water levels on the Yellowstone River provided unsafe conditions for ground surveys during the first two weeks of the response

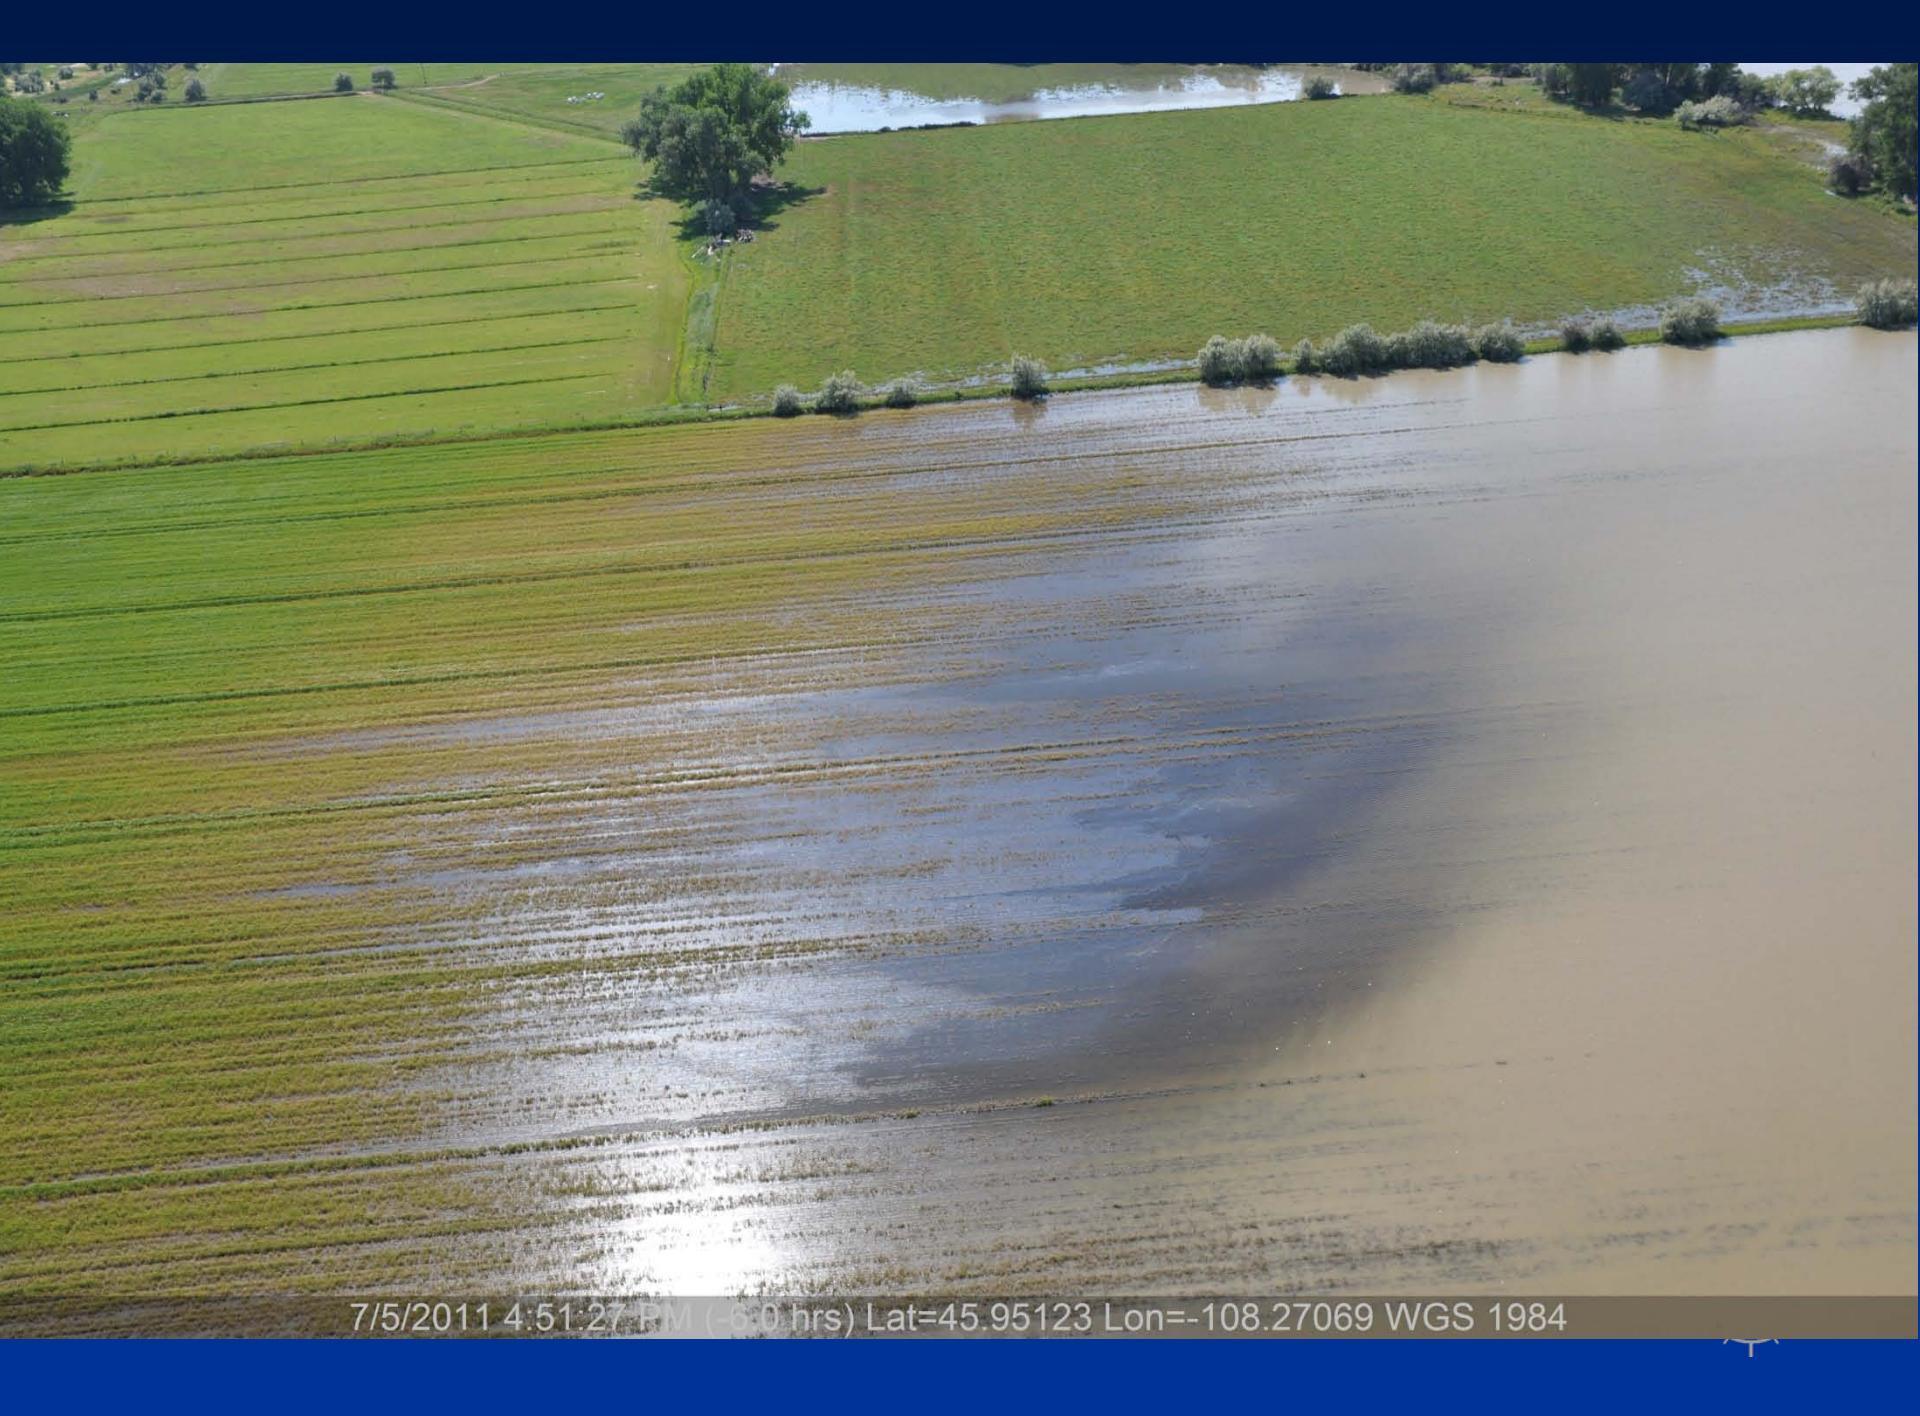
N 45° 39' 13" W 108° 45' 32" 4:44:53 PM 7/4/2011 Adjacent lands in flooded areas were oiled resulting in third party claims

SCAT-Claims Liaison position created as an interface between private landowner and cleanup operations

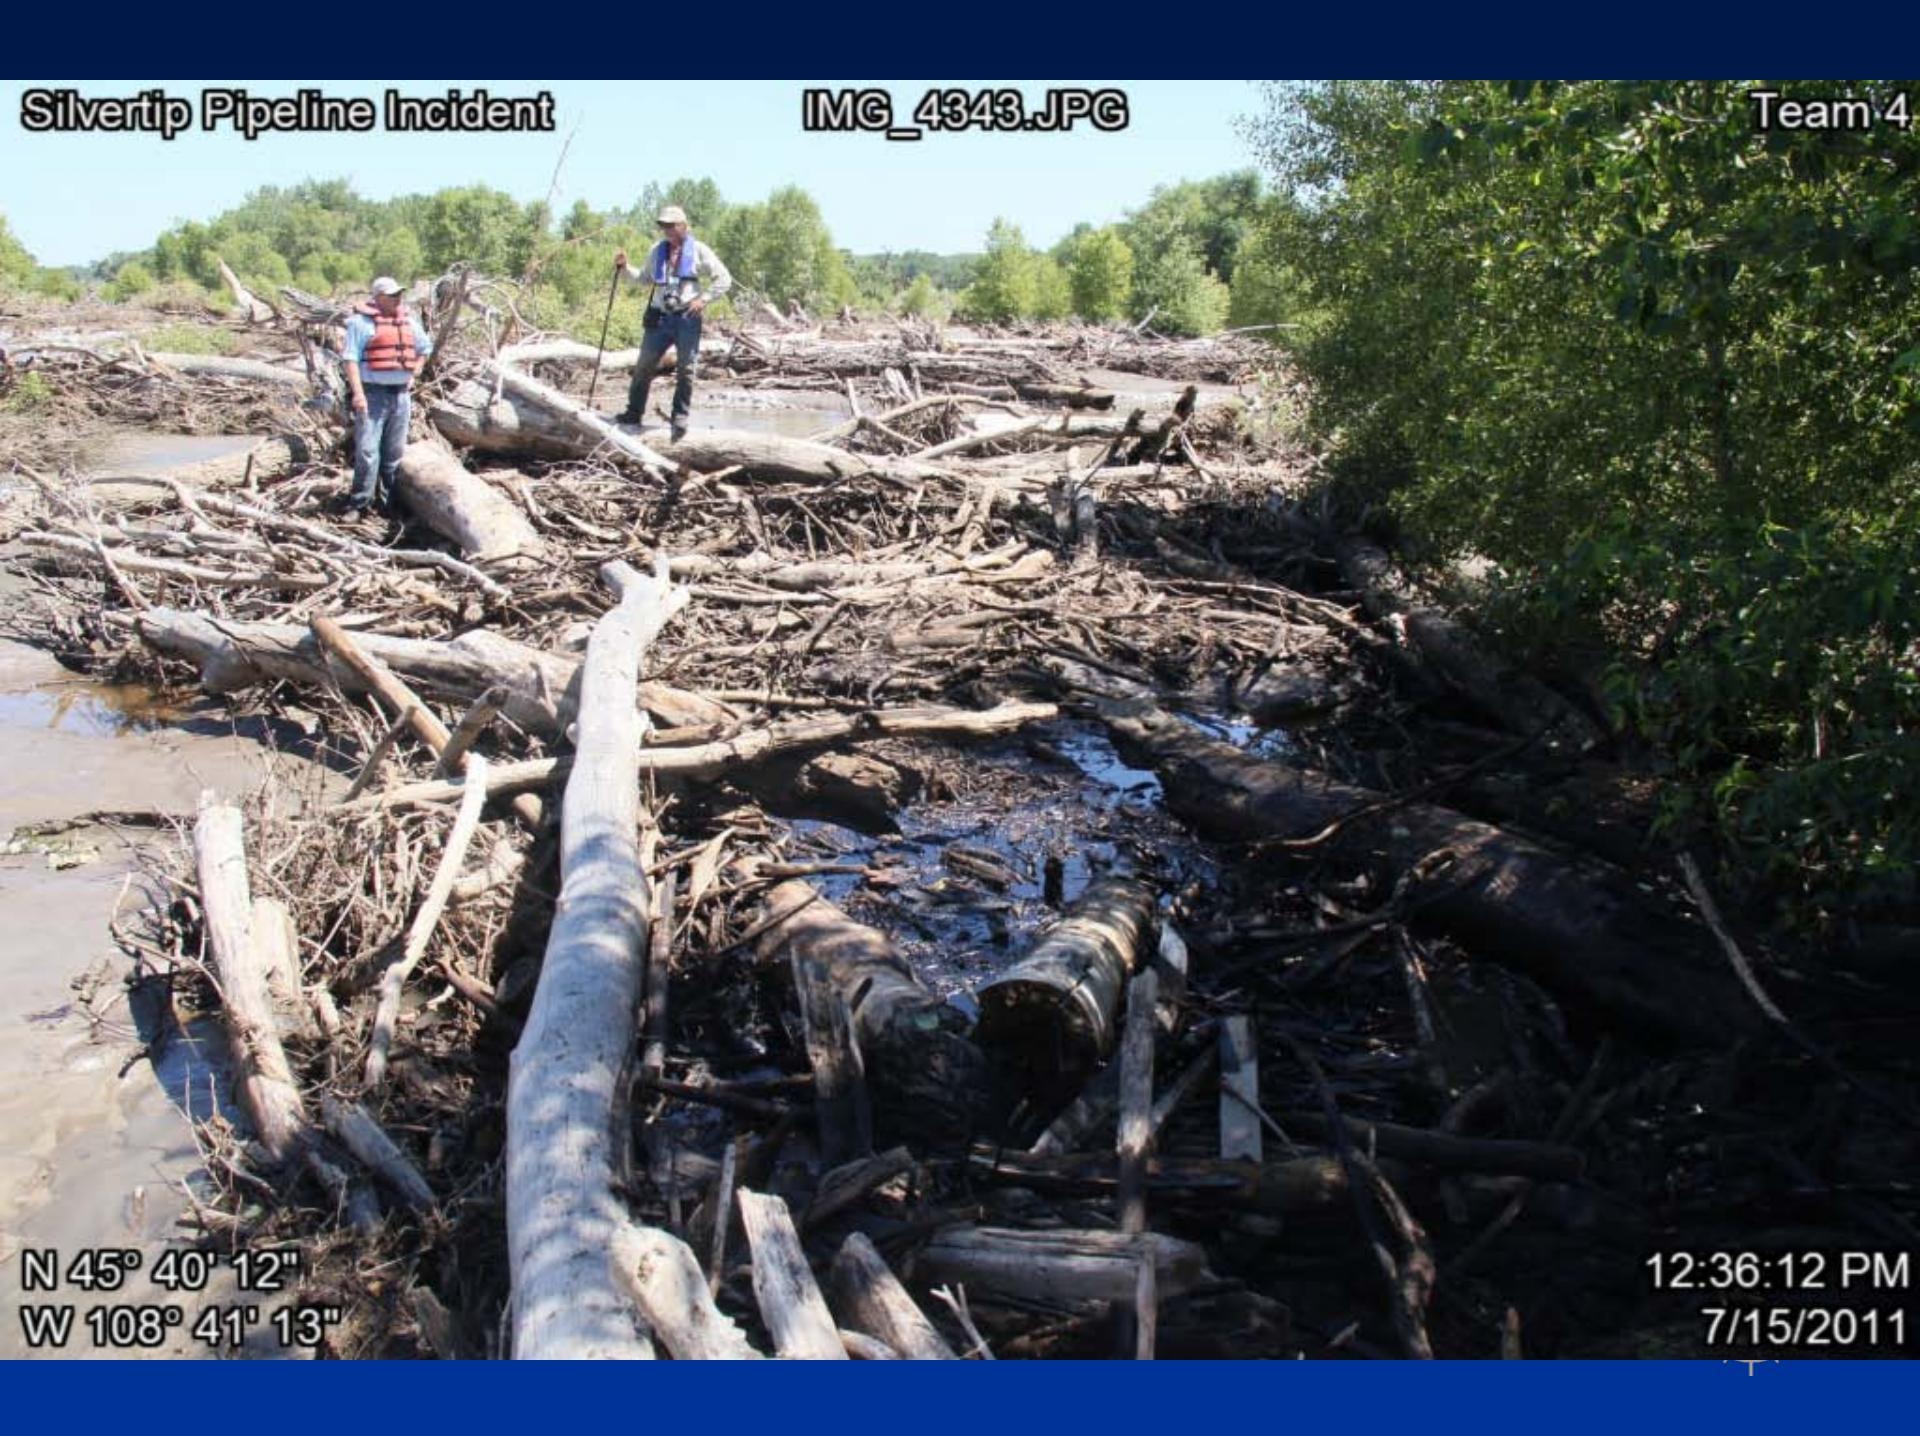
IMG_4339.JPG

Woody Debris

Oil trapped in large debris provided challenges for safe treatment and disposal
