Project number: 4435-029 Document number: V3729 Version: 3 Date: September 4, 2014

MILE 122.7 DERAILMENT – COAL RECOVERY REPORT FOR SILVER CREEK AND BURNABY LAKE

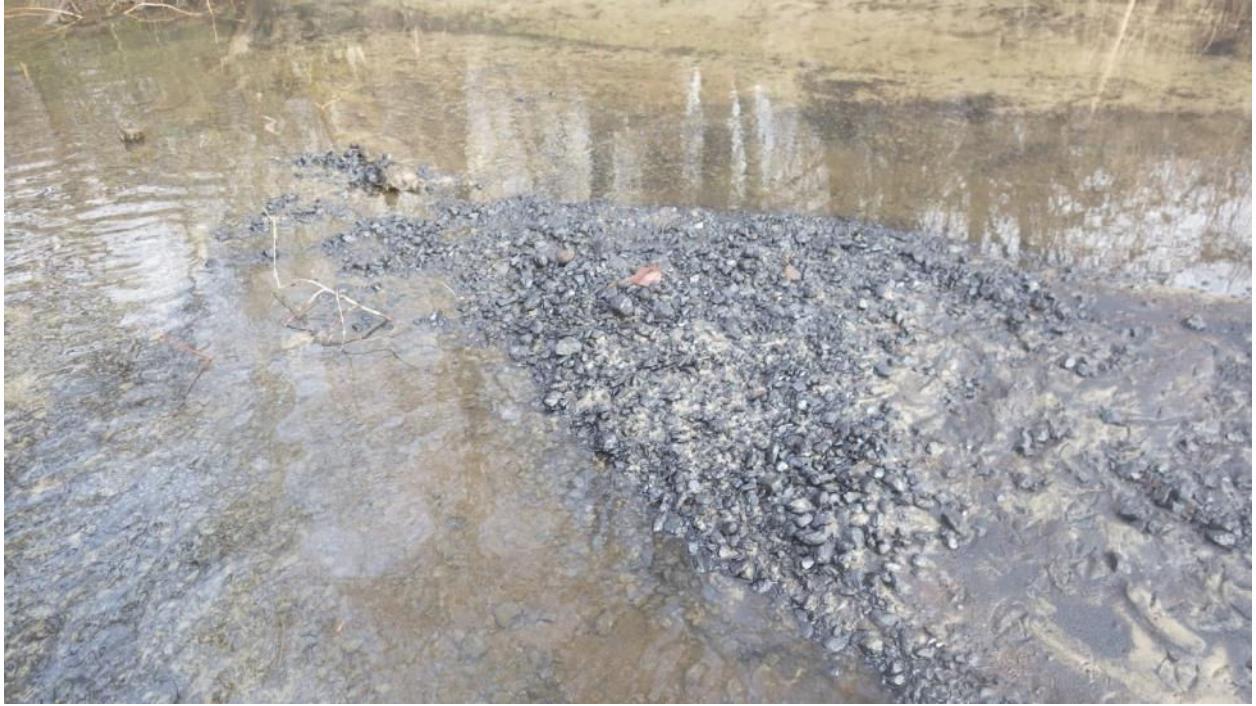
Photo 1. Example of large particle deposition across the channel near Silver Creek confluence with Burnaby Lake, January 16, 2014.

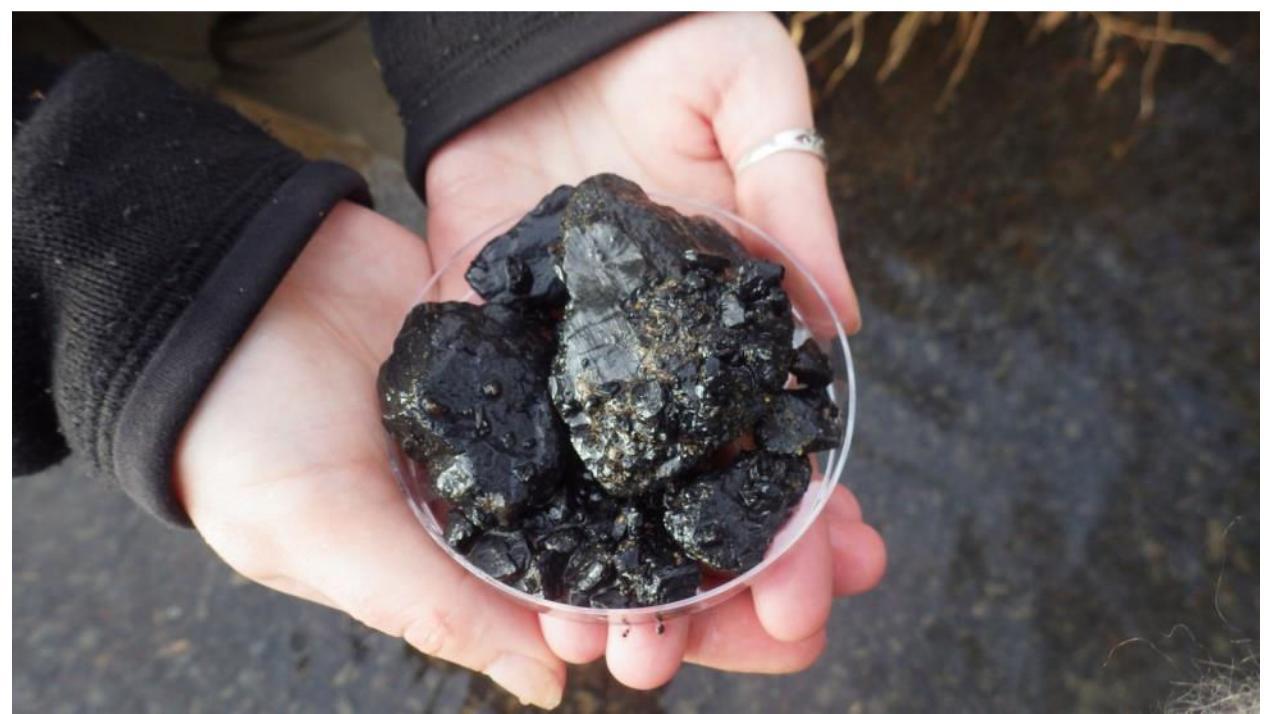
Photo 2. Sample of coal particle size in Silver Creek, from fines to 6 cm (large gravel), at the confluence (41m downstream of footbridge), January 16, 2014.

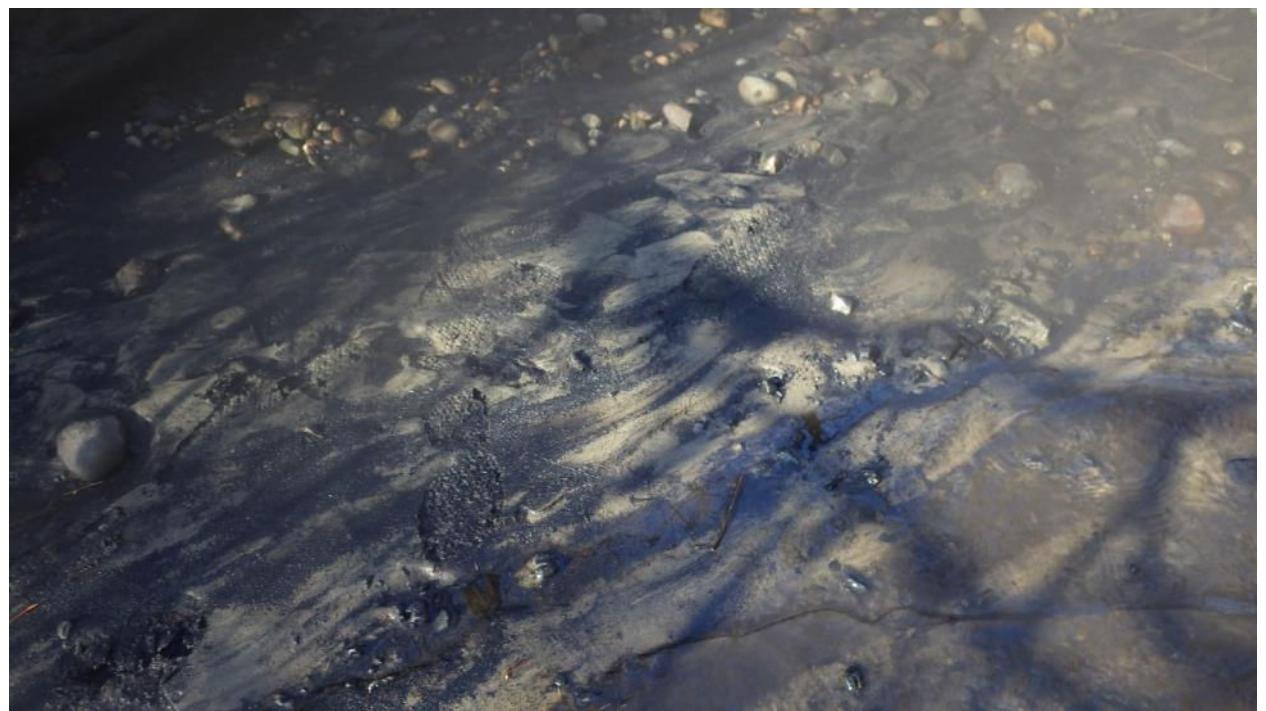
Photo 3. Example of surface dusting in Silver Creek, 35 m downstream of footbridge, January 16, 2014.

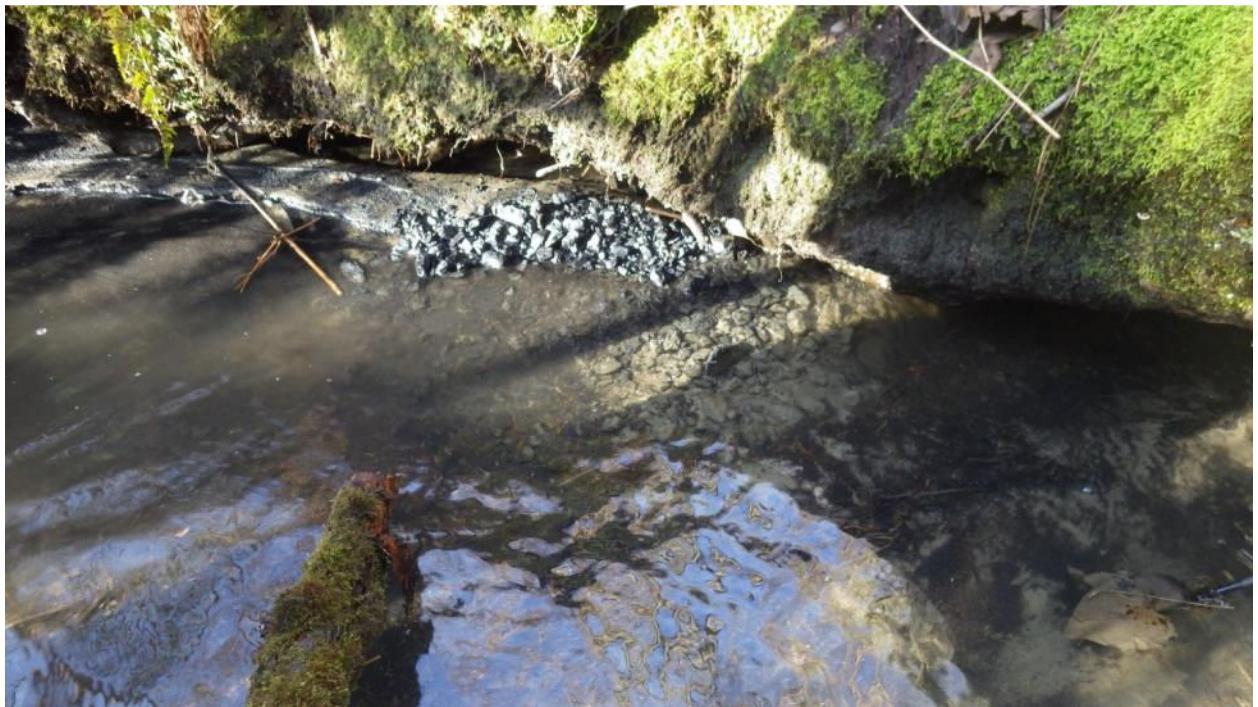
Photo 4. Small pocket (0.4 m^2) of large particles (1 - 4 cm diameter) up to 12 cm thick, observed near the footbridge in Silver Creek, January 16, 2014.

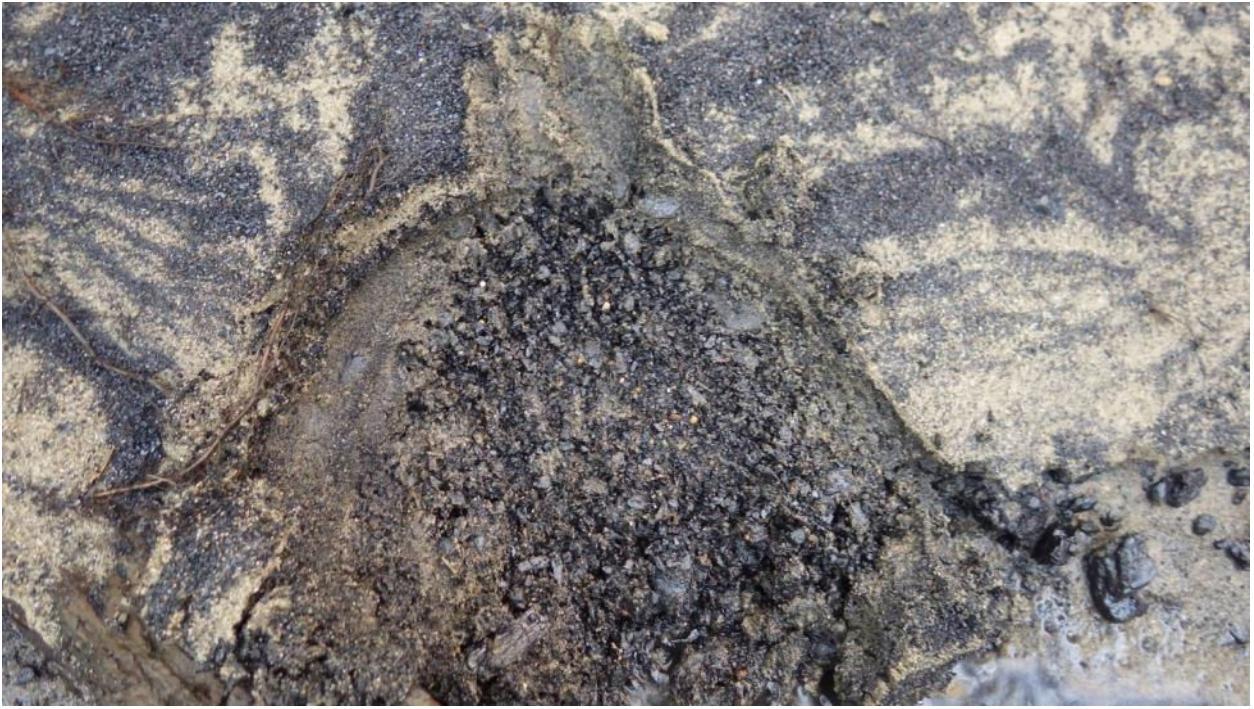
Photo 5. Stratified deposit of various particle sizes (fines at the surface, coarser grain underneath) with sand layers in between, in Silver Creek 118 m upstream from footbridge, January 16, 2014.

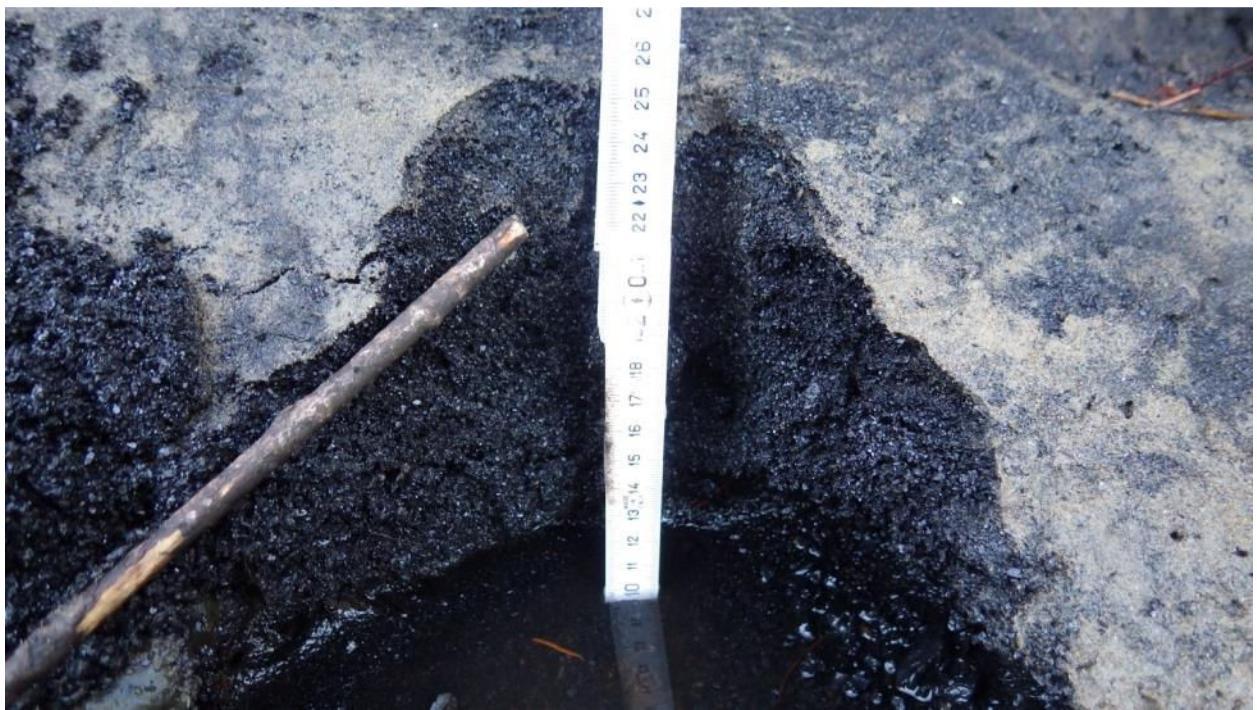
Photo 6. Deposition area (3.75 m2) of fines to 3-5 mm particles, up to 25 cm thick in Silver Creek 195 m upstream from footbridge, January 16, 2014.

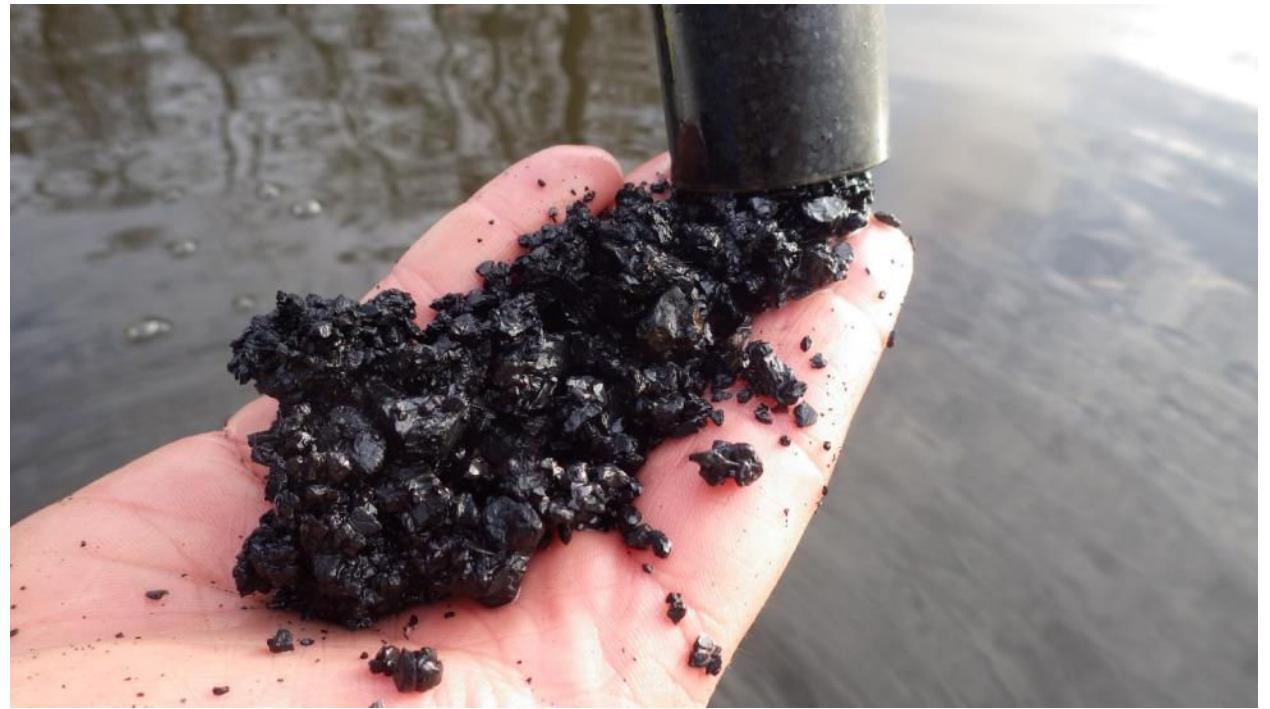
Photo 7. Representative coarse particle size of core samples collected along the west portion of alluvial fan in Burnaby Lake, January 17, 2014.

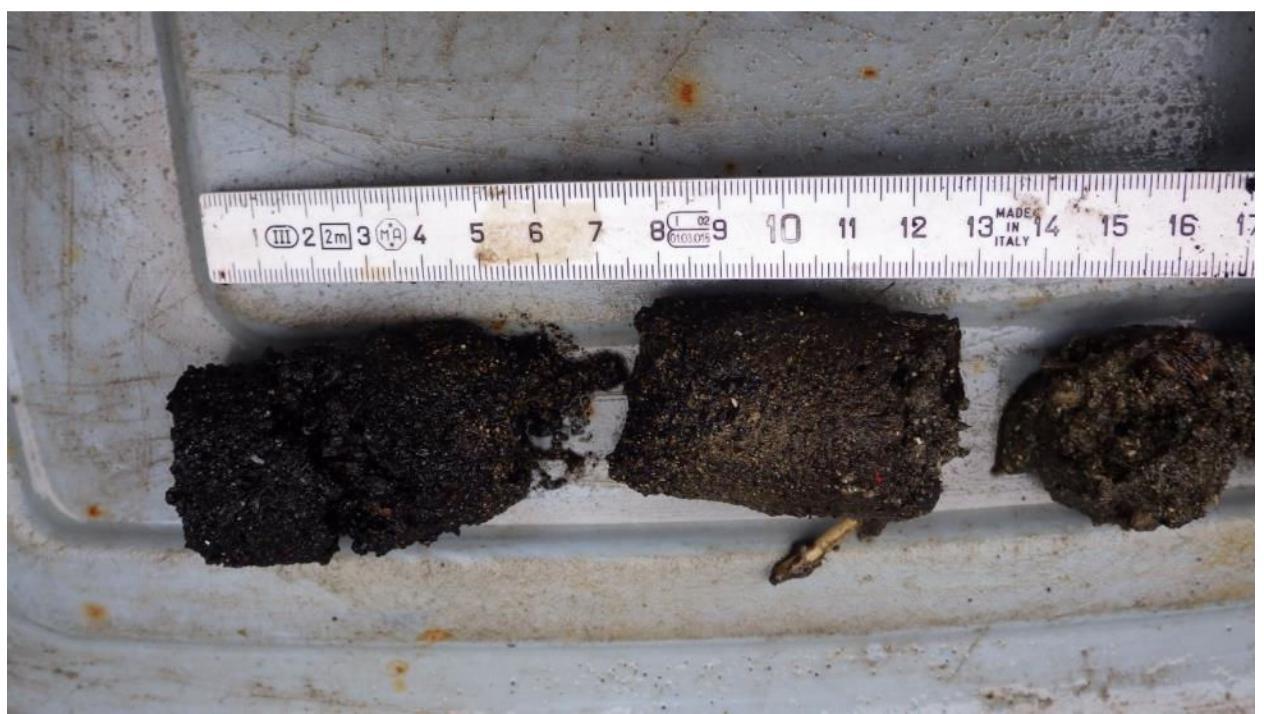
Photo 8. Representative example of fine particle size core sample and division of substrate layers collected along the east portion of the alluvial fan (25 m transect 4 m from shore), January 17, 2014.

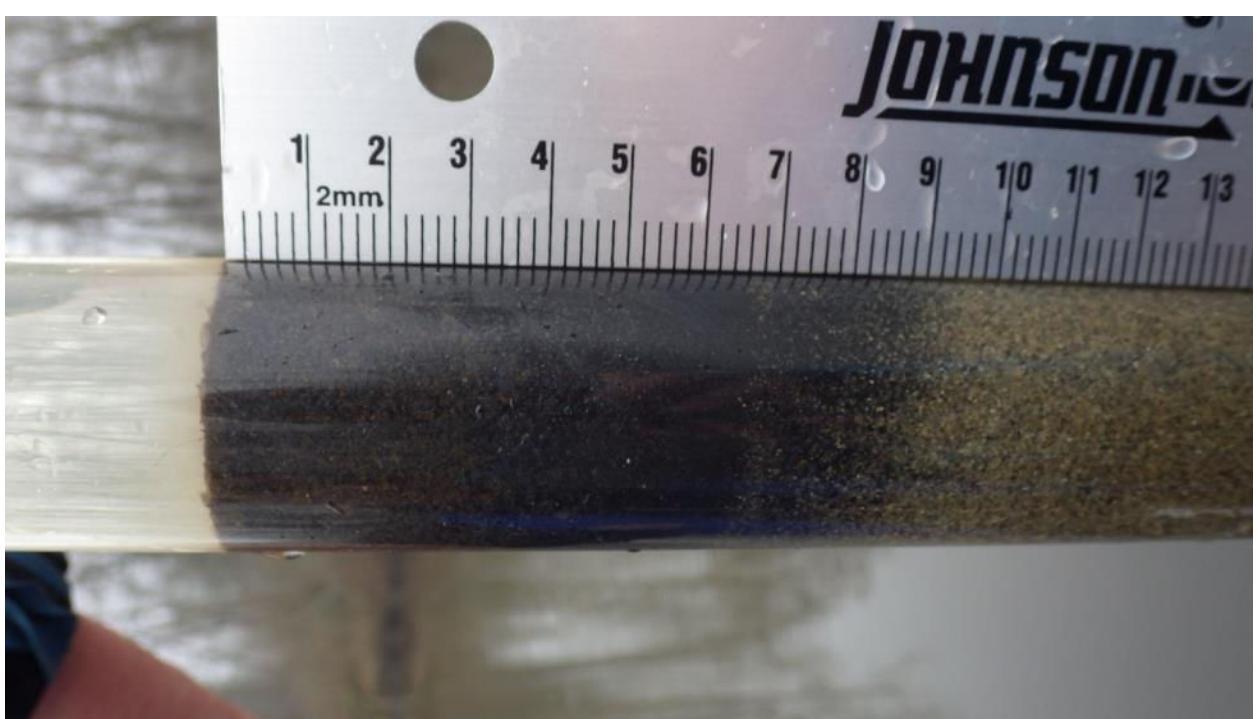
Photo 9. Example of clear contact between coal deposition and underlying sand substrate. Core sample collected on alluvial fan at 25 m transect, 15.5 m from shore in Burnaby Lake, January 17, 2014.

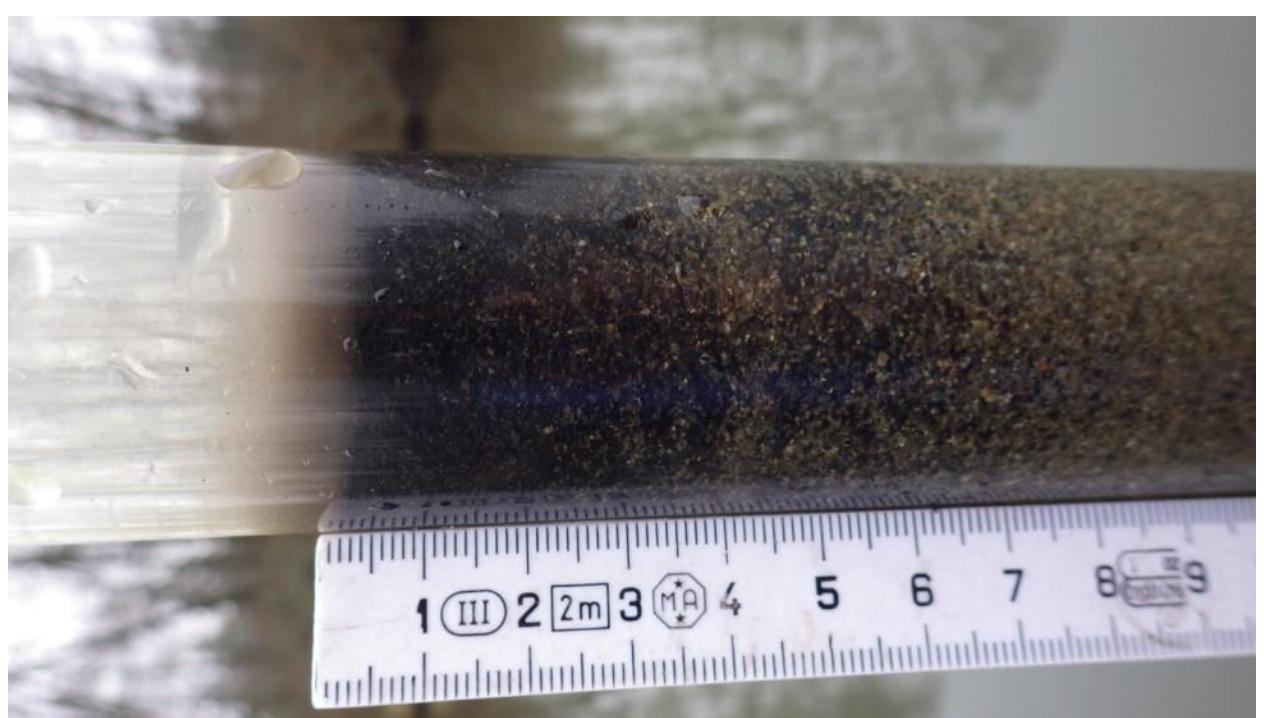
Photo 10. Example of mixed contact between coal deposition and underlying sand substrate. Core sample collected on alluvial fan at 30 m transect, 13.5 m from shore in Burnaby Lake, January 17, 2014.

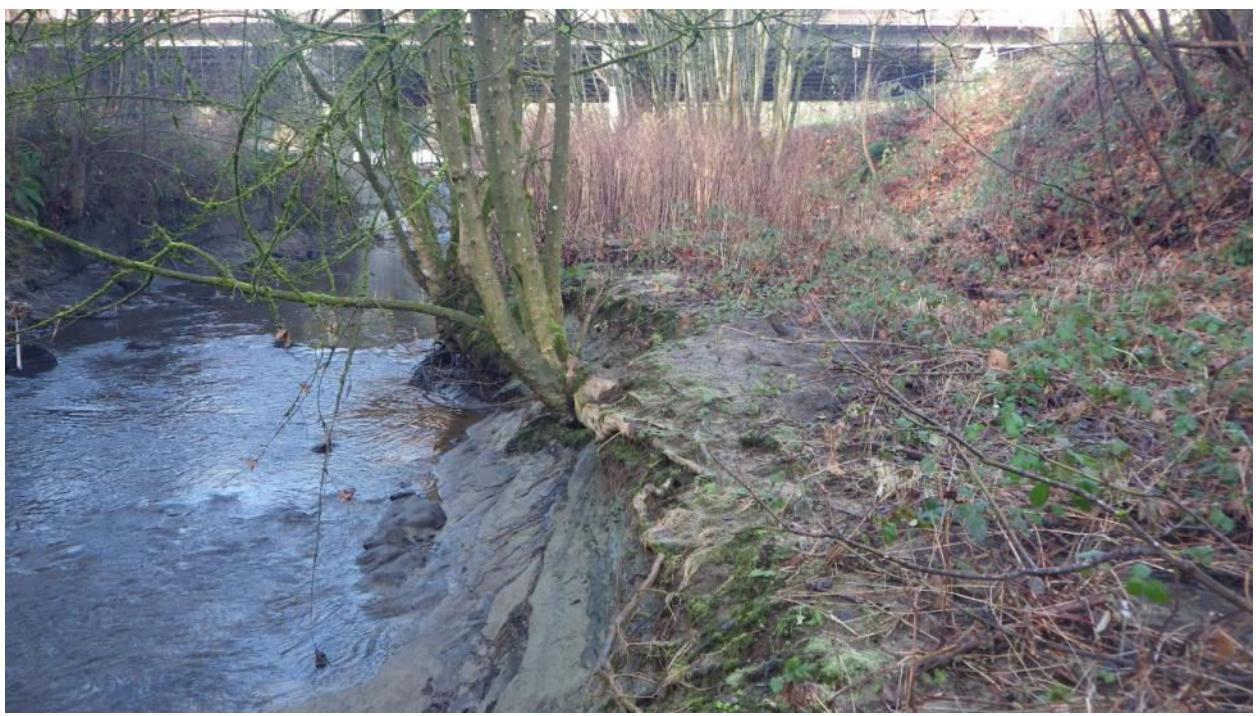
Photo 11. Example of surface deposition observed on an elevated bench along Brunette River approximately 1.3 m above low water level. The deposit was 15 m long by 7 m wide (estimated coverage of 1% and 1-5 mm deep) approximately 50 m downstream of the Gaglardi Overpass, January 29, 2014.

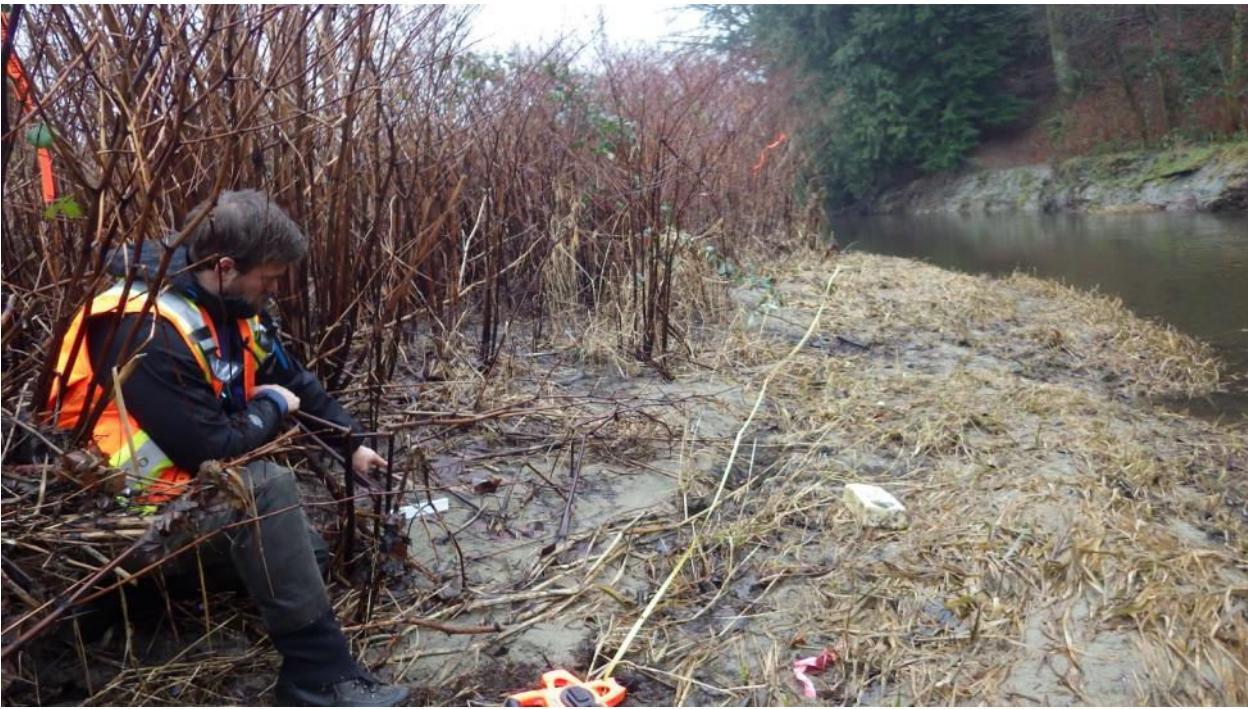
Photo 12. Example of surface deposition located on an elevated bench along Brunette River approximately 0.8 m above low water level. The deposit was 4 m long by 1.5 m wide (estimated coverage of 1% and up to 5 mm deep) located approximately 40 m downstream of Hume Park, New Westminster, January 29, 2014.

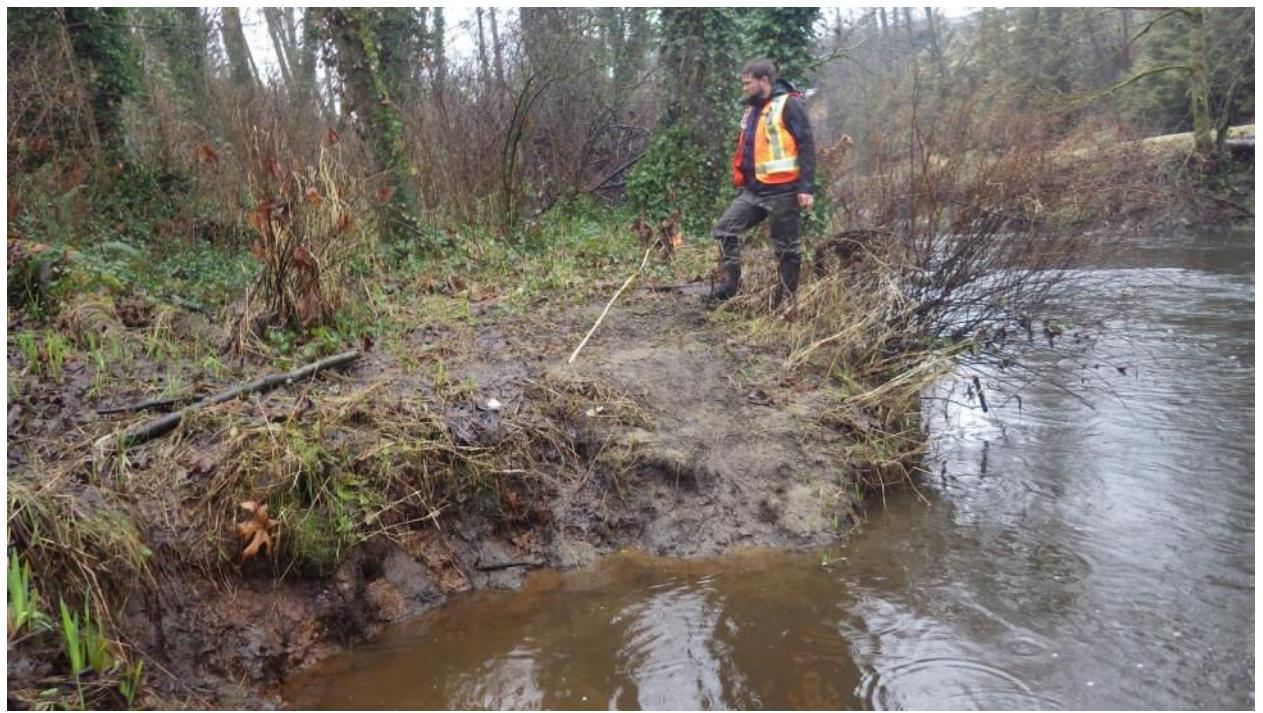
Photo 13. Example of surface deposition on an elevated bench along Brunette River approximately 1.1 m above low water level. The deposit was 25 m long by 1 m wide (estimated coverage of 5%, and approximately 1 mm deep), January 29, 2014.

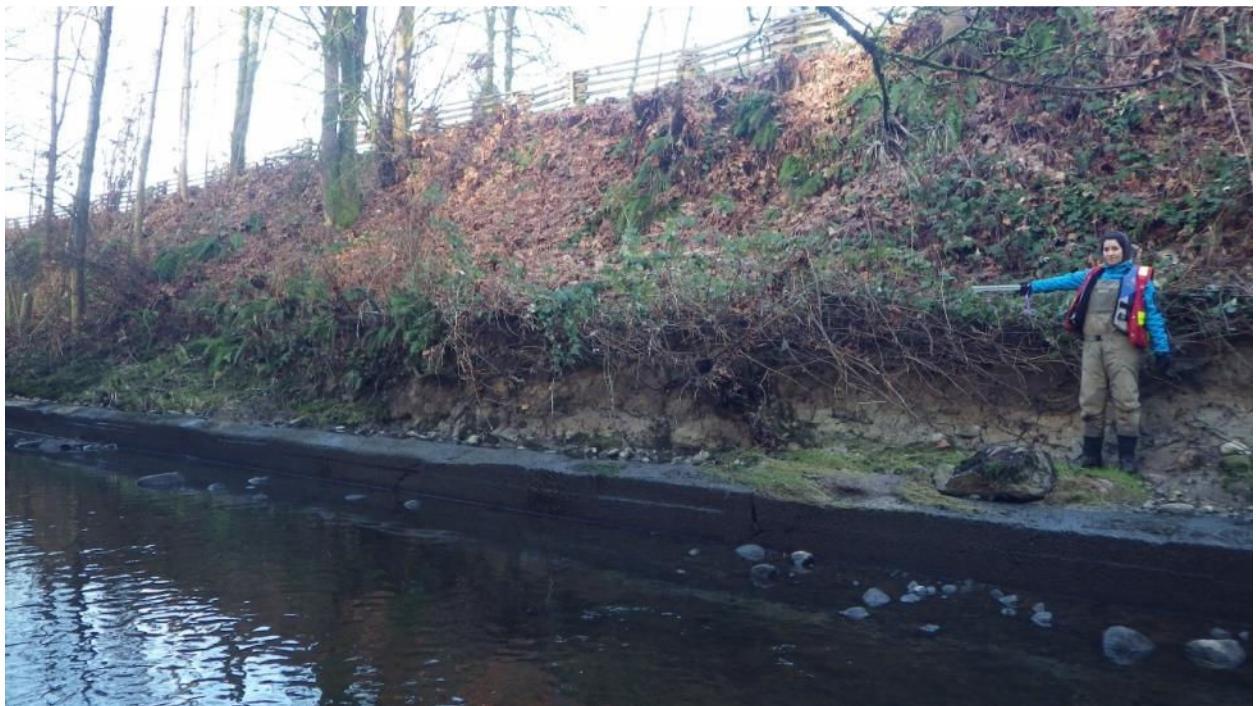
Photo 14. Example of surface deposition on an elevated bench along Brunette River located approximately 145 m downstream of the Cariboo Dam, January 29, 2014

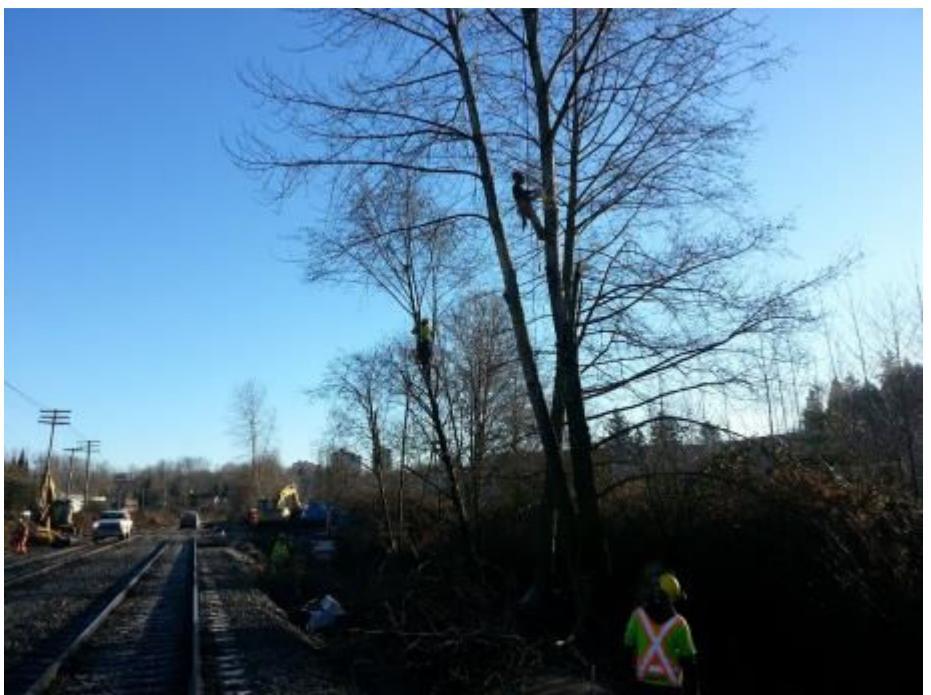
- Selected Danger Trees⁴ and other trees located in areas of beaver activity in the CN ROW (23 specimens in total) were either removed or topped (Appendix 2, Photo 7). Hazard trees removed as part of the stabilization work were replaced with additional tree and tall shrub planting conducted as follows:

Photo 7. Danger trees and other trees deemed hazardous to railway infrastructure in or near areas of beaver activity were assessed and removed during Silver Creek bank protection/stabilization works.

- Trees that fell across the stream or close to the tracks were removed from site. Trees felled on the south bank, away from the tracks, were left on site as habitat features. *Note: in August 2014, new leaf growth was observed on multiple topped deciduous specimens in the ROW.*

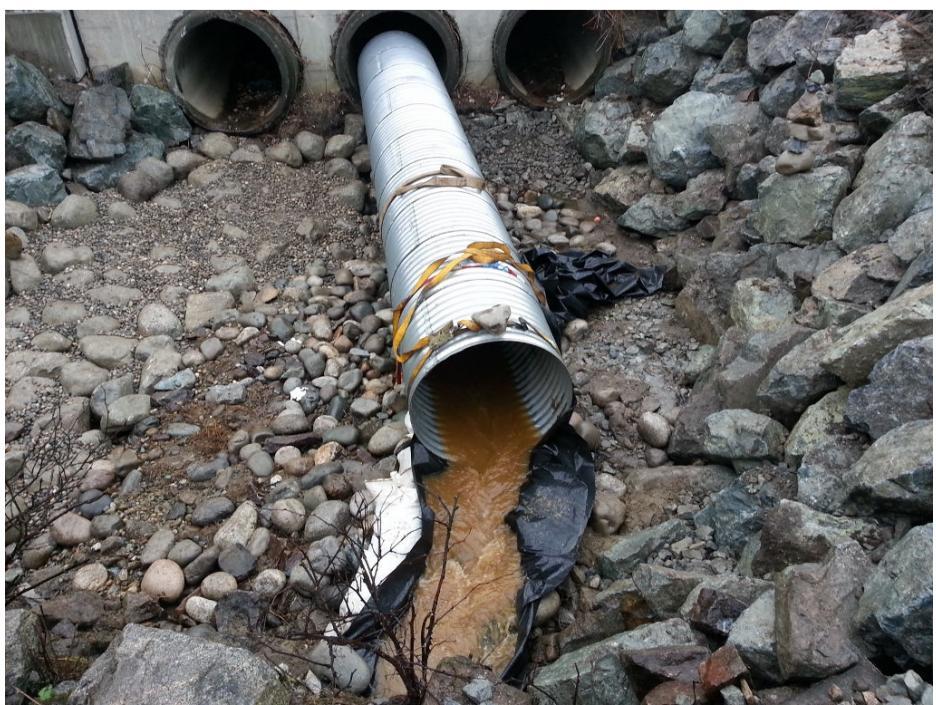
Photo 8. Example of turbid water originating for the City of Burnaby storm sewer and being discharged into Silver Creek, January 28, 2014 following a rain event.

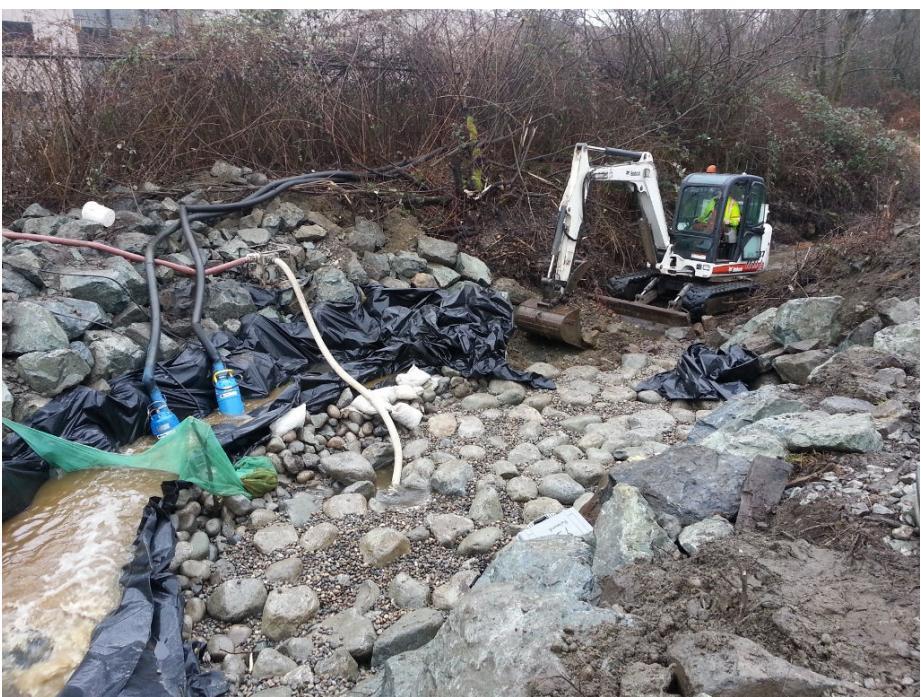
Photo 9. Water from upstream of the work area (in this case turbid water originating from the City of Burnaby storm sewer system) was intercepted by pumps and diverted around the work area, January 28, 2014 following a rain event.

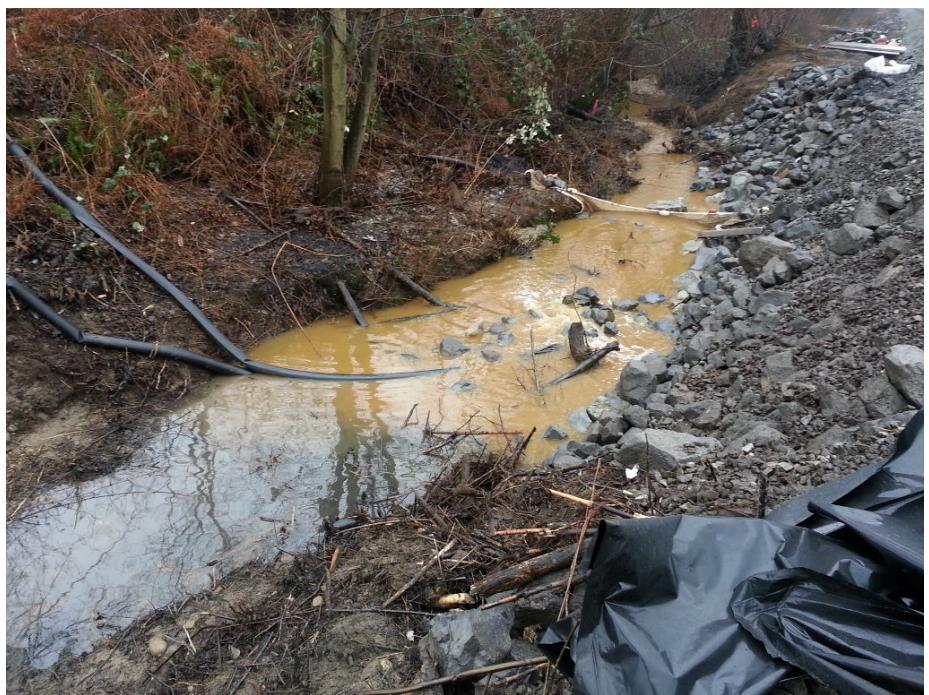
Photo 10. Water from upstream of the work area (in this case turbid water originating from the City of Burnaby storm sewer system) was discharged back into Silver Creek downstream of the work area, January 28, 2014 following a rain event. Note cleaner water on left from upstream work area.
