PROTOCOL FOR THE INSPECTION OF BRIDGE BEARINGS

Ministry of Forests, Lands and Natural Resource Operations

Allnorth Consultants Limited

February, 2011

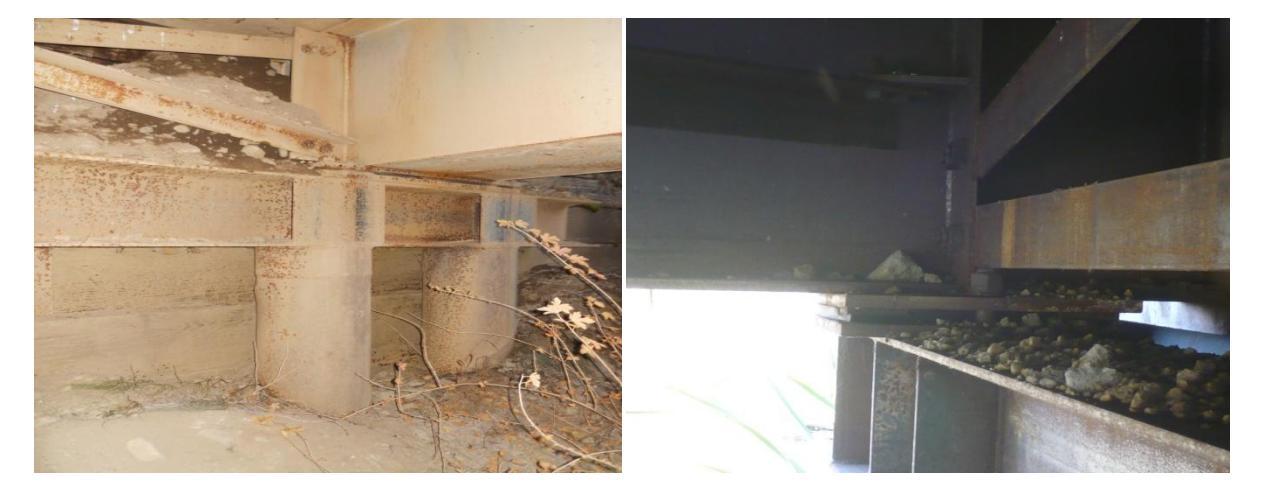
<u>Cause:</u> Dirt, dust and debris can be deposited during construction, through subsequent use by traffic and wind, or in some cases by flooding.

Implication: Allowing dirt and debris to remain in contact with the bearings attracts moisture from rain, runoff or humid air and the moisture promotes deterioration. Consequences include rotting timbers, rusting steel and spalling concrete.

Example of dirt and debris impeding the function of bearings and promoting deterioration.

<u>Recommendation</u>: Dirt, Dust and Debris that has accumulated during construction should be cleaned immediately and prior to placing the structure in service. Materials that accumulate while the structure is in service should be removed as part of a regular maintenance program.

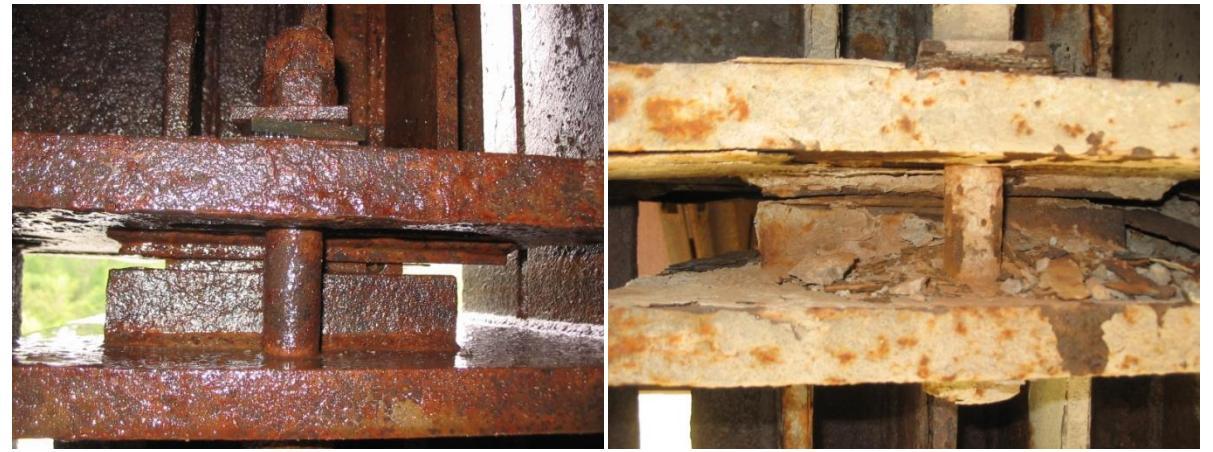
<u>Cause:</u> Corrosive elements include airborne chemicals, (pollution), ice melting chemicals applied to the road surfaces in colder climates and even salt mist found in coastal environments. These elements react with the bridge components causing accelerated deterioration of the materials.

Extreme examples of rusted bearings

Recommendation: Water that is observed to be flowing onto the bridge and contacting the bearings should be diverted away from the structure. If corrosive chemicals are utilized for ice melting during winter applications, consideration should be given to avoiding depositing these materials on the bridges. For those applications subject to salt spray or other corrosive elements in the air, consider selecting different materials for the bearings or protective painting etc.

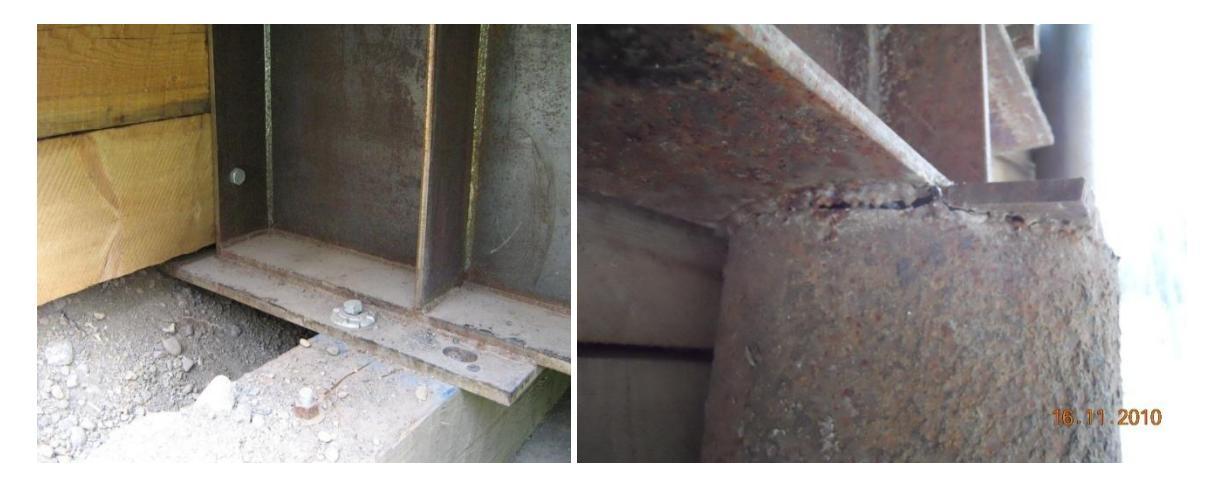
<u>Cause:</u> Loose, bent, broken or missing fasteners are most likely the result of an installation defect or wear and tear as the structure is stressed during use. Other more serious causes are discussed in subsequent sections of this protocol.

Missing lag screw

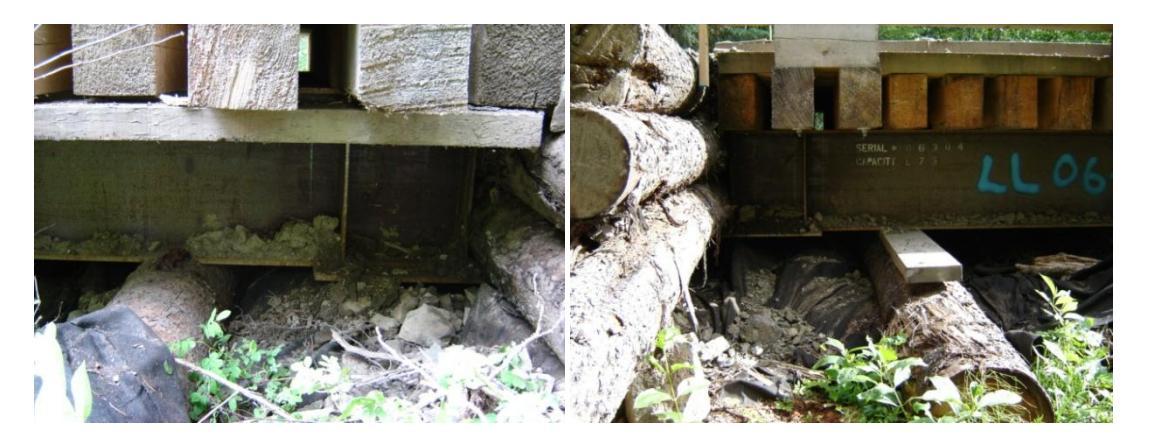
<u>Implication</u>: As detailed in the General Section, mis-aligned components may contribute to early failure of the structure by allowing bending of the flanges, webs or stiffeners in the girders thereby lowering their ability to support the intended loads. Progression of deformation may ultimately lead to structural failure.

Neither the bearing plate nor the stiffener is properly aligned with the sills.

<u>Recommendation</u>: For structures that were improperly installed, the superstructure should be lifted off the foundation and the sills repositioned at the appropriate spacing to allow the plates and stiffeners to center over the sills. The superstructure should then be properly fastened to the sills prior to be put in service. Consider restricting load sizes until repairs are complete. Alternatively it may be possible and easier to add web stiffeners and address securing the bridge without removing it. These solutions will require referral to a Professional for recommendation.

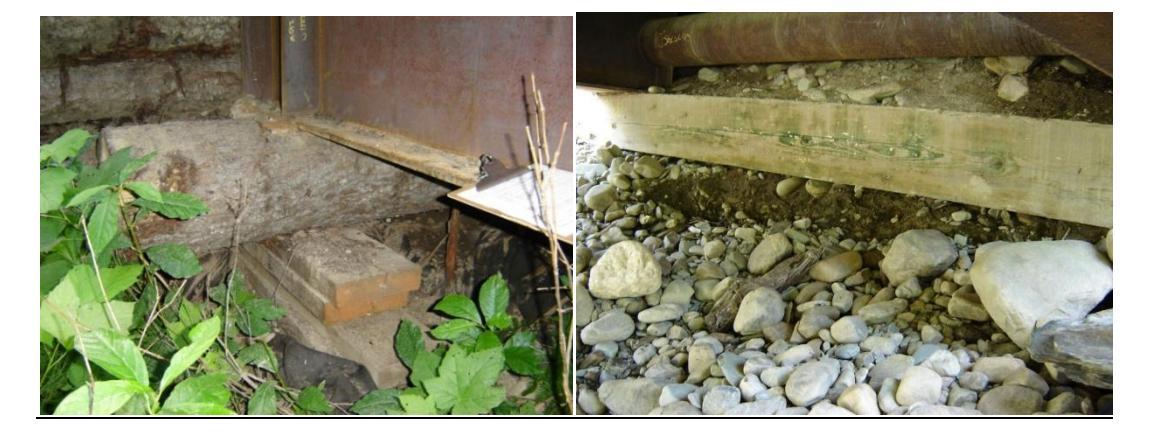
<u>Implication</u>: If the foundation does not provide adequate support for the structure and the loads to be applied, uneven settlement, twisting and bending of the superstructure and ultimately structural failure may result.

Voids under foundations caused by settlement or erosion (those blocks are insufficient)

<u>Recommendation</u>: For structures that were improperly installed, the superstructure should be lifted off the foundation and adequate bearing capacity established in the underlying soils. The sills can then be re-positioned and the superstructure should then be properly fastened to the sills prior to being put in service. *Consider restricting load sizes until repairs are complete.*

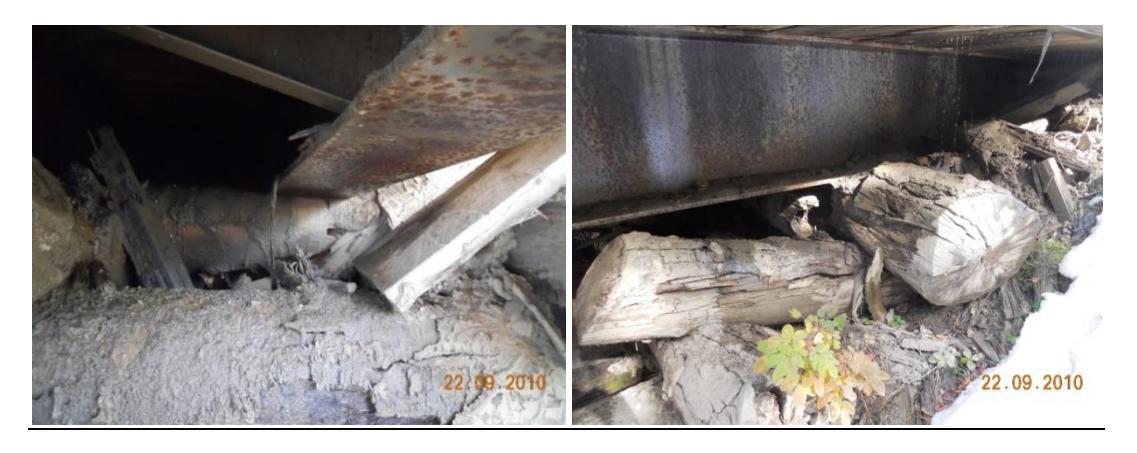
Broken materials under girders caused by using under sized materials or subsequent deterioration

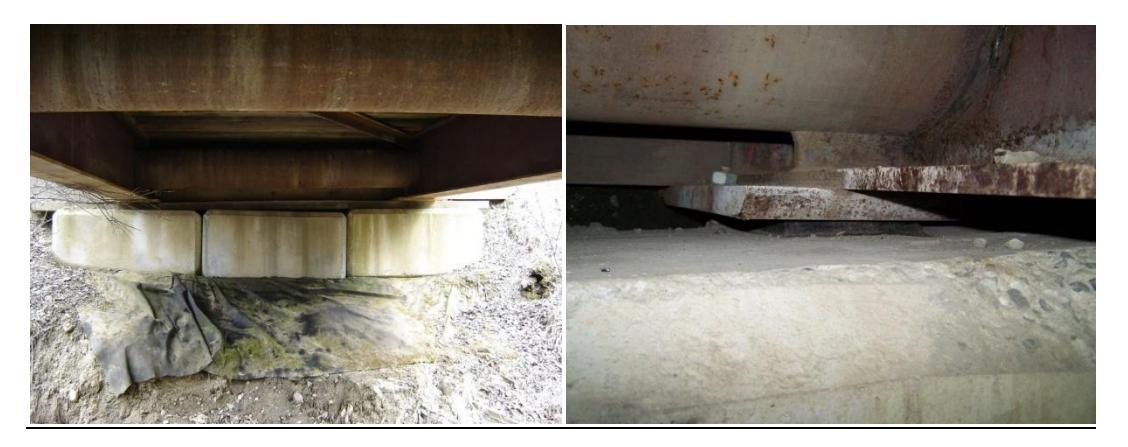
<u>Cause:</u> Poor design. Poor construction technique, lack of adequate supervision during construction.

<u>Implication</u>: The significance of this problem is dependent on the bearing capacity of the underlying soils and the quality of materials and quality of installation of the lock blocks. If there is insufficient bearing capacity in the soils, the forces being transferred through a single lock block may be larger than the soil's capacity to resist and result in uneven settlement of the structure. The blocks themselves may fracture under heavy loads. This can eventually lead to racking or twisting of the superstructure and ultimately structural failure.

Left: Inadequate cap does not bear on center block. Right: No cap, only 1 block carries entire load

<u>Recommendation</u>: All lock block foundations require an adequately sized and properly fastened cap beam for the girders to bear on. The soils underneath the lock blocks must be properly compacted during installation to ensure uneven settlement does not occur. If uneven settlement has occurred, repairs are required to be undertaken to address the settlement and may entail the entire structure being removed and a proper base prepared for the lock blocks to bear on. If settlement has not occurred, consideration should be made for designing and installing an appropriately designed cap beam. Fractured or broken blocks should be replaced or otherwise repaired as directed by an engineer.

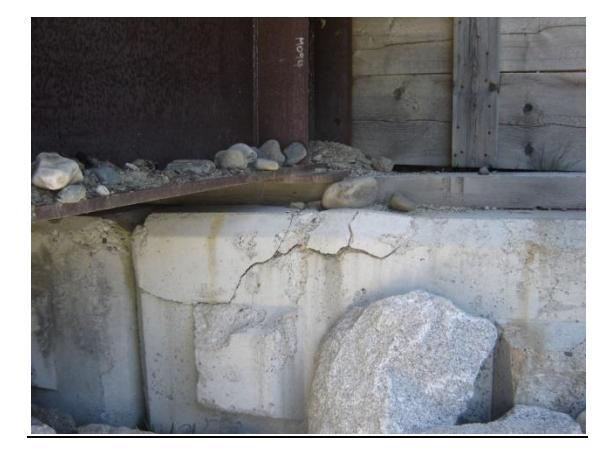
Fractured lock block.

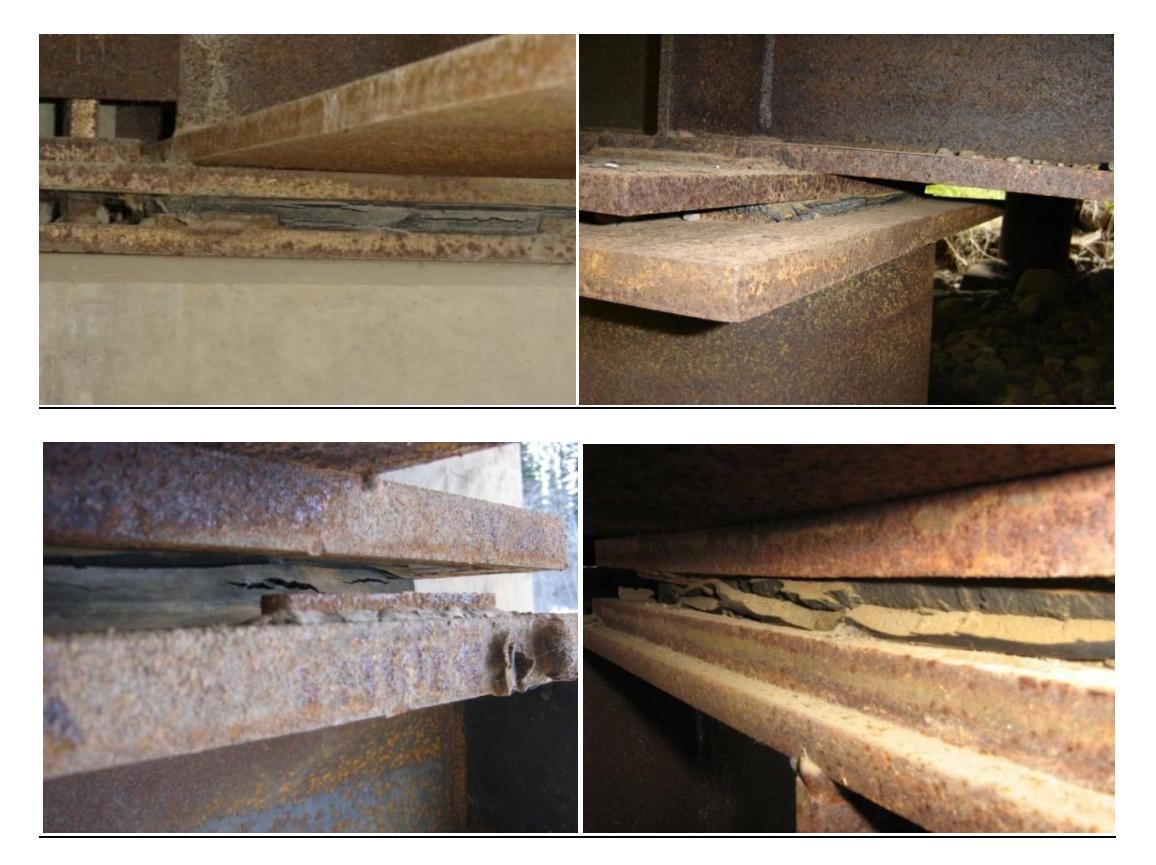
The elastomeric bearing pads in the following images show signs of cracking and are losing their flexibility.

Examples of physical deterioration of elastomeric pads.

<u>Cause:</u> Deterioration of the elastomeric pad is often caused by the presence of corrosive elements and or crushing.

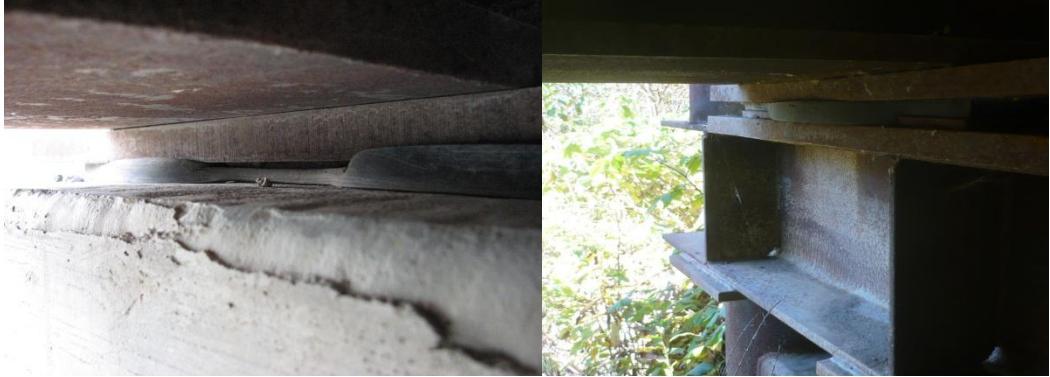
Examples of crushing (bulging) of the elastomeric pad is evident in these two images

<u>Cause:</u> Deformation of the Elastomeric Pad may have 3 causes. 1.) The strength of the original pad may have been underspecified or incorrect material supplied for construction. 2.) The pads may be subject to loading that was not anticipated during design. 3.) The anchor bolts may have been over tightened not allowing for the clearance as specified on the design drawings.

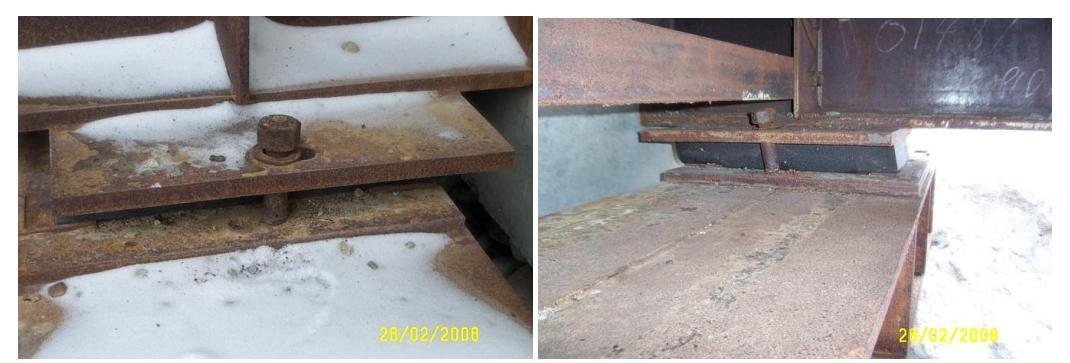
The bolts securing these bearings to the foundation have been sheared off.

<u>Cause:</u> Bending and shearing of the bolts connecting the upper and lower bearing plates may be the result of several different causes

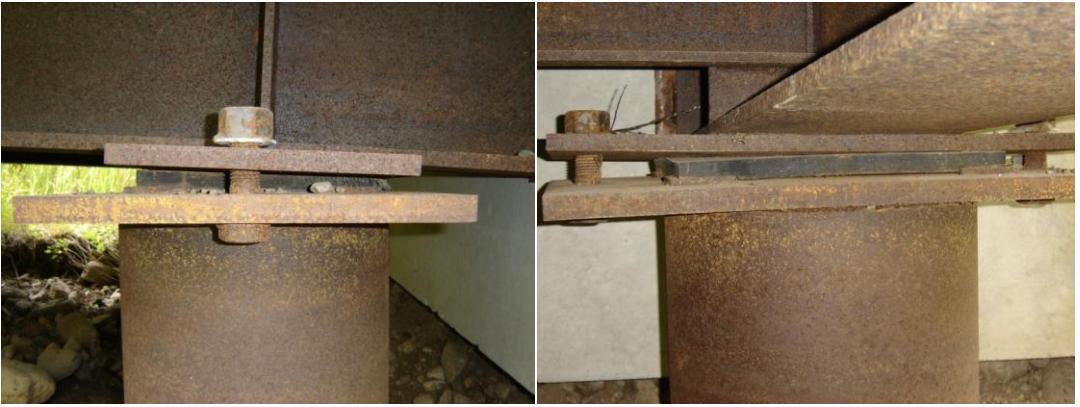
Left: Side view of bearing, plates are not parallel causing crushing at the abutment end of the pad. Right: Same bearing, viewed from under the bridge, note gap on the face and left side.

In this case the cause of the problems noted in the preceding 4 images is uneven settlement of one spread footing. The uneven settlement is causing a tilt to the support tower that puts unanticipated loading onto the superstructure through the bearing.

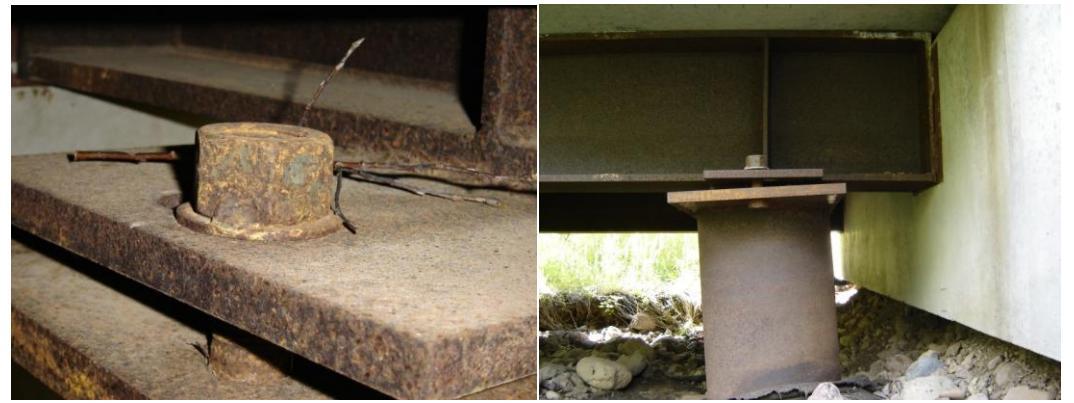
Left: Same bearing, bolt is at the limit of expansion in the expansion slot Right: Overview of the same bearing.

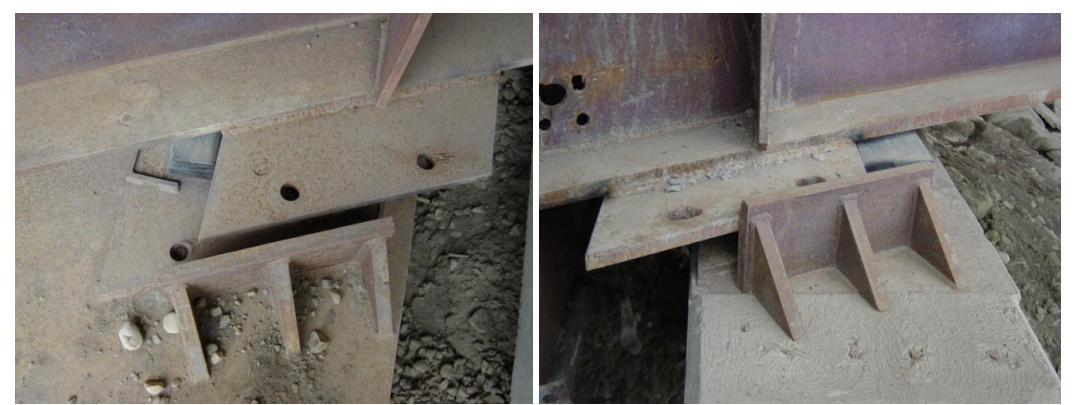
After the failure of the bolts, the bearing plates on both ends of this bridge have shifted to such an extent that there is now insufficient bearing area.

<u>Cause:</u> In this case it was determined that there were unforeseen geotechnical forces at work in the slopes adjacent to one of the abutments. This unanticipated pressure was causing the foundation to move relative to the superstructure.

It is recommended that any significant occurrence of shifted bearing plates be referred to a professional engineer for advice.
