ALASKA HIGHWAY #97N CORRIDOR IMPROVEMENT STUDY

DAWSON CREEK TO FORT ST. JOHN, BC

FINAL REPORT

March 2008
H-08321.00

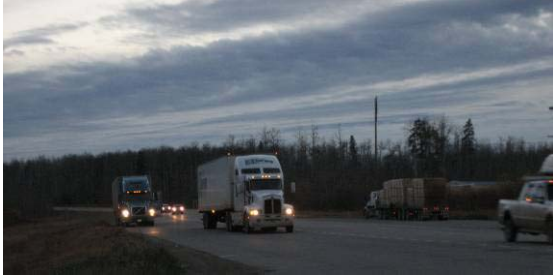
<p><i>Heavy truck traffic and congestion</i></p> <p>Truck traffic was observed to be significant. Some risky manoeuvres were observed being taken by drivers while trying to pass heavy vehicles. The lack of passing opportunities also contributes to the frequencies of such dangerous manoeuvres. Along hill sections where one travel lane is provided, significant delays are experienced by vehicles following behind heavy vehicles. Numerous “wide loads” were observed, further contributing to delay.</p>

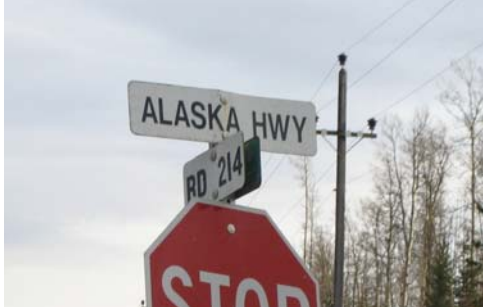
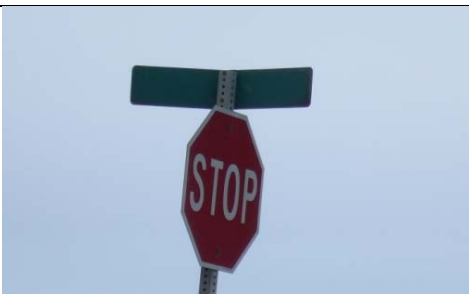
<p><i>Signing issues</i></p> <p>Some issues were noted with respect to the conspicuity and location of signs. Street name signs were small, and not in the current “white on green” standard. Some street name signs were visible from one direction only. Advance street name signage was not provided at all locations. Low</p>

<p>visibility signage makes it more difficult for wayfinding. Resulting last-minute turns may contribute to collision risk.</p>

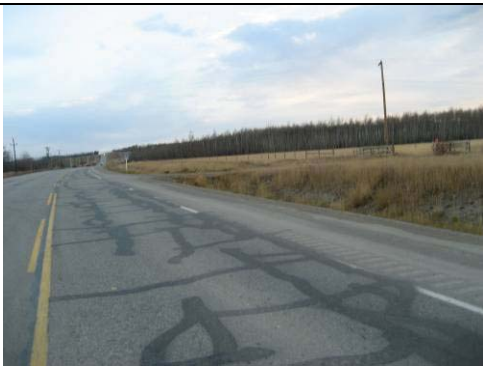
<p><i>Delineation issues</i> Pavement markings along some sections were observed to be faded. Clear delineation to clarify travel lanes and other transitions such as merging areas may improve guidance for drivers.</p>

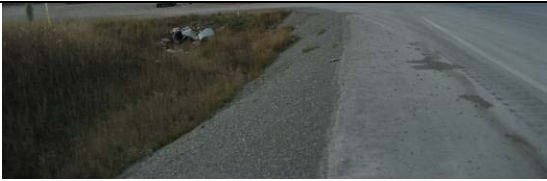
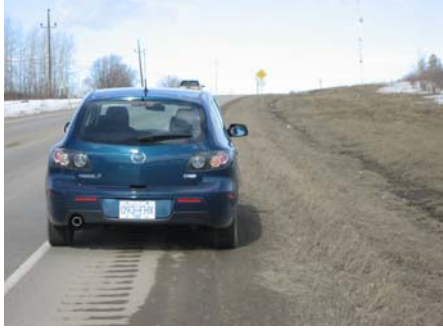
<p><i>Speeding and lack of police presence</i> Speed data was not available. However, during several drive-throughs of the corridor, it was noted that vehicles speeds are generally high and often in excess of the posted speed limit. Speeding may contribute to increased severity of collisions.</p>	<p>Photo not available</p>
<p><i>Narrow / steep side slopes at some locations</i> While a wide shoulder is provided along the corridor for the most part, some locations have narrow and steep side slopes. This does not allow a larger vehicle with sufficient area to pull over, and may contribute to the severity of collisions.</p>

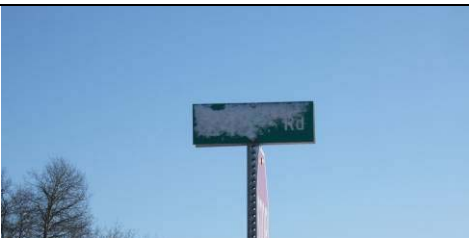
<p><i>Winter Driving Conditions</i> In addition to making the pavement surface more slippery, winter weather also makes the delineation, signage and even the roadway more difficult to see, adding to the driver's workload.</p>

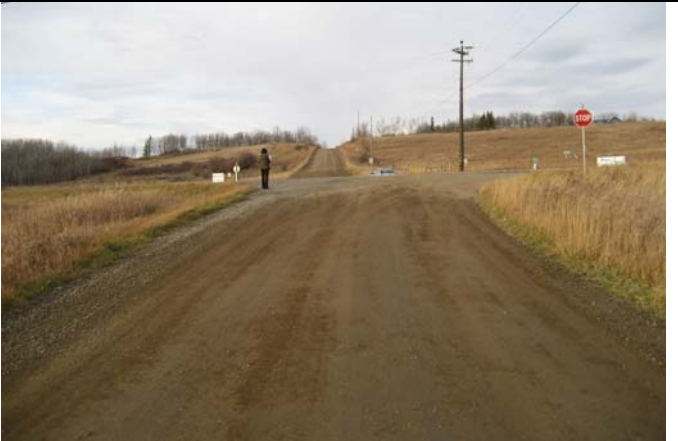
<p>Westbound Approach</p> <p>The westbound and eastbound approaches of the intersection are misaligned.</p>

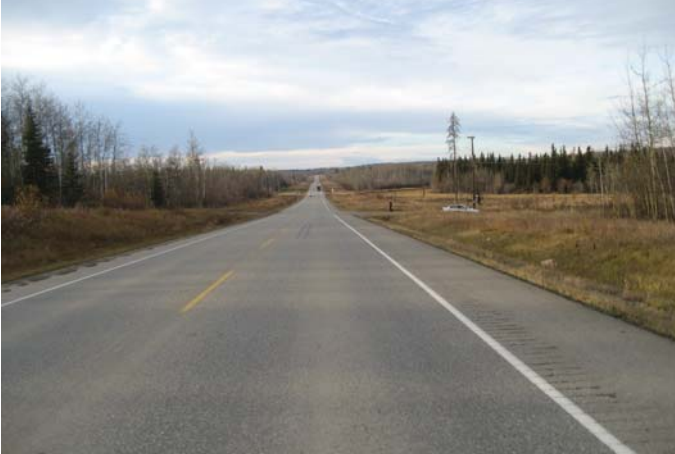
<p>Northbound Approach</p> <p>Lighting is not provided at the intersection.</p> <p>The small road signs and the lack of lighting make it difficult to see the intersection from both the northbound and the southbound directions.</p>

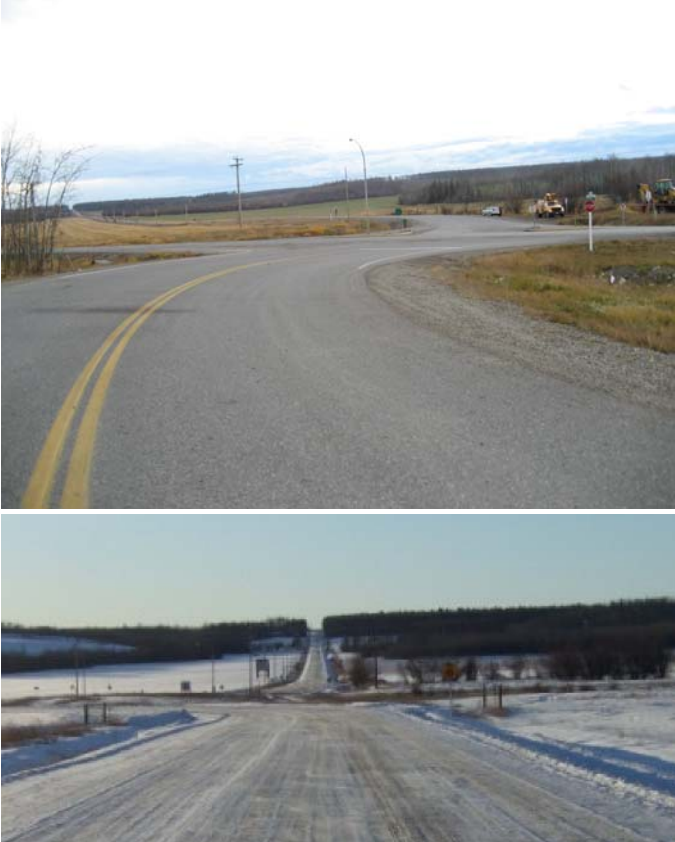
<p>Westbound Approach</p> <p>From the westbound approach, the eastbound approach looks aligned with the westbound approach, but there is actually a horizontal curve in the road. There is a warning sign to warn westbound drivers of the horizontal curve.</p>

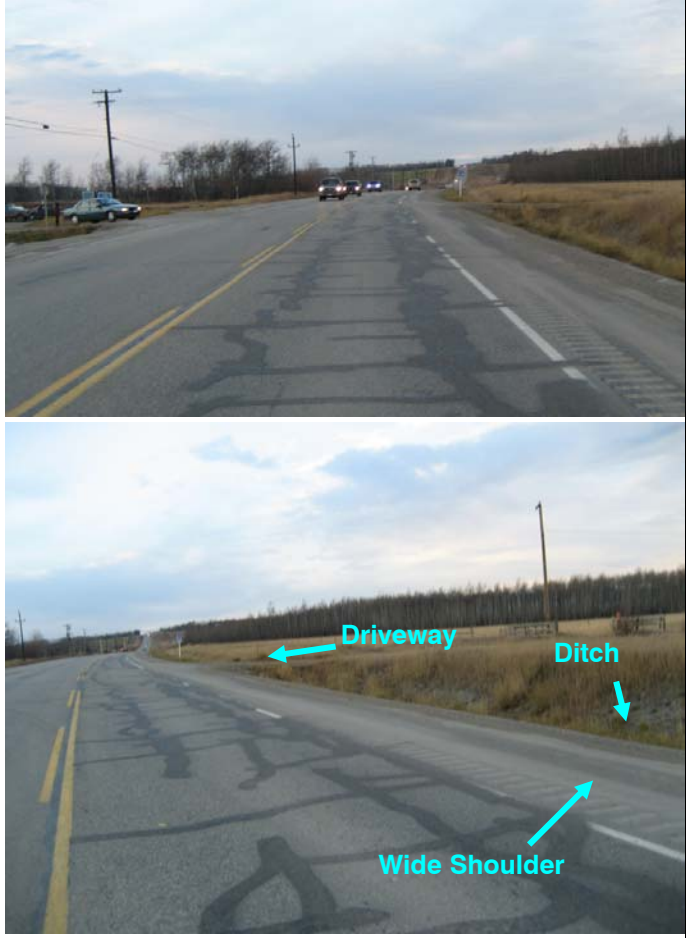
<p>Northbound Approach</p> <p>There is no northbound left-turn lane into the store, which may result in long queues.</p> <p>The accesses to the store are poorly lit. Except for the lights at the gas station, lighting is not provided at the accesses.</p> <p>The shoulder is wide in the northbound direction. However, the ditch makes it difficult for drivers to use the shoulder to pass vehicles turning left into the store. The driveway, also located in the northbound direction, may limit further widening of the shoulder.</p>

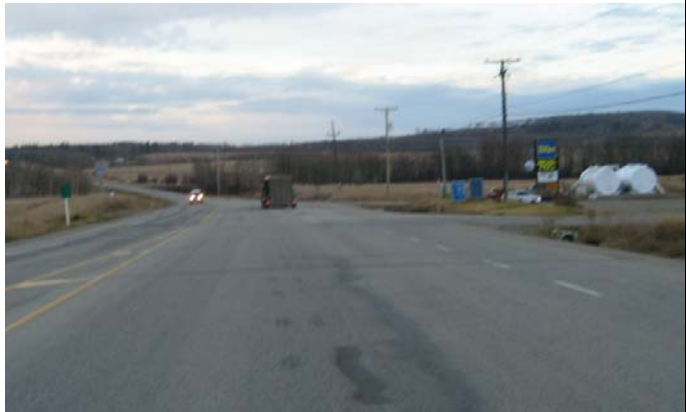
<p>Southbound Approach</p> <p>There is an acceleration lane beginning at Parkland Road that continues to the South access of the store. Although this lane allows drivers to turn into the north store access, the lane configuration is confusing to drivers who do not intend to turn into the store.</p>

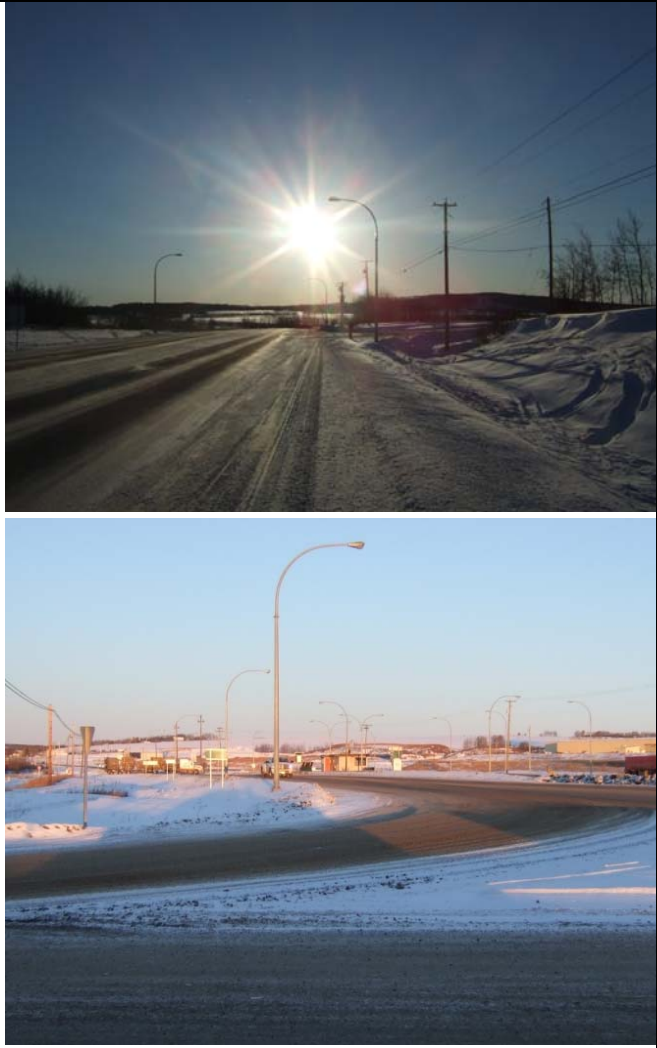
<p>Southbound Approach</p> <p>From Parkland Road, sight distance to the south is restricted by the horizontal curve. Street furniture on the west side of the highway also limits sight distance to the south.</p> <p>There is a southbound right-turn lane; however, it is difficult to see the lane markings for this lane.</p>

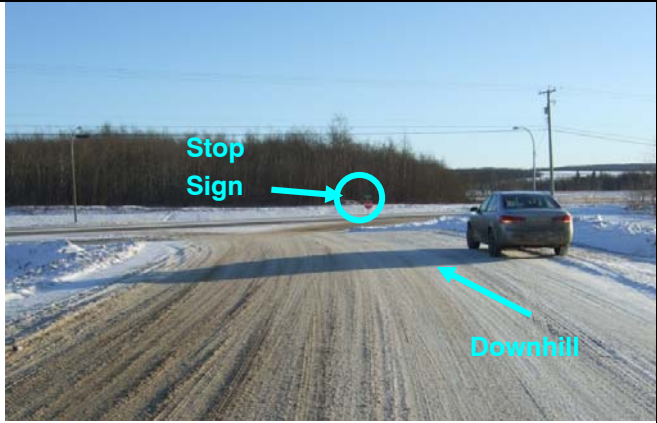
<p>Eastbound Approach</p> <p>There is a vertical crest just west of the eastbound approach. This may make the stop sign, which is situated at the bottom of the vertical curve, difficult to see.</p>

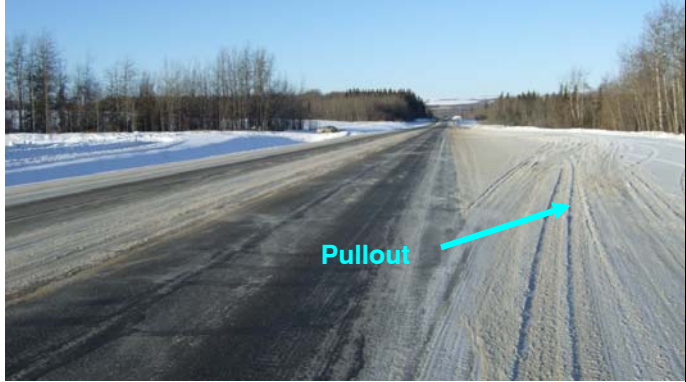
<p>Northbound Approach</p> <p>There is a pullout in the northbound direction, which may distract drivers from seeing the intersection.</p> <p>There is a passing lane in the Northbound direction. The passing lane makes it difficult for drivers to make left-turns from 245 Road onto the highway.</p>

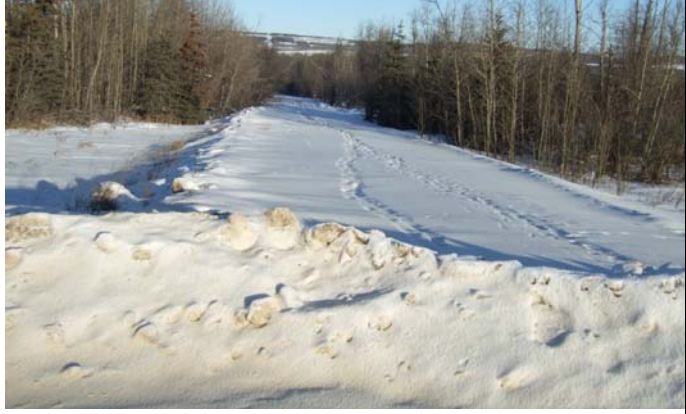
<p>Westbound Approach</p> <p>During the winter season, it appears that the westbound approach is not maintained and is closed.</p>

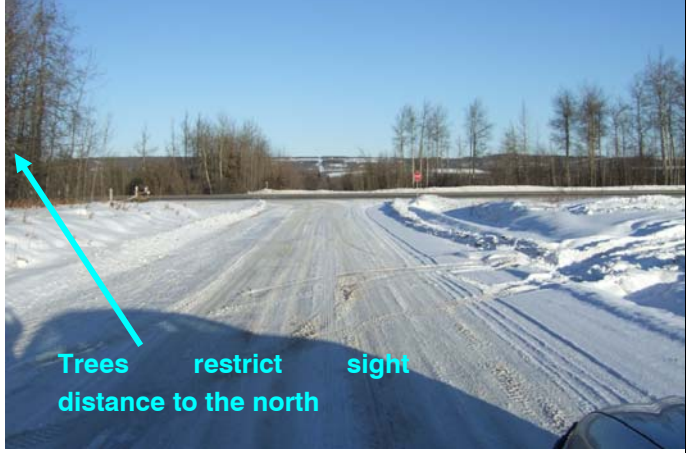
<p>Eastbound Approach</p> <p>From the eastbound approach, sight distance to the north is restricted by the trees.</p>
	<p>General Observations</p> <p>Lighting is not provided at the intersection.</p> <p>The minor approaches of the intersection are not aligned.</p>

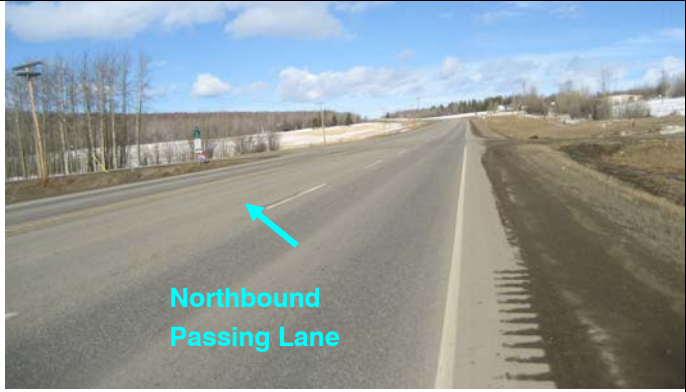
<p>Northbound Approach</p> <p>A northbound passing lane goes continues through the intersection. The passing lane makes it difficult for drivers to make left-turns from Braden Road onto the highway.</p>

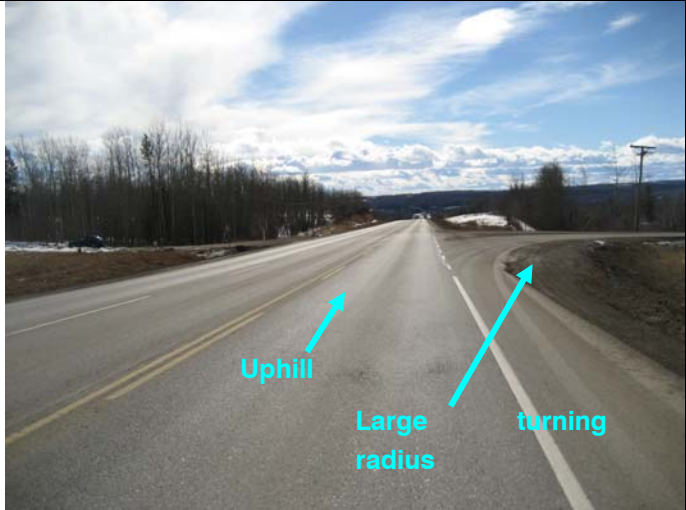
<p>Southbound Approach</p> <p>Sight distance to the south is restricted by the vertical curve</p> <p>There is a channelized southbound right turn lane with a big turning radius.</p> <p>Braden can be considered a major intersection as it provides access to the District of Chetwynd. However, there are no signs directing drivers to the intersection.</p>

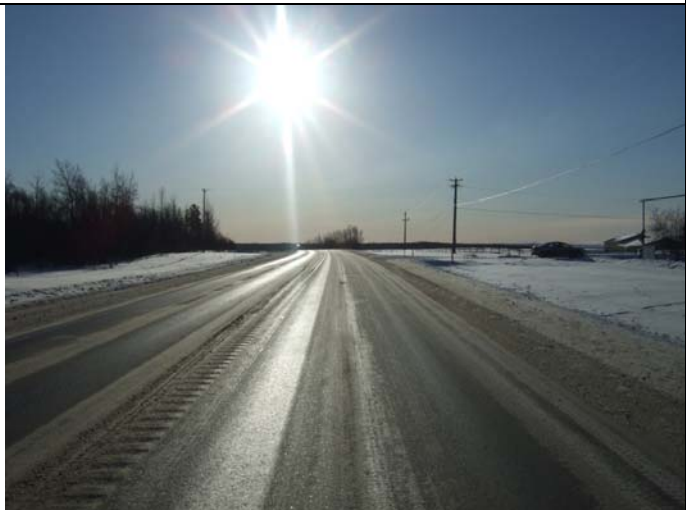
<p>Southbound Approach</p> <p>There is a vertical curve approximately 200 meters from the intersection. This may not allow enough sight distance for a slow moving farm vehicle.</p>

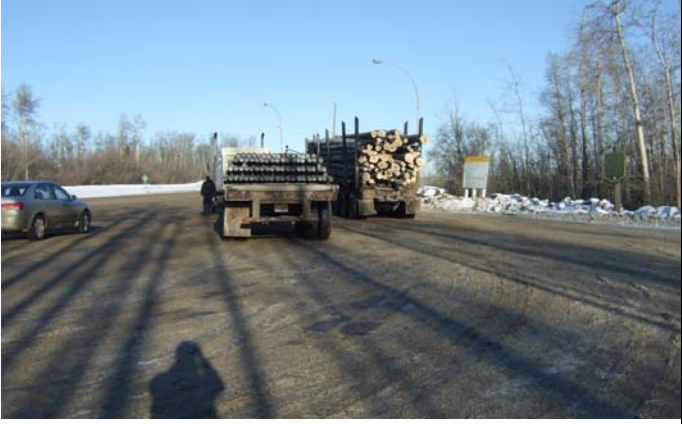
<p>Northbound Approach</p> <p>The brake check is very wide, but has no lane markings. No particular parking order was observed to be followed by truckers at the brake check. Some trucks were observed to be on the shoulder, while other trucks pulled all the way in.</p> <p>It is suggested to provide signage to indicate to drivers where to stop. Parking stalls for RVs and passenger cars can also be drawn in.</p>
---	---

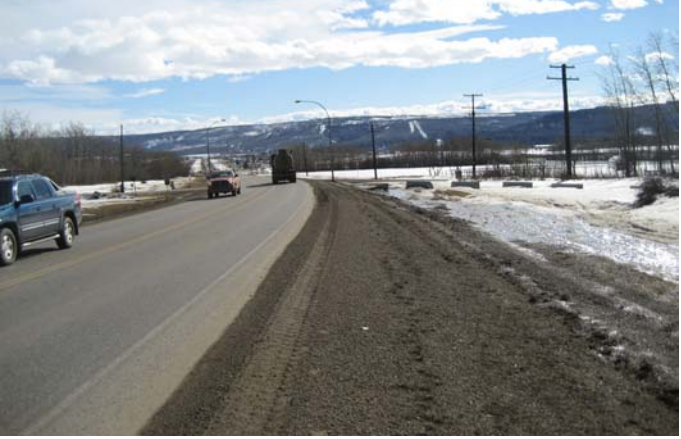
<p>Southbound Approach</p> <p>The southbound right-turn radius is tight.</p> <p>Although the school east of the intersection can generate a significant amount of traffic, there are no left-turn lanes at the intersection.</p> <p>The street name signs are small and the intersection is inconspicuous.</p>

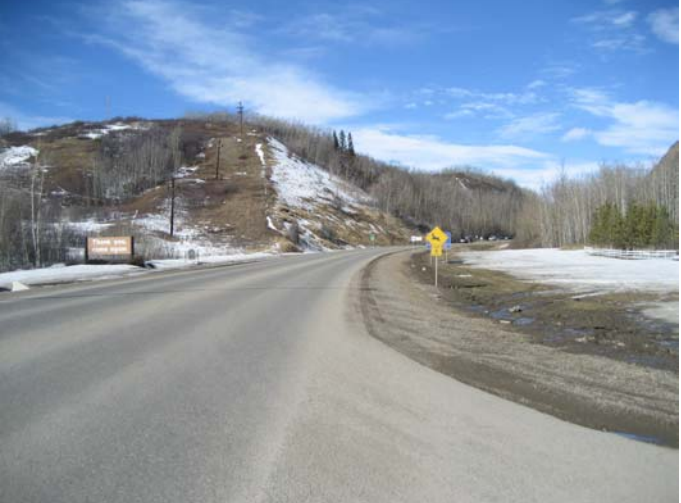
<p>Westbound Approach</p> <p>From the westbound approach, sight distance to the north is restricted by signs.</p>
	<p>General Observations</p> <p>The street name signs are small and the intersection is inconspicuous</p>

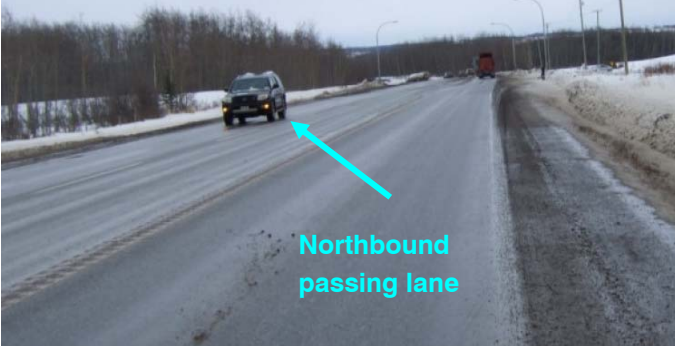
<p>A photograph of a northbound highway with a passing lane. A cyan arrow points to the passing lane, and the text "Northbound passing lane" is written in cyan below the arrow.</p>	<p>Northbound Approach</p> <p>The intersection warning sign in the northbound approach does not indicate the name of the upcoming intersection.</p> <p>The intersection is located at a passing lane, which makes it difficult for drivers to turn left onto the highway from Tod Road.</p>

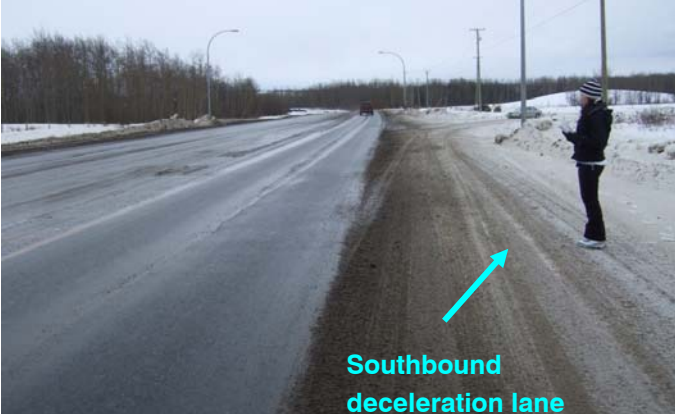
<p>A photograph of a southbound highway showing a deceleration lane. A cyan arrow points to the deceleration lane, and the text "Southbound deceleration lane" is written in cyan below the arrow.</p>	<p>Southbound Approach</p> <p>There is a southbound deceleration lane onto Tod Road.</p> <p>Sight distance to the southbound direction is insufficient because of the horizontal and vertical curves. When looking in the southbound direction, it is slightly confusing when determining where oncoming cars are coming from.</p>

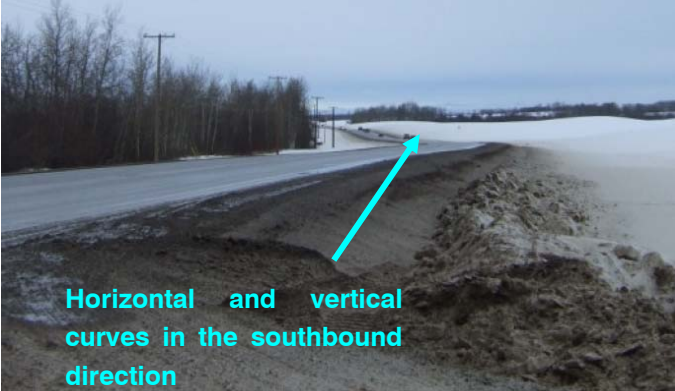
<p>A photograph showing the road curving in the southbound direction. A cyan arrow points to the curve, and the text "Horizontal and vertical curves in the southbound direction" is written in cyan below the arrow.</p>	<p>In the southbound direction, there are no signs regarding the upcoming intersection.</p>

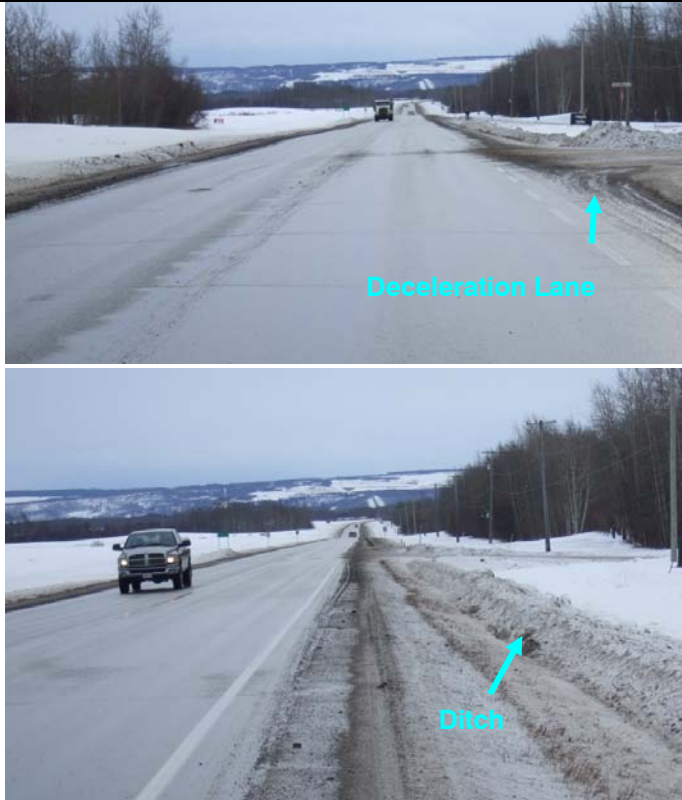
<p>Southbound Approach</p> <p>There is a southbound deceleration lane to turn into the intersection; however, there are no signs to indicate the presence of this lane. In the winter season, the lane is very difficult to see.</p> <p>The ditch on the southbound side of the road is steep and makes it difficult for drivers to use the shoulder as a pull-over area.</p>

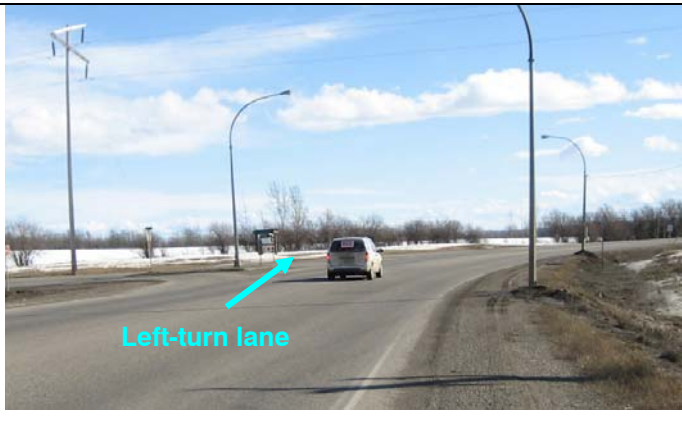
<p>Southbound Approach</p> <p>In the southbound direction, it is difficult to see the intersection. The underpass just before the intersection distracts drivers from seeing the intersection.</p> <p>There is a southbound left-turn lane at the intersection; however, it is difficult to see the lane marking. The southbound left-turn has a very tight turning radius even for a passenger car.</p>

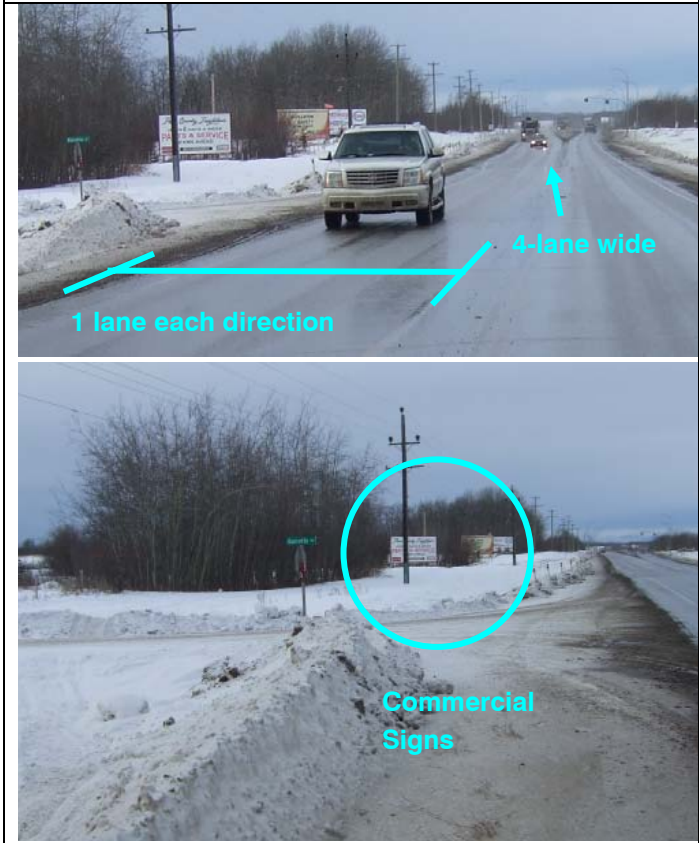
<p>Northbound Approach</p> <p>The lane configuration changes at the intersection from 1 lane in each direction to 2 lanes in each direction. There are no warning signs to indicate the change in the lane configuration. During the winter season, the lane marking is covered by snow and is not easily visible by drivers. This is of particular concern in the southbound direction because the narrowing of the highway will cause confusion over lane position. Combined with high travel speeds, the lane drop may make it difficult for turning vehicles to judge gaps in Highway traffic.</p> <p>In the northbound direction, there are many commercial signs along the highway, which may distract drivers from seeing the intersection.</p>
