# HIGHWAY 7 EASTBOUND SHERLING TRANSIT BUS STOP

**Geotechnical Design Report**

Client Name: Urban Systems Ltd. Date: May 9, 2024 File: 43376

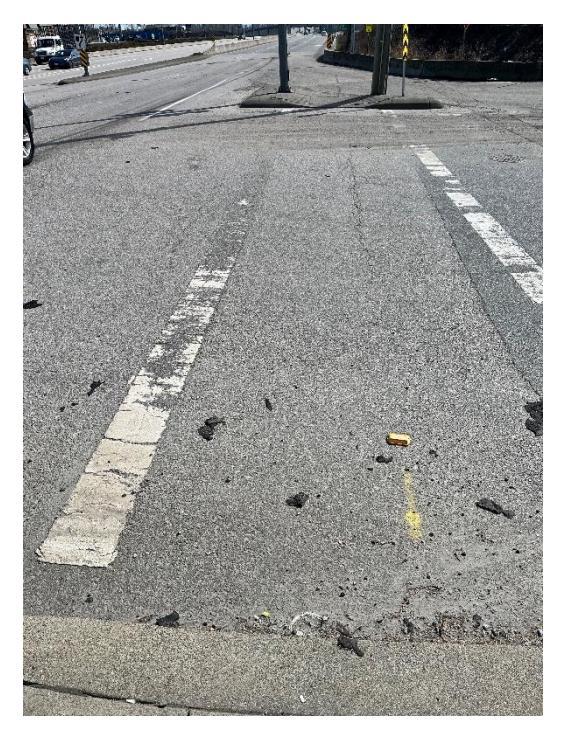
Photo 1: Moderate Severity Traverse Cracking At Sherling Avenue Crosswalk (EB Hwy &)

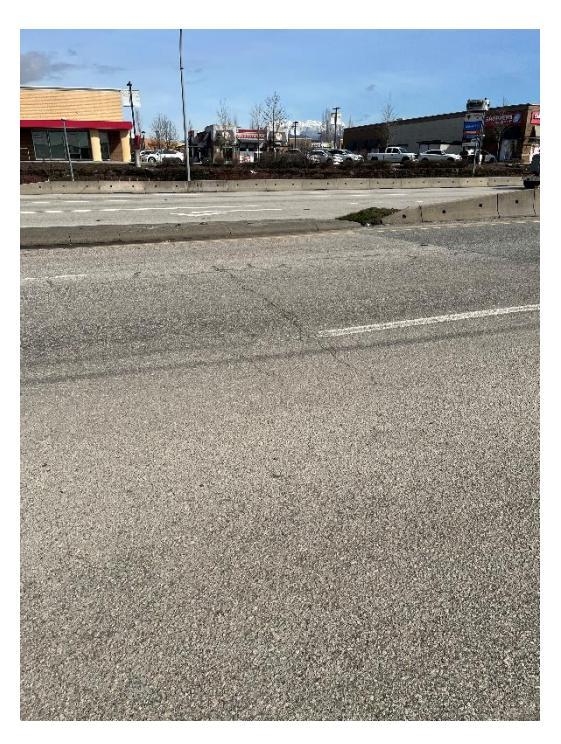
Photo 2: Moderate to Low Severity Traverse Cracking Near Sta. 100+90 (EB Hwy 7)

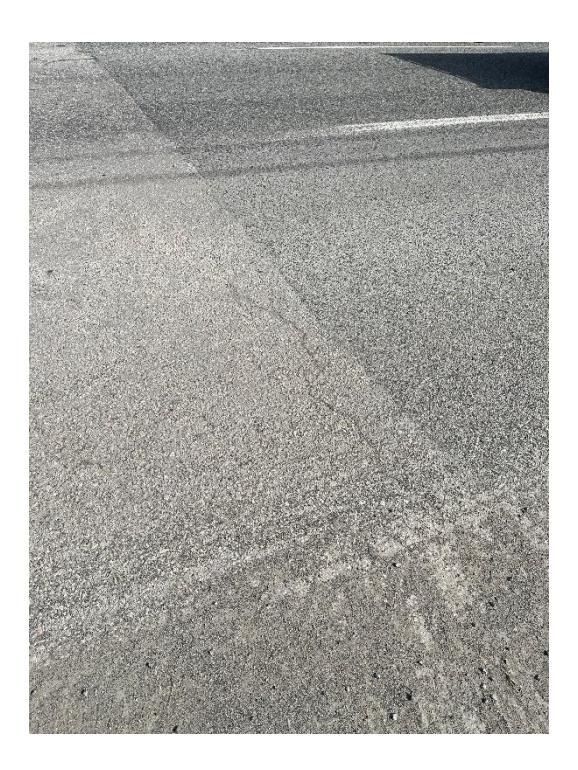
Photo 3: Low Severity Traverse Cracking Near Sta. 101+00 (Eastbound Hwy 7)

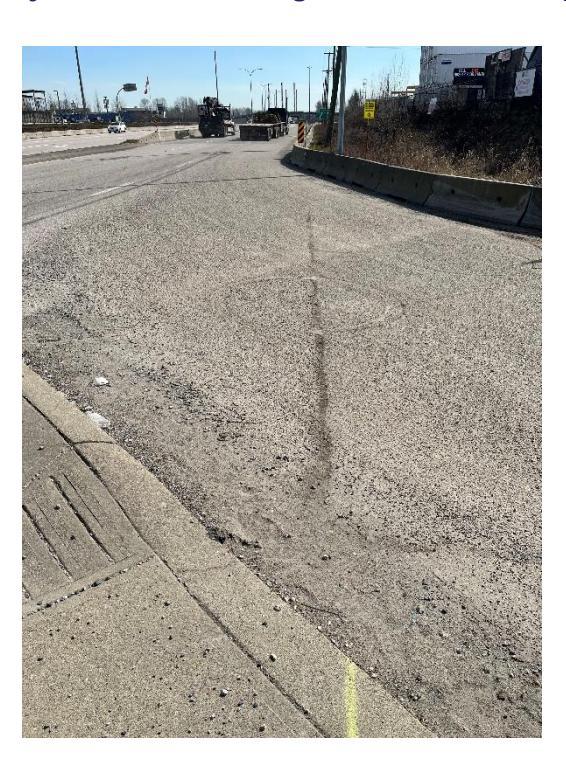
Photo 4: Moderate to High Severity Raveling at EB Turn Lane (NB Sherling Ave)
