# Geotechnical Investigation for Fulford-Ganges Road from Cranberry Road to Seaview Avenue, Salt Spring Island, BC

#### PRESENTED TO Ministry of Transportation and Infrastructure

NOVEMBER 23, 2021 ISSUED FOR USE FILE: 704-TRN.PAVE03225-05

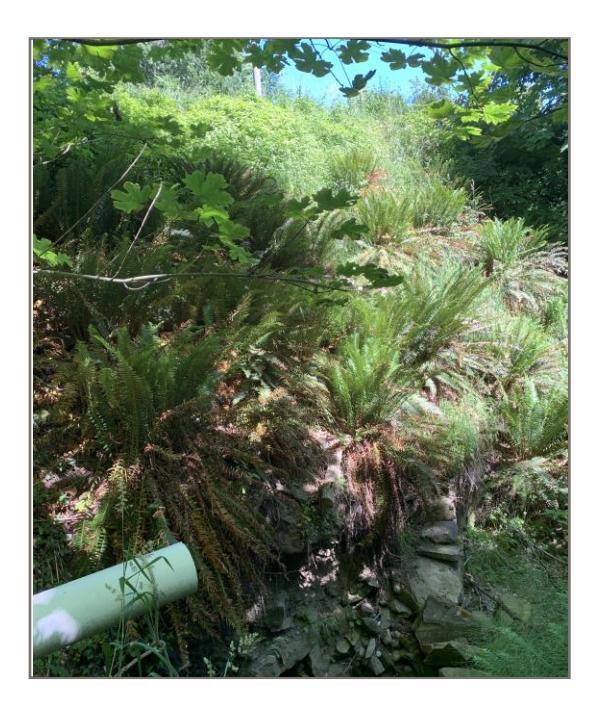
- The culvert water entry point is a stone cut culvert, and the exit point is a round steel pipe culvert. The stone cut culvert and steep pipe culvert appear to be connected;
- The steel pipe culvert shows signs of deformation;
- The steel pipe appears to be founded directly on the till-like soils;
- A geotextile membrane and rip rap were observed on the east side slope. The exposed sections of geotextile were in a deteriorated state;
- SPTs conducted at 21BH09 indicate that very loose zones exist within the fill soils that comprise the slope and fill overlying the culvert; and
- Erosion has caused undercutting on the west side and a steep incision into the native till-like soils near the base of the slope on the east side.

Photo 1: Looking southeast. View of the slope on west side of culvert/road

- Removal and replacement of the very loose fill soils with Engineered Fill;
- Removal of the existing culvert and detailed design and installation of a new culvert;
- Detailed slope and/or retaining wall design; and
- Reinforcement of the undercut and incised soil beyond the toes of the slope on both the west and east sides.

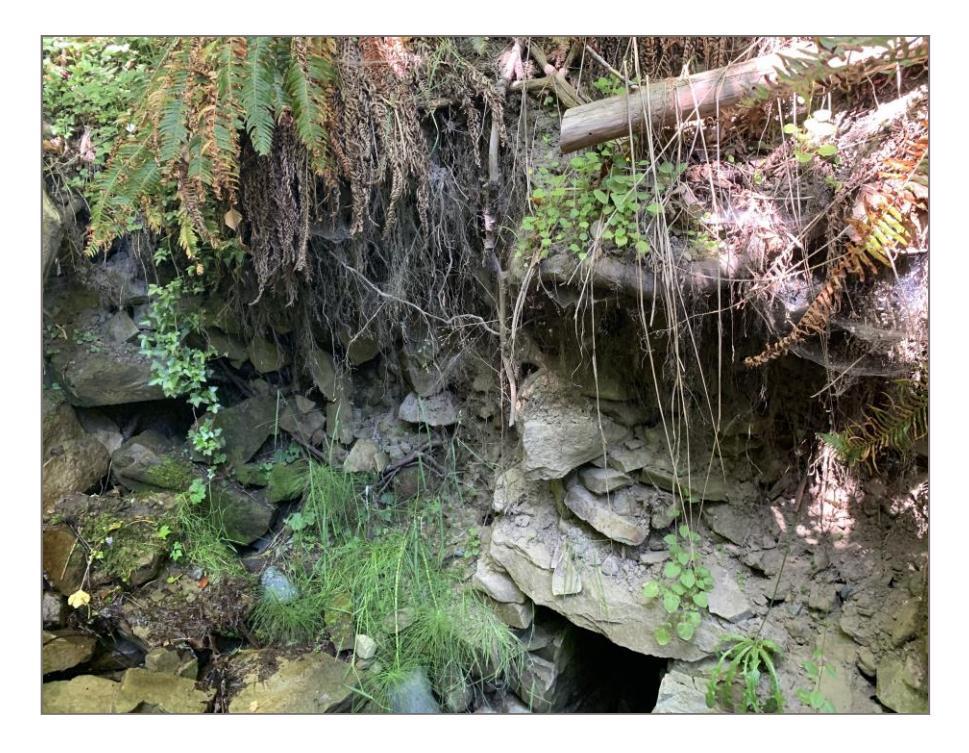
Photo 2: Looking east. View of undercutting (stone cut culvert entry point on west side of culvert/road)

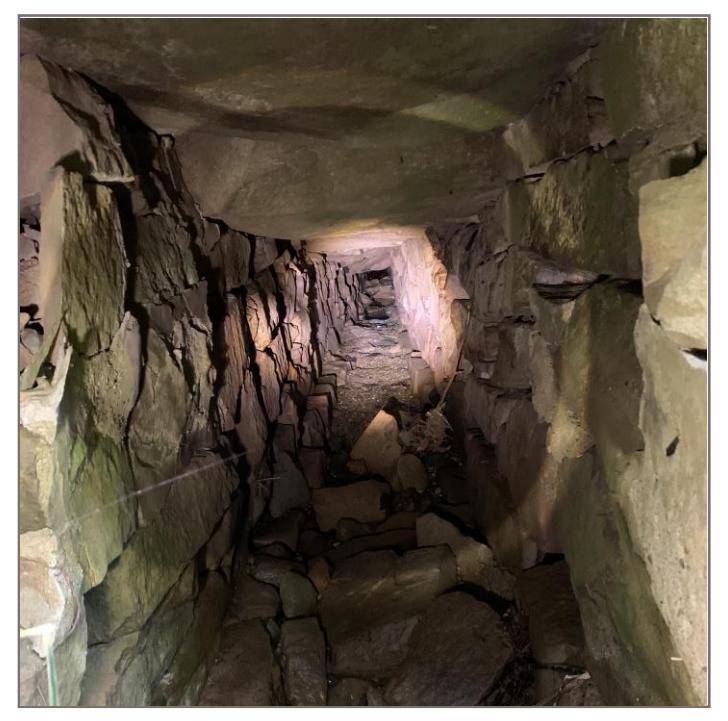
Photo 3: Looking east. View inside of stone cut culvert

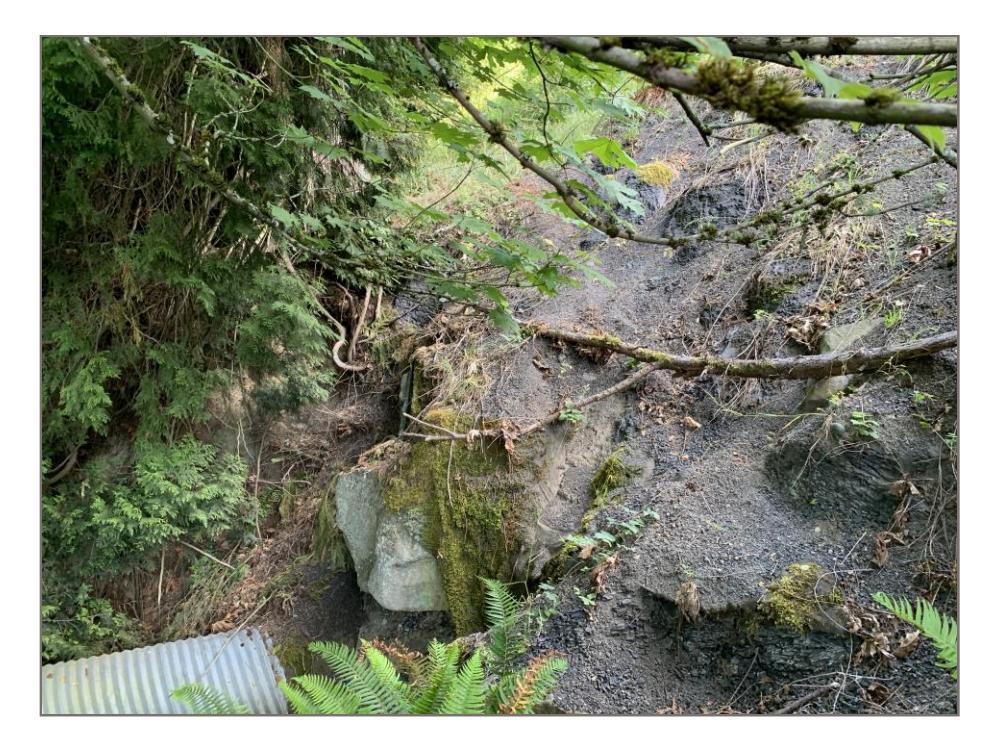
Photo 4: Looking south. View of the slope on east side of culvert/road

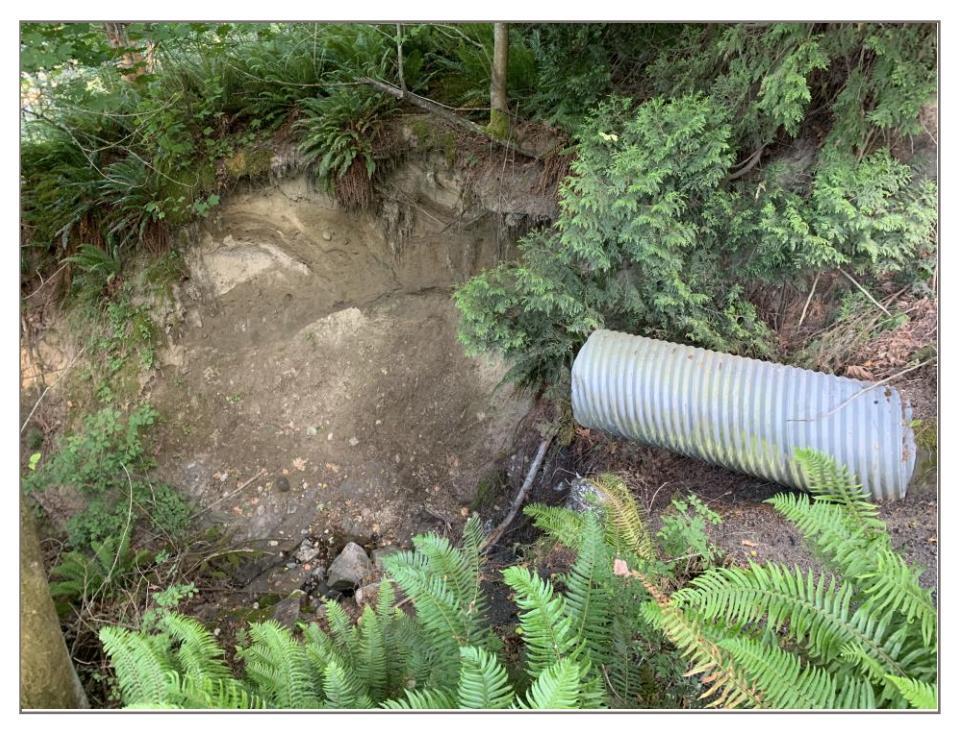
Photo 5: Looking east. View of the incised till-like soil near tow of slope on east side of culvert/road

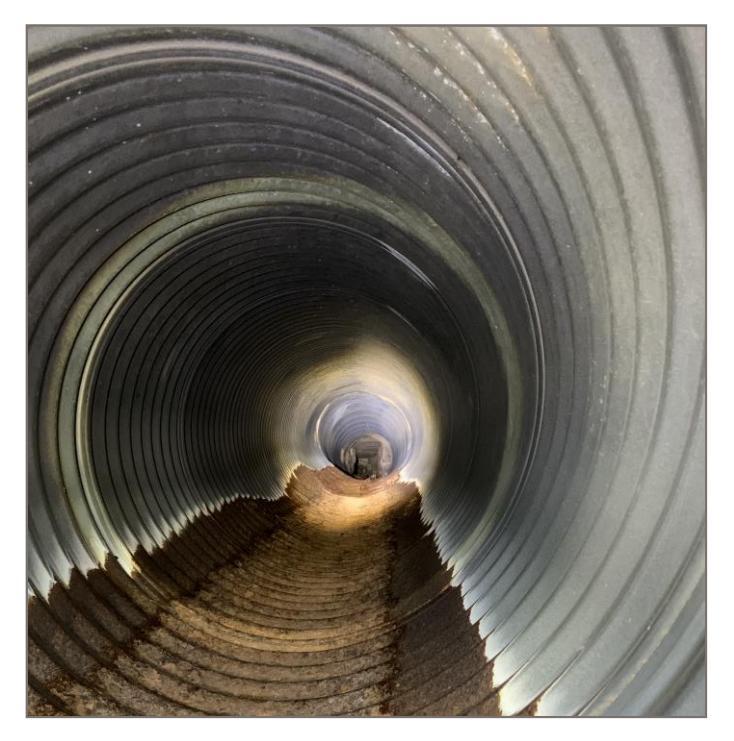
Photo 6: Looking west. View inside round steel pipe culvert showing evidence of deformation
