February 26, 2019

Reference: 5295.13

Re: Fish and Fish Habitat – Dunn Lake Road

Fish and Fish Habitat

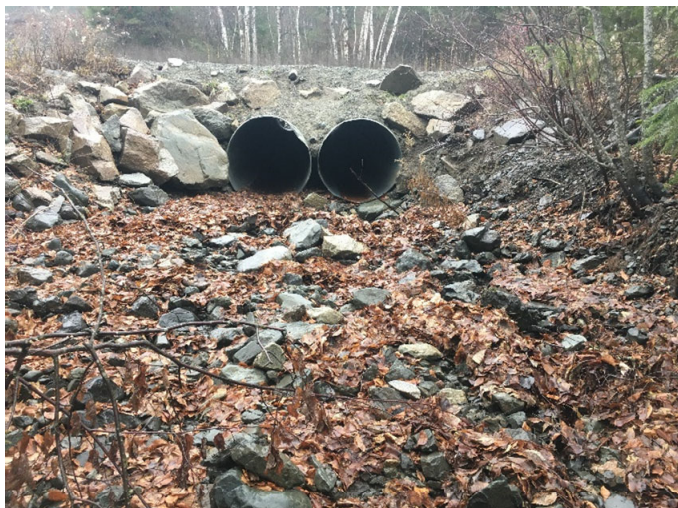
No Spawning habitat was present due to the lack of spawning substrate and the ephemeral nature of the watercourse. Rearing and migration values were rated as poor with no pools greater than 50 cm in depth, limited cover, and increasing stream gradient upstream of the Dunn Lake Road crossing. There is potential for fish presence during periods of flow due to the connectivity to the North Thompson river. Potential fish presence would be seasonal and opportunistic as rearing values were poor and no spawning habitat was present. Two 1200 mm corrugated steel pipes (CSP) are located at the road crossing.

Photo 1. Skowootum creek 2 x 1200mm CSP

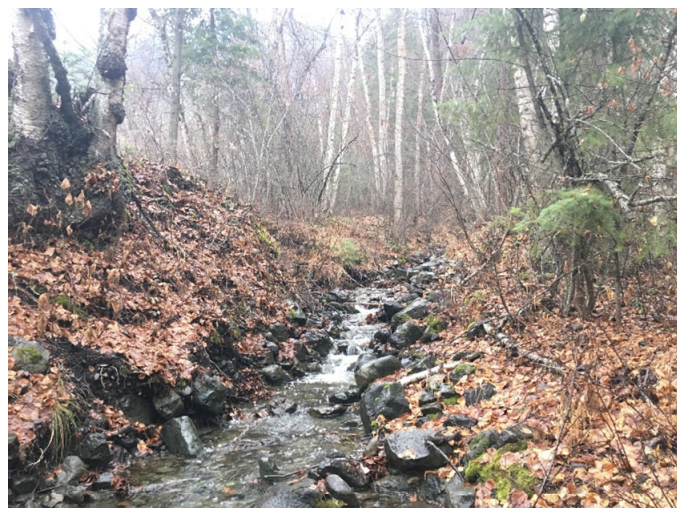
Photo 2. Skowootum creek - water flow above Dunn Lake Road ROW

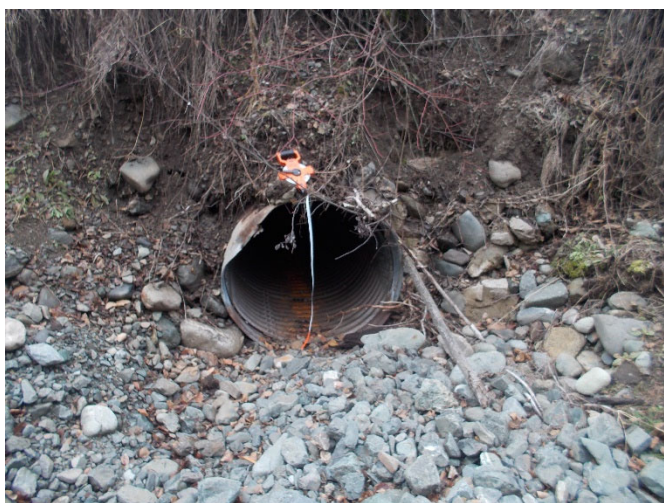
Photo 3. Skowootum creek - 1000mm culvert inlet at CN ROW

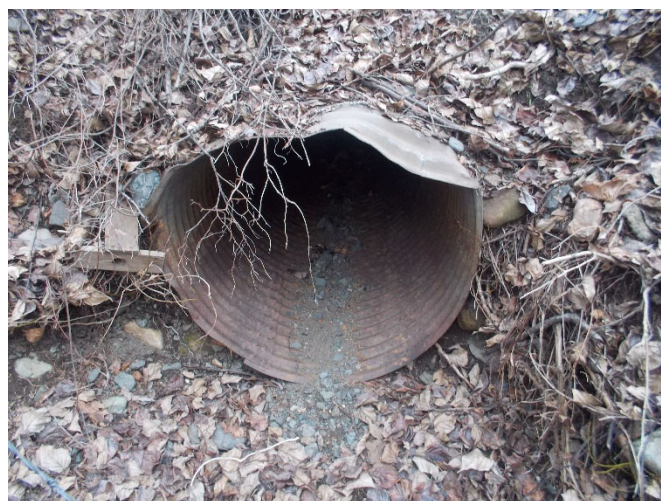
Photo 4. Skowootum creek - 1000mm culvert outlet at CN ROW

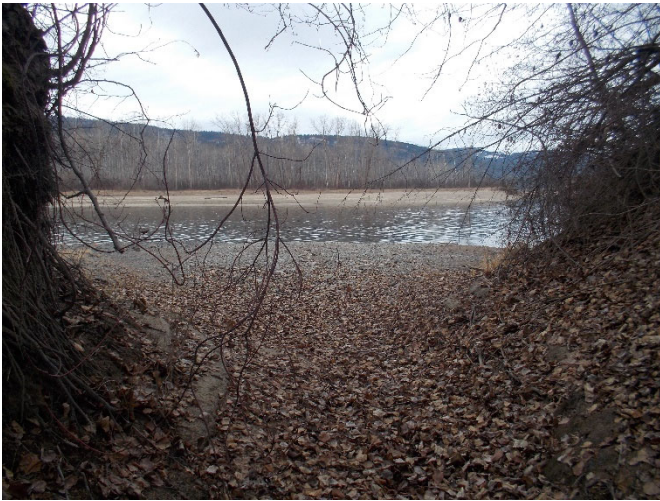
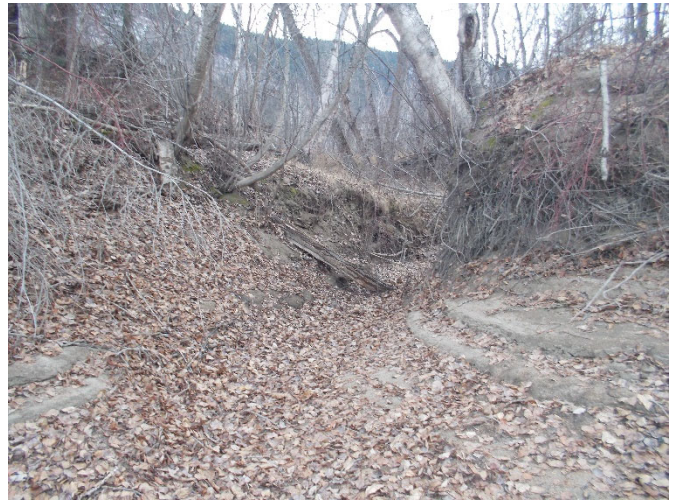
Photo 5. Skowootum and North Thompson confluence

Photo 6. Skowootum and North Thompson confluence

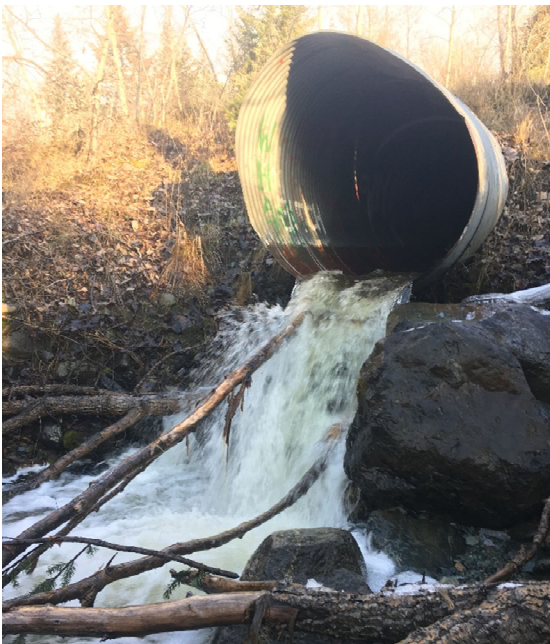
Watercourse-ID 2 was classified as a fish bearing stream (S2) based on its connectivity to the North Thompson and lack of permanent fish barriers up until the current Dunn Lake Road crossing. Anecdotal information from Simpcw First Nation indicated the presence of Rainbow Trout upstream of the Dunn Lake Road crossing. At the crossing there is an 1800 mm CSP that has a vertical outlet drop of 1.2 m that prevents upstream migration of fish (Photo 3).

Photo 7. Newhykulston creek - 1800mm CSP creating fish barrier to upstream fish migration

1. The larger streams should be managed for fish passage, including Skowootum Creek, Newhykulston Creek and Chu Chua Creek.
2. All 3 contain active channels with bedload considerations.
3. The mean channel width of these streams is likely too large for the installation of single structure open bottom culverts that allow for long term maintenance free fish passage.
4. The remaining four streams within the Project area can be managed as non-fish bearing.
5. Construction should consider instream work window (July 22-September 30; Window of least risk for North Thompson).
6. An environmental monitor - QEP should be available throughout the construction phases of the project to facilitate implementation of a Construction Environmental Management Plan and develop or oversee site specific mitigation strategies addressing potential impacts to environmental aspects, as needed.

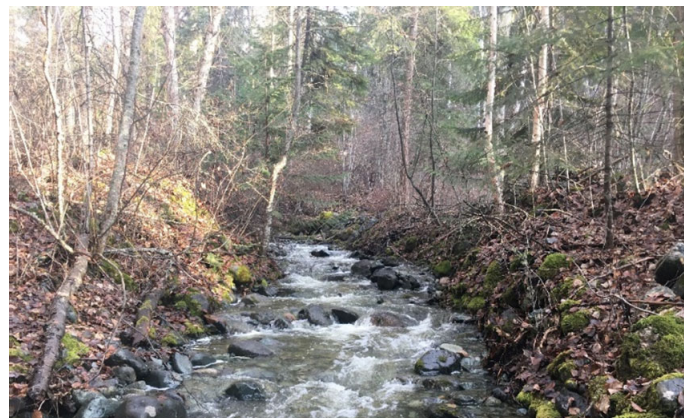
Photo 8. Newhykulston creek - dyked banks above Dunn Lake Road ROW

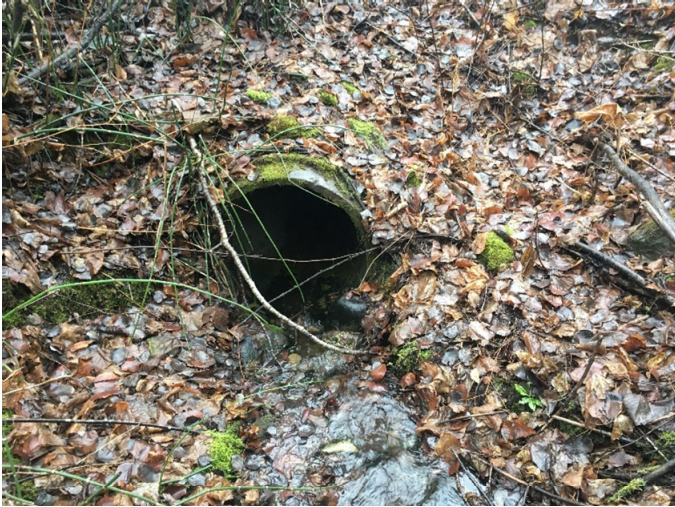
Photo 9. Kikwilli creek - 600mm NCSP at inlet

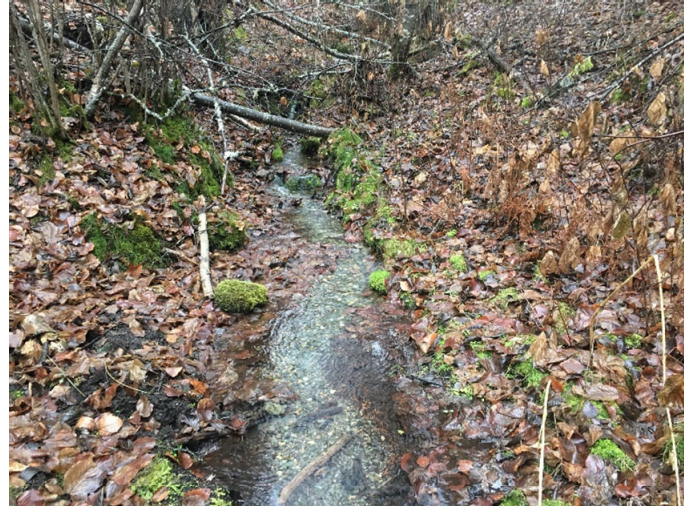
Photo 10. Kikwilli creek - small channel (S6) above ROW

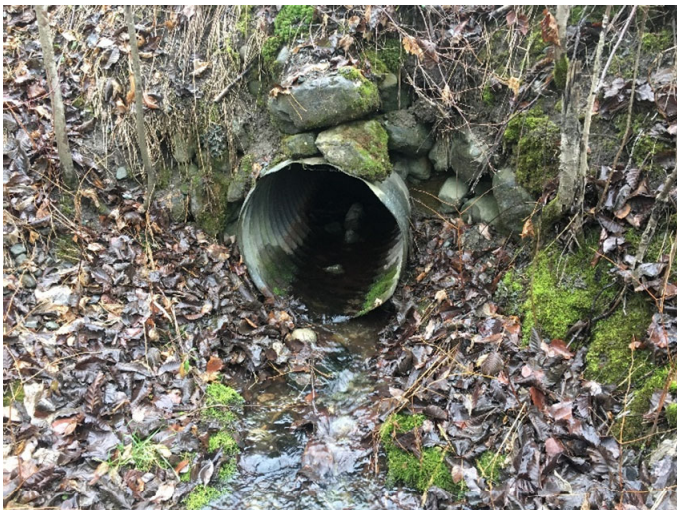
Photo 11. Kikwilli creek - 600mm CSP at outlet

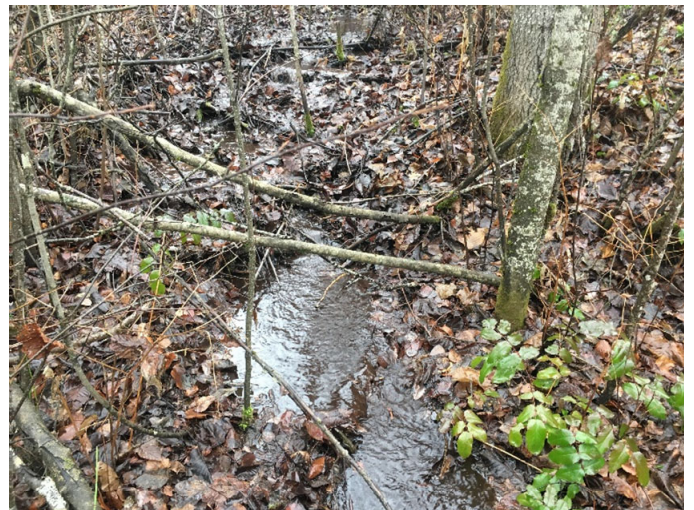
Photo 12. Kikwilli creek – Below Dunn Lake Road (NCD) roughly where creek seeps into ground and goes sub-surface

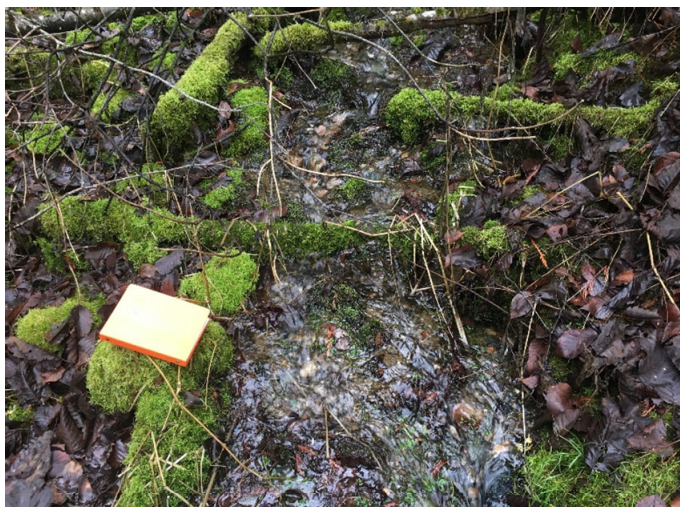
Photo 13. Watercourse-ID 5 - water flow above Dunn Lake Road ROW

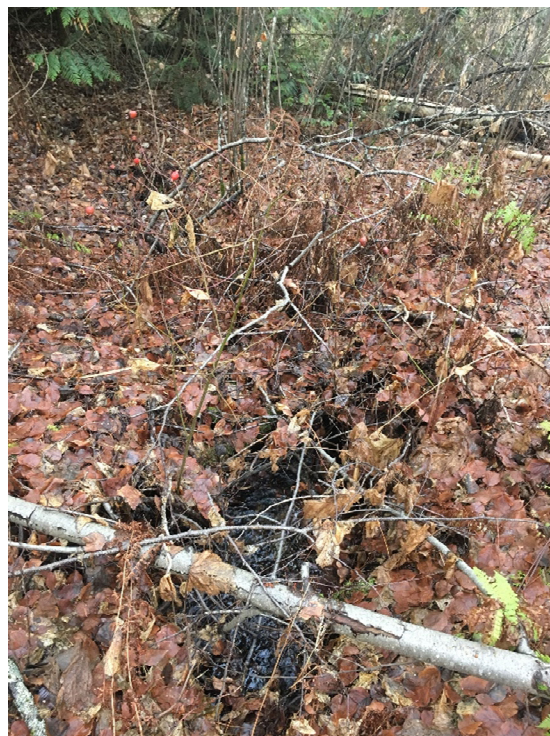
Photo 14. Watercourse-ID 5 - point where stream goes sub-surface

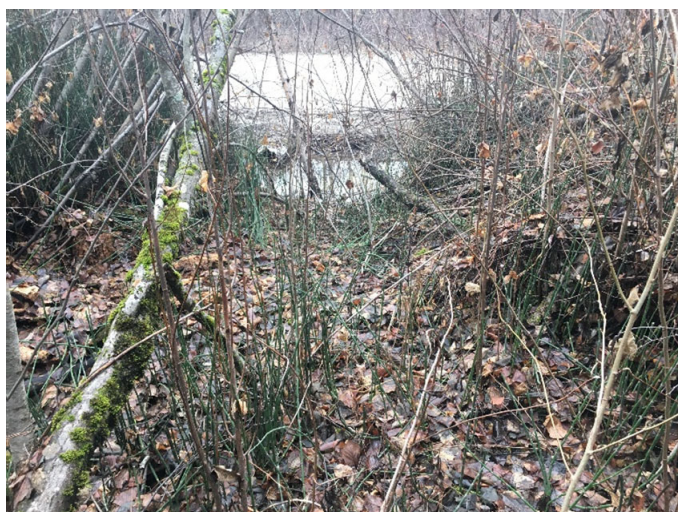
Photo 15. Watercourse-ID 6 - Intermittent NCD above Dunn Lake Road ROW

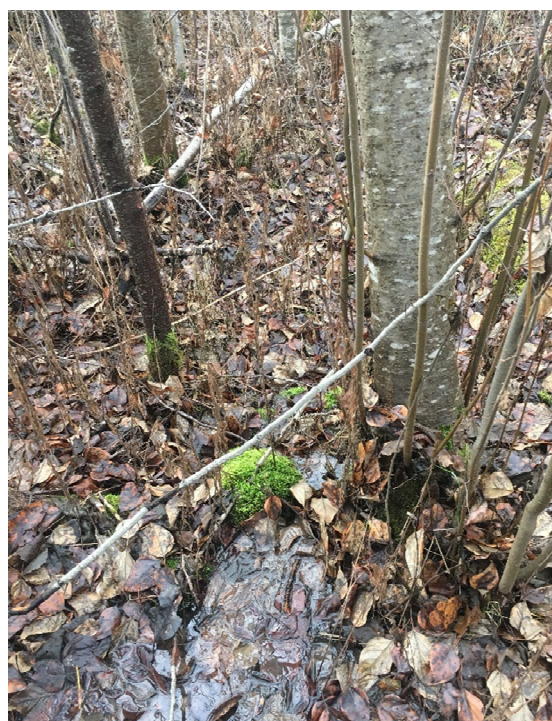
Photo 11. Watercourse-ID 6 - NCD goes subsurface below Dunn Lake Road ROW

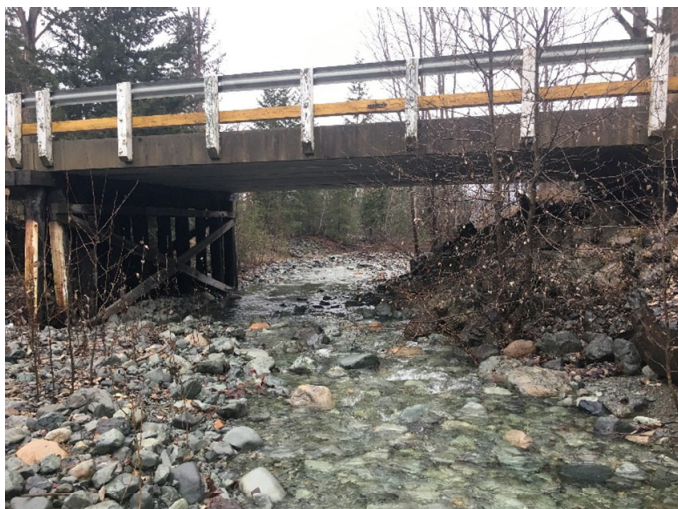
Photo 17. Chu-Chua creek - Dunn Lake Road bridge crossing

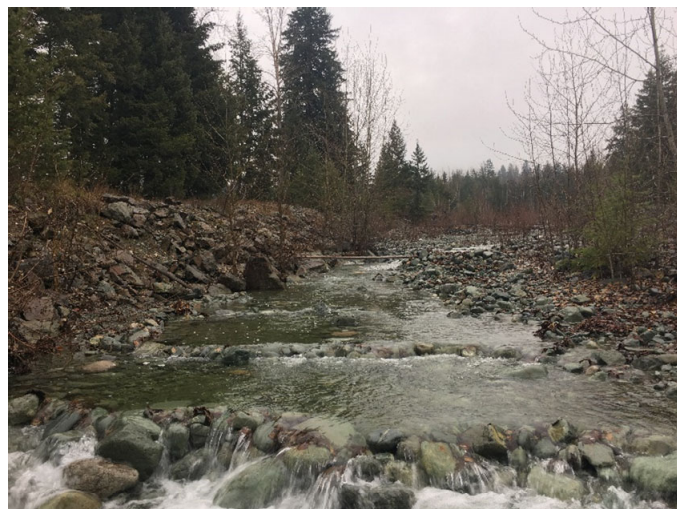
Photo 18. Chu-Chua creek - Upstream of ROW, dyked banks of creek

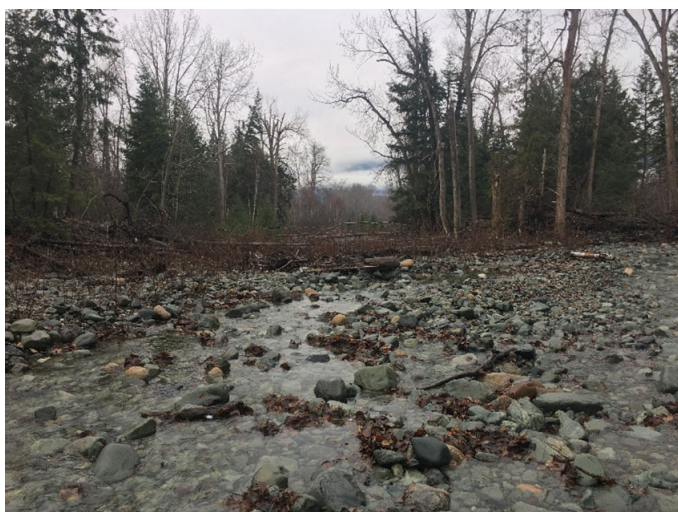
Photo 19. Downstream of ROW - creek fans out, dyked banks of creek

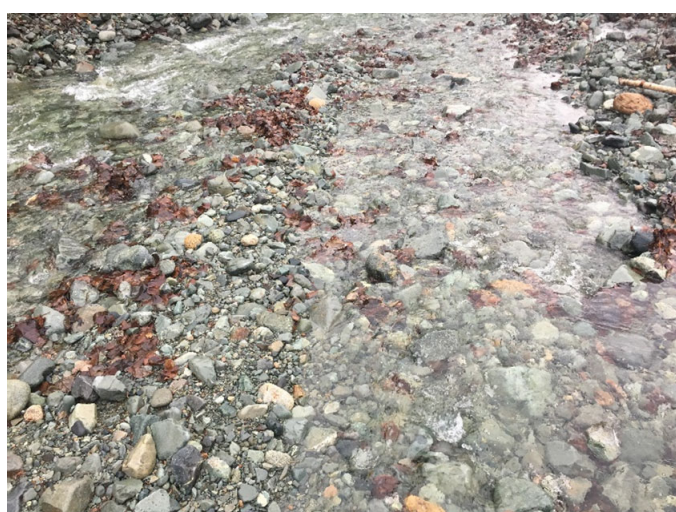
Photo 20. Chu-Chua creek - stream substrate

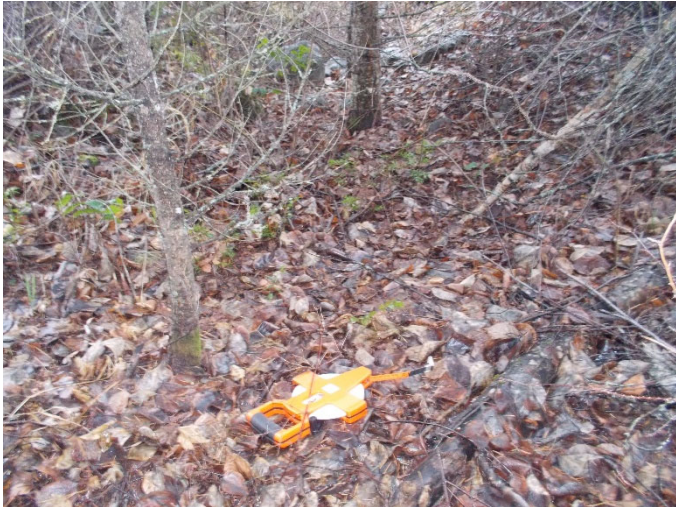
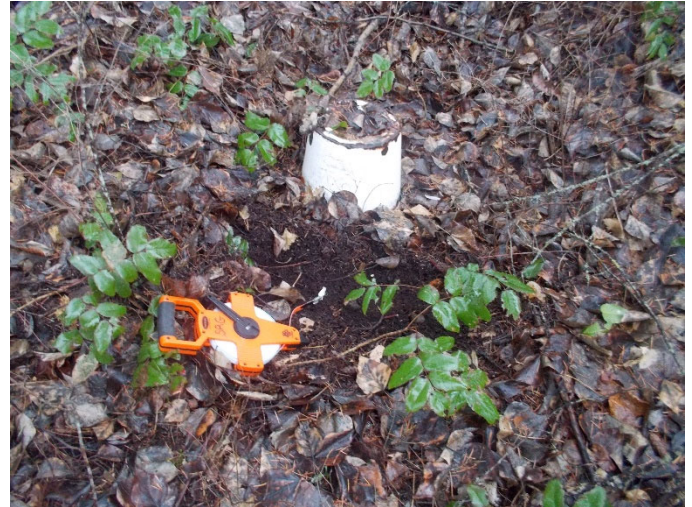
Photo 21. Watercourse-ID 4 – no sign of alluvial processes

Photo 22. Watercourse-ID 4 - no sign of alluvial processes

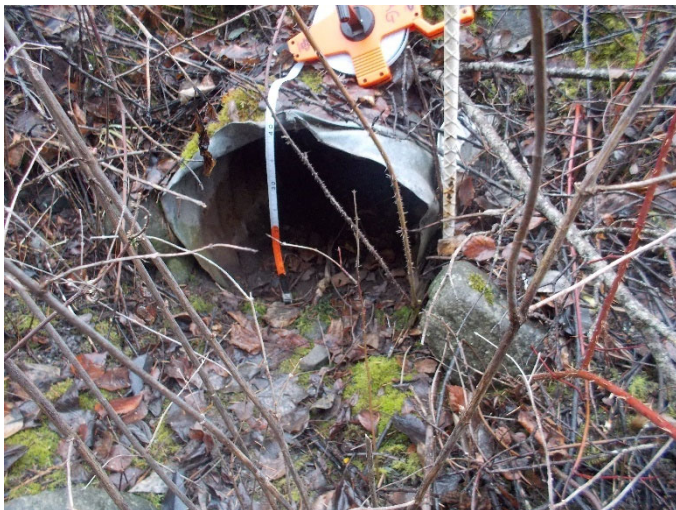
Photo 23. Watercourse-ID 4 - 500mm CSP at inlet, no sign of recent flows
