This report is an addendum to the “Bedrock Geology of the South Island Aggregates Stebbings Road Quarry” by Kirk Hancock, P.Geo. It updates the geological background, presents new mapping of the adjacent “Butler Quarry”, and includes geological comments for the South Shawnigan area.

## 2. Butler Quarry and area mapping

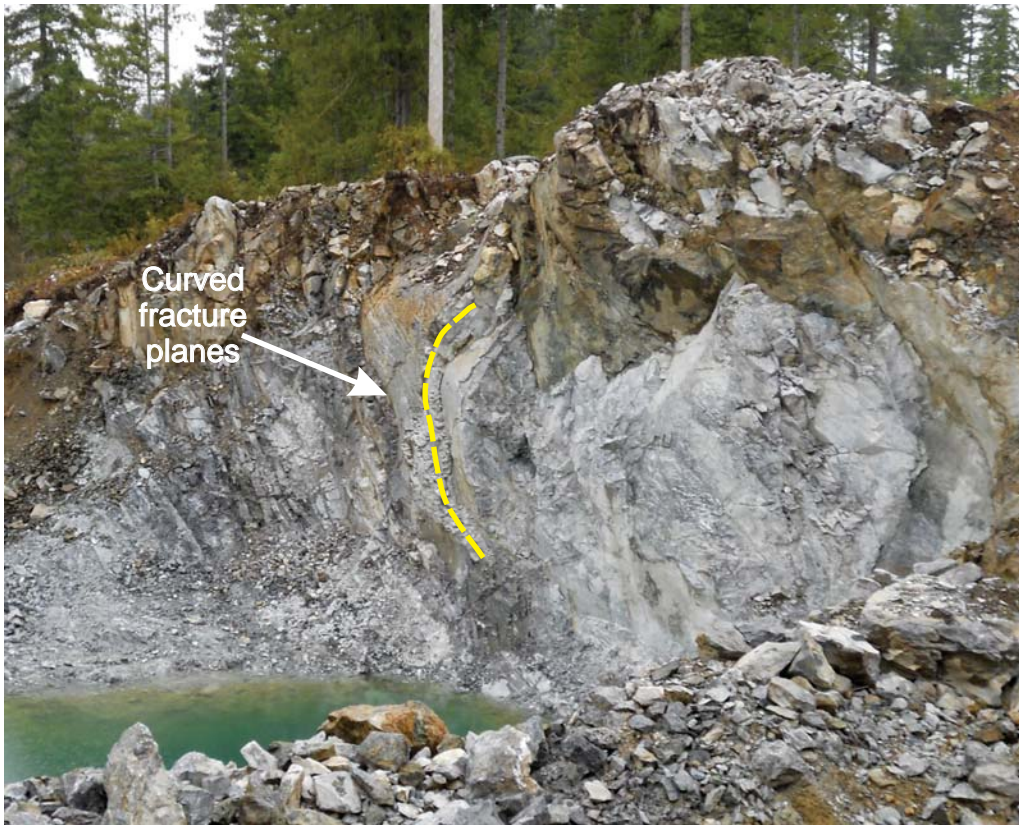
The carbonate at the quarry comprises variably mottled grey through white marble. The marble is fine grained and all original textures have been destroyed by recrystallization. Interwoven through the marble are centimetre scale anatomising webs of black material. The rock releases a strong, fetid odour when broken, suggesting that the black material represents an insoluble organic residue concentrated due to solution of carbonate during recrystallization. The marble is well fractured along the trend of the fault. Fracture spacing is typically on the centimetre to decimetre scale and is curvilinear at metre scale [Photo 1]. In several places, the marble exhibits brittle fracture faces with entrained fragments and gouges. Photo 2 shows a face where this is well developed.

**Photo 1: Curvilinear fracturing of carbonate in the Butler Quarry**

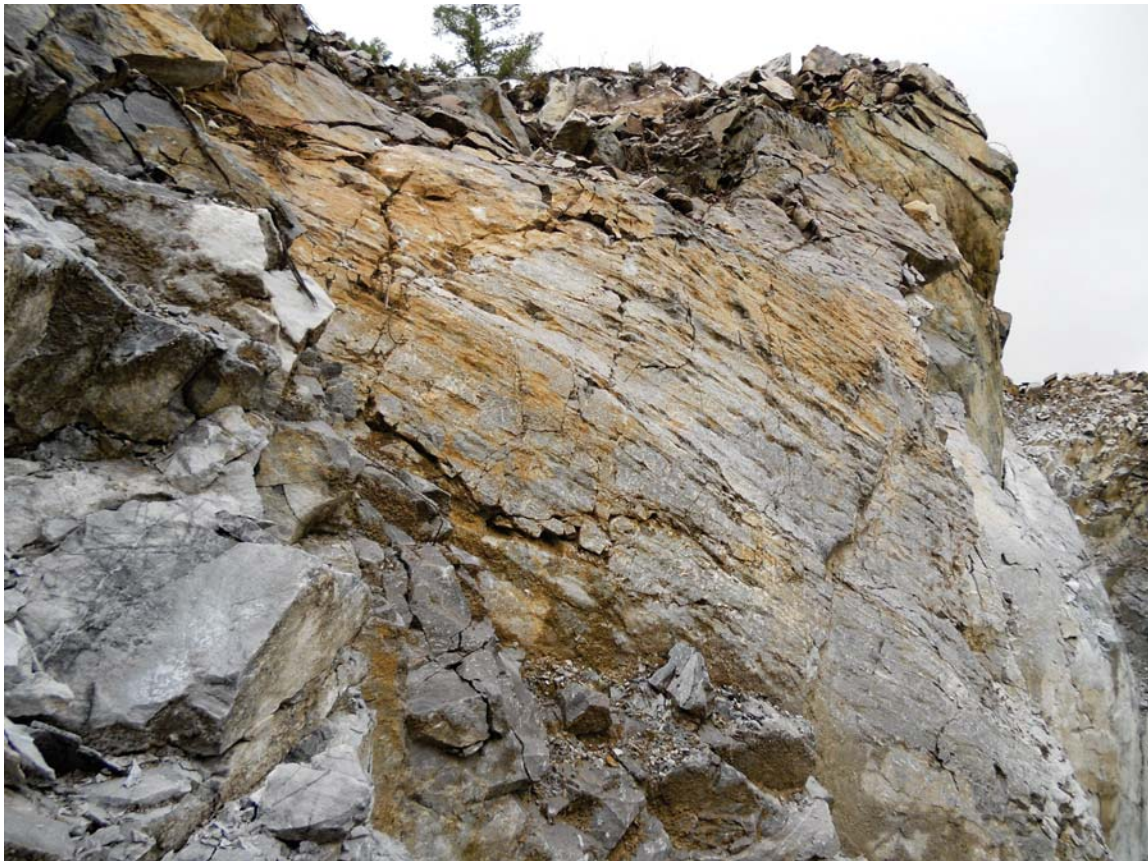
**Photo 2: Entrained fragments and gouges along a fracture face in the Butler Quarry**

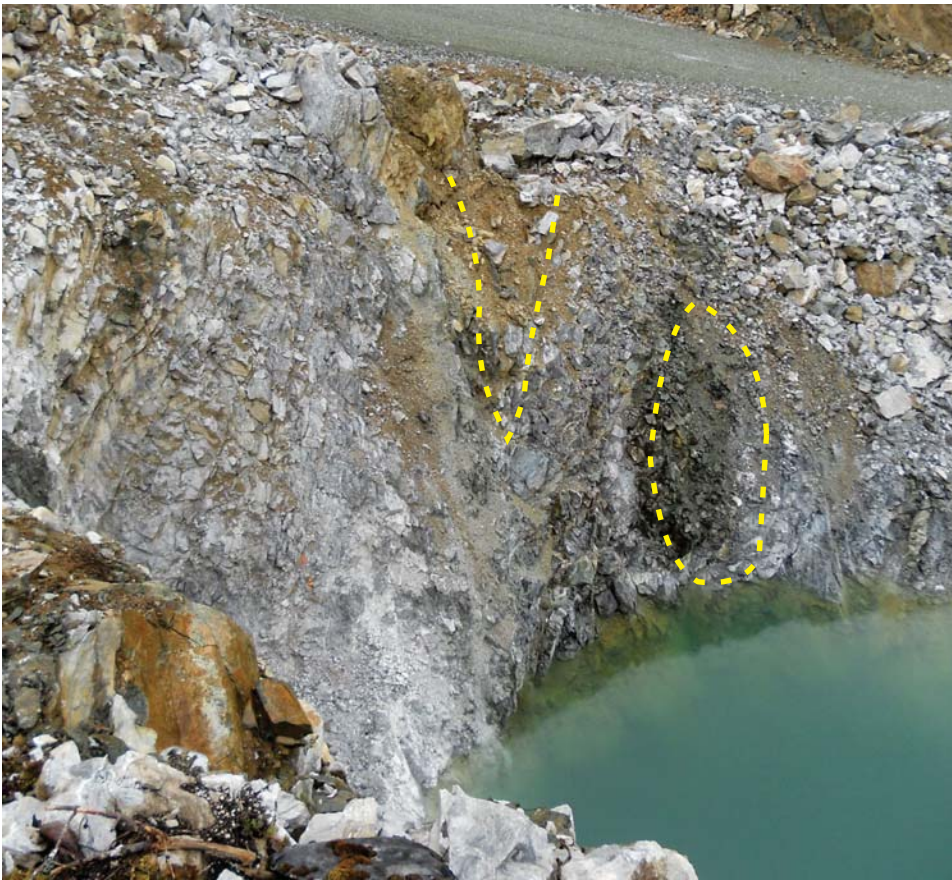
Metre-scale tabular bodies of host diorite, either dikes or faulted slivers, are in the marble. The bodies are moderately to significantly altered to chlorite, and in a few places, completely altered to chlorite [Photo 3].

Photo 3: Dark, diorite wedges within carbonate and shear zone  
Diorite outlined by yellow dashed line

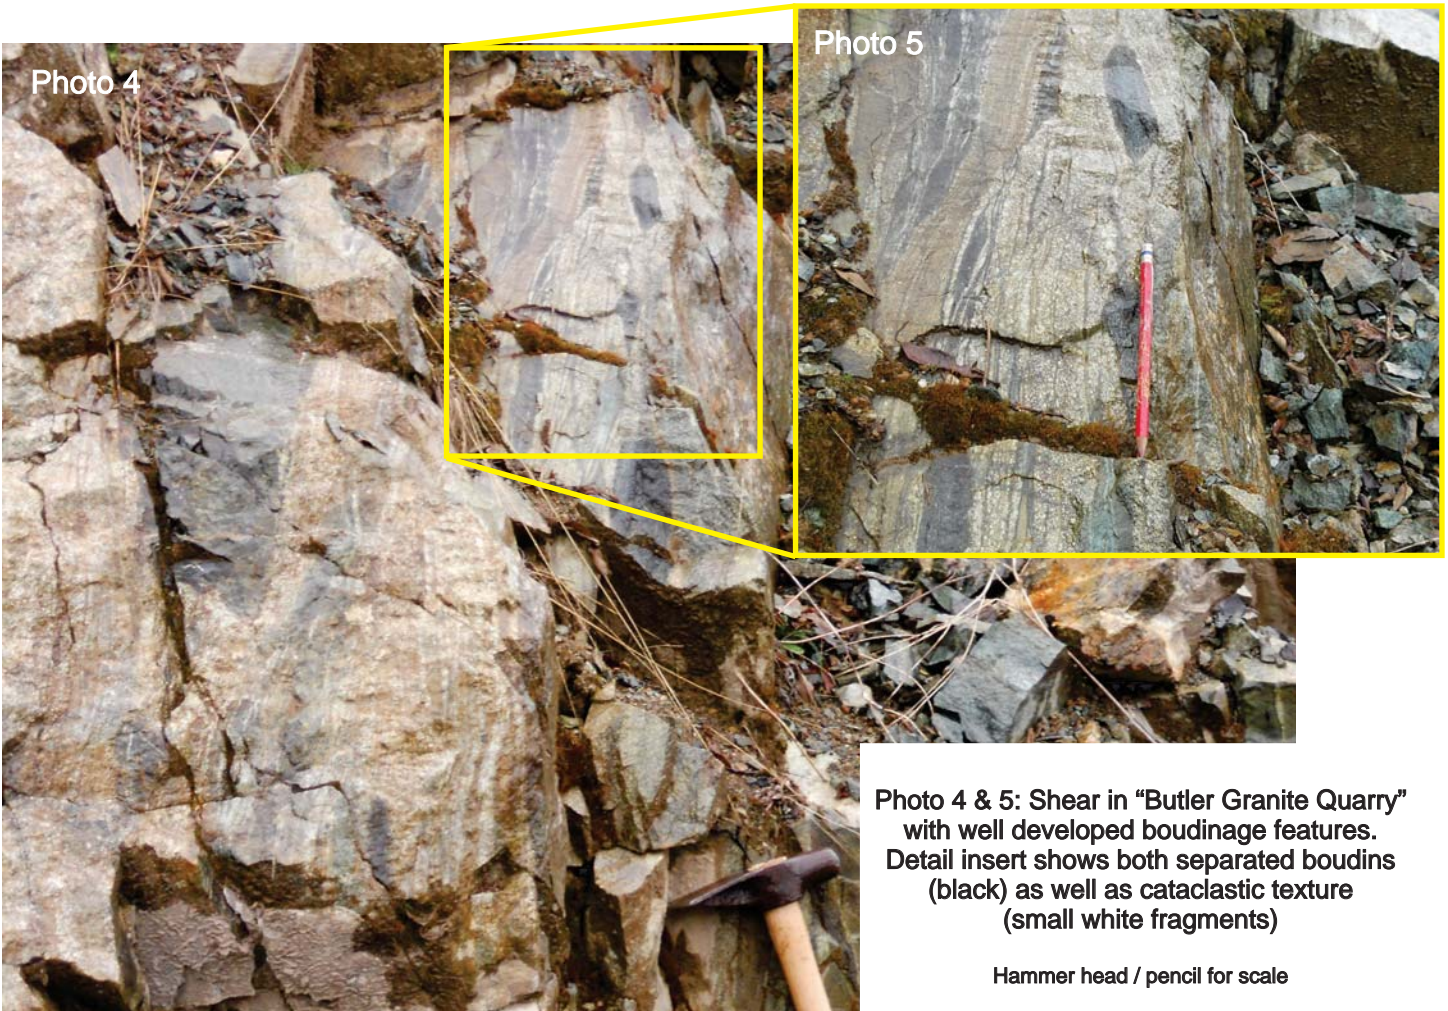
though less well exposed. Approximately 40 metres to the east, in the “granite quarry” a zone of highly strained diorite with well developed cataclastic textures, about 3 metres wide, is exposed. Local black, fine-grained material within the zone shows good, shear parallel boudinage features (stretched and separated layers of material) [Photos 4 & 5]. The black material has the same appearance as local diorite [basaltic] dykes [Photo 6]. The zone is parallel to the shear hosting the carbonate of the “Butler Quarry”.

Photo 4 & 5: Shear in “Butler Granite Quarry” with well developed boudinage features. Detail insert shows both separated boudins (black) as well as cataclastic texture (small white fragments)

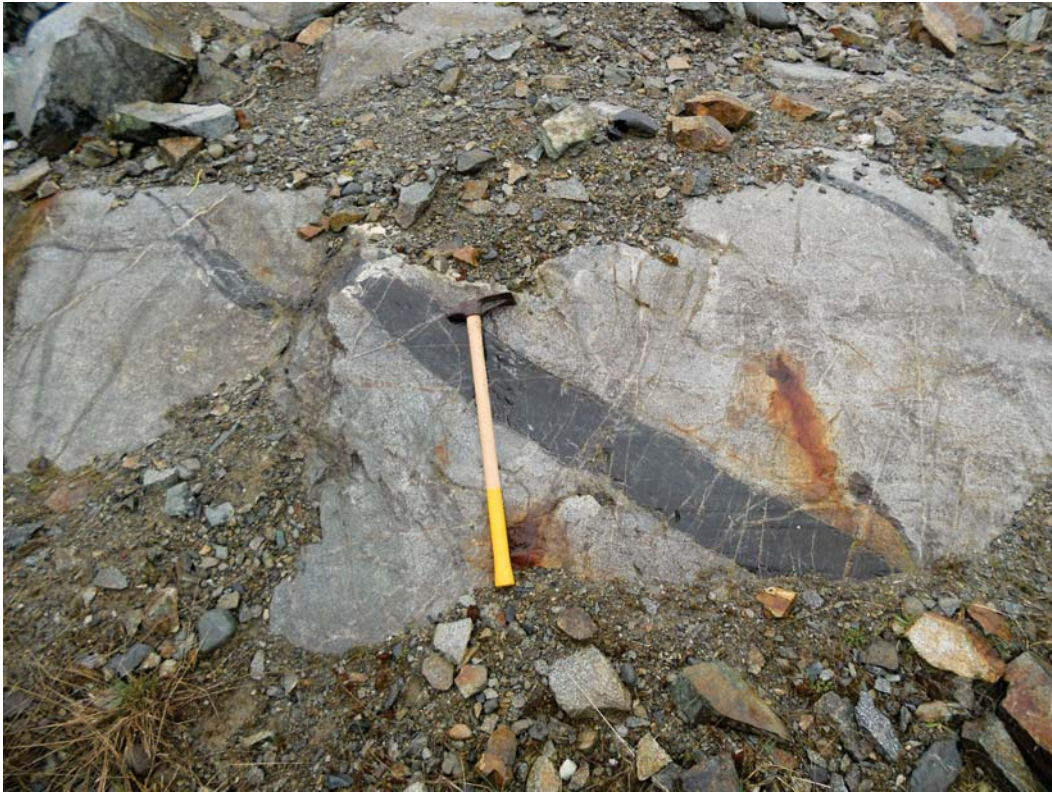
**Photo 6: Dyke in Wark gneiss diorite**
