# **Green Lake, B.C. Lakeshore Survey**

June 2008

Environmental Protection Division

Ministry of Environment

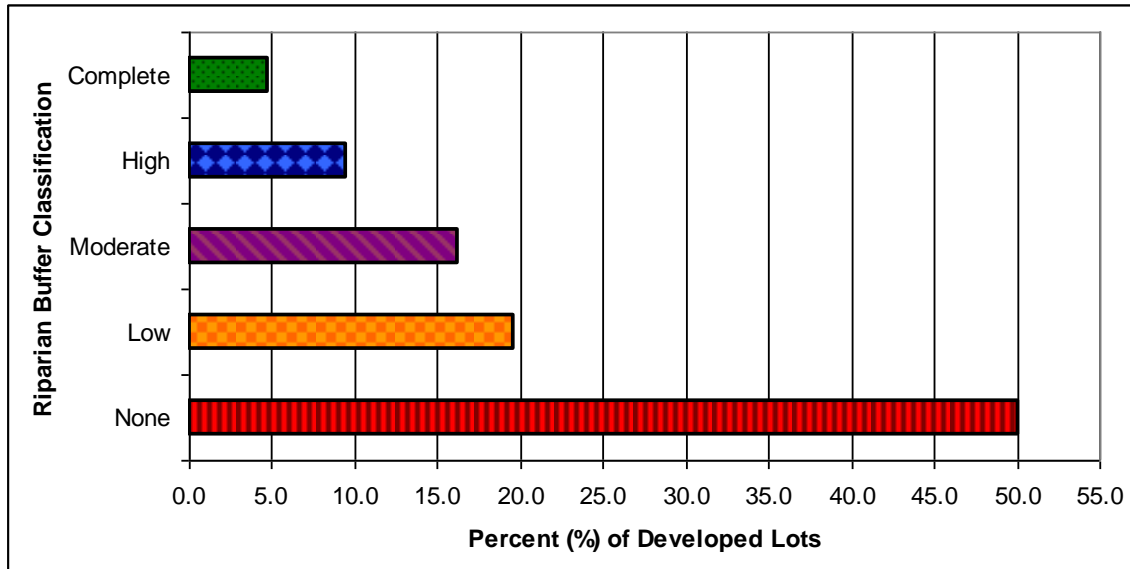
**FIGURE 1.1** – A comparison of riparian buffer classification showed that the majority of the developed lakeshore on Green Lakes North shore was within the moderate riparian buffer classification and lower. 16.2% Moderate, 19.6% Low, and 50.0% None, the classifications were based on the lakeshore survey guidelines (Appendix B).

The following percentage of developed lots and respective riparian buffer classification was observed on the North shore: 50.0% None, 19.6% Low, 16.2% Moderate, 9.5% High, and 4.7% Complete (Figure 1.1). A similar trend was observed on the South shore

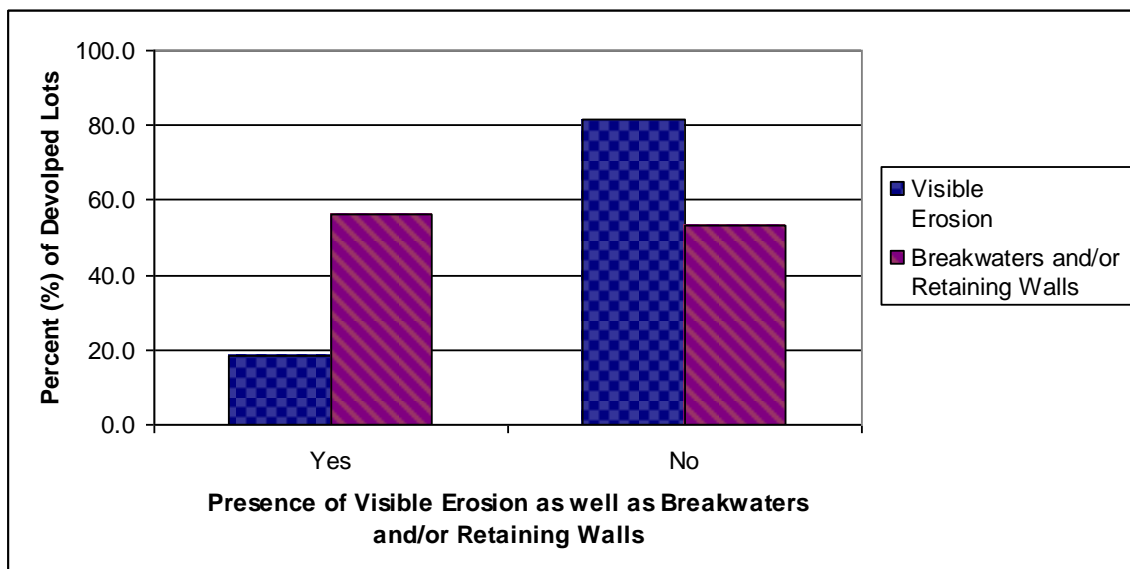
**FIGURE 1.2** – 18.2% of developed lots on the North shore of Green Lake showed signs of erosion. This could be due in part to 56.1% of developed lots having breakwaters and/or retaining walls. The presence of a breakwater and/or retaining wall can promote erosion on neighbouring lots due to the deflection of waves and water currents from one shore onto another increasing the erosion risk.

Shoreline erosion was visible on 27 (18.2%) of the developed lots along the North shore of Green Lake (Figure 1.2) and 40 (14.7%) of the developed lots along the South shore of Green Lake (Figure 2.2). In most cases the erosion was due to the complete lack of a riparian buffer and in some cases a combination of steep slopes and lack of a riparian buffer. The roots of a riparian buffer reinforce the soil and sand and help to hold them together preventing land loss by protecting the shoreline from slumping or being washed away thus without one the risk of erosion increases greatly.

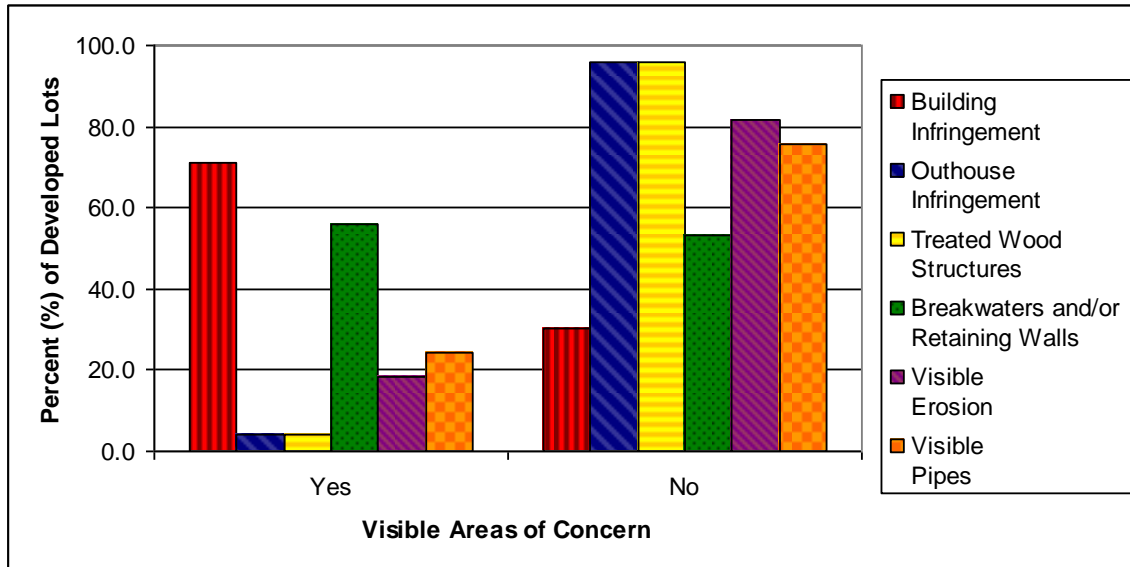
**FIGURE 1.3** – An overview of the visible areas of concern clearly showed that the most visible concerns were building infringement and the presence of breakwaters and/or retaining walls. 70.9% of the buildings on the North shore were less than 15m from the high water mark. The setback distances are based on the lakeshore survey guidelines (Appendix B). 56.1% of developed lots had breakwaters and/or retaining walls which can promote erosion on neighbouring lots due to the deflection of waves and water currents from one shore onto another increasing the erosion risk.

An overview of the visible areas of concern on the North shore (Figure 1.3) and on the South shore (Figure 2.3) clearly shows that the most visible areas of concern were building infringement and the appearance of breakwaters and/or retaining walls. 105 (70.9%) of the developed lots on the North shore and 215 (78.8%) of the developed lots on the South shore had buildings that were less than 15m from the high water mark as is the recommended distance according to the CRD Shoreland Management Policy and the TNRD Lakeshore Development Guidelines. Infringing buildings are problematic because they leave insufficient room for a natural vegetated riparian buffer zone and adequate distance between septic systems and the lake. This can result in the physical loss of property, increased flood risk, pollution from runoff, destruction of fish and other wildlife habitat, and changes to nutrient input affecting water quality. Breakwaters and/or retaining walls were visible on 83 (56.1%) of the developed lots on the North shore (Figure 1.2) and 199 (72.9%) of the developed lots on the South shore (Figure 2.2). The

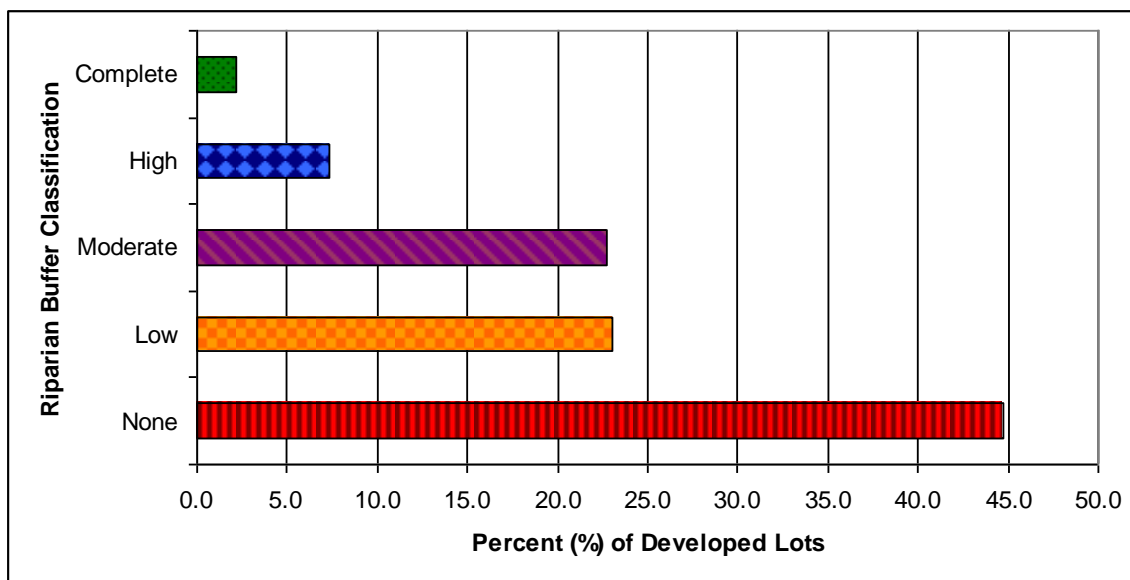
**FIGURE 2.1** – A comparison of riparian buffer classification showed that the majority of the developed lakeshore on Green Lakes South shore was within the moderate riparian buffer classification and lower. 22.7% Moderate, 23.1% Low, and 44.7% None, the classifications were based on the lakeshore survey guidelines (Appendix B)

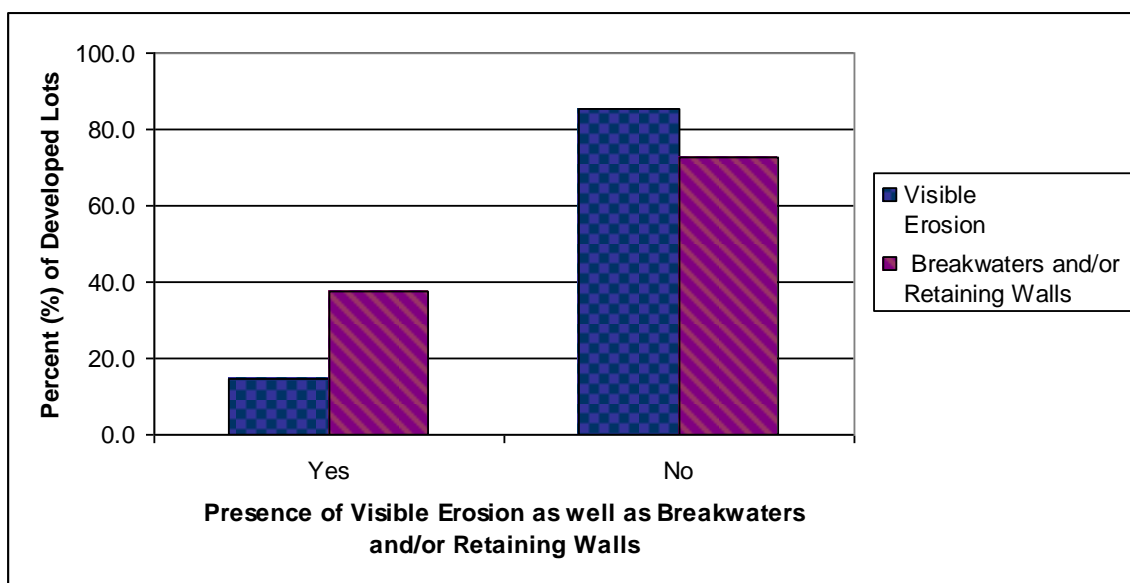
**FIGURE 2.2** – 14.7% of developed lots on the South shore of Green Lake showed signs of erosion. This could be due in part to 37.4% of developed lots having breakwaters and/or retaining walls. The presence of a breakwater and/or retaining wall can promote erosion on neighbouring lots due to the deflection of waves and water currents from one shore onto another increasing the erosion risk.

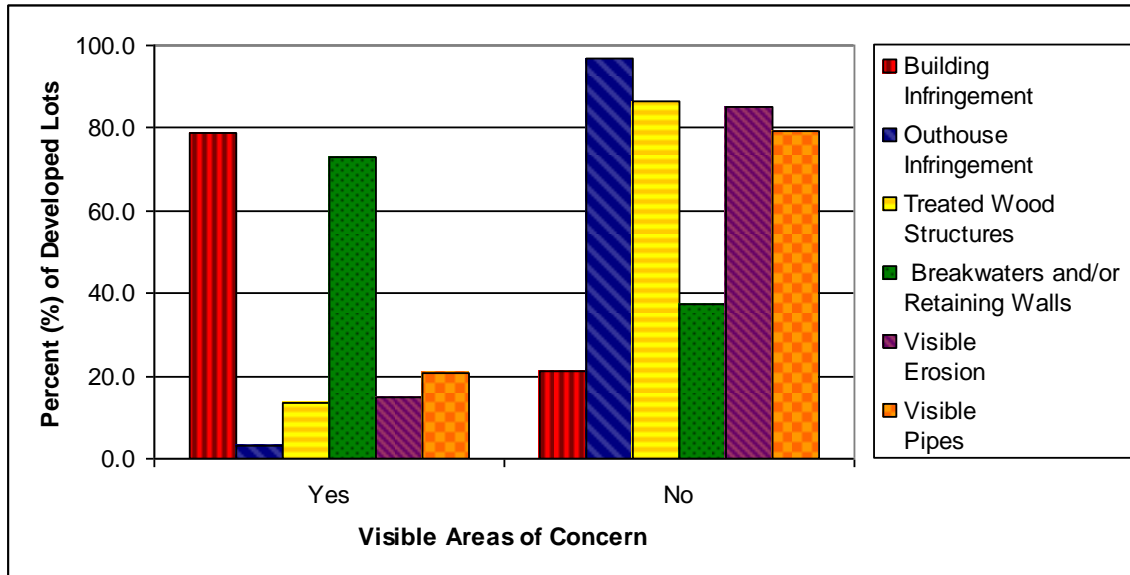
**FIGURE 2.3** – An overview of the visible areas of concern clearly showed that the most visible concerns were building infringement and the presence of breakwaters and/or retaining walls. 78.8% of the buildings on the North shore were less than 15m from the high water mark. The setback distances are based on the lakeshore survey guidelines (Appendix B). 72.9% of developed lots had breakwaters and/or retaining walls which can promote erosion on neighbouring lots due to the deflection of waves and water currents from one shore onto another increasing the erosion risk.
