Green Lake, B.C. Lakeshore Survey

June 2008

Environmental Protection Division

Ministry of Environment

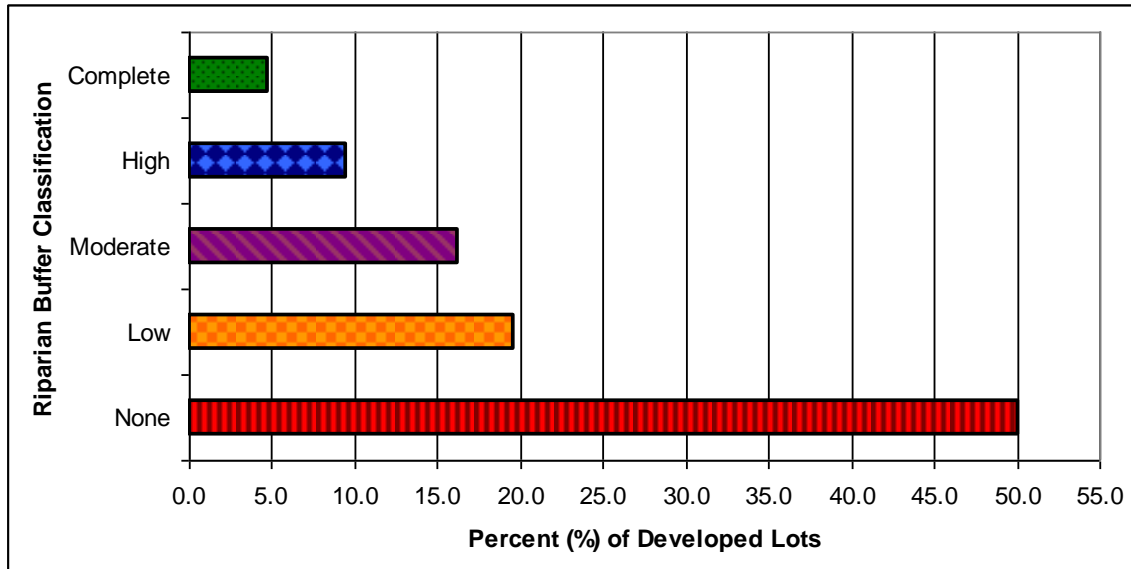
FIGURE 1.1 – A comparison of riparian buffer classification showed that the majority of the developed lakeshore on Green Lakes North shore was within the moderate riparian buffer classification and lower. 16.2% Moderate, 19.6% Low, and 50.0% None, the classifications were based on the lakeshore survey guidelines (Appendix B).

The following percentage of developed lots and respective riparian buffer classification was observed on the North shore: 50.0% None, 19.6% Low, 16.2% Moderate, 9.5% High, and 4.7% Complete (Figure 1.1). A similar trend was observed on the South shore

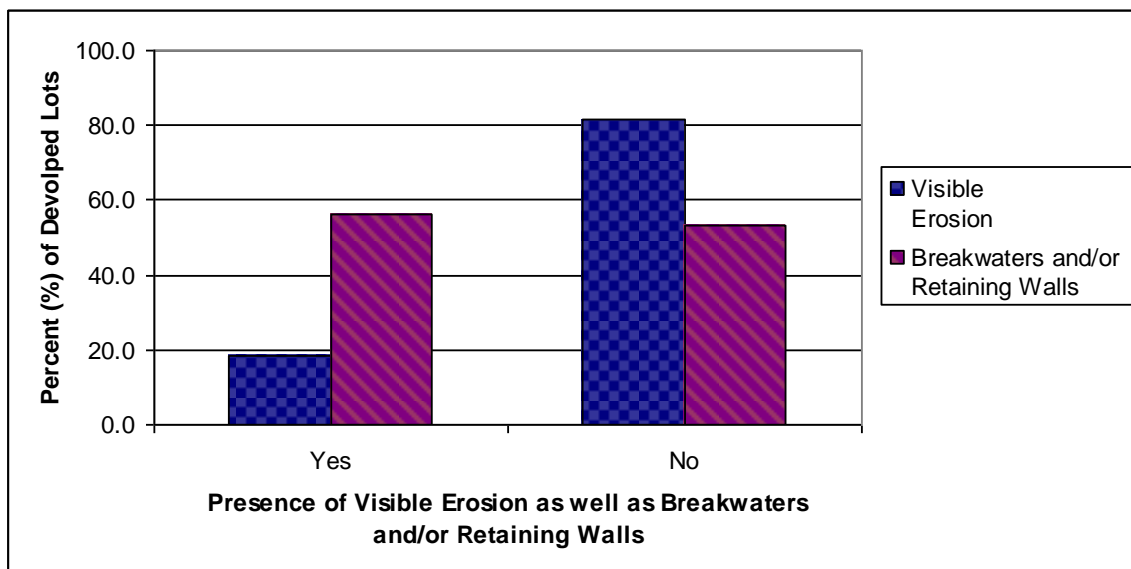
FIGURE 1.2 – 18.2% of developed lots on the North shore of Green Lake showed signs of erosion. This could be due in part to 56.1% of developed lots having breakwaters and/or retaining walls. The presence of a breakwater and/or retaining wall can promote erosion on neighbouring lots due to the deflection of waves and water currents from one shore onto another increasing the erosion risk.

Shoreline erosion was visible on 27 (18.2%) of the developed lots along the North shore of Green Lake (Figure 1.2) and 40 (14.7%) of the developed lots along the South shore of Green Lake (Figure 2.2). In most cases the erosion was due to the complete lack of a riparian buffer and in some cases a combination of steep slopes and lack of a riparian buffer. The roots of a riparian buffer reinforce the soil and sand and help to hold them together preventing land loss by protecting the shoreline from slumping or being washed away thus without one the risk of erosion increases greatly.
