Watch Lake, B.C. Lakeshore Survey

June 2008

Environmental Protection Division

Ministry of Environment

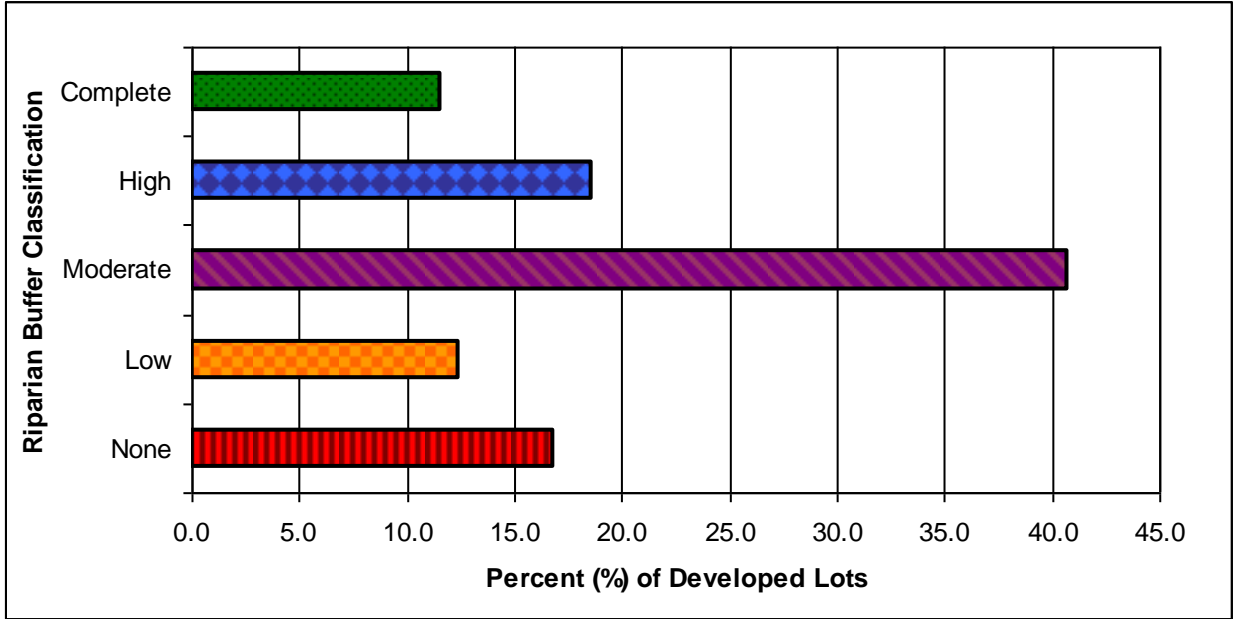
FIGURE 1.1 – A comparison of riparian buffer classification shows that the majority of the developed lakeshore on Watch Lake is within the moderate riparian buffer classification and higher. 40.7% Moderate, 18.6% High, and 11.5% Complete, classifications were based on the lakeshore survey guidelines (Appendix B)

The following percentage of developed lots and respective riparian buffer classification was observed: 16.8% None, 12.4% Low, 40.7% Moderate, 18.6% High, and 11.5% Complete (Figure 1.1). Overall the majority of developed lots showed a riparian buffer

classification of moderate or higher suggesting that the overall condition of the lakes riparian buffer was generally functioning.

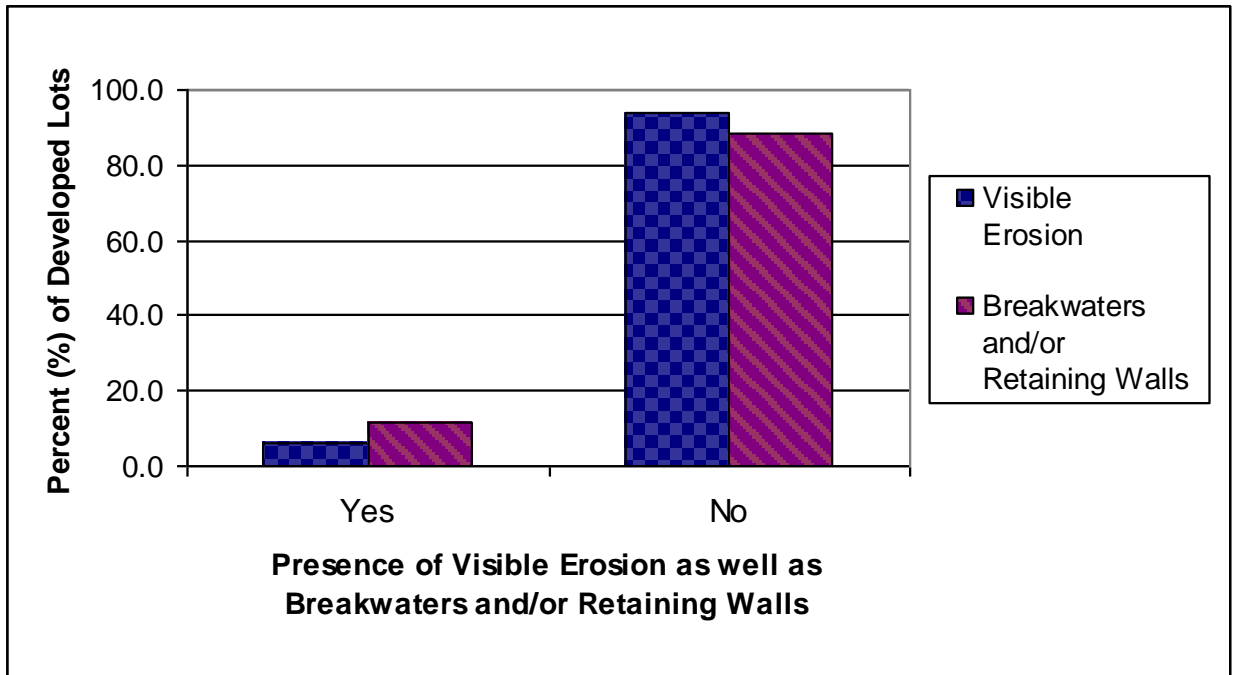
FIGURE 1.2 – The presence of a breakwater and/or retaining wall can promote erosion on neighbouring lots due to the deflection of waves and water currents from one shore onto another increasing the erosion risk. The majority of developed lots on Watch Lake do not show signs of erosion and do not have breakwaters and/or retaining walls.

Shoreline erosion was only visible on seven (6.2%) of the developed lots along the Watch Lake lakeshore. In five of the seven cases the erosion was due to steep slopes and the resulting foot traffic and removal of vegetation allowing for lake access. The other two cases were due to cattle accessing the lake for drinking water. The low occurrence of erosion may be due in part to the high percentage of densely vegetated riparian buffers. The low presence of breakwaters and/or retaining walls may also have contributed to the lack of visible erosion due to the lack of deflection of waves and water currents from neighbouring breakwaters and/or retaining walls (Figure 1.2).

Current developments should be encouraged to improve their current riparian buffer zones as much as possible. This can be accomplished by planting/replanting natural vegetation and using natural water break methods as opposed to retaining walls and imported breakwaters.

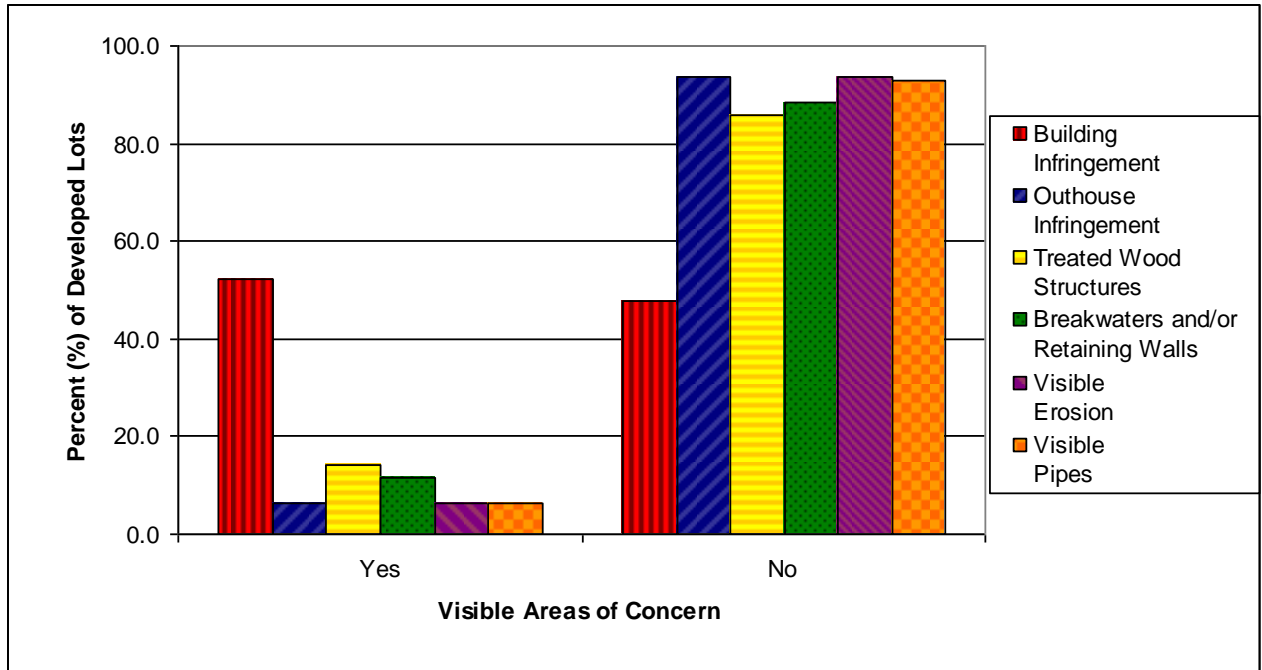
FIGURE 1.3 – An overview of the visible areas of concern clearly shows that the most visible concern is building infringement. 52.2% of the buildings on the Watch Lake lakeshore are less than 15m from the high water mark. The setback distances are based on the lakeshore survey guidelines (Appendix B).

An overview of the visible areas of concern (Figure 1.3) clearly shows that the most visible area of concern is building infringement. 59 (52.2%) of the buildings on the Watch Lake shoreline are less than 15m from the high water mark as is the recommended distance according to the CRD Shoreland Management Policy. Infringing buildings are problematic because they leave insufficient room for a natural vegetated riparian buffer zone and adequate distance between septic systems and the lake. This can result in the physical loss of property, increased flood risk, pollution from runoff, destruction of fish and other wildlife habitat, and changes to nutrient input affecting water quality.
