Watch Lake, B.C. Lakeshore Survey

June 2008

Environmental Protection Division

Ministry of Environment

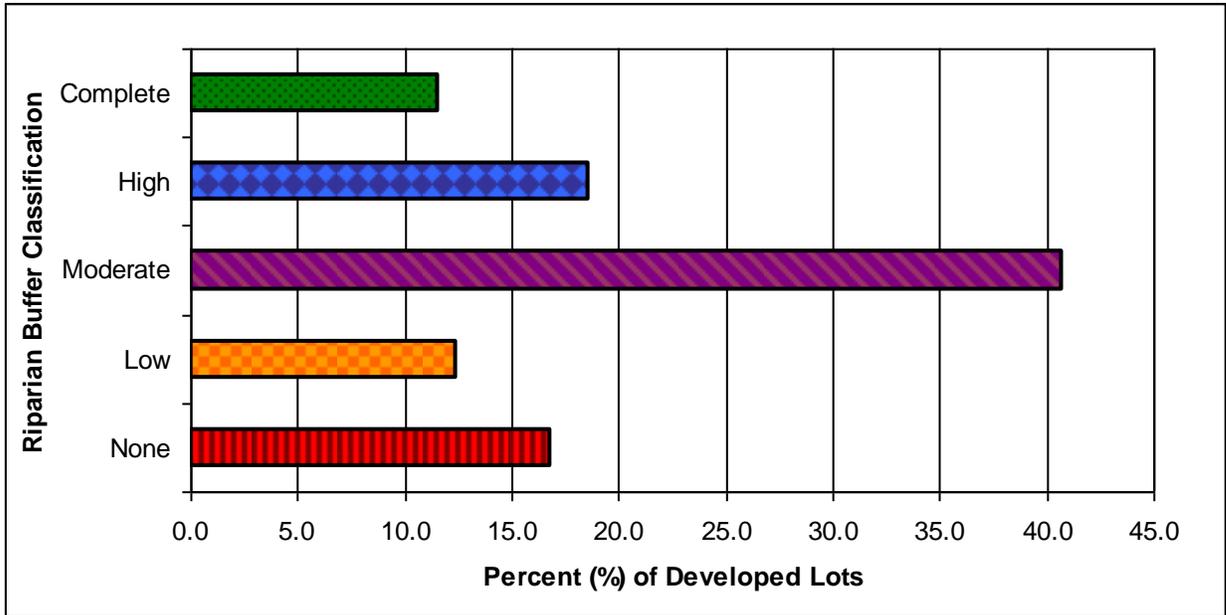
FIGURE 1.1 – A comparison of riparian buffer classification shows that the majority of the developed lakeshore on Watch Lake is within the moderate riparian buffer classification and higher. 40.7% Moderate, 18.6% High, and 11.5% Complete, classifications were based on the lakeshore survey guidelines (Appendix B)

The following percentage of developed lots and respective riparian buffer classification was observed: 16.8% None, 12.4% Low, 40.7% Moderate, 18.6% High, and 11.5% Complete (Figure 1.1). Overall the majority of developed lots showed a riparian buffer

classification of moderate or higher suggesting that the overall condition of the lakes riparian buffer was generally functioning.

Current developments should be encouraged to improve their current riparian buffer zones as much as possible. This can be accomplished by planting/replanting natural vegetation and using natural water break methods as opposed to retaining walls and imported breakwaters.

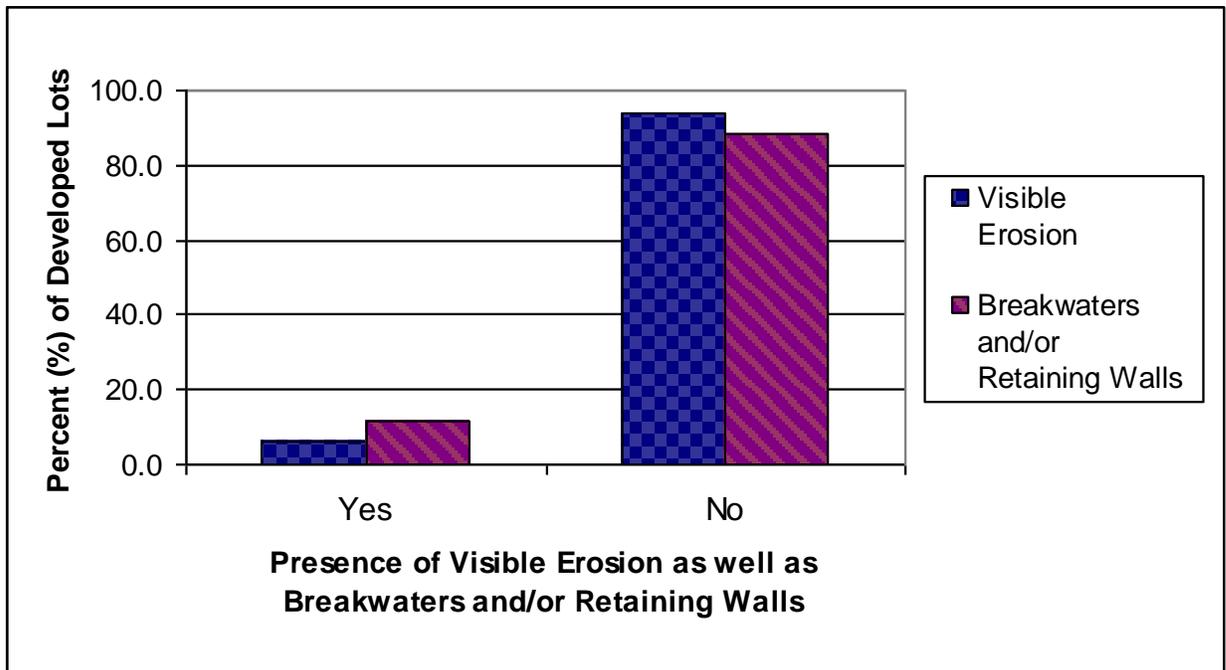
FIGURE 1.2 – The presence of a breakwater and/or retaining wall can promote erosion on neighbouring lots due to the deflection of waves and water currents from one shore onto another increasing the erosion risk. The majority of developed lots on Watch Lake do not show signs of erosion and do not have breakwaters and/or retaining walls.

Shoreline erosion was only visible on seven (6.2%) of the developed lots along the Watch Lake lakeshore. In five of the seven cases the erosion was due to steep slopes and the resulting foot traffic and removal of vegetation allowing for lake access. The other two cases were due to cattle accessing the lake for drinking water. The low occurrence of erosion may be due in part to the high percentage of densely vegetated riparian buffers. The low presence of breakwaters and/or retaining walls may also have contributed to the lack of visible erosion due to the lack of deflection of waves and water currents from neighbouring breakwaters and/or retaining walls (Figure 1.2).

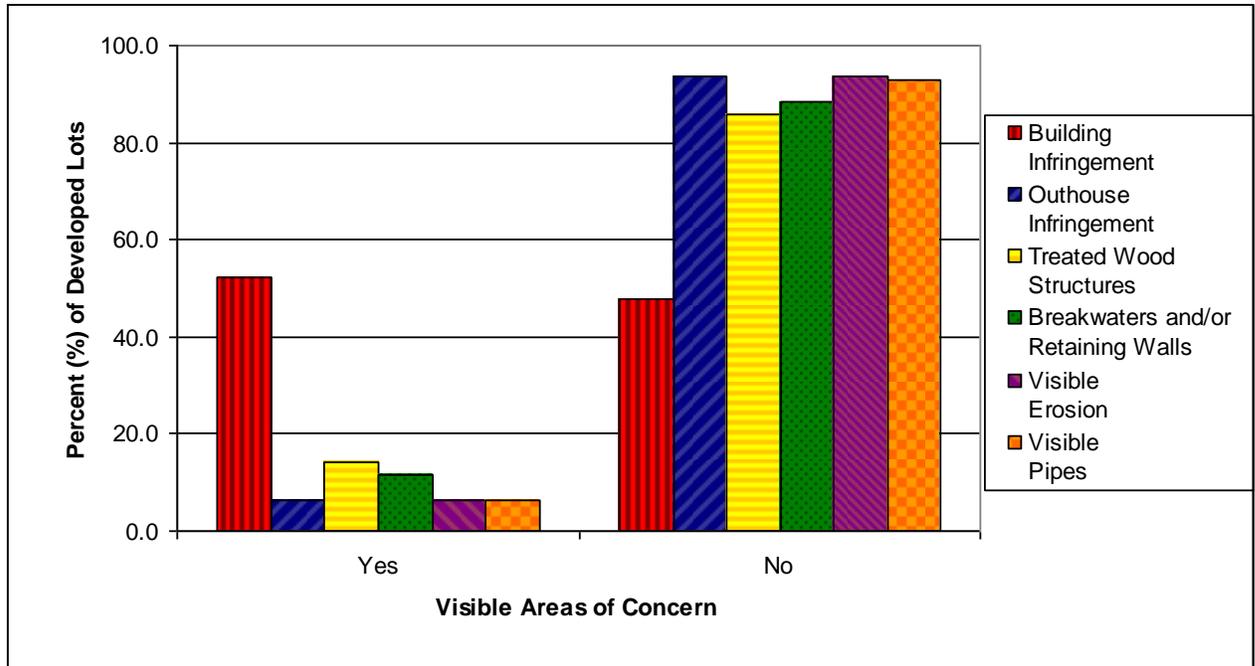
FIGURE 1.3 – An overview of the visible areas of concern clearly shows that the most visible concern is building infringement. 52.2% of the buildings on the Watch Lake lakeshore are less than 15m from the high water mark. The setback distances are based on the lakeshore survey guidelines (Appendix B).

An overview of the visible areas of concern (Figure 1.3) clearly shows that the most visible area of concern is building infringement. 59 (52.2%) of the buildings on the Watch Lake shoreline are less than 15m from the high water mark as is the recommended distance according to the CRD Shoreland Management Policy. Infringing buildings are problematic because they leave insufficient room for a natural vegetated riparian buffer zone and adequate distance between septic systems and the lake. This can result in the physical loss of property, increased flood risk, pollution from runoff, destruction of fish and other wildlife habitat, and changes to nutrient input affecting water quality.

New development should continue to be encouraged to correspond with the CRD Lakeshore Management Policy and district lot sizes should consistently be large enough to support adequate septic systems and riparian buffer zones.
