**City of
Riverbend Cost
Recovery Plan
Engineer
Assessment**

DFA Sample Report

Project Title: Recovery Repair Works

Name of Event: Spring Freshet Flood 2020

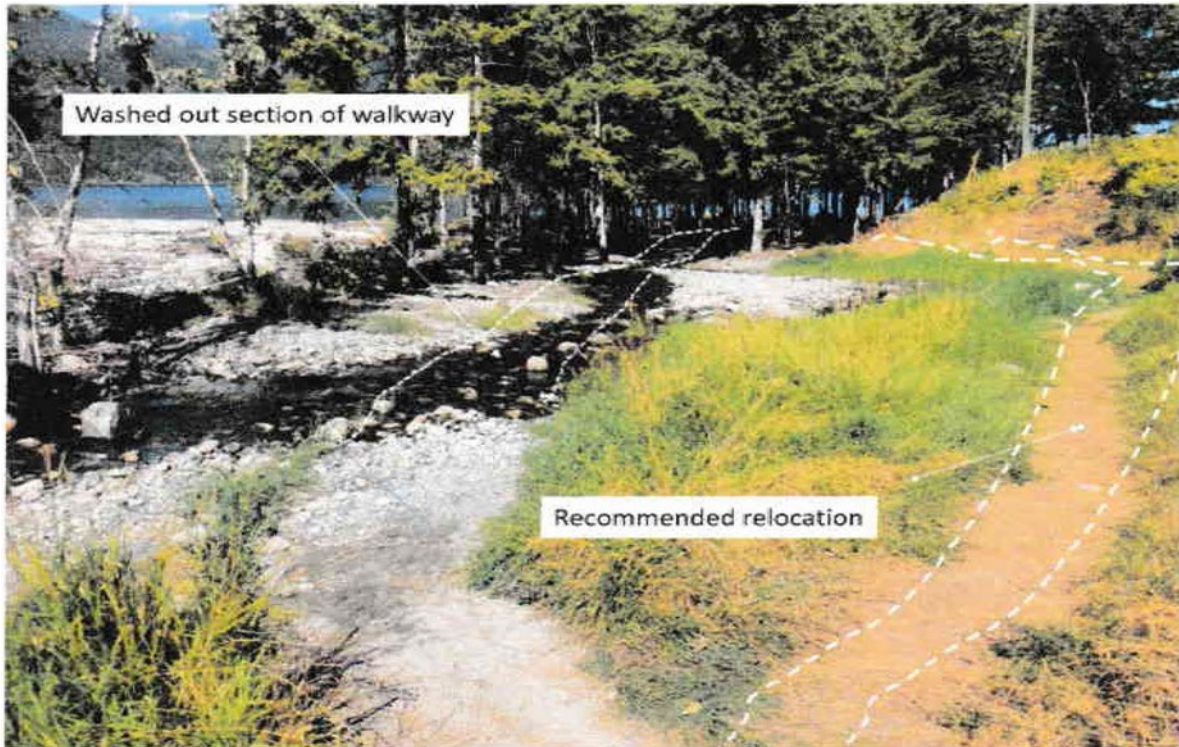
Figure 2: Site I - Walkway Flooding and Erosion August 25, 2020

Site 1 - Walkway: A large volume of bed load was deposited and was shifting in the main channel of Carpenter Creek during the event resulting in an avulsion at the downstream right bank and subsequent flooding and erosion of a 55 m long section of 1-meter-wide gravel walkway as shown in Figure 2. The City does not have pre-event photos. The trail was in good working order before the spring flooding occurred.

The estimated cost to reconstruct the walkway is summarized in Table 1. The estimate is based on the relocation of the section of walkway approximately as shown in Figure 2. It is deemed impractical to reconstruct the washed-out section of walkway in the location it existed prior to the flood.

Firstly, it would require the excavation of the substrate of the main channel of Carpenter Creek to divert the water from the worksite. This work in and about a stream would require authorization from MFLNRORD increasing the project duration and cost substantially. It is questionable whether the ministry would authorize this work.

Secondly, because of the elevated main creek bed adjacent to the entrance to the new channel that eroded the walkway and the continued deposition and shifting of gravel and

accumulation of log jams there is a high probability that the area would flood again next freshet.

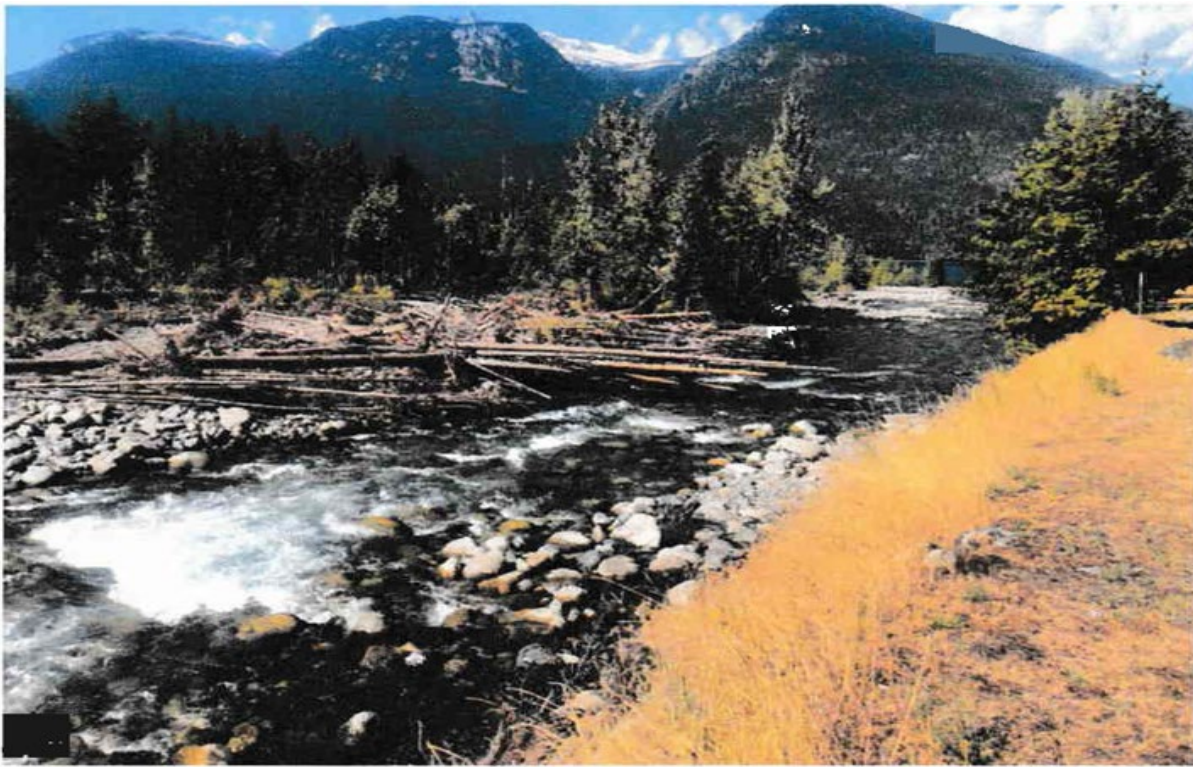
Figure 3: Site 2 Log Jam August 25, 2020

Site 2 - Log jam: The high creek flows resulted in the development of several new log jams in the creek channel throughout the City. The City is concerned that the log jam shown in Figure 3 will increase the risk of erosion of the adjacent riprapped bank. The removal of the jam would reduce the likelihood of a bigger jam forming in subsequent freshet flows and would reduce the risk of damage to the adjacent riprap bank protection. However, there was no evidence of loss of riprap from the bank resulting from this event. The removal of the jam would require prior authorization from MFLNRORD. One alternative is to cut up and spread the logs in channel to reduce the likelihood of creek redirection.

Site 2 Log Jam is not eligible for DFA funding: removal of tree debris is considered mitigative as no infrastructure is impacted.

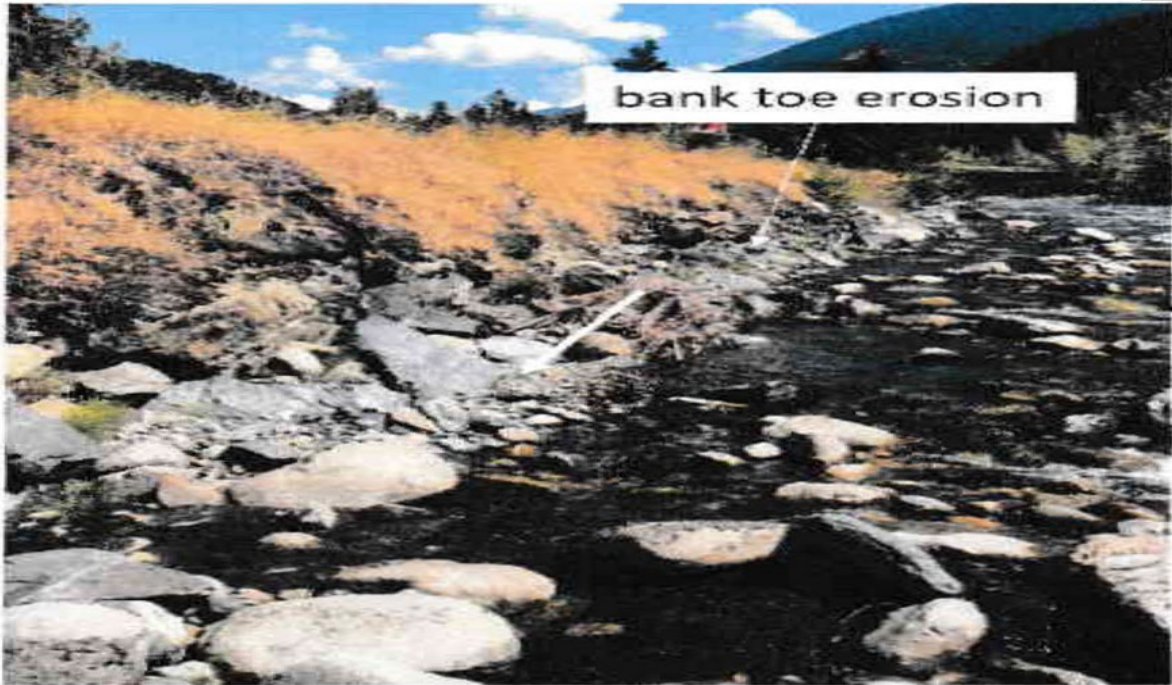
Figure 4: Site 3 Riprap Toe Erosion August 25, 2020

Site 3 Right Bank Erosion: A 15 m length of riprap bank protection, approximately 190 m downstream from the Highway 6 bridge (see Figure I) was damaged as shown in Figure 4. Costs (Table 1) for riprap repairs to this site and Sites 4 and 5 are considered eligible.

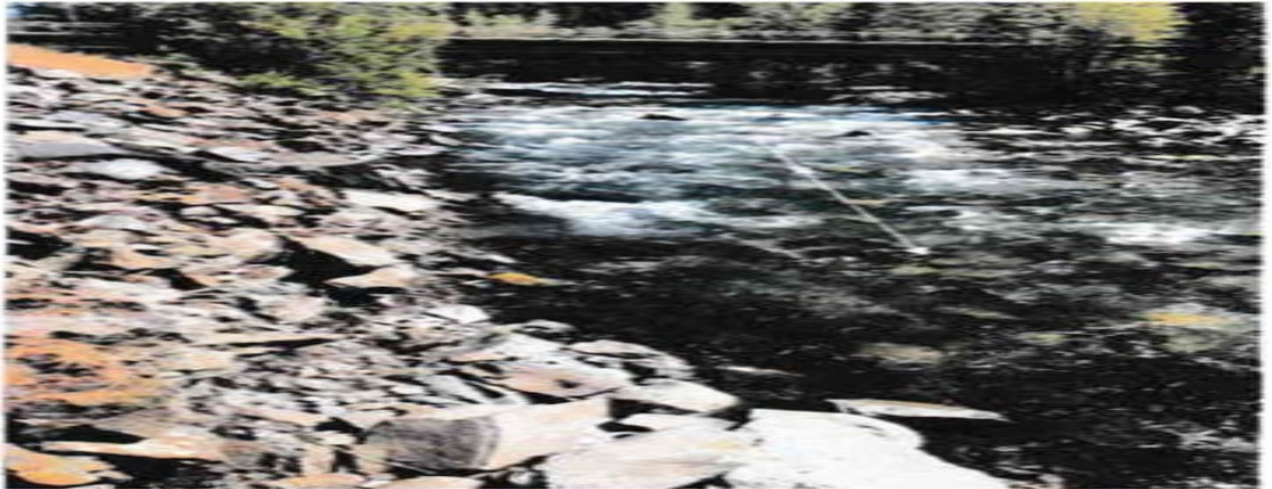
Figure 5: Site 4 Riprap Lost August 25, 2020

Site 4 -Riprap Replacement: Approximately 67 m of bank protection was damaged as shown in Figure 5.

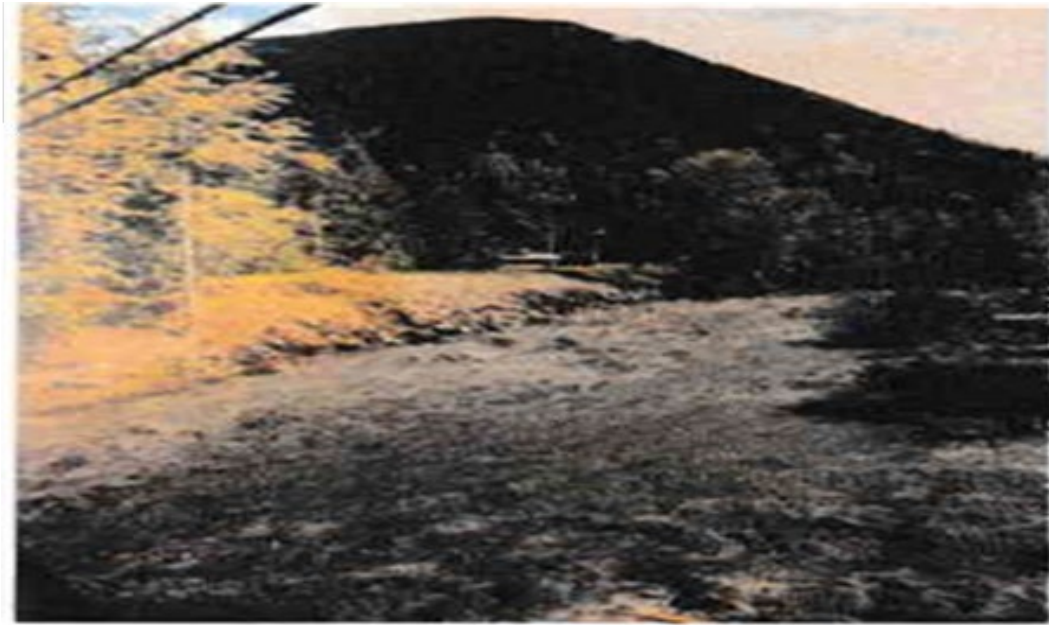
Figure 6: Site 5 Bank Erosion August 25, 2020

Site 5 Riprap Replacement: Riprap erosion protection on a 26 m section of dike upstream of the Highway 6 bridge was eroded as shown in Figures 6 to 8. A large gravel bar and trees in the channel upstream of the bridge and adjacent to this site constricted the channel, caused log jams, and resulted in water being forced to impinge directly into the dike as shown in Figures 7 through 9.

The estimated volume of riprap lost during the May 31/June event is 143 m³. Simply reconstructing to the pre-event configuration is not recommended as there would be a high likelihood of a repeat failure. Conceptual review indicates that the maximum riprap slope angle should be 1.5H: 1V (which is consistent with the 2013 riprap design) and should include a toe trench (also part of the 2013 design).

The cost of repairs summary (Table 1) for Site 5 is based on the plan to reconstruct the bank with a flatter slope angle and scour protection described above. The construction will involve instream work. Consequently, authorization will be required from MFLNRORD. Most likely MFLNRORD will require an environmental assessment and oversight during construction. This cost is included in Table 1.

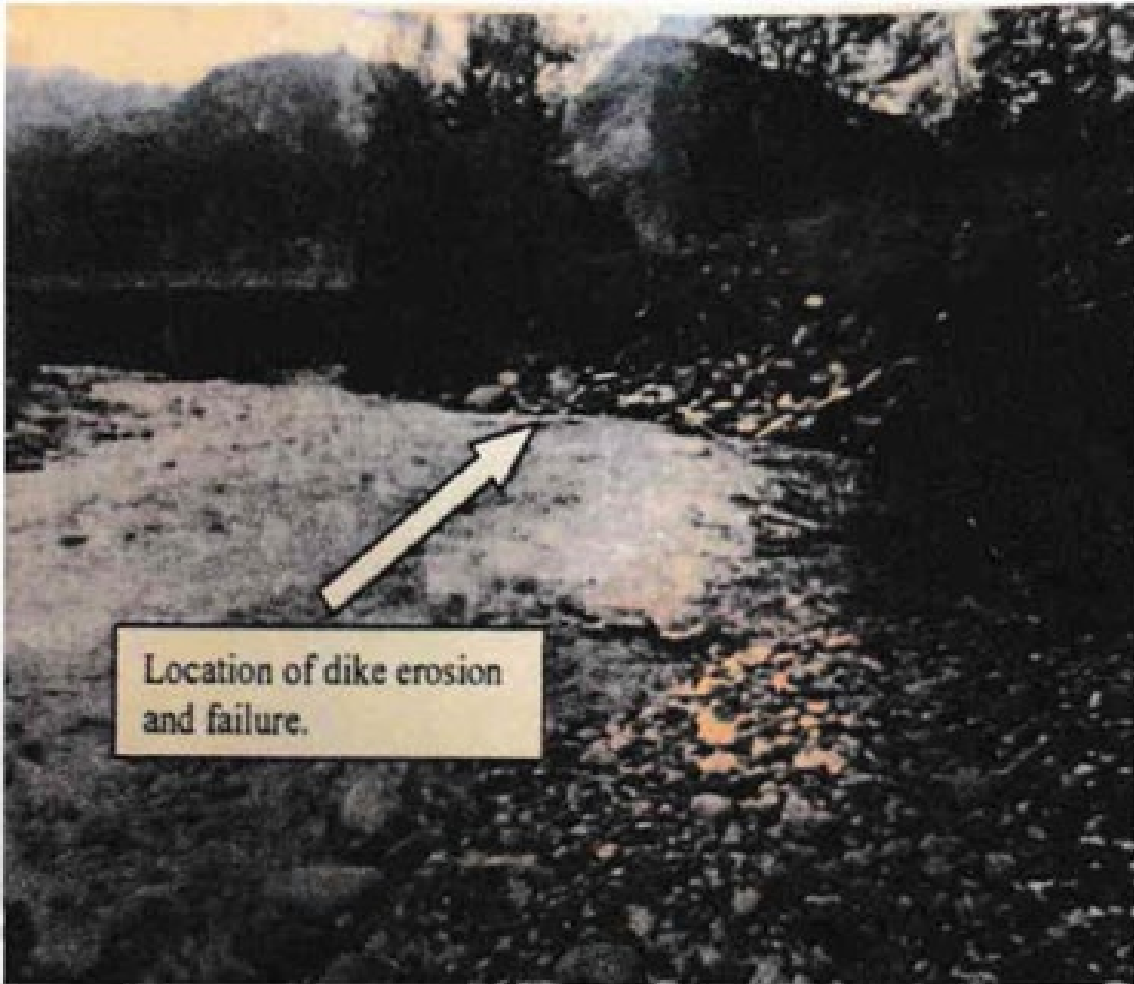
Figure 10: Site 5 View of Erosion Resulting from June 2013 Flood (CGT 2013)

The dike was initially constructed in the 1970's and upgraded in the 1990's. During the 2013 freshet the dike was damaged at this same location with loss of erosion protection and some of the dike prism as shown in Figure 10. The photo in Figure 10 was taken from CGT Engineering report to the City dated September 11, 2013. In 2014 the dike slope was reconstructed and armored with riprap, as shown in Figure I, taken from CGT report to the City dated September 8, 2014. It is understood the repairs were funded partially by the Province.
