Assessing fuel treatment effectiveness:

A case study of the Nohomin Creek wildfire encroachment on the community of Stryen 9

January 2024

Project number: 301015438 Report number: WFTR 2024 N.3

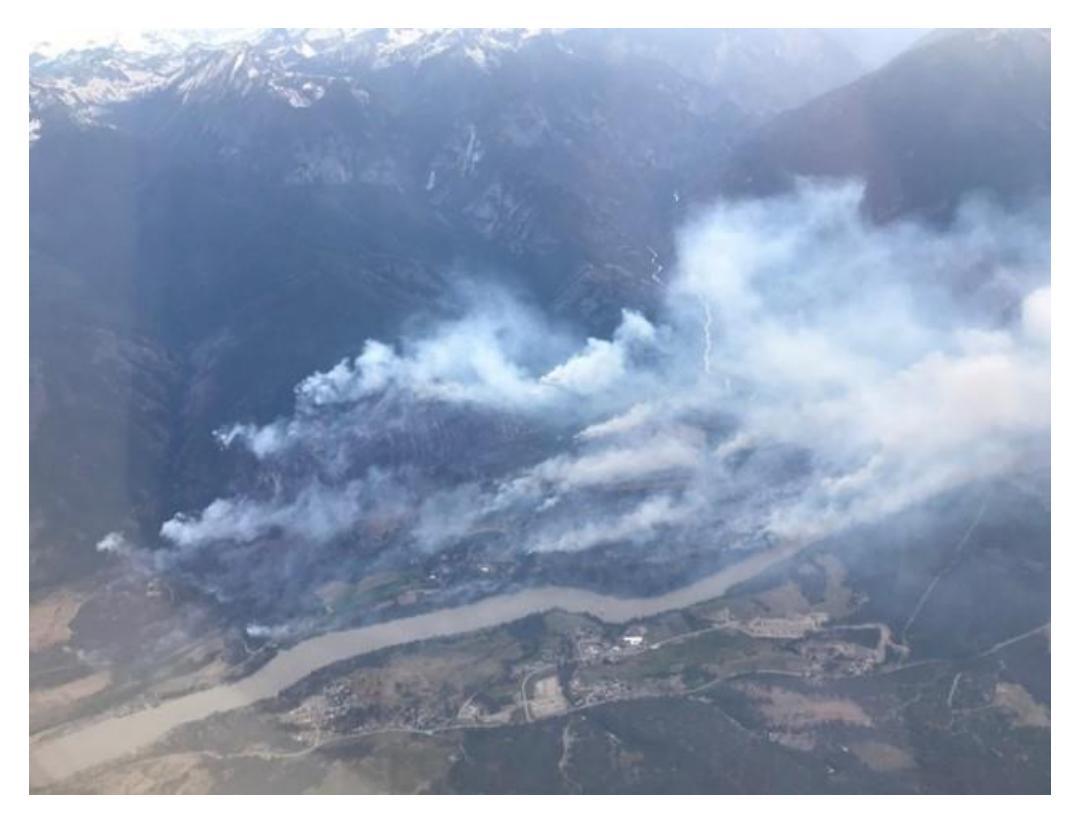
Figure 1. Fire spread in the Fraser Valley on July 14, 2022. Photograph courtesy of the BCWS.

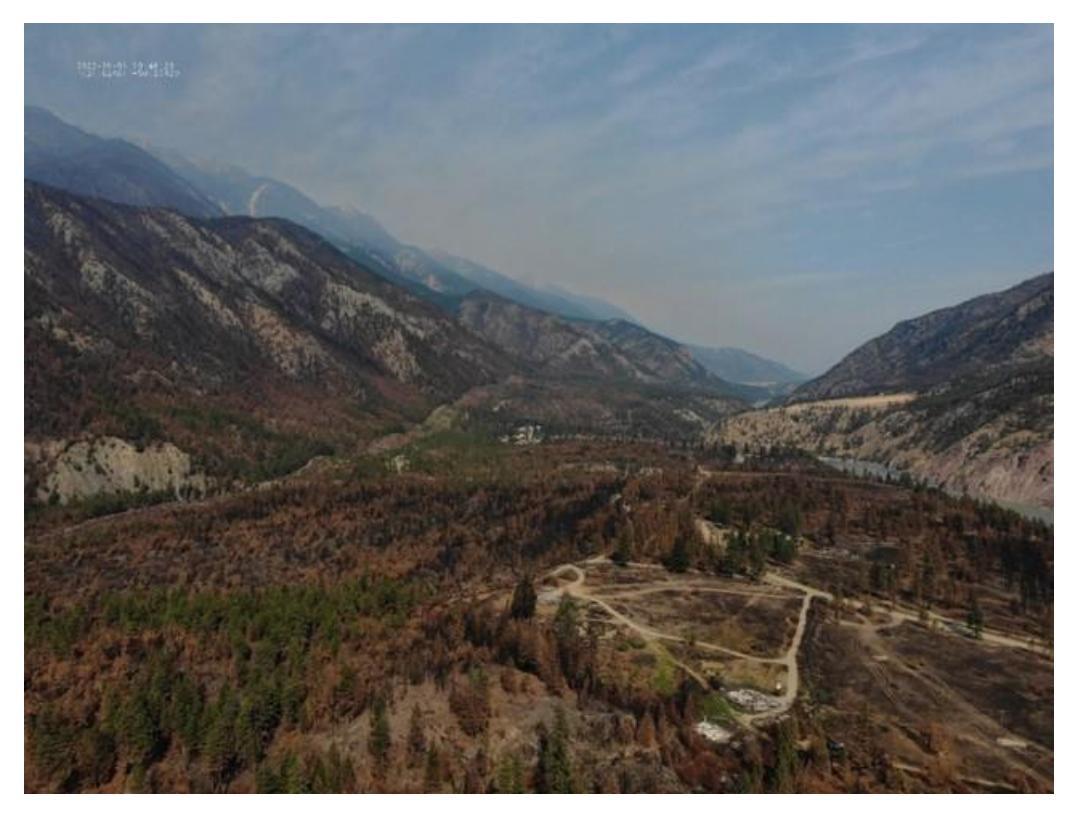
Figure 2. Fire spread across the Stein River and toward the residential area of Stryen 9 (photo centre) Credit: Steve Hvenegaard.

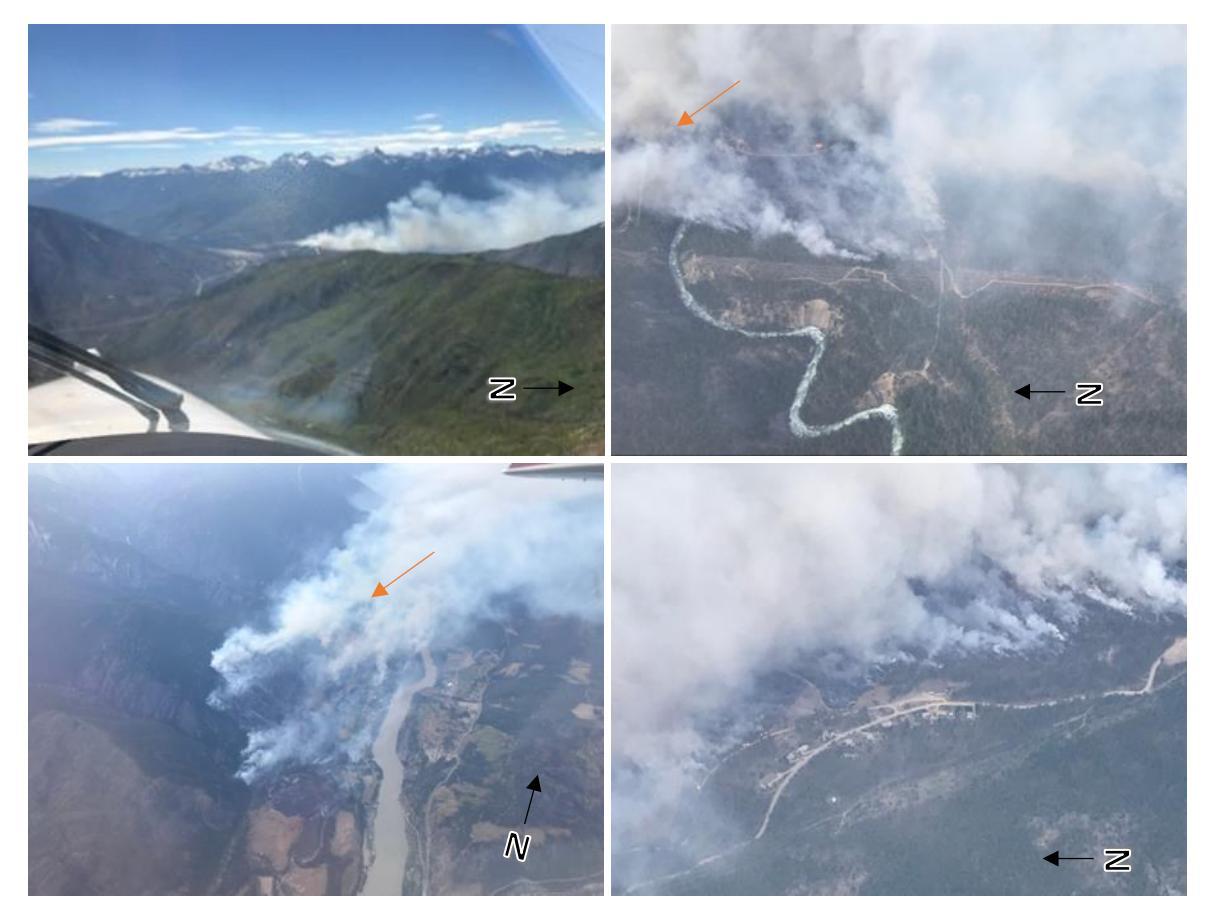
Figure 3. Nohomin Creek wildfire chronology: Looking west towards Lytton 27 IR, arrival of the birddog at 1517 h (top left) while approaching the community of Lytton 27 IR from the east. Dense smoke on the north shore of the Stein River (orange arrow) at 1945 h suggesting the fire had spotted over the river (top right). Confirmation of spot fire on the north bank of the Stein River at 2005 h (orange arrow, bottom left). The community of Stryen 9 at 2308 h after the wildfire had passed (bottom right). Photographs courtesy of BCWS.

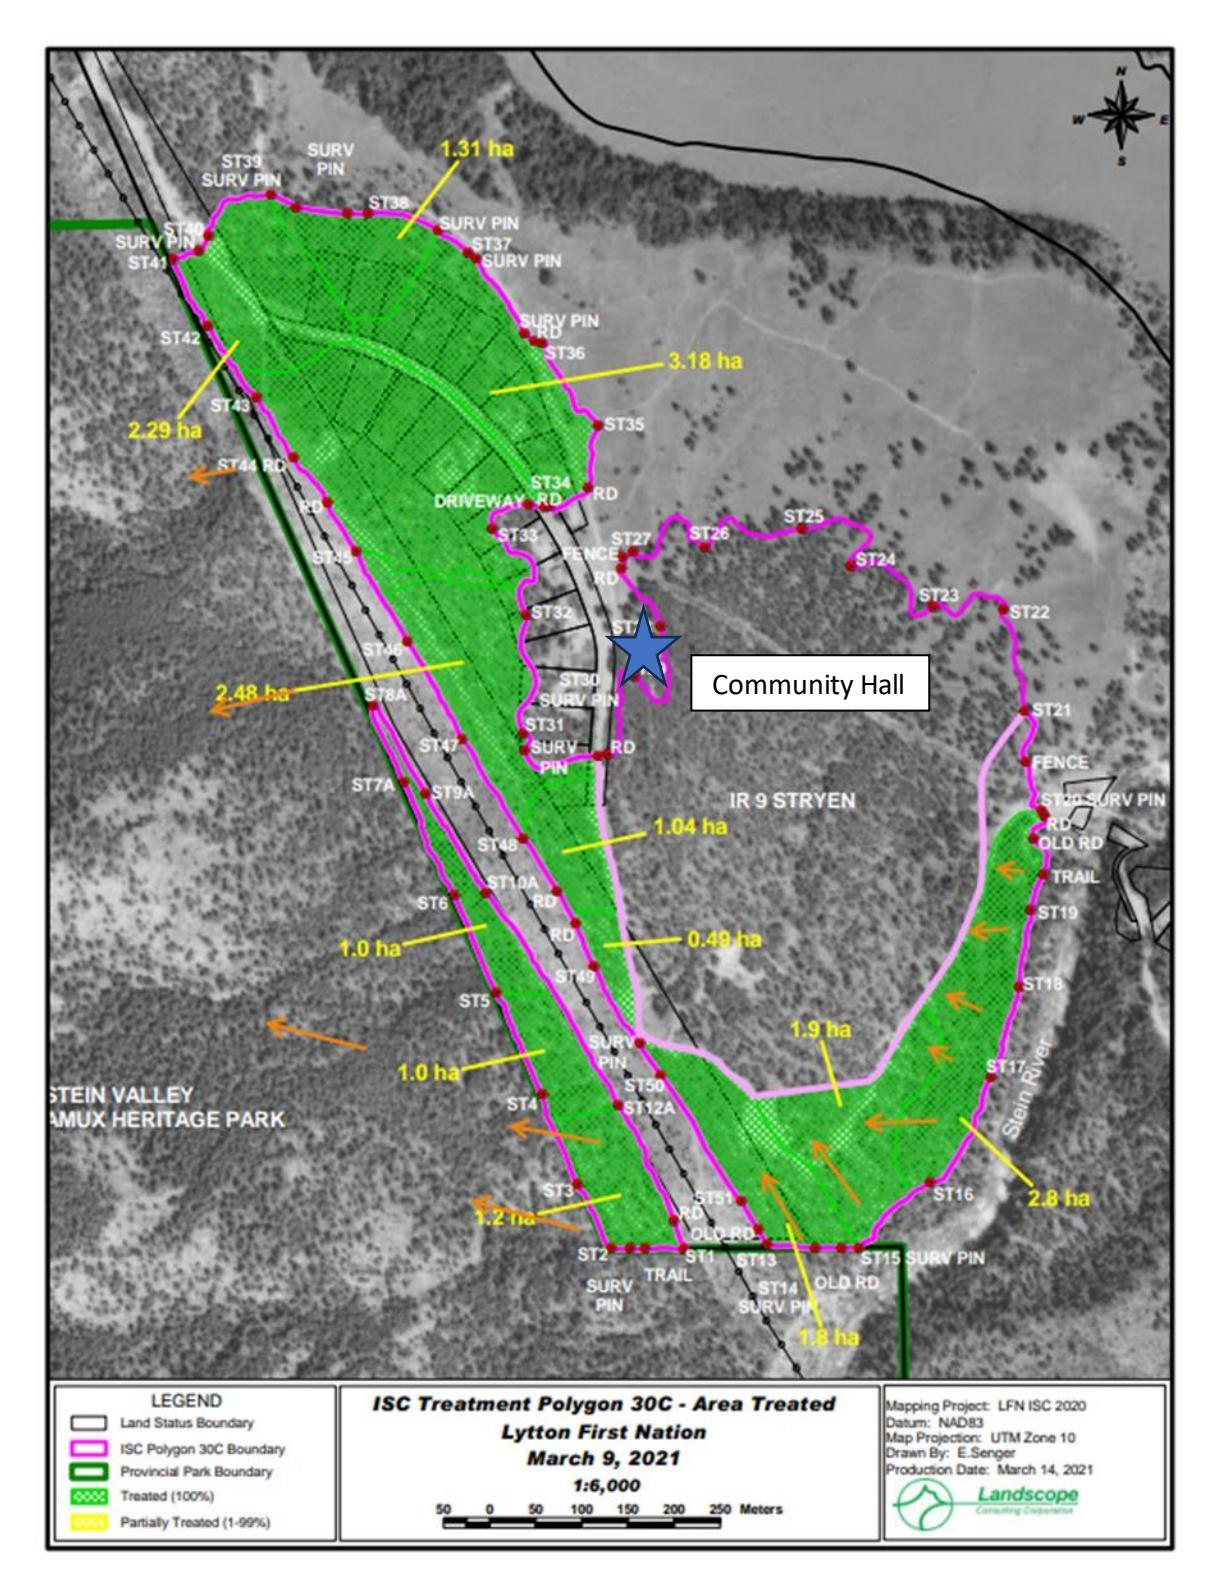
The fuel treatment defined as Polygon 30C (Figure 4) was planned and developed to alter the forest fuel conditions, that in the event of a wildfire, the levels of fire behaviour, the likelihood of crown fire initiation, fire intensity and rate of spread will be reduced to a level that the wildfire will be less aggressive and destructive in areas proximal to the community. (Landscope Consulting Corporation, 2020)

Figure 4. Fuel treatment Polygon 30C (purple boundary) surrounding the Stryen 9 residential area. The orange arrows indicate the direction of fire spread.

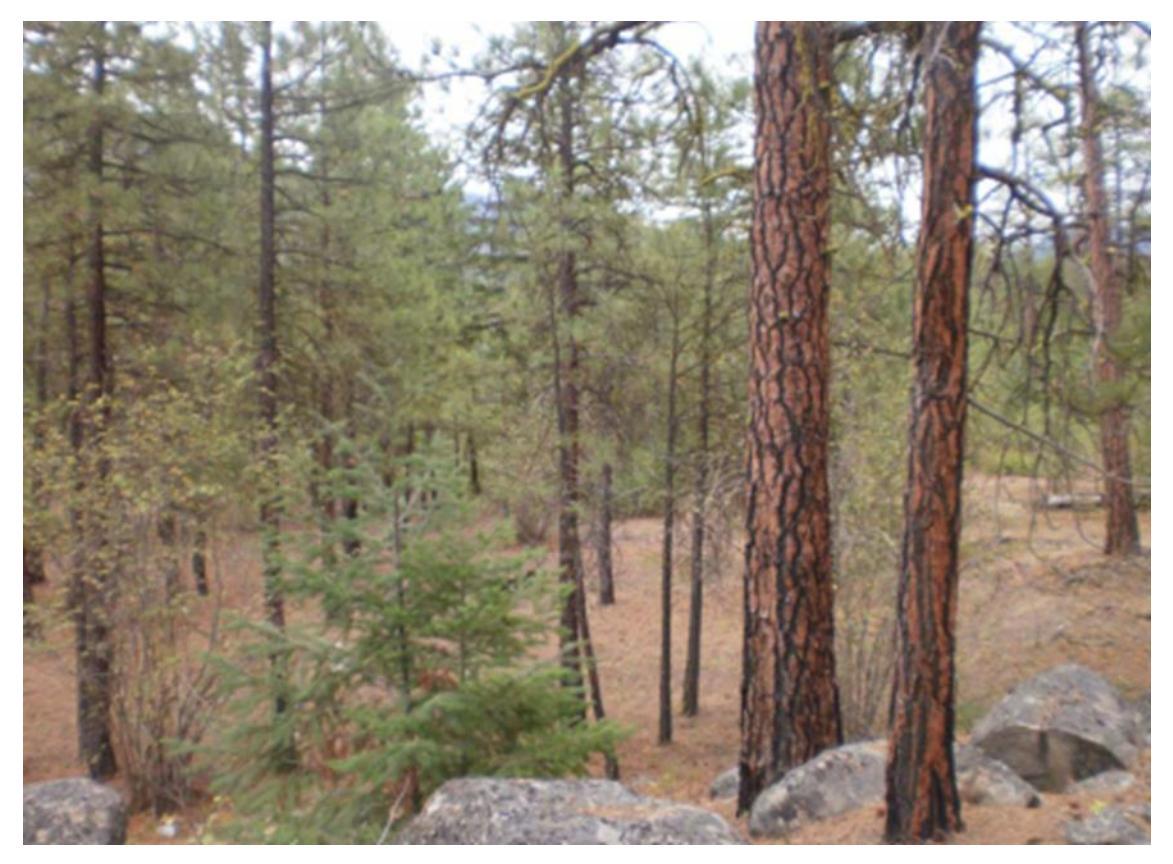
The contrast in stand density can be seen in the pre-treatment (Figure 5) and post-fire (Figure 6) photographs. The post-fire photo is not, however, a good indicator of post-treatment surface fuel loading since a large portion of litter and woody debris would have been consumed by the fire. A <u>360-degree panorama of this area</u> shows the extensive stand-thinning at the south end of TUA. Any surface litter shown in this panorama is post-fire needle cast.

Figure 5. Pre-treatment stand structure in polygon 30C at WTA Plot 30C-12. Photograph courtesy of Landscope Consulting Corporation.

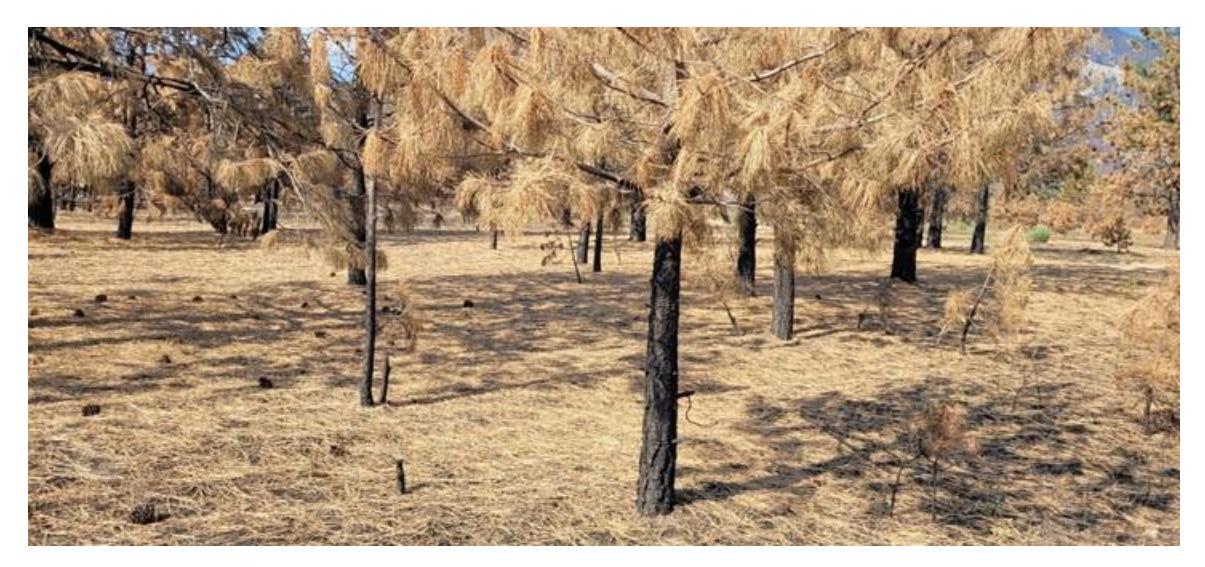
Figure 6. Post-burn view of the fuel treatment south of the community hall.

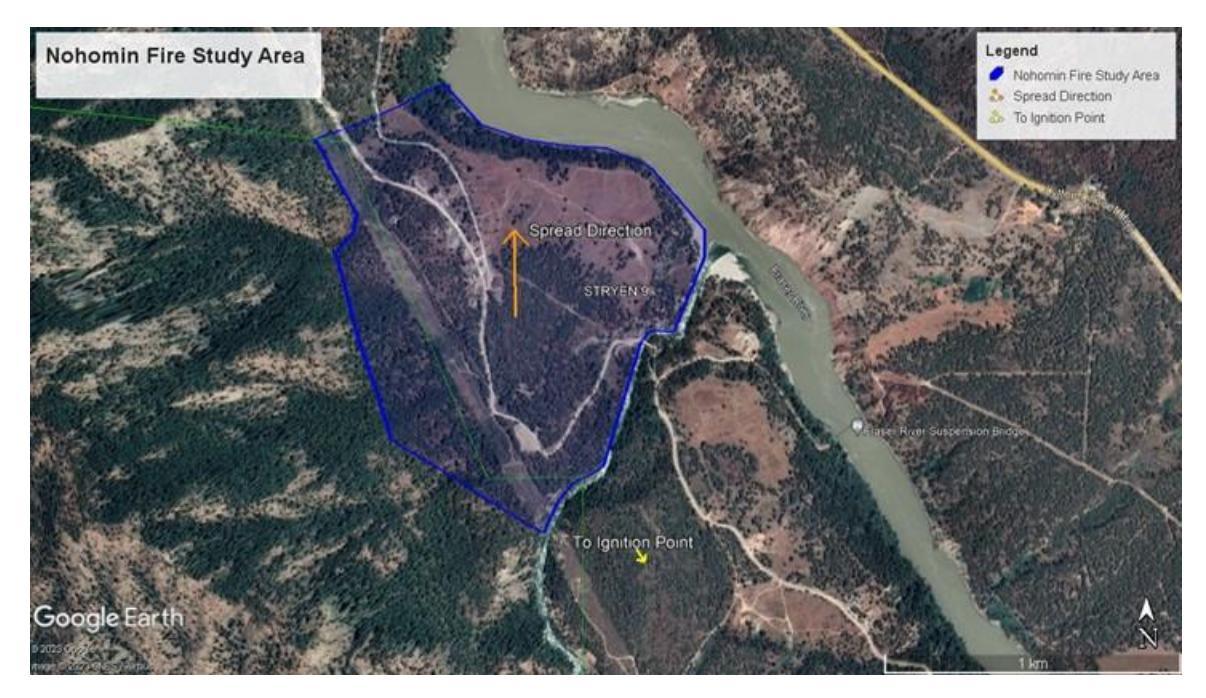
Figure 9. The Nohomin Creek wildfire study area (blue polygon) surrounding the community of Stryen 9 and fire spread direction (orange arrow) at the time of contact with the community fuel treatment. The direction to the ignition point is indicated by the yellow arrow at the bottom of the image.

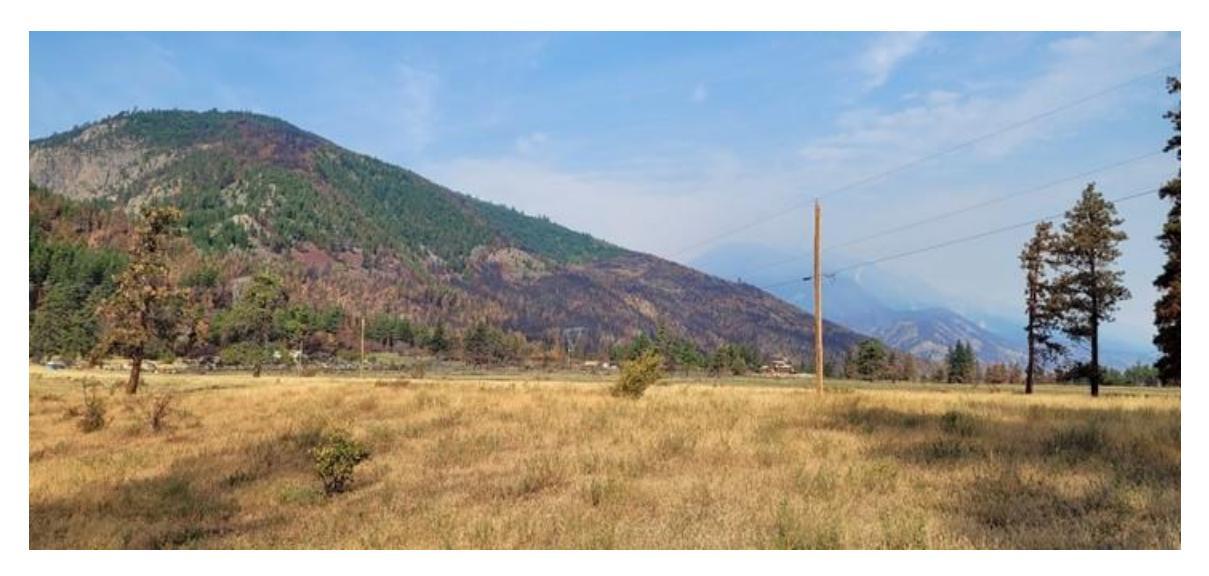
Figure 12. Valley bottom looking north towards the community of Stryen 9. The south aspect slope of the Stein River valley, part of Stein Mountain, can be seen in the upper left of the photo.

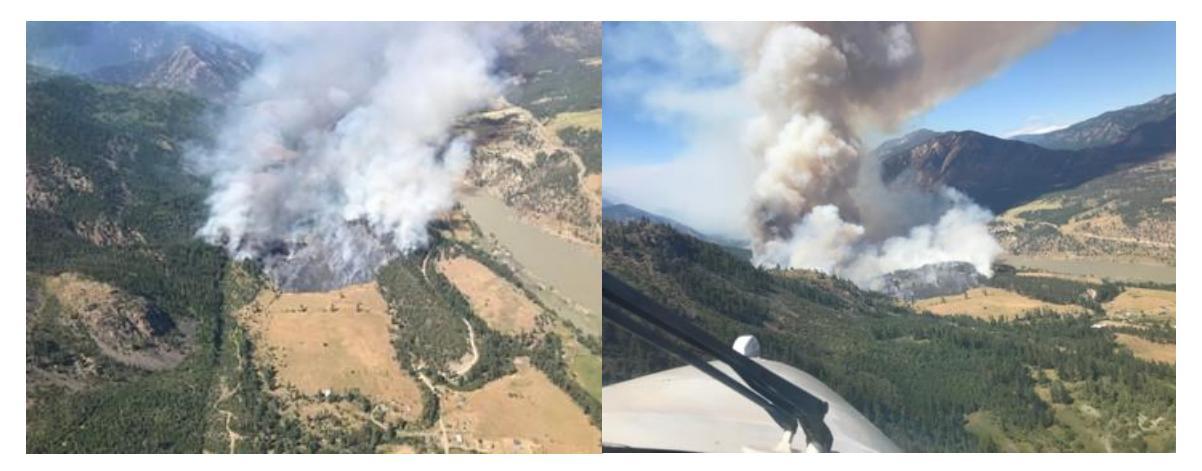
The fire behaviour of the Nohomin Creek wildfire was a combination of vigorous surface fire with intermittent crowning. The angle of the smoke column observed from aerial photos suggests a wind-dominated column and wind-driven growth for much of the burning period (Figure 13). During peak burning, at 1600 h, the intensity increased such that the fire became column-dominated and continuous crowning occurred. Intermittent periods of continuous crowning are noted by completely consumed canopies, seen in both the aerial photographs as well as in the post-fire analysis of crown consumption.

Figure 13. Winds from the western valley mixing with the dominant southern winds, driving the fire north (Left). The fire transitioned to column-dominated during an increase in burning intensity at approximately 1600 h (Right). Photographs courtesy of the BCWS.

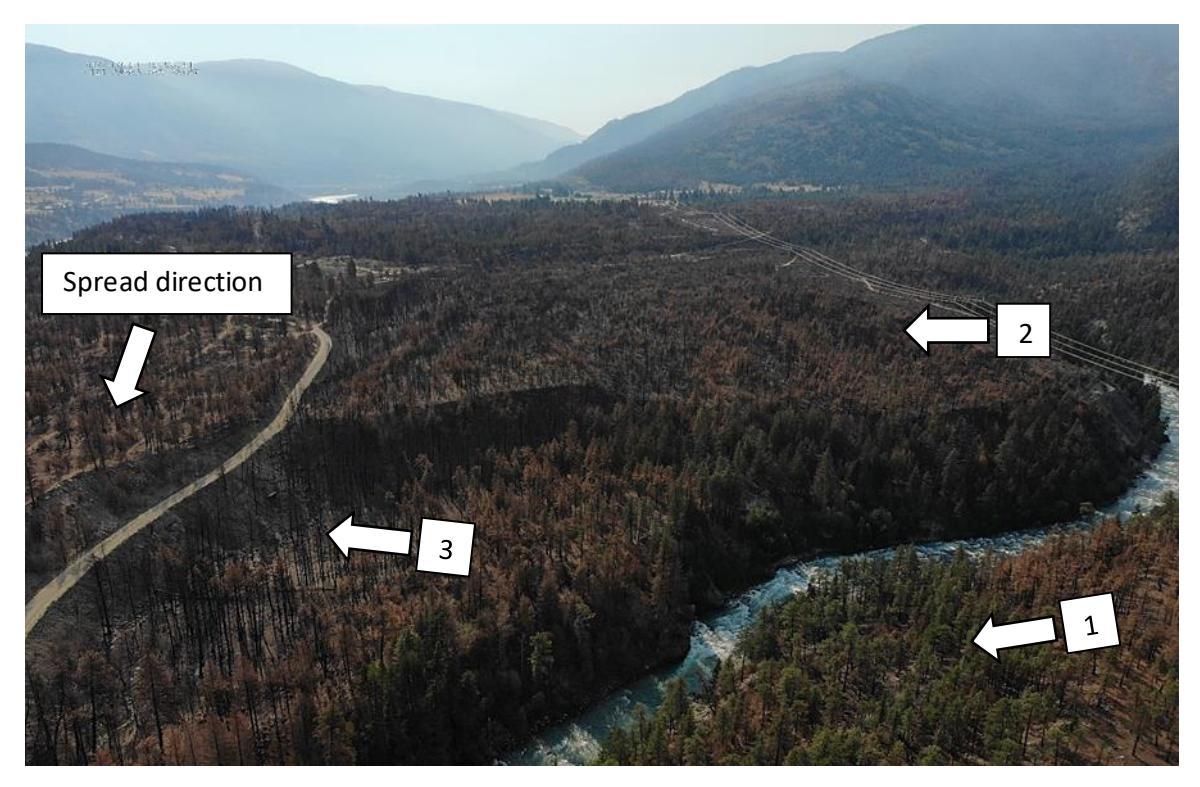
Figure 14. Aerial imagery looking south at contrasts in fire intensity observed on opposites sides of the Stein River: (1) indicates surface fire, (2) intermittent crowning, and (3) continuous crowning.

Reviewing the post-fire aerial imagery (Figure 14), the fire achieved peak burning intensity before jumping the Stein River (arrow 3), as indicated by the charred tree stems with no remaining needles. Upon crossing the Stein River (Figure 15), the fire entered a treated fuel area where it burned up a short, terraced slope and into a gravel road, spotting over the fuel-free areas in rapid succession (Figure 16).
