WATER QUALITY MONITORING AGREEMENT

WATER QUALITY ASSESSMENT OF Fraser River

AT RED PASS (1984 – 2004)

March 2007

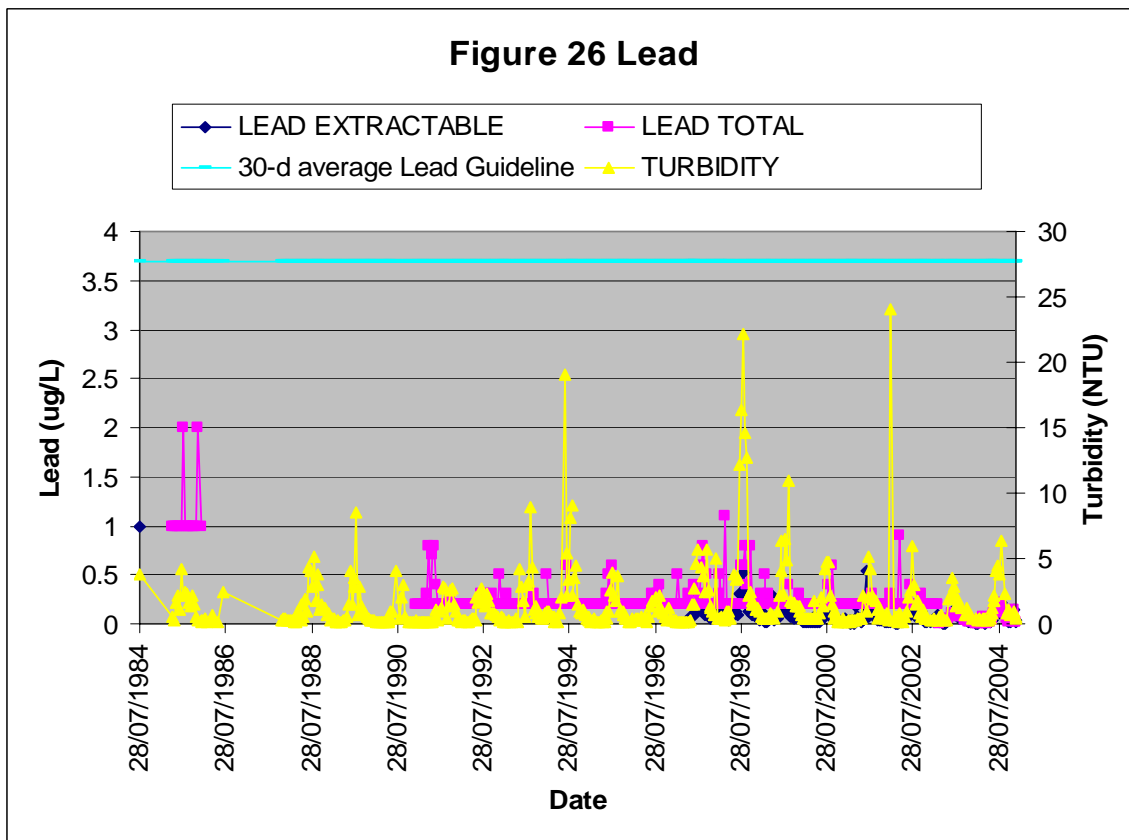
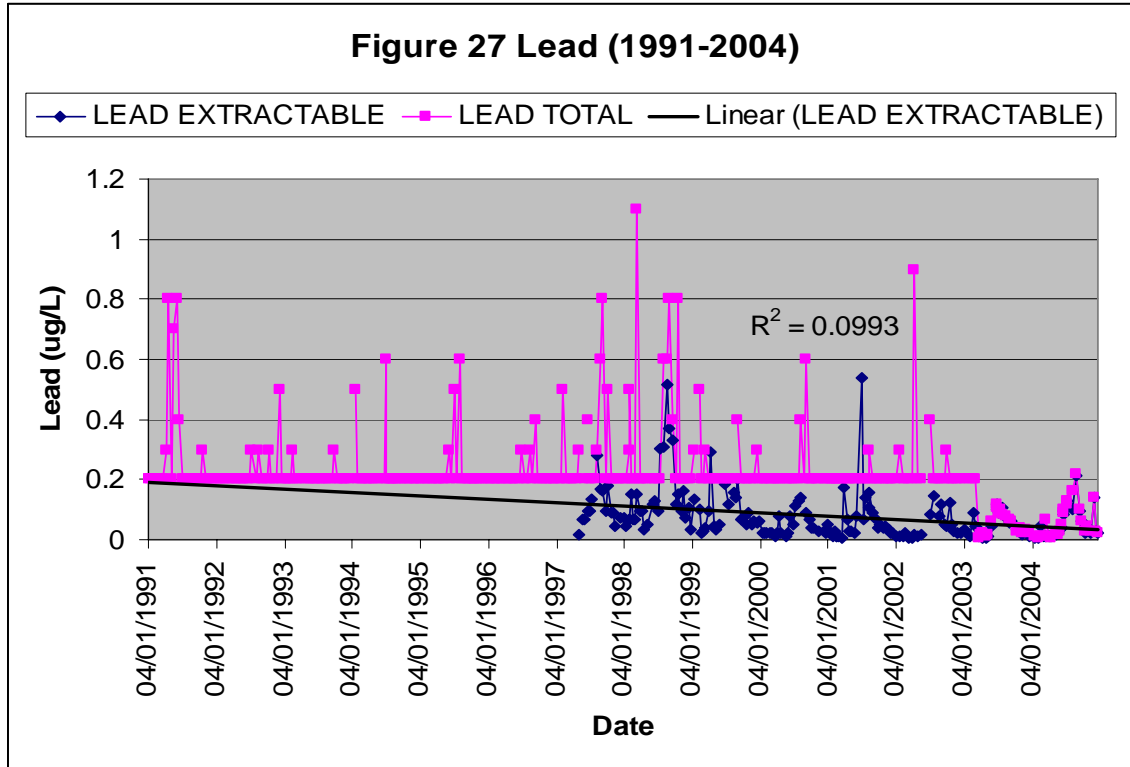
Guidelines for **total lead** (10 µg/L for drinking water and 30-day mean of 3.7 µg/L for aquatic life) were not exceeded by any samples collected between 1984 and 2004 (Figure 26). There appears (Figure 27) to be a trend of lower extractable lead concentrations during the 1991-2004 period. There seems to be some correlation between total lead concentrations and turbidity.

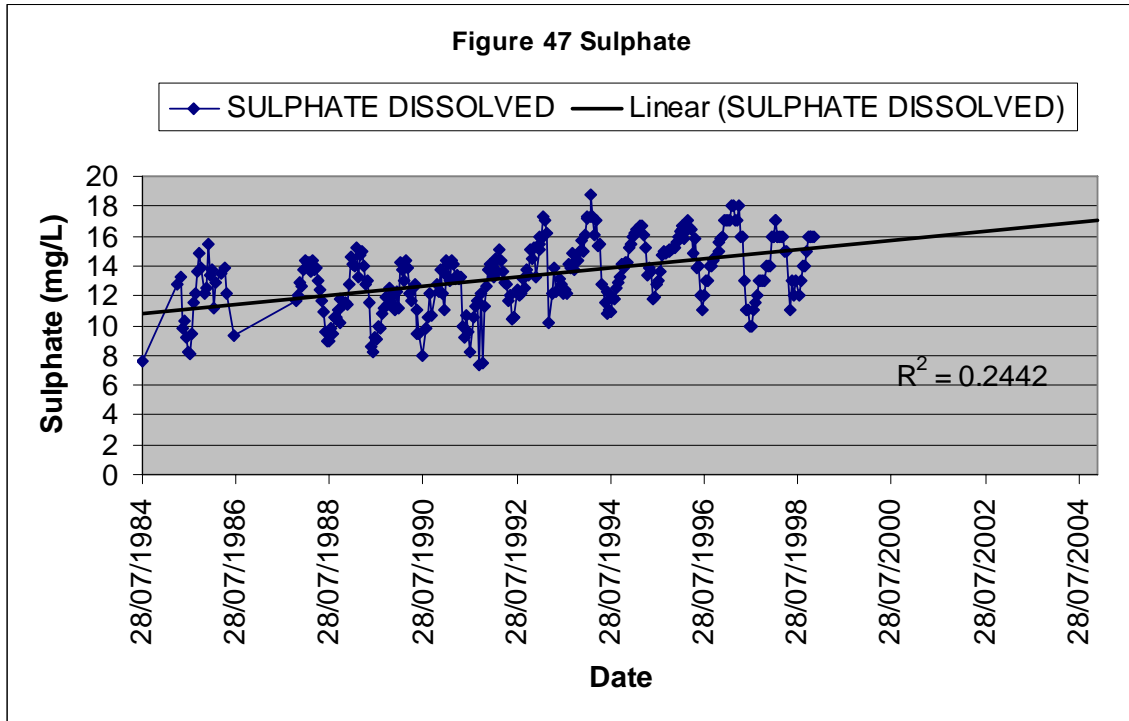
Dissolved sulphate concentrations had a definite trend towards increasing values over time (Figure 47). However, all concentrations were well below guideline values (a maximum of 100 mg/L for the protection of aquatic life), and are therefore not a cause for concern at this time.
