WATER QUALITY ASSESSMENT OF Elk River AT SPARWOOD (2002 – 2005)

Prepared by:
L. G. Swain, P. Eng.
B.C. Ministry of Environment

March 2007

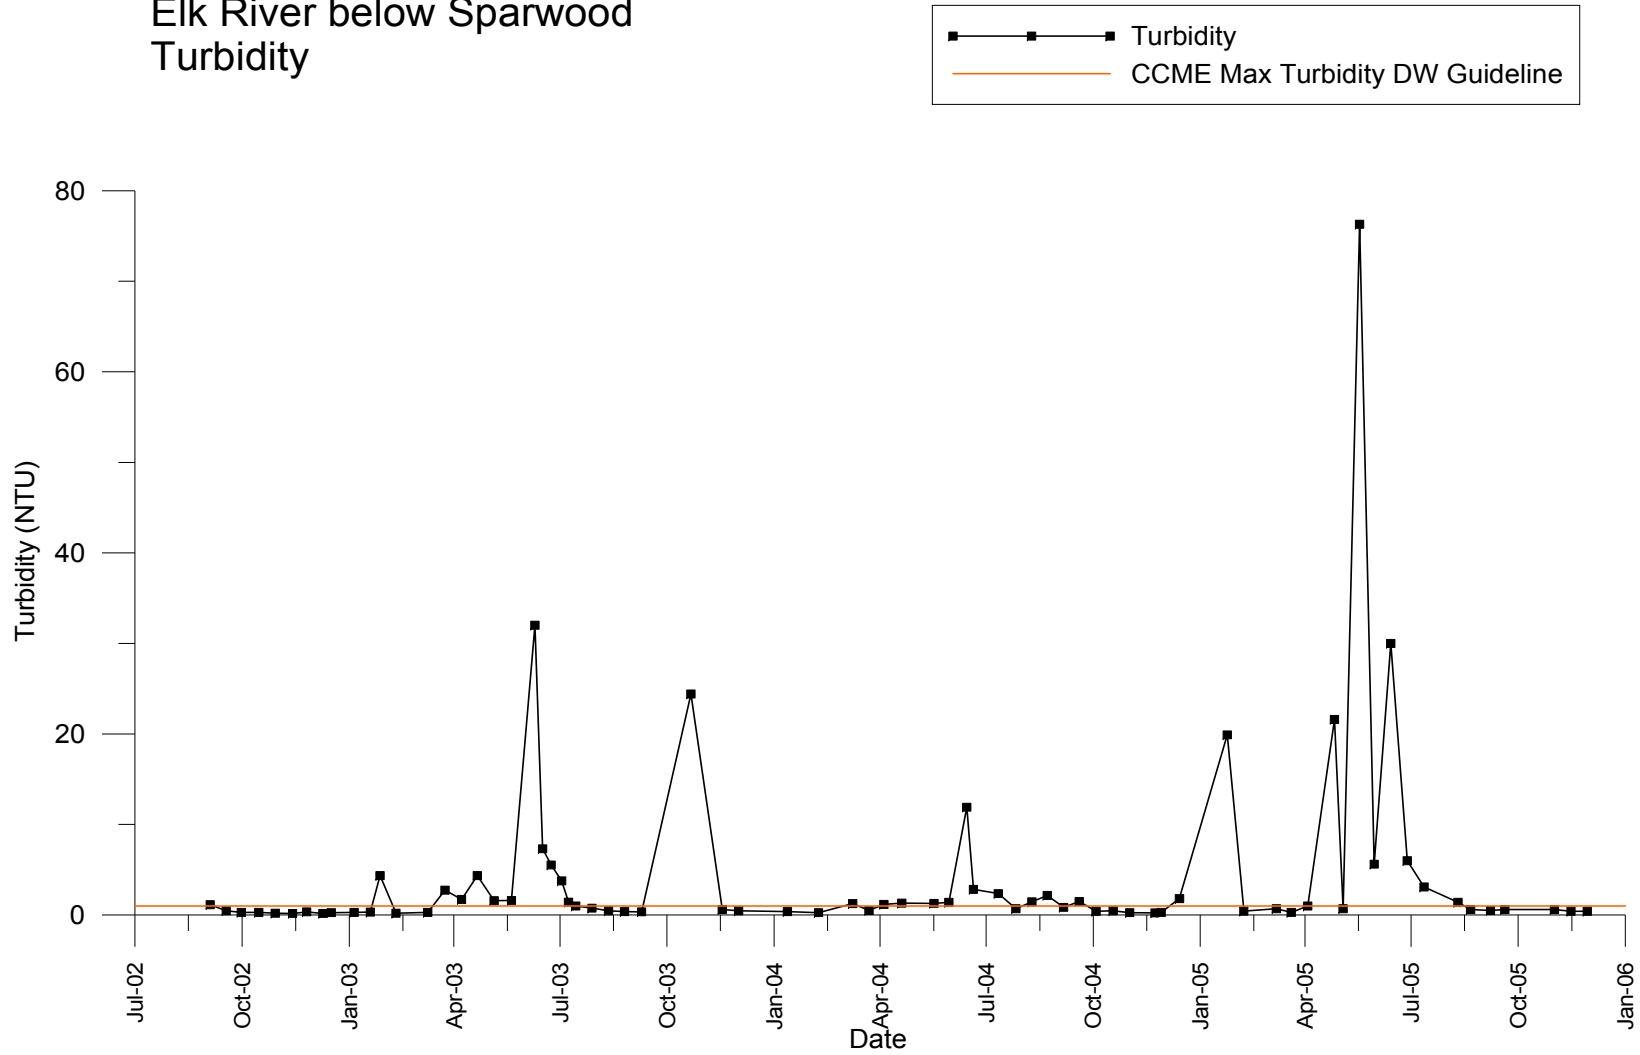
Figure 51
Elk River below Sparwood
Turbidity

Turbidity (Figure 51) has occasionally been above the guideline for source waters used for drinking with no treatment. Therefore some treatment will be required for solids removal on occasion..

- Turbidity, fecal coliform and e. coli concentrations exceeded source water protection guidelines for use of the water with disinfection only. This means that the water should have partial treatment to remove both turbidity and improve the removal of bacteria.
