WATER QUALITY MONITORING AGREEMENT

WATER QUALITY ASSESSMENT OF KETTLE RIVER AT CARSON (1980 – 2002)

Prepared by:
Burke Phippen
BWP Consulting

January, 2003

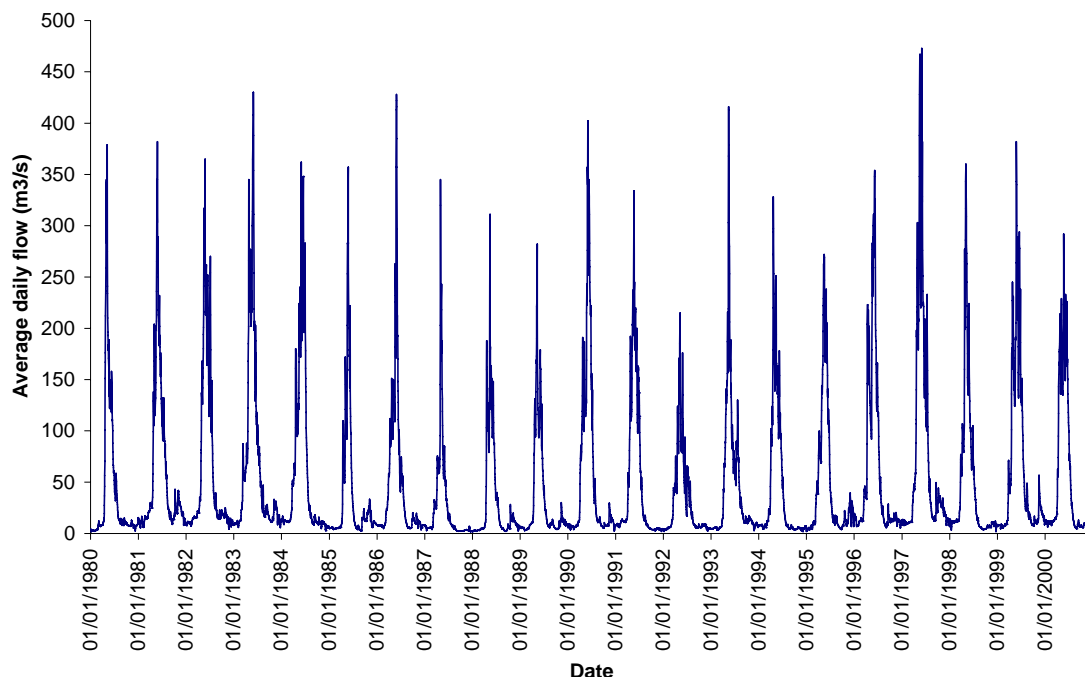
Figure 2. Kettle River at Ferry Flow (1980 - 2000)

The Kettle River at Carson is located just upstream and south west from Grand Forks, B.C. where the Kettle River makes its return into Canada, crossing back into B.C. from Washington State (Figure 1). The drainage area of the Kettle River at Carson watershed is 6730 km². The river flow is monitored at the nearest upstream Environment Canada station number BC08NN013 (Kettle River at the ferry crossing). The flow data are plotted in Figure 2.

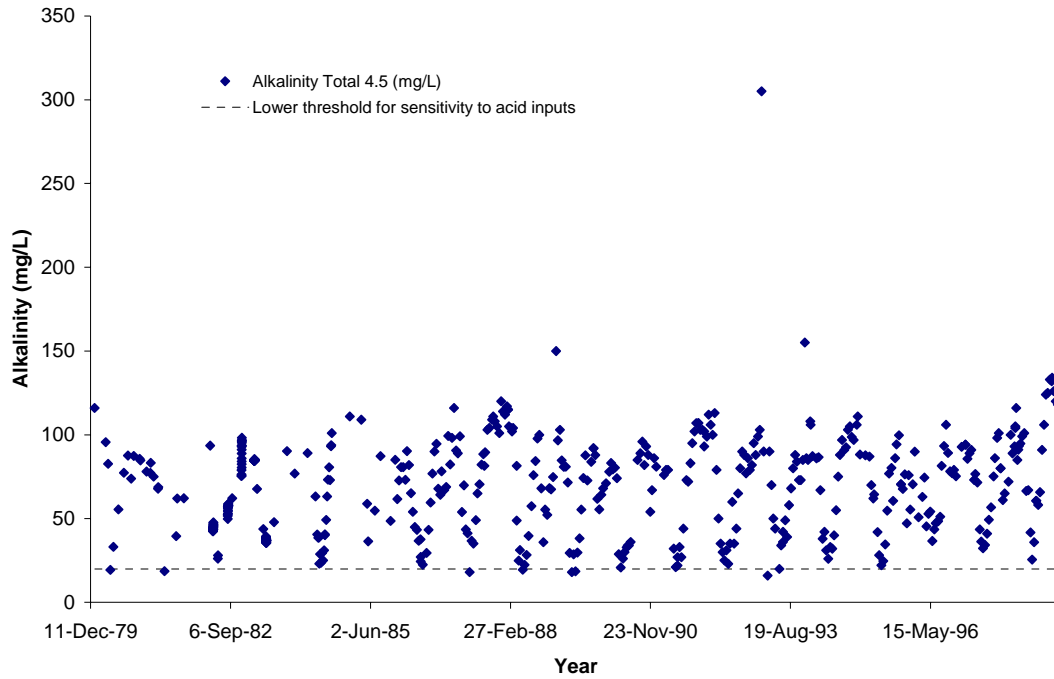
Figure 3. Kettle River at Carson - Alkalinity, Total

Total alkalinity (Figure 3) and **dissolved calcium** (Figure 11) concentrations indicate that the Kettle River at Carson is well buffered and has a low sensitivity to acid inputs.

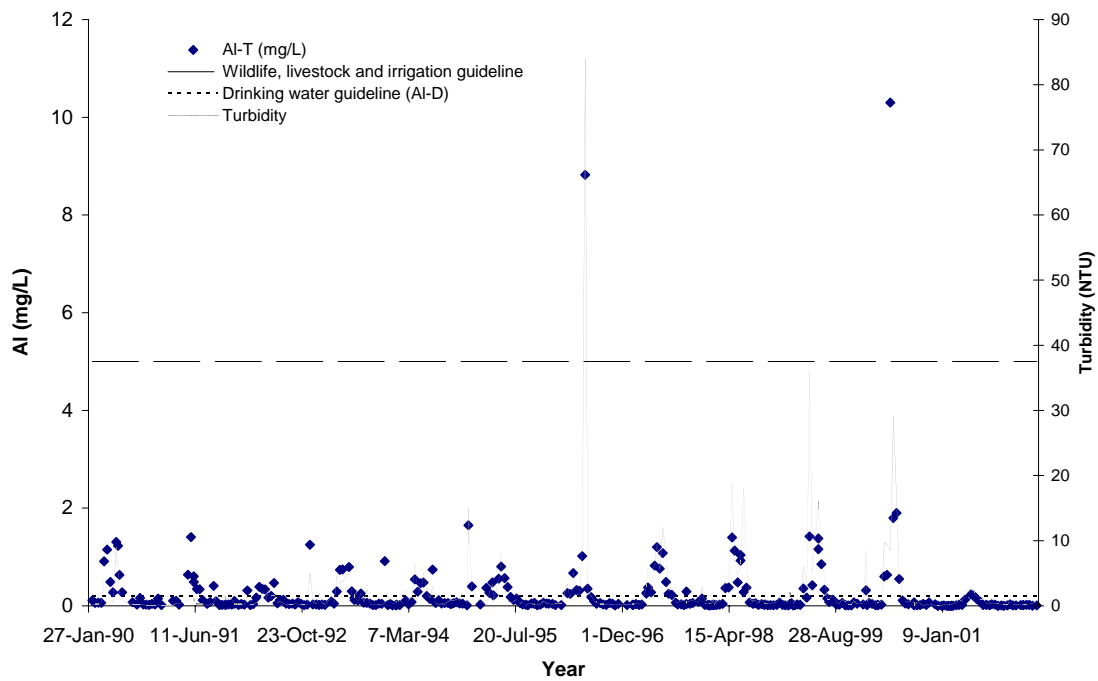
Figure 4. Kettle River at Carson - Aluminum, Total

Total aluminum concentrations often exceeded the aquatic life guideline of 0.1 mg/L dissolved aluminum (36% of 322 samples) as well as the drinking water guideline of 0.2 mg/L dissolved aluminum (28% of samples) (Figure 4). However, as the total fraction of aluminum was measured and the guidelines are expressed in terms of dissolved aluminum, an accurate assessment of attainment cannot be made. The wildlife, livestock and irrigation guideline of 5 mg/L was exceeded by two values, and the maximum recorded value was 10.3 mg/L on May 9, 2000. The strong correlation between total aluminum and turbidity (Figure 4) suggests that the majority of the aluminum was

associated with particulate matter and would therefore be unavailable to biota as well as removed by treatment for turbidity prior to consumption as drinking water.

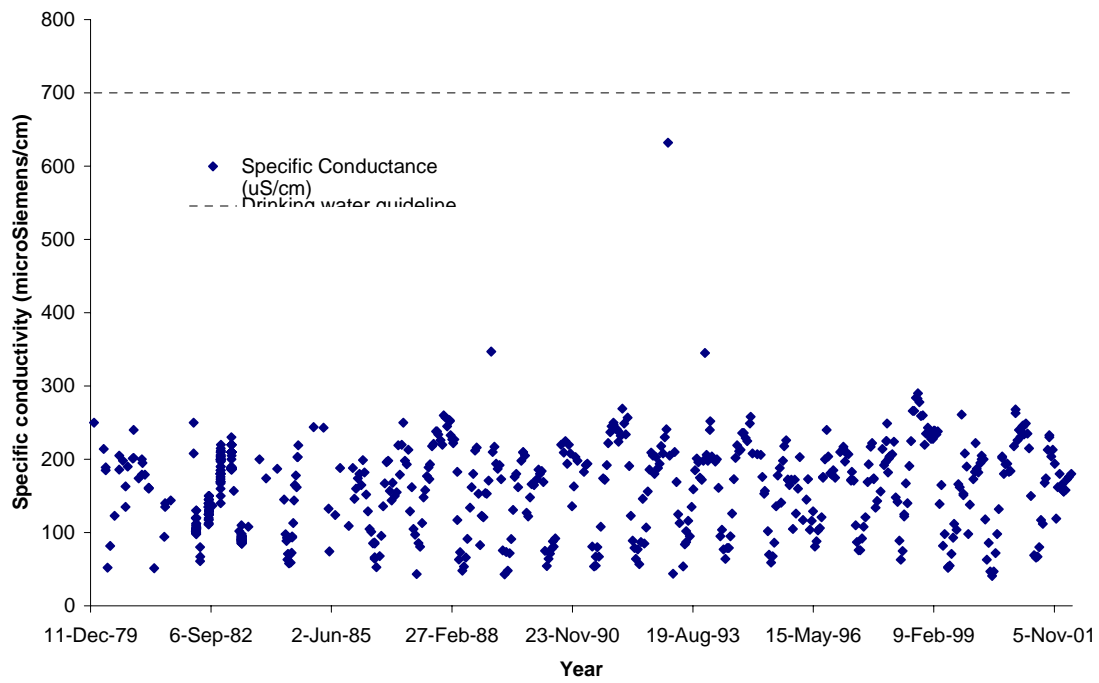
Figure 20. Kettle River at Carson - Conductivity, Specific

Specific conductivity values also varied seasonally, with maximum values during winter (low-flow) and minimum values occurring during spring freshet (Figure 20). This reflects the influence of groundwater contributions to baseline flows. Values were generally between 50 and 250 $\mu\text{S}/\text{cm}$, and no values exceeded the drinking water guideline of 700 $\mu\text{S}/\text{cm}$.

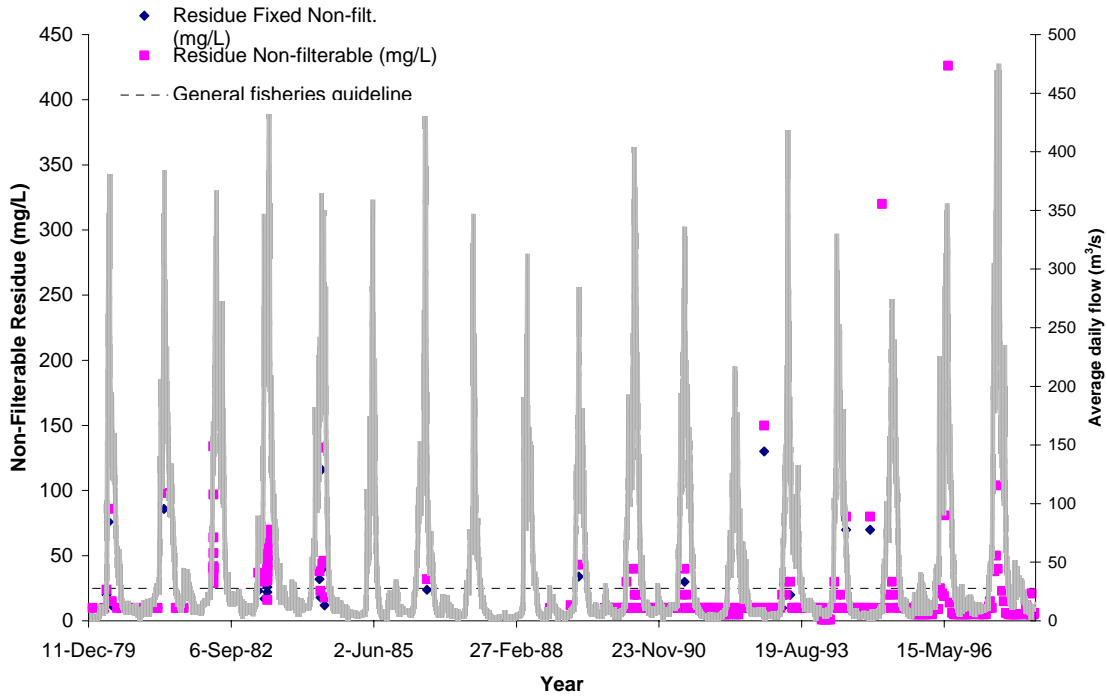
Figure 40. Kettle River at Carson - Residue, Non-Filterable

Concentrations of **non-filterable residue** (total suspended solids) ranged from below detectable limits (< 5 mg/L) to a maximum of 426 mg/L on June 10, 1996 (Figure 40). Non-filterable residue values showed a strong seasonal trend, with peak values occurring during the spring freshet (correlation coefficient between NFR and flow = 0.44, $p < 0.001$). Fifty-four values (20% of the 269 samples collected between 1980 and 2002) exceeded the general fisheries guideline of 25 mg/L.
