B.C. Lake Stewardship & Monitoring Program

## PURDEN LAKE 2004-2006

*A partnership between the B.C. Lake Stewardship Society & the Ministry of Environment*

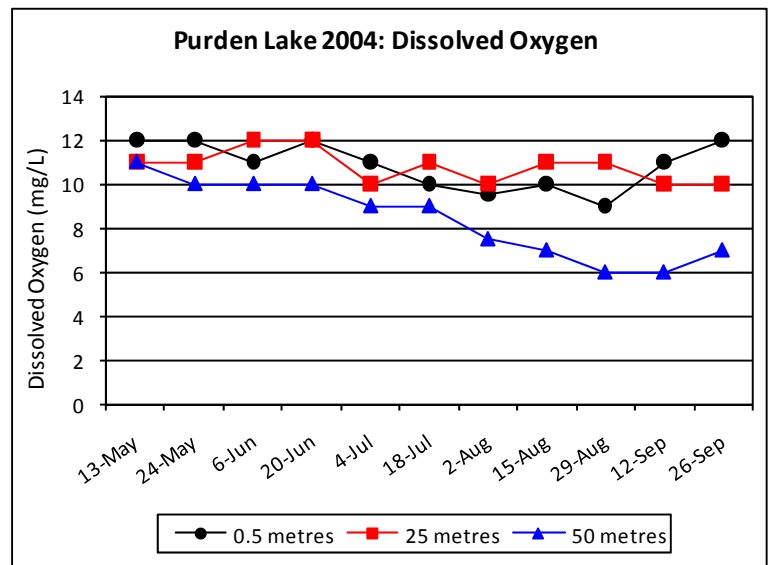
The figure above shows the oxygen patterns for Purden Lake in 2004. They are comparable to the oxygen patterns for the other two study years. Surface and mid-depth water remained near saturation for most of the summer, not dropping below 9 mg/L and 10 mg/L, respectively. The lake displayed a gradual decline in dissolved oxygen (DO) at the near-bottom depth through the sampling period, with the waters reaching a minimum of 6 mg/L. Anoxic conditions were not reached and these bottom concentrations would support aquatic life. The strong temperature gradient that was present, wind activity, plankton density and distribution, as well as settling of organic material to the bottom of the lake, likely influenced oxygen distribution throughout the water column. Vertical mixing and the aeration of bottom waters is not evident as fall overturn had not occurred by the end of the sampling season. This likely happened in early October.

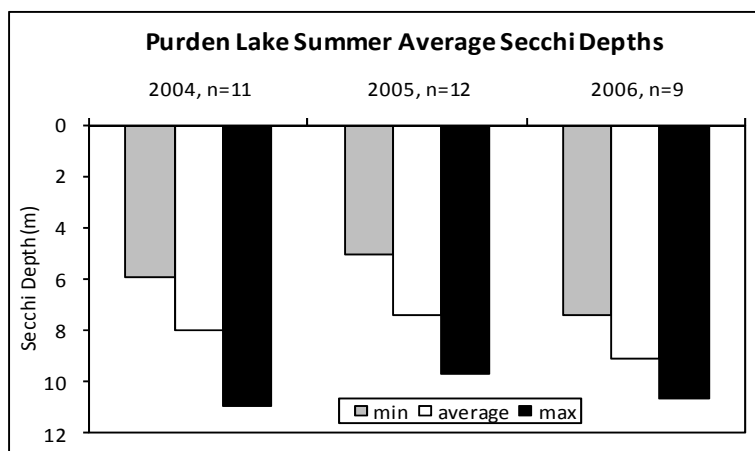
The following graph shows the minimum, average and maximum Secchi depths recorded for Purden Lake from 2004 to 2006, as well as the number of readings each year (n). During these years of sampling the average Secchi depth measurements ranged from 7.4 m (2005) to 9.1 m (2006), indicating relatively little change has occurred during the sampling period. Based on these Secchi values Purden Lake was exhibiting oligotrophic conditions.
