SUMMARY OF PROVINCIAL WATER QUALITY EFFECTIVENESS EVALUATION RESULTS (2008-2010)

EXTENSION NOTE #22

December 2011

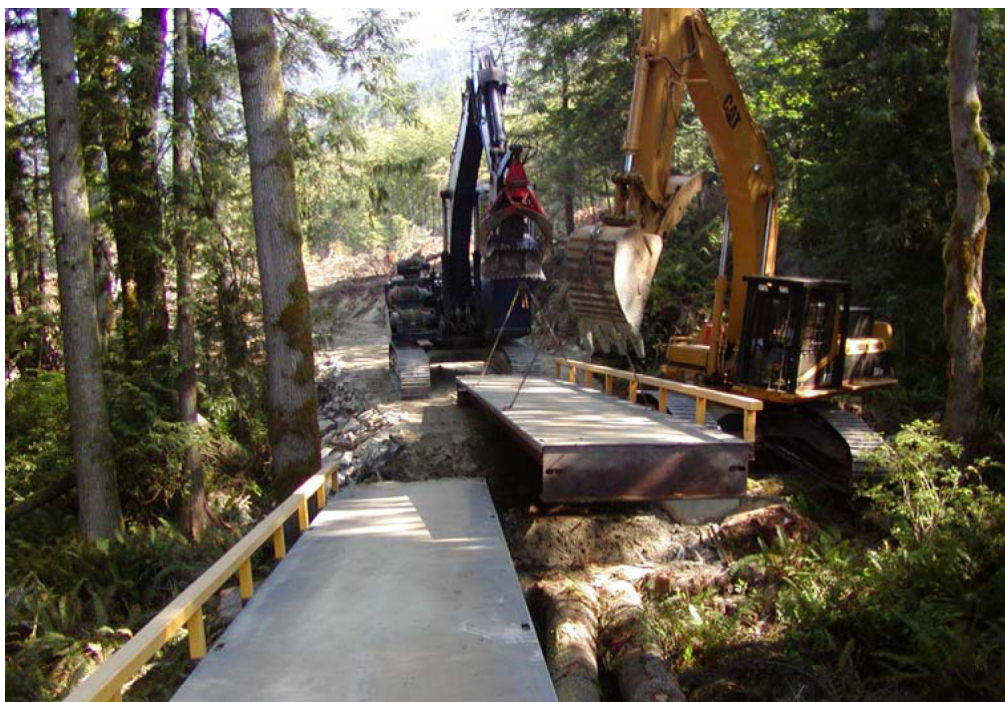
Carefully designed and installed stream crossings result in low erosion potential.

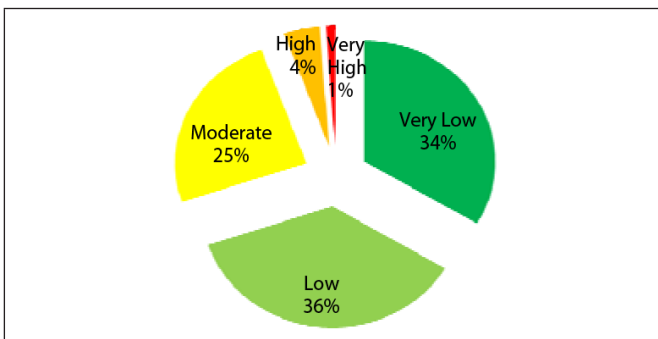
Figure 1. Proportion of sites evaluated throughout British Columbia with given water quality impact rating (2008–2010).

Of the 2643 sites evaluated, 34% were classed as having a “Very Low” impact (Figure 1). These sites were not considered to be adversely affecting water quality in any measurable way. Another 36% were classed as having a “Low” impact, which means they were generating some fine sediment but still within normal background levels for the stream. An additional 25% of sites were evaluated as having “Moderate” impact. Depending on the potential risk to in-stream and downstream values such as fish resources or downstream domestic water intakes, this level of impact may be of concern to water resource managers. The vast majority of sites rated as “Moderate” were not considered to be sensitive as no intakes were present downstream, nor were these sites directly connected to fish streams. Another 4% of sites were classed as “High” and 1% “Very High” for potential water quality impact. Substantial water quality impacts had or are occurring on these sites. Three major harvesting-related landslides occurred within the sampled sites and, while rare, had major consequences for water quality and channel morphology. Because the water quality effectiveness evaluation is a routine-level investigation, a further detailed professional assessment of these sites will more accurately estimate sediment generation as well as site remediation recommendations.

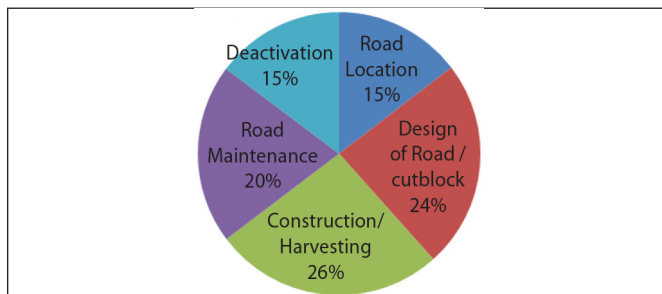
Figure 2. Forest management activity and recommendations for improvement based on 1172 observations.

Problems associated with impacted sites (“Moderate” rating or higher) were divided among five areas of concern from initial planning of road location to road deactivation (Figure 2). These categories suggest that improvements can be made at all stages of a road’s life.

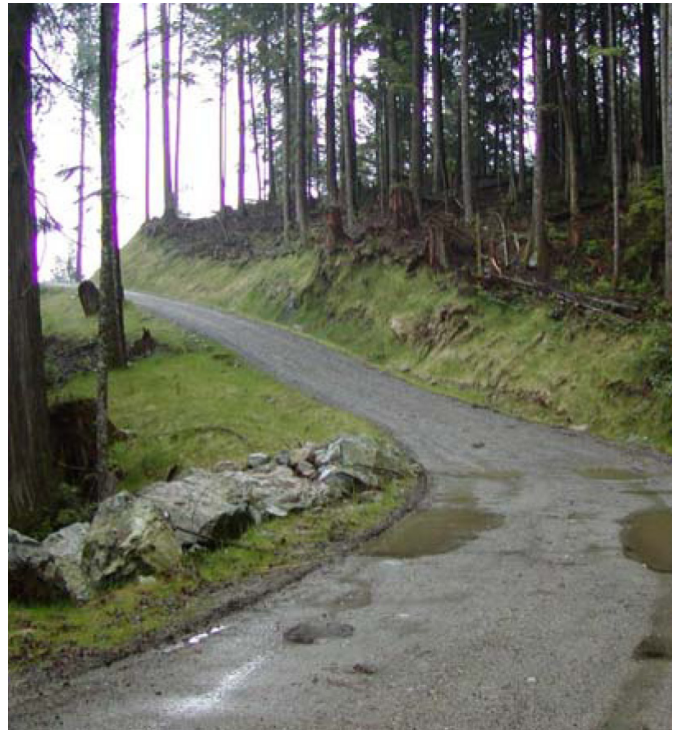
Figure 3. This resource road approaching a stream crossing has incorporated many attributes required to minimize water quality impacts. The cut banks and fill slope are well vegetated, a culvert and ditchblock are strategically located to remove inside ditch water and allow sufficient forest floor to reabsorb the water, a swale is located before the bridge, and the bridge deck itself (from which the photo was taken) built above road grade.
