SUMMARY OF PROVINCIAL WATER QUALITY EFFECTIVENESS EVALUATION RESULTS (2008-2010)

EXTENSION NOTE #22

December 2011

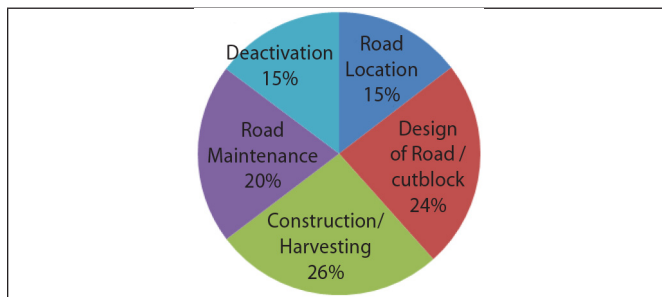
Figure 2. Forest management activity and recommendations for improvement based on 1172 observations.

Problems associated with impacted sites (“Moderate” rating or higher) were divided among five areas of concern from initial planning of road location to road deactivation (Figure 2). These categories suggest that improvements can be made at all stages of a road’s life.
