## EVALUATING SOIL CONSERVATION USING HIGH RESOLUTION AIR PHOTOS AND EXPERT ELICITATION

Prepared by the Soils Value Team:

December 2011

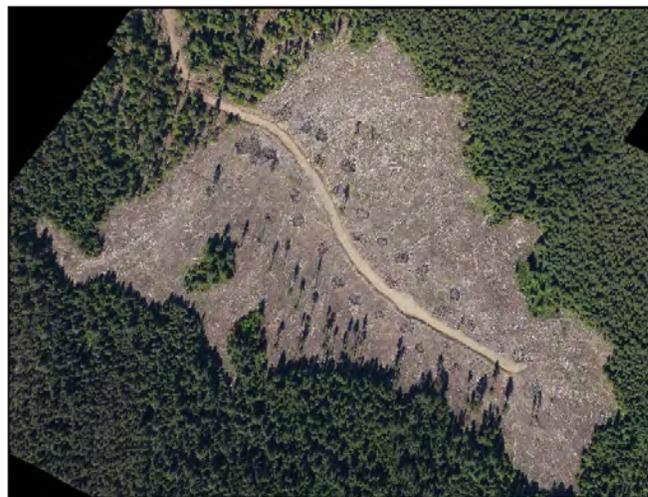
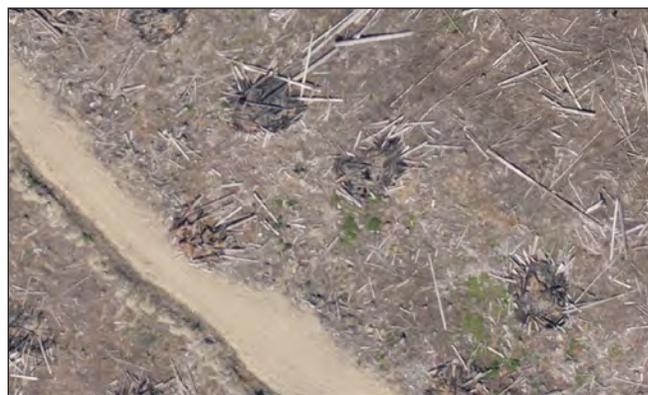
*Example 3.1: Rated “Objectives achieved” by 3 out of 3 evaluators (Pic\_43).*

*Close up of Pic\_43 showing absence of soil disturbance, lots of CWD*

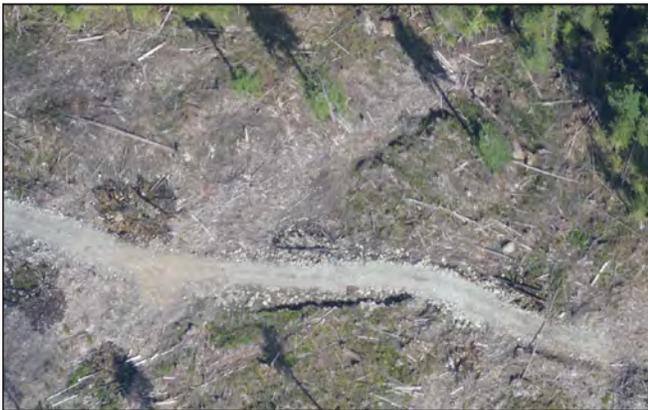
**Example 3.2:** Rated “Objectives achieved” by 4 out of 4 evaluators (Pic\_70).

Close-up of Pic\_70 showing absence of soil disturbance.

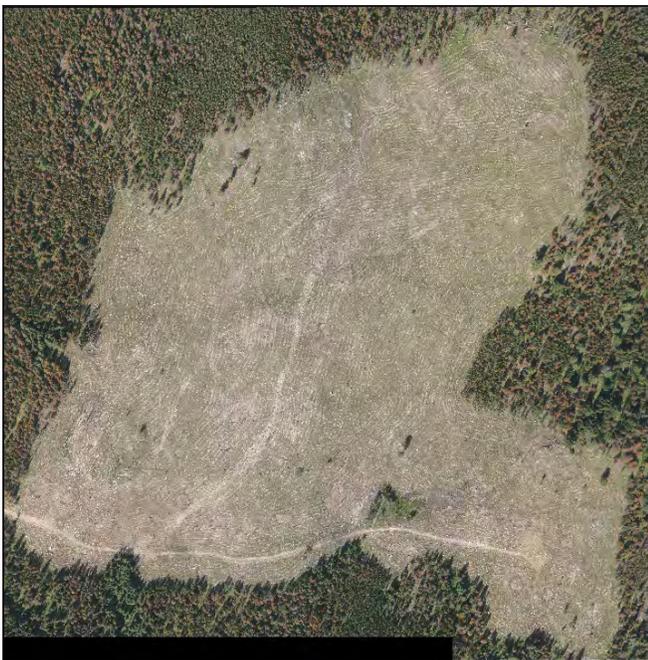
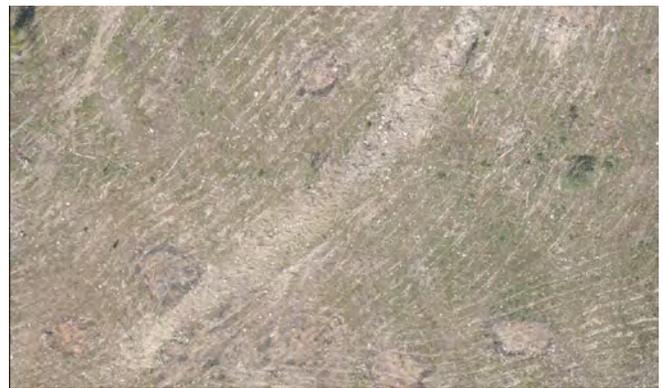
**Example 3.3:** Rated “Moderate achievement” by each of the 4 experts (Pic\_32).

Close-up of Pic\_32 showing site prep, rehabilitated road, and low amounts of coarse woody debris.

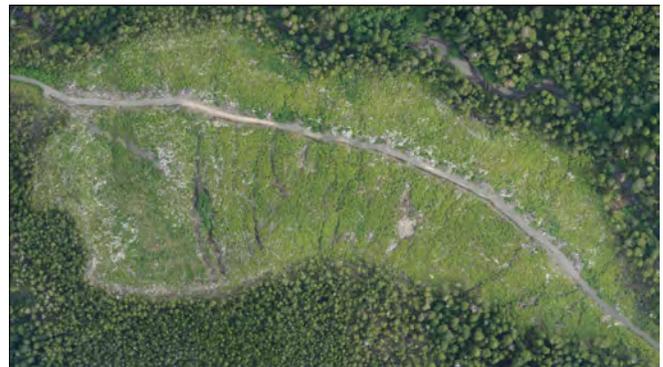
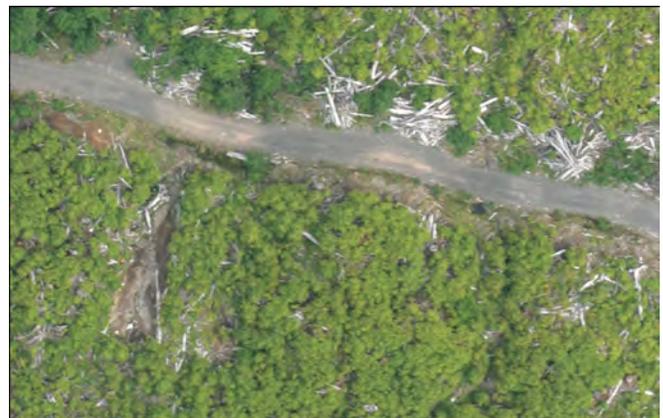
**Example 3.4:** Rated “Moderate achievement” by 2 and “Don’t know” by 1 evaluator (Pic\_45).

Close-up of Pic\_45 showing erosion on left side of the image; lots of brush complicates evaluation.

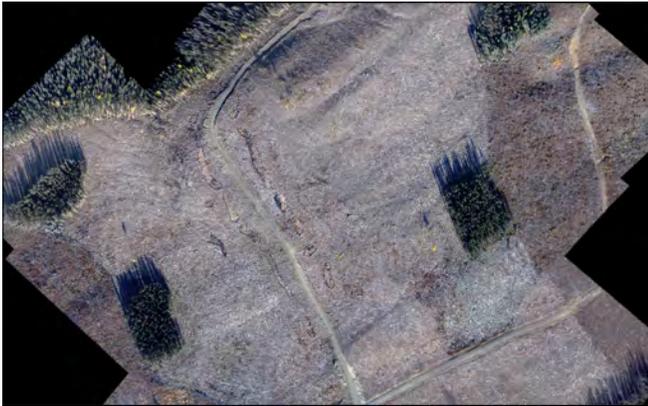
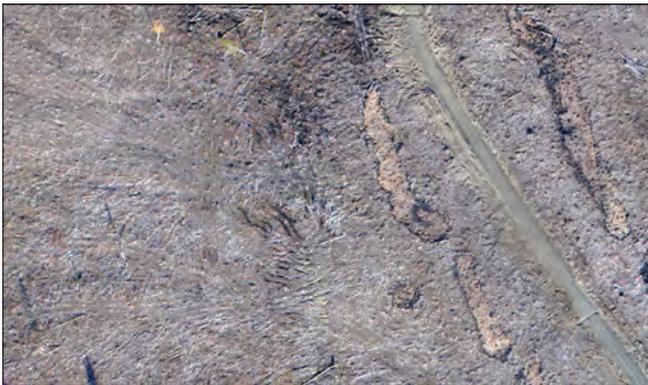
**Example 3.5:** Rated “Objectives not achieved” by 3 out of 3 evaluators (Pic\_52).

Close-up of Pic\_52 showing significant amounts of soil disturbance in the NAR and RWA.

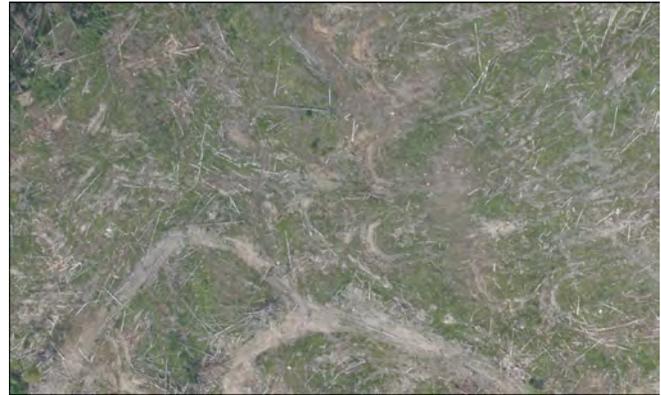
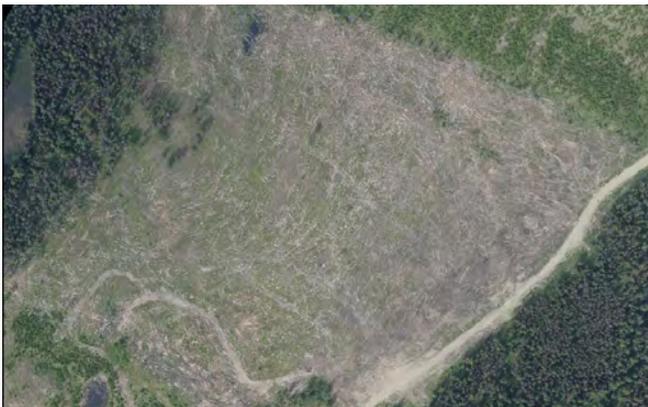
Close-up of Pic\_95 showing extensive soil disturbance in the NAR.

**Example 3.6:** Rated “Objectives not achieved” by 3 out of 3 evaluators (Pic\_95).

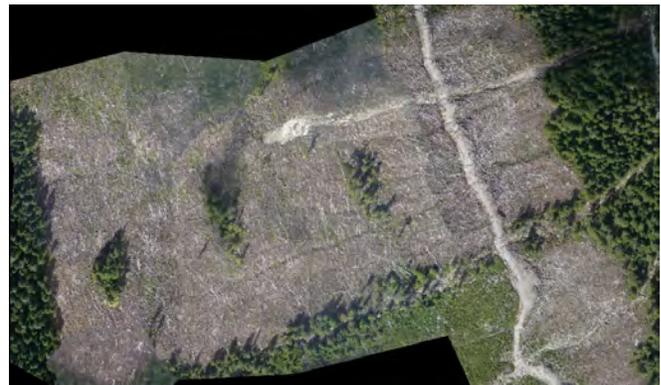
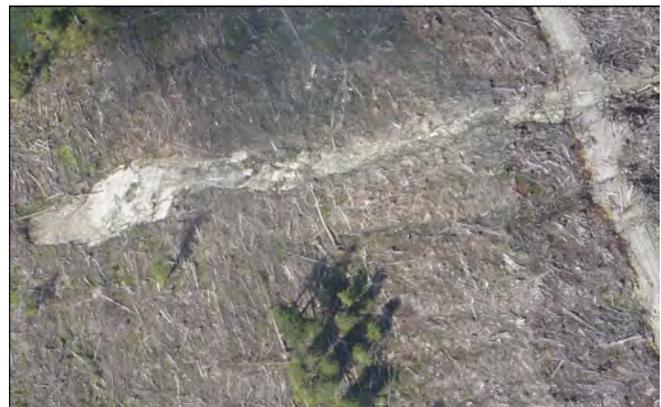
**Example 3.7:** Rated “Objectives not achieved” by 3 out of 5 evaluators (Pic\_52).

Close-up of Pic\_52 showing slope failure.

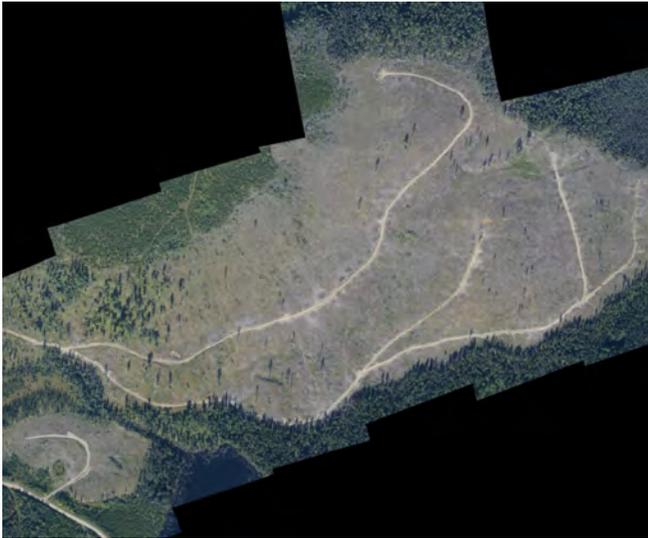
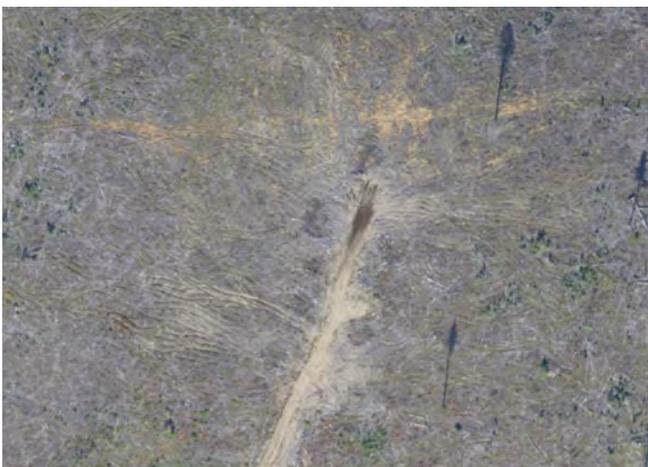
**Pic\_21: EEHRI "Not achieved" Field "Moderate" Re-evaluated "Not achieved."**

**Close-up of Pic\_21 showing soil disturbance in the NAR.**

All of these blocks should likely be revisited to understand better the reasons for discrepancy.

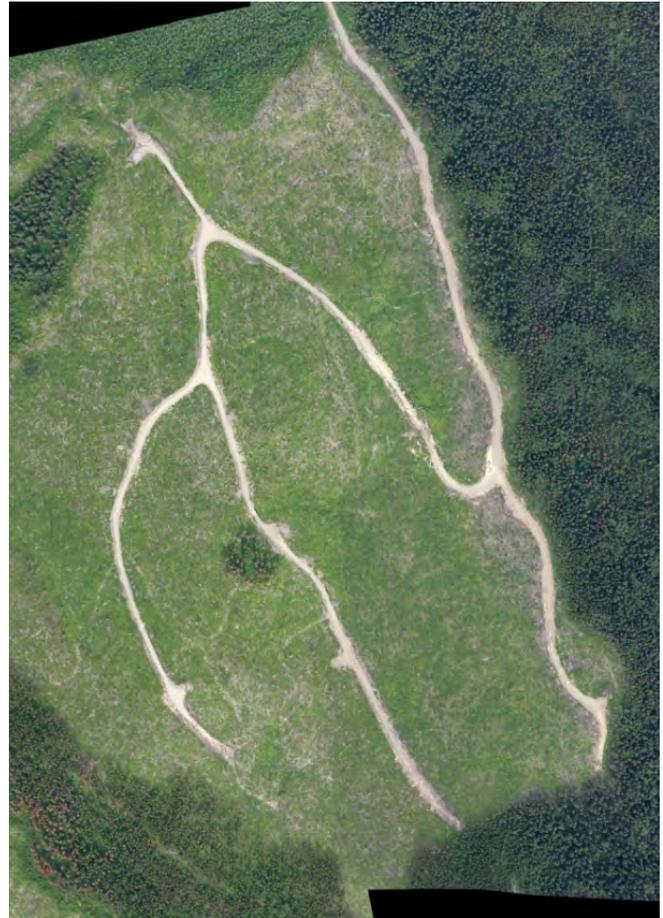
**Pic\_26: EEHRI "Not achieved" Field "Moderate" Re-evaluated "Moderate."**

**Close-up of Pic\_26 showing numerous gray areas that were interpreted as disturbance by experts.**

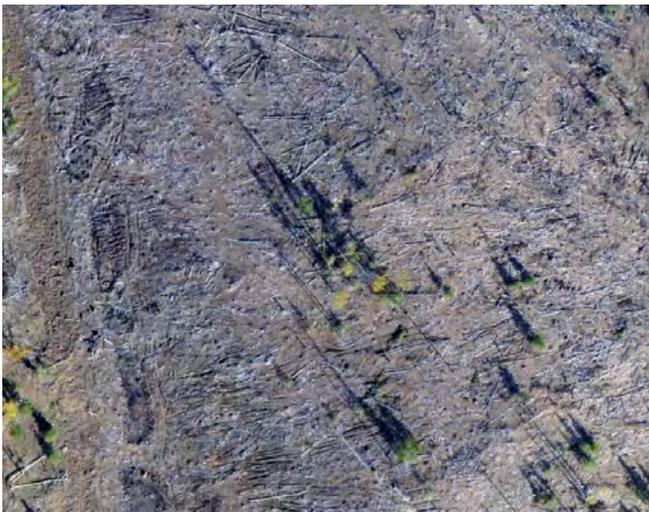
**Pic\_34:** EEHRI "Not achieved" Field "Achieved"  
Re-evaluated "Achieved."

**Close-up of Pic\_34 showing an area where the experts saw significant soil disturbance in the NAR.**

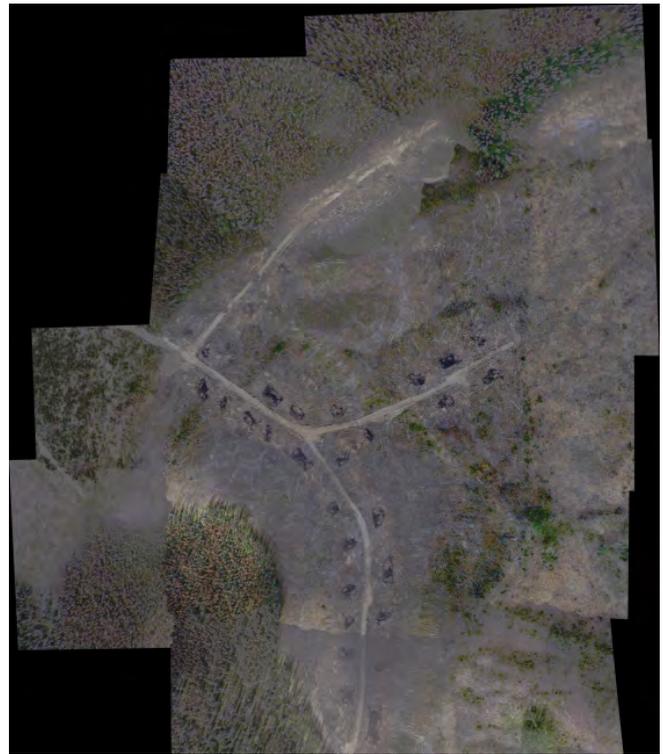
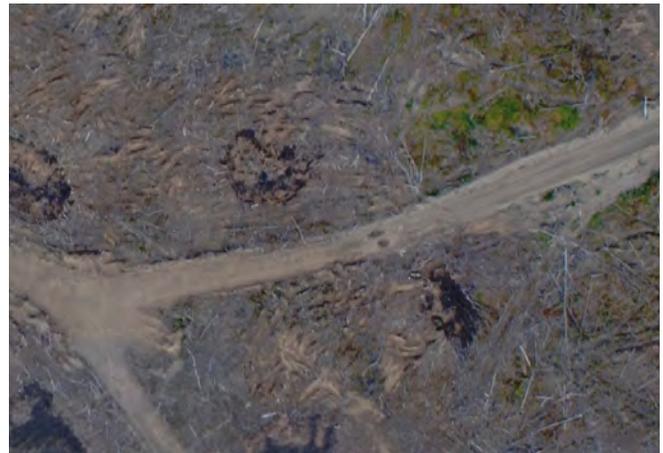
**Pic\_49:** EEHRI "Not achieved" Field "Moderate"  
Re-evaluated "Not achieved."

**Close-up of Pic\_49 showing an area where experts saw significant soil disturbance in the RWA, NAR.**

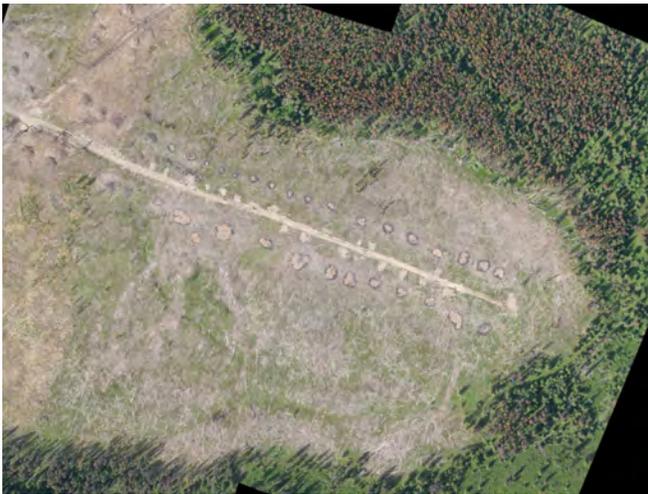
**Pic\_66:** EEHRI "Not achieved" Field "Achieved"  
Re-evaluated "Achieved."

Close-up of Pic\_66 showing rutting in wet areas.

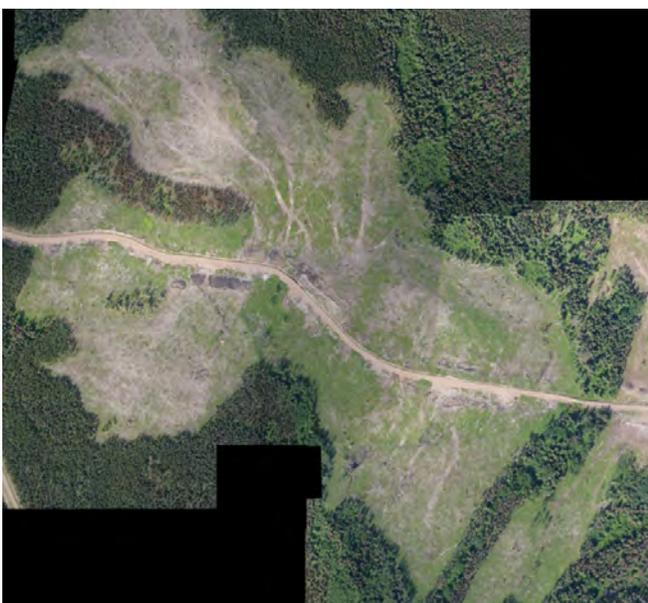
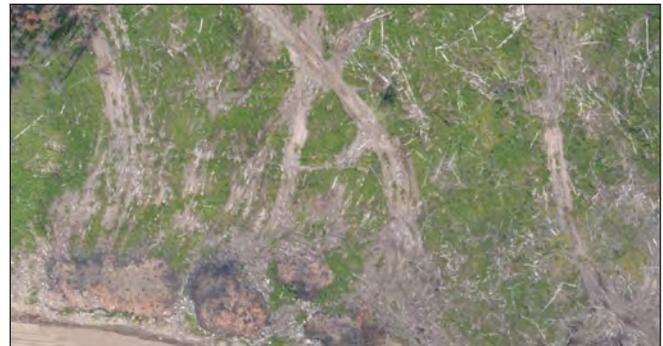
**Pic\_102:** EEHRI "Not achieved" Field "Achieved"  
Re-evaluated "Not achieved."

Close-up of Pic\_102 showing soil disturbance on trails  
and dispersed disturbance in the NAR.

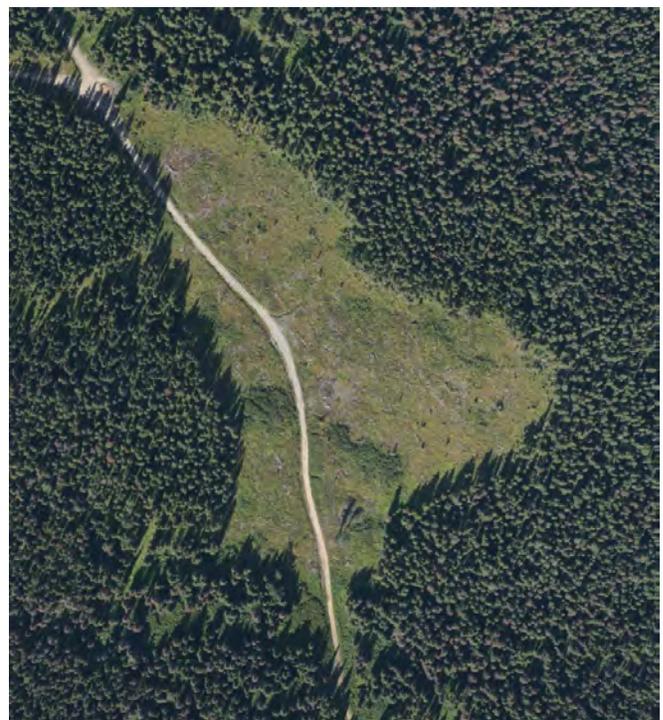
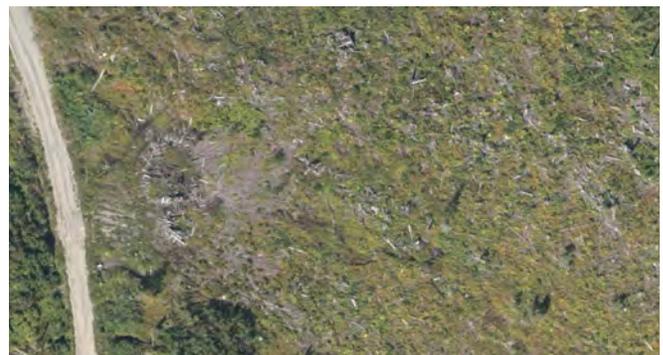
**Pic\_109:** EEHRI "Not achieved" Field "Moderate"  
Re-evaluated "Moderate."

Close-up of Pic\_109 showing areas where experts saw  
soil disturbance but field staff did not.

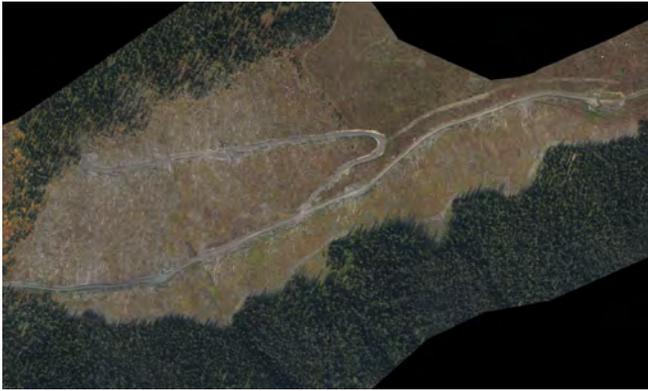
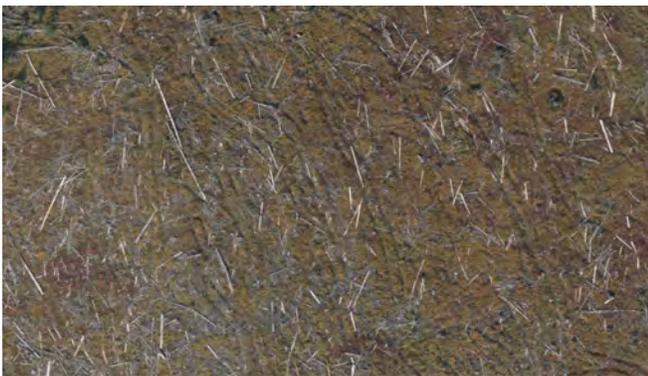
**Pic\_114:** EEHRI "Not achieved" Field "Moderate" Re-evaluated "Moderate."

*Close-up of Pic\_114 with areas of soil disturbance identified by the experts but not by field staff.*

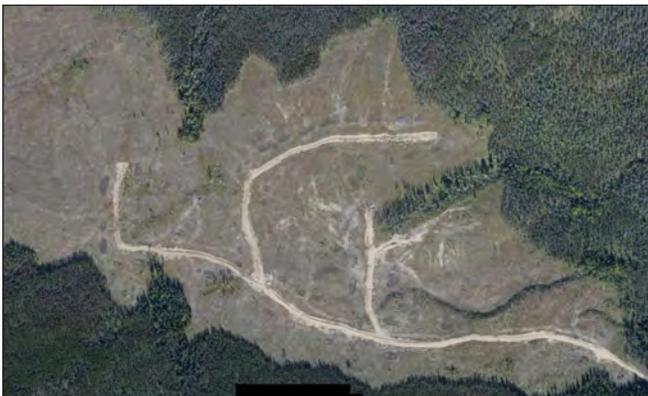
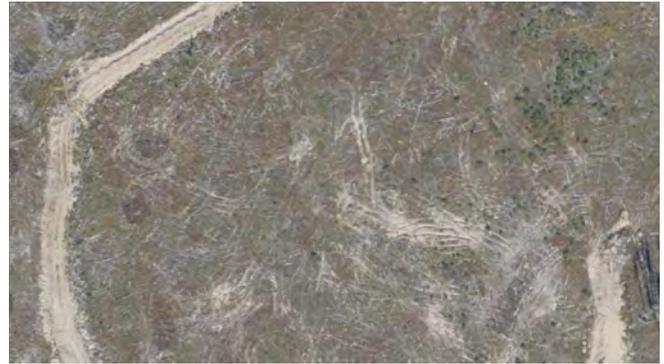
**Pic\_118:** EEHRI "Not achieved" Field "Moderate" Re-evaluated "Not achieved."

*Close-up of Pic\_118 soil disturbance recognized by field staff, but not incorporated into assessment.*

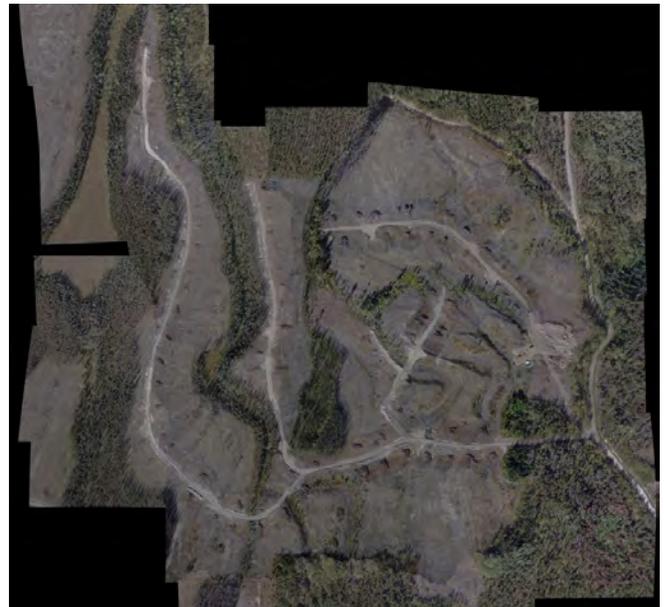
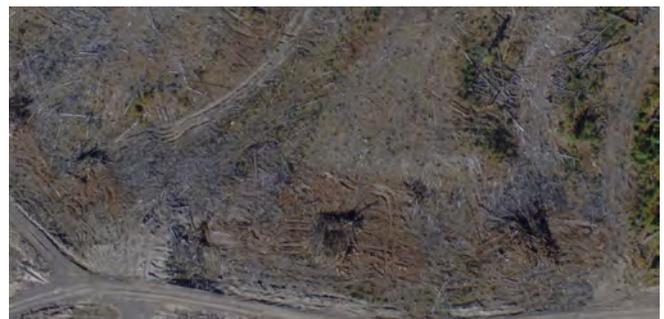
**Pic\_121:** EEHRI "Not achieved" Field "Moderate" Re-evaluated "Moderate."

*Close-up of Pic\_121 showing typical NAR and RWA soil disturbance in this block.*

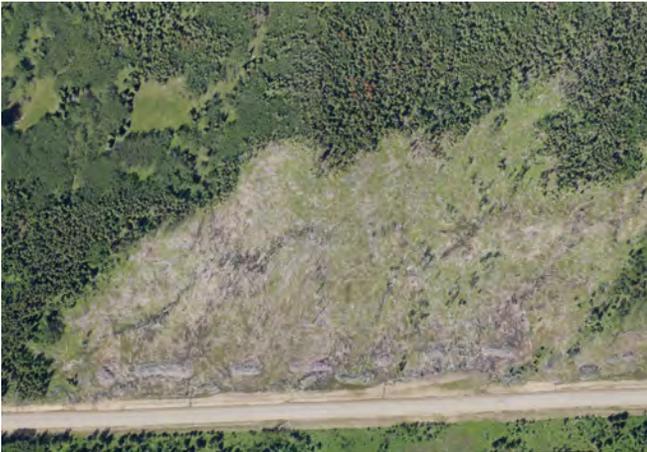
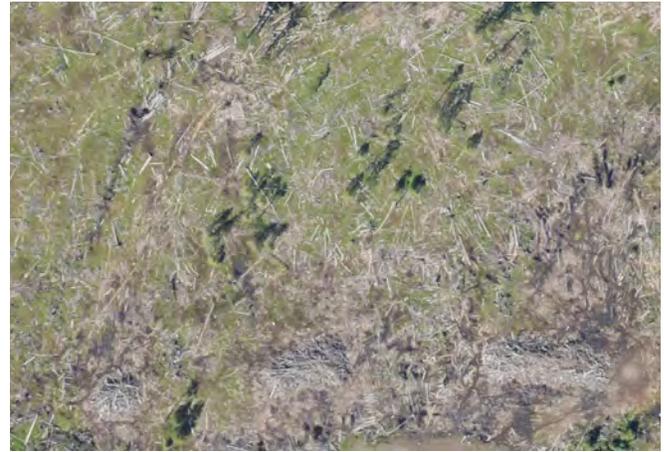
**Pic\_137:** *EEHRI "Not achieved" Field "Moderate" Re-evaluated "Moderate."*

*Close-up of Pic\_137 showing soil disturbance associated with wet soils in this block.*
