# The Bowron River Watershed Project:

*A Landscape-level Assessment of the Post-salvage  
Change in Stream and Riparian Function*

*2007*

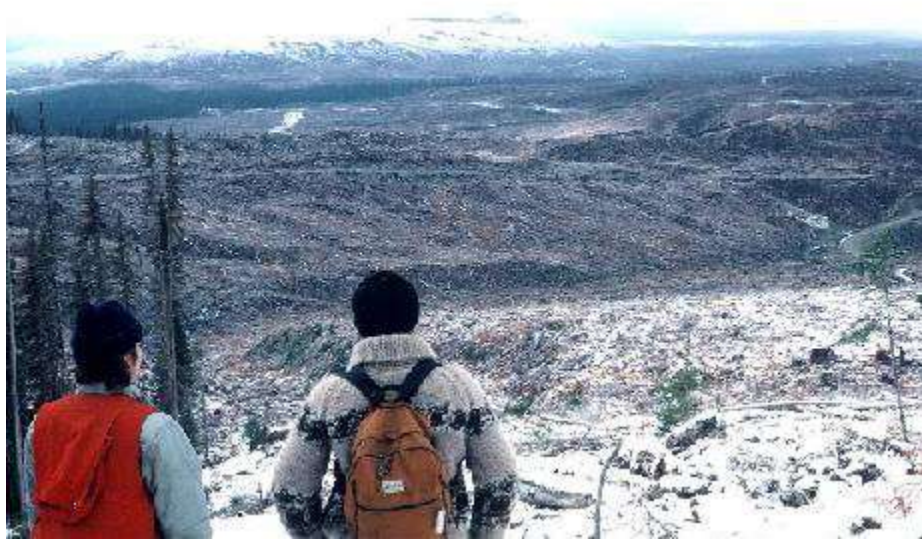
Figure 1: North view toward the Bowron River from an unnamed hill in the Indian Point Creek watershed, November 1984. (Photo courtesy of Robert Hodgkinson, MFR Prince George.)

Harvest activity was most extensive in the upper Bowron, removing 30% of the timber and producing a 50000-ha clearcut. Harvesting was also extensive in the middle and lower Bowron but occurred at a slower rate. During peak harvest, approximately 700 loads of logs were removed from the Bowron every day. Many riparian areas of small and mid-sized streams were completely harvested (Figures 1 and 2).

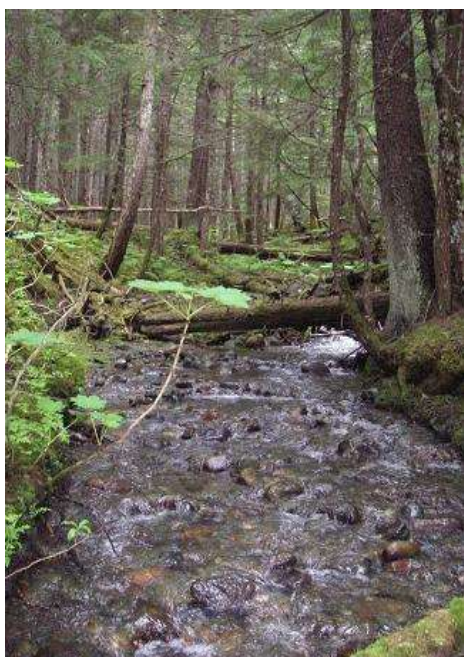
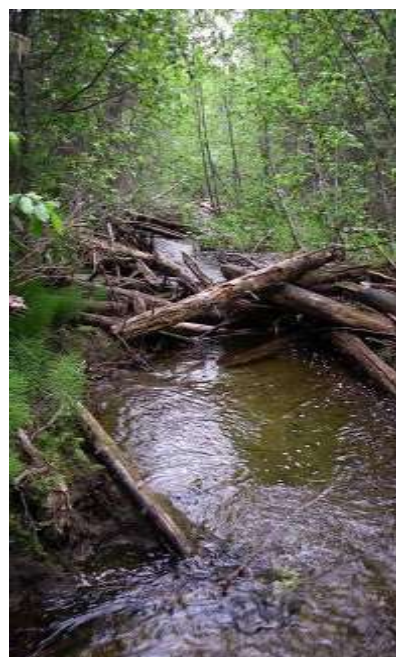
Figure 7: Reference stream in the Swamp sub-basin (left photo) showing undercut banks, coniferous riparian vegetation, coarse substrate, and old stable LWD in the stream. A harvested stream section in the A sub-basin (right photo) showing a lack of undercut banks, lack of coniferous in the riparian zone, fine sediments along the substrate, and recently created LWD piles.

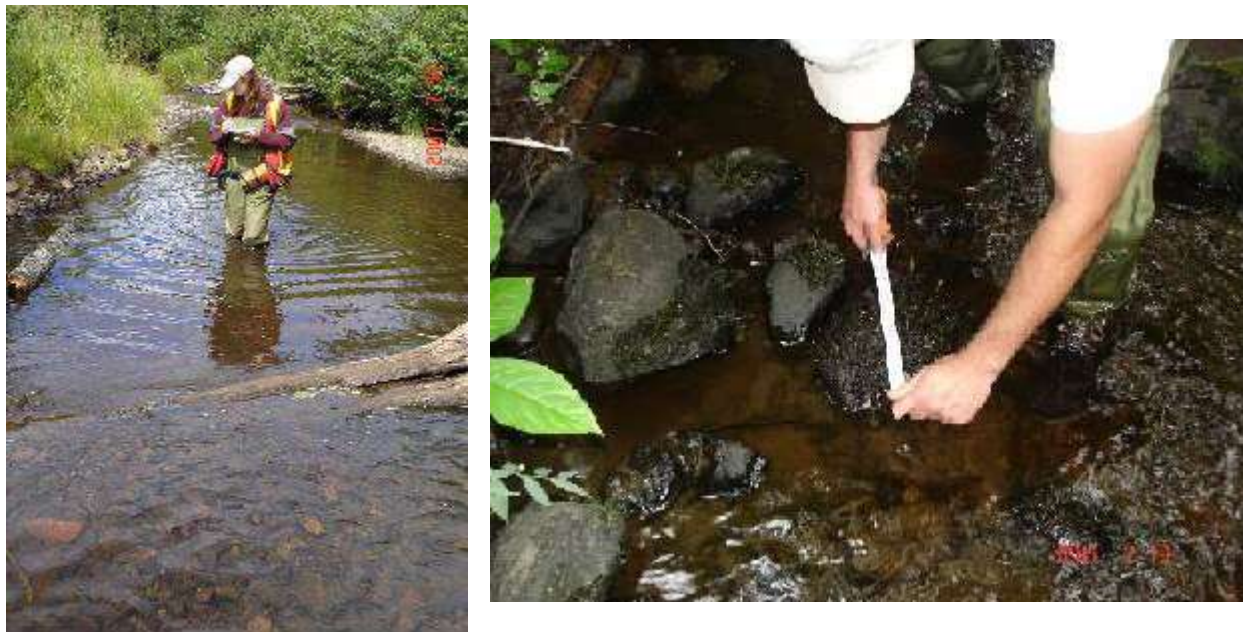
Figure 8: Counting LWD and measuring pool length (left photo), calculating moss coverage on streambed cobbles and boulders (right photo).

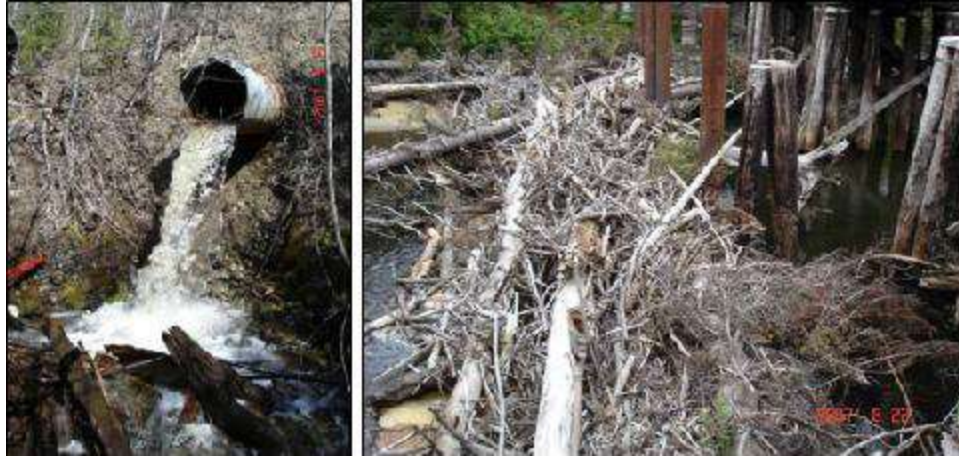
- Fish passage barriers-hanging culverts were observed on S4 streams that dropped 1-2 m downstream of main haul roads (Figure 11). Similarly, fish passage would be blocked by woody debris dams such as that observed at the mouth of Indian Point Creek during the summer of 2007 (Figure 11).

Figure 11: A hanging culvert at Saw sub-basin (left photo) and the woody debris jam below the bridge at the mouth of Indian Point Creek in August of 2007 (right photo).

8. Ensure that erosion and sediment control plans are developed and followed during road construction in watersheds with sensitive soils.
9. Decommission road crossings once harvesting operations are completed and ensure that site rehabilitation is sufficient to prevent sediment delivery to the stream.

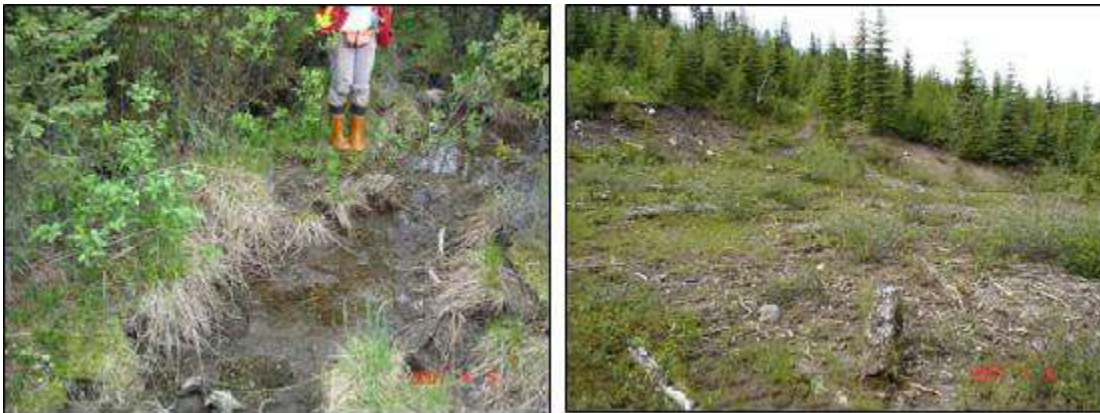
- Heavy equipment operation on roads, landings, and occasionally in the riparian zone was found to compact and rut soil so that vegetation re-growth was limited decades after salvage harvesting (Figure 12).

Figure 12: Machine tracks within the riparian zone of Unnamed A sub-basin, harvested over 20 years ago (left photo) and a landing site that is over 20 years old in the Haggen Creek basin above site 2 (right photo).

1. Maintain sufficient stand structure and volume in the Riparian Management Zone to protect the Riparian Reserve Zone.
2. Minimize the use of heavy equipment in the Riparian Management Zone of watersheds with fine soil types to minimize soil disturbance.

10. Remediate roads and landings, particularly those close to streams, promptly after harvest operations to prevent sediment delivery to the stream.

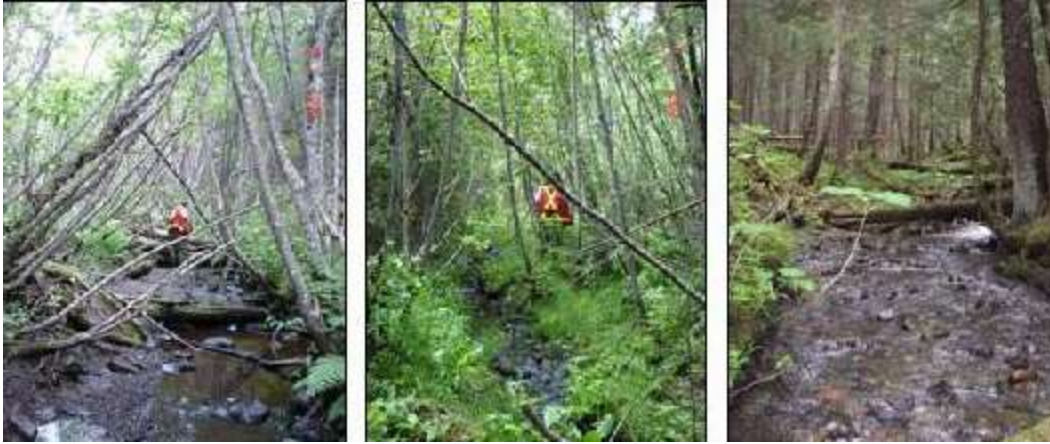
- Riparian harvesting - salvaged riparian areas showed minimal conifer re-growth 20-30 years after harvesting. Instead, these areas were dominated by deciduous re-growth (typically alder and willow species), which may be inadequate for future LWD requirements. Even where riparian zones were replanted, survival rates were low or growth was poor, so riparian stand structure was quite different from unlogged sites, which typically included a mixture of tree species (Figure 13).

Figure 13: Riparian forests in a 30- (left photo) and 40-year stand (center photo) after harvesting (Purden Site 1, Tsus/Fly Site 2) showing a significant deciduous canopy compared to the reference site (right photo), which has more mixed species and conifers in particular (Swamp basin).

4. Retain understorey and non-merchantable trees in the RMZ where harvesting activities occur. Also retain all trees with root networks that extend into a streambank.

6. Brush and subsequently monitor replanted riparian zones to ensure that planted trees are growing efficiently.
7. Maintain natural drainage patterns. Natural drainage patterns must be considered and incorporated into road network design.

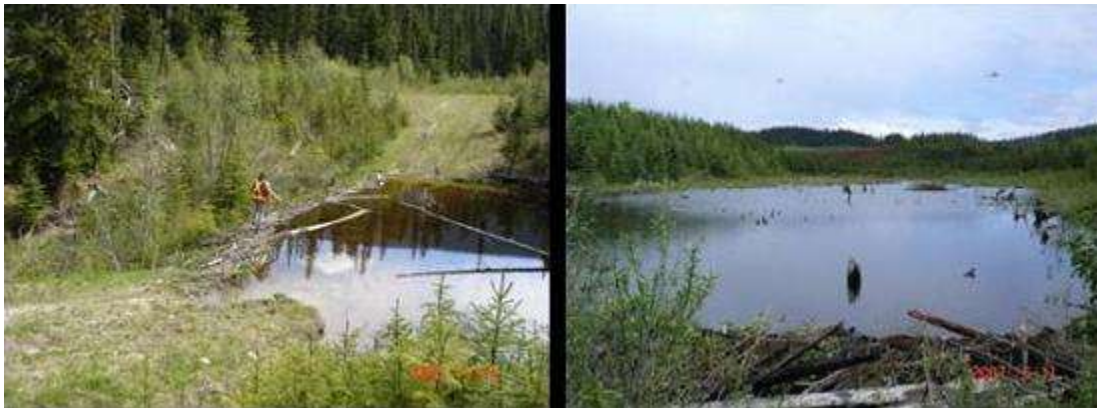
- Beaver activity in riparian zones and streams following salvage harvesting - in low-gradient systems can further decrease the level of watershed function and possibly fisheries productivity by storing water, sediment, and LWD, and possibly blocking fish passage at old crossings that have not been decommissioned (Figure 14).

Figure 14: Beaver dams and a beaver lodge located in upper and middle Bowron (left and right photo, respectively). Both of these beaver dams use a road to block the flow of water.
