## RECORD PHOTOGRAPHS, 1996 DEC

## East Cable

## West Cable

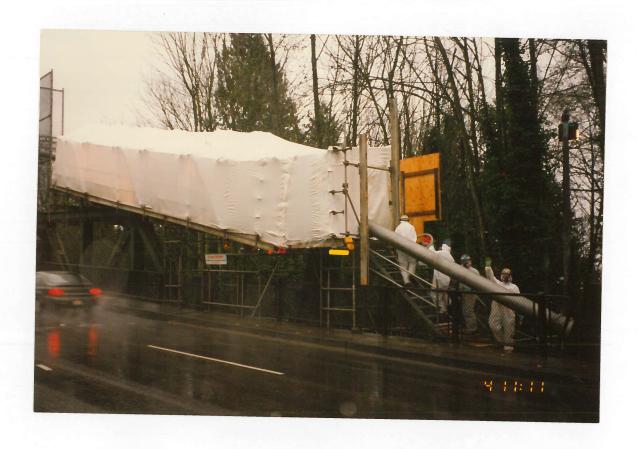
No. 1

Work shelter built over main cable at southeast corner.

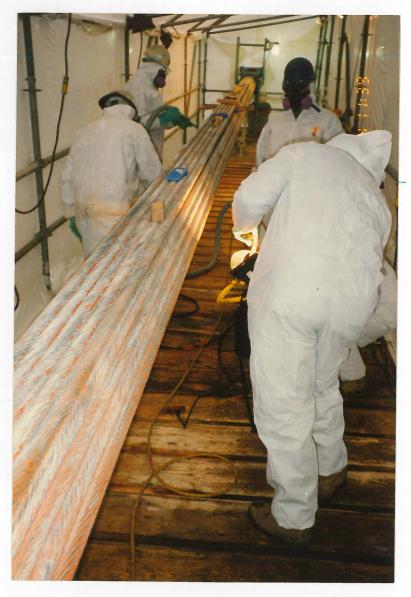
No. 2

General view of the exposed main cable strands.

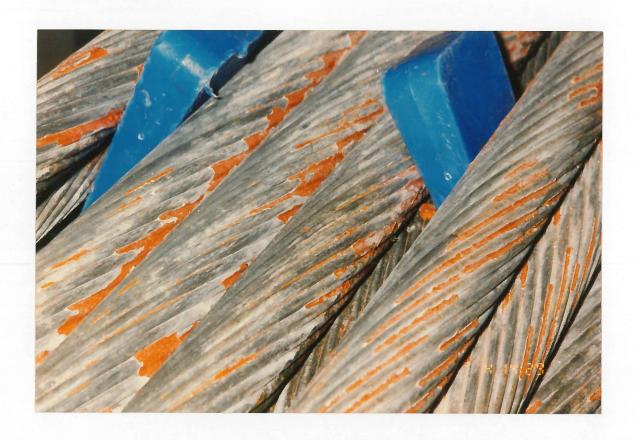
No. 4
Outer layers of strands raised on plastic wedges, detail.

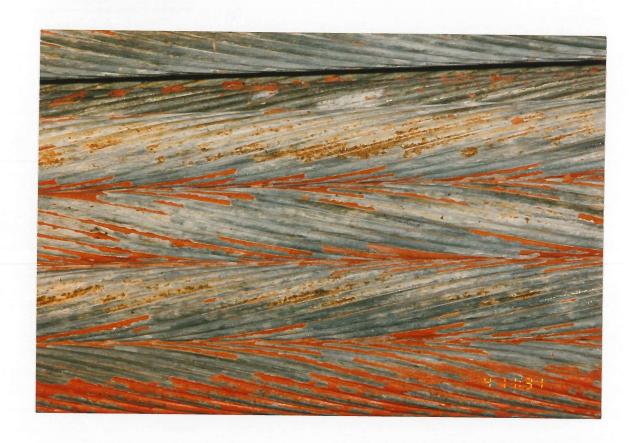
No. 5

Rust spots on top strands of main cable (worst case).

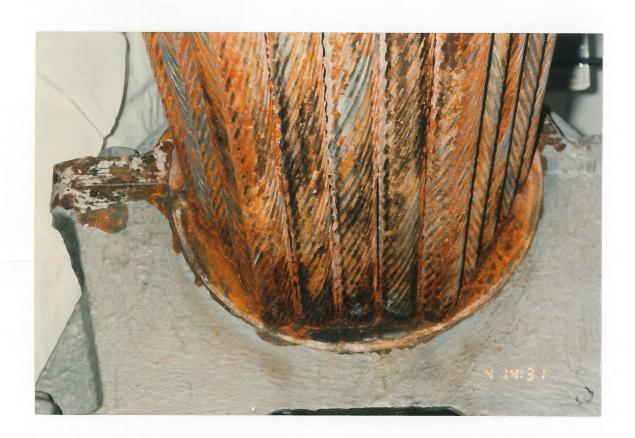
No. 6

Dark brown cedar stains under main cable at south cable post.

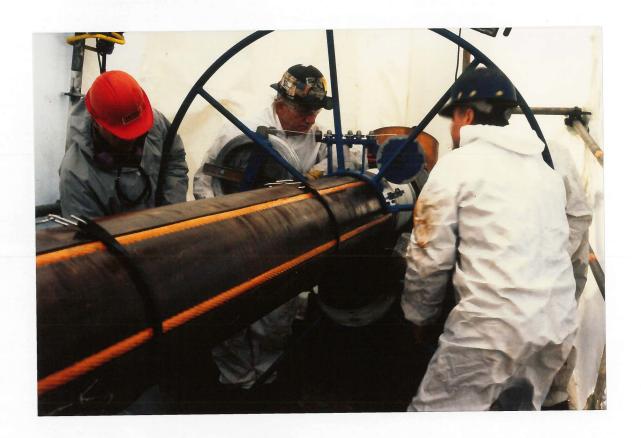
No. 7
Wrapping machine, single wire with counterweight.

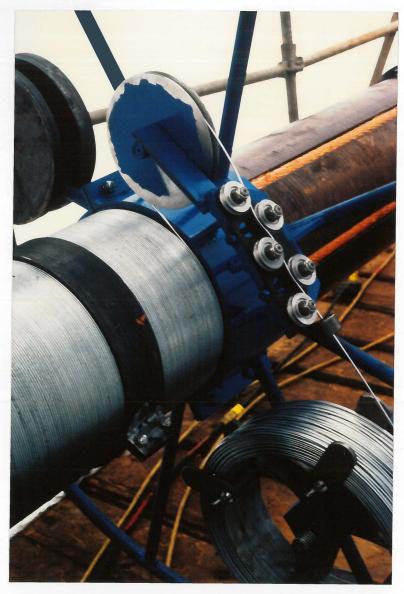
No. 8
Wrapping machine, single wire with counterweight, detail.

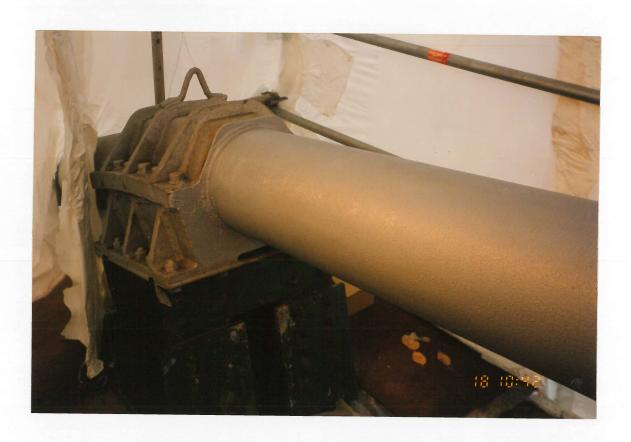
No. 9

Main cable, after rewrapping and first coat of paint, near the south cable post.

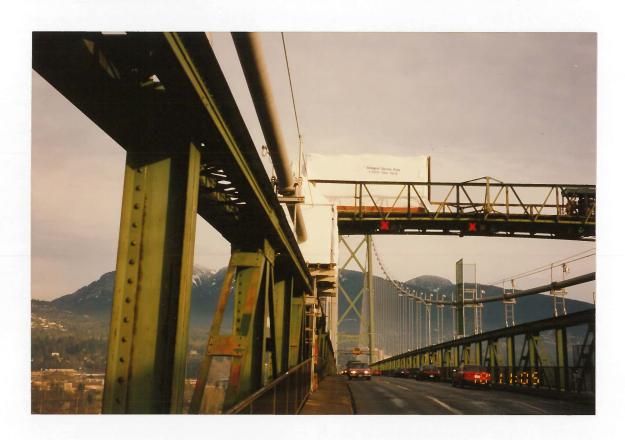
No. 10
Work shelter at midspan (C48W).

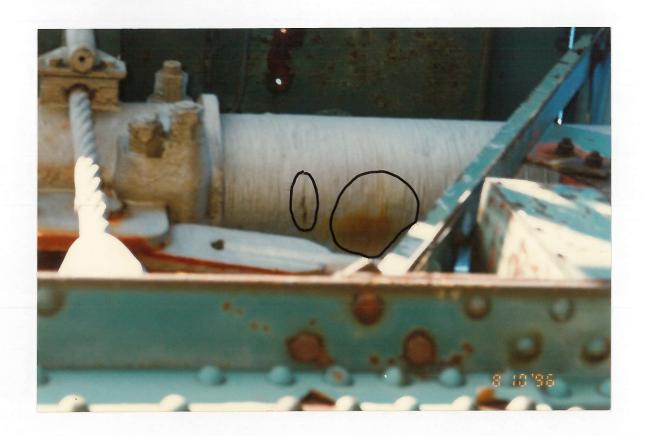
No. 11

Surface of old wrapping at midspan, with two brown stains [as supplied to B&T by J. Mullen].

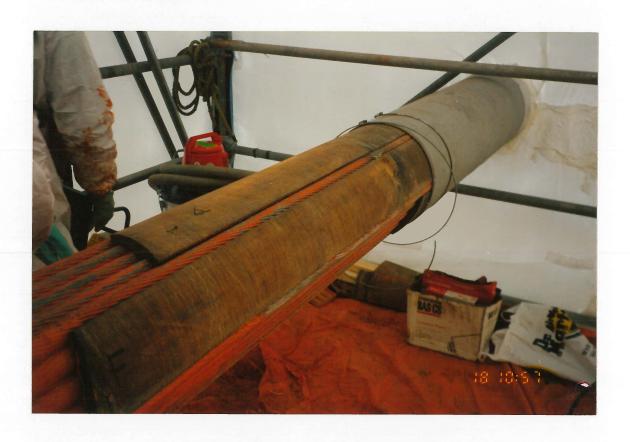
No. 12

Typical arrangement of cedar fillers on the main cable. Old wrapping wire is at far end.

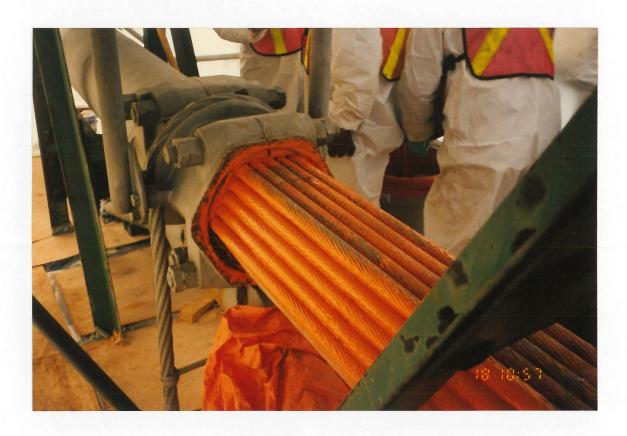
No. 13

The main cable at C48W, the left side is repainted with red lead paste.

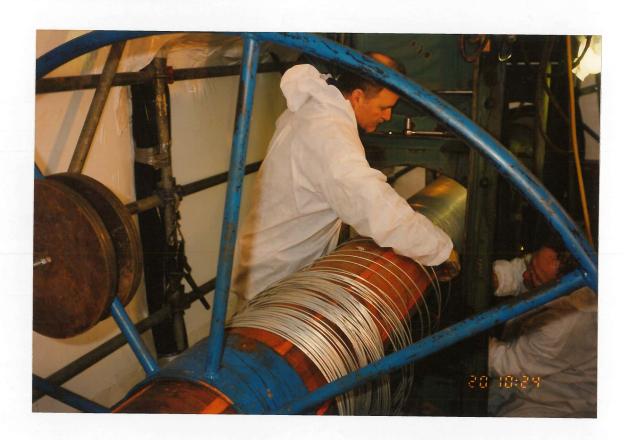
No. 14

Hand wrapping the main cable at close quarters.
