Ministry of Environment Inspection Record

Environmental
Protection
Division

Inspection Number: 29427		Inspection Status: FINAL	
EP System: <u>AMS</u>		Inspection Date: 2016-07-14	
EP System Number: 108370		EP System Status: <u>Active</u>	
Region: <u>Okanagan</u>		Office: <u>Penticton</u>	
Trigger: <u>Planned</u>		Incidents of Non-Compliance Observed: <u>No</u>	
Non-Compliance Decision Matrix Level: <u>Level 1</u>		Non-Compliance Decision Matrix Category: <u>Category A</u>	
Inspector Name(s): Devan Oldfield		CPIX: <u>0 to 1 = Low</u>	
Audit:		Total Non-Compliance(s): 0	
Regulated Party: Wilma and Thys Haambucker			
Regulated Party Contact(s): Wilma and Thys Haambucker			
Legal Address: 2160 Deep Creek Road Enderby, BC V0E 1V3			
Phone No: 250 546 0346		Fax No:	
Contact Email: glorybou@telus.net			
Location Description or Site Address: 2160 Deep Creek Road Enderby, BC V0E 1V3			
Latitude: 50.536967 N		Longitude: 119.236003 W	
Receiving Environment(s): <u>Groundwater & Land</u>

Authorization: 108370	Wilma and Thys Haambucker
CVIS IR #: 29107	July 14, 2016

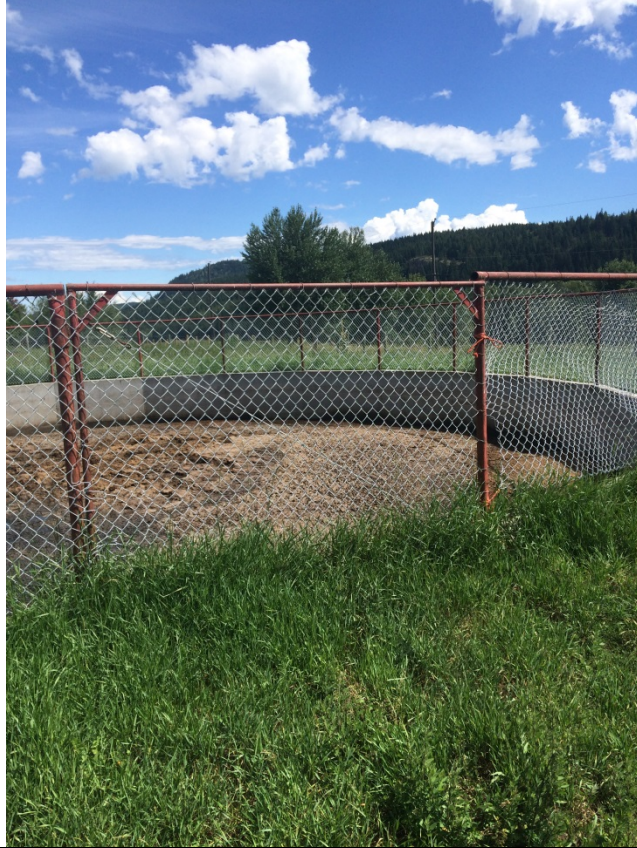
Photo 1

Permanent manure storage
for the main barn.

Photo taken facing north
northeast

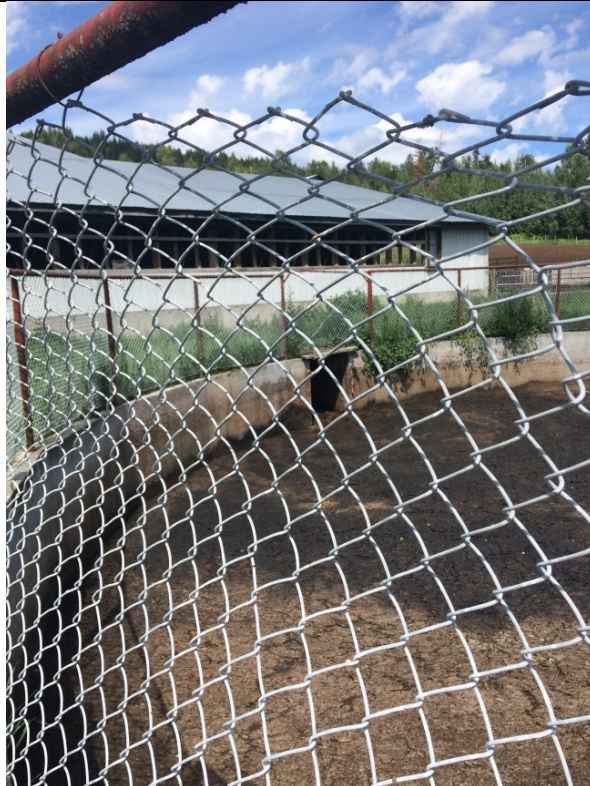
Photo 2

Permanent manure storage
for the main barn. Channel
leading to the barn interior
is visible in photo centre.

Photo taken facing
northwest.

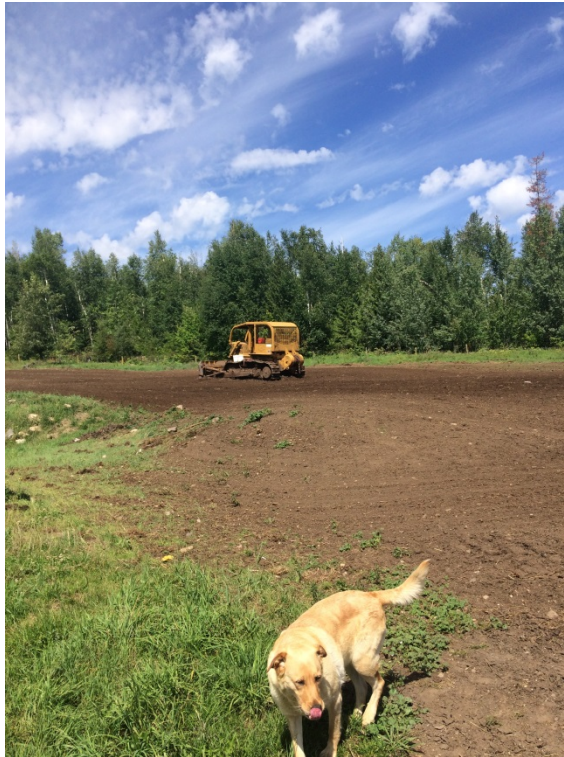
Photo 3

Historic area of field stored manure. Recently stored manure had been worked into the land prior to inspection. No field storage observed during inspection.

Photo taken facing northwest.

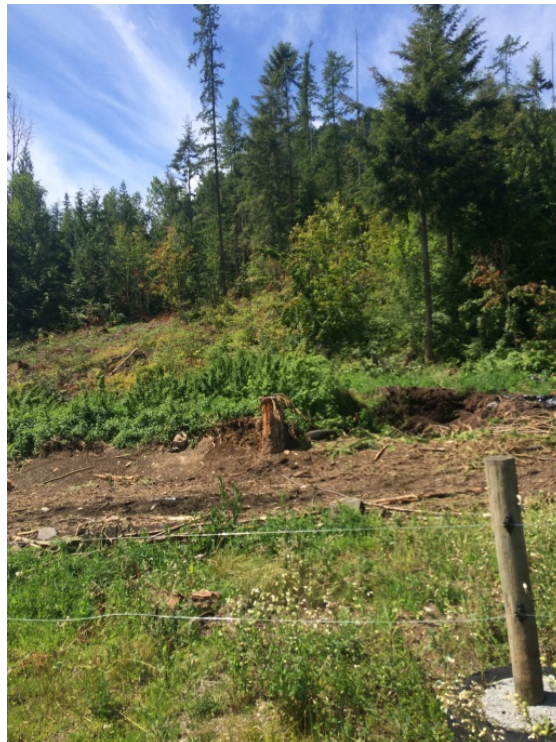
Photo 4

Approximate location of permanent manure storage facility for the calf barn. Expected to be constructed in late fall of 2016.

Photo taken facing west.

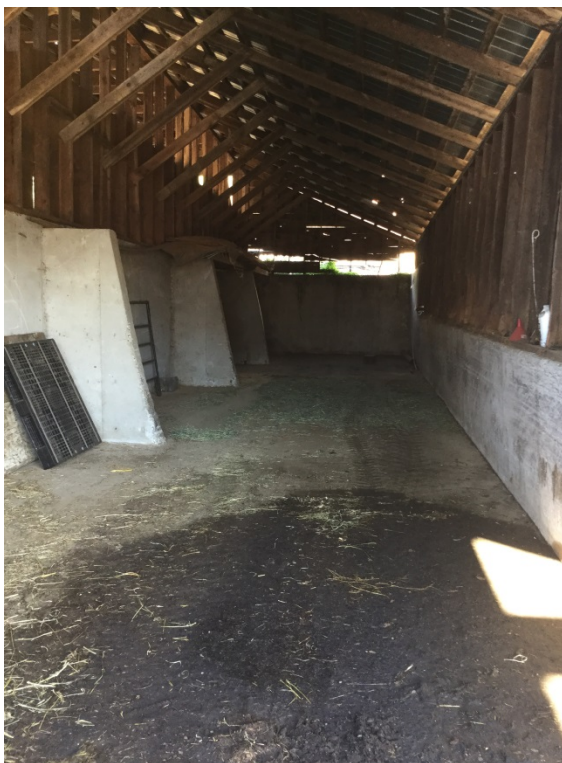
Photo 5

Requirement Type: <u>Operations</u>
Requirement Description:
1 Retain a Qualified Professional to identify drainage management measures necessary to effectively control runoff and to ensure that solids, leachate, contaminated runoff and drift from sprayed materials do not enter watercourses or any source of water for irrigation or drinking water purposes or leave the property. Implement drainage management measures identified by the Qualified Professional by July 31, 2016.
Details/Findings: The Manure and Nutrient Management report provided by Ruth McDougall for the Haambuckers operation lists the following key items to be followed for the management of drainage issues identified onsite; 1. Construct manure storage facility for manure generated in the calf barn during the winter storage period sized to hold 86 cubic metres of manure. 2. Maintain the stated setbacks during manure application. Ruth further states that "No required drainage management measures were identified during site visits and in discussions with the farm owners aside from calf manure storage." On August 23, 2016, I received photos from Wilma Haambucker, depicting their proposed alternate manure storage area from what was presented in their Manure and Nutrient Management Report. It is my opinion that the alternate location proposed by Wilma Haambucker more than meets the requirements for a permanent manure storage facility for the calf barn. See Photos 5 and 6.

Location of calf barn manure storage. More than sufficient space for anticipated volumes as discussed in the Nutrient Management Plan dated July 29, 2016.

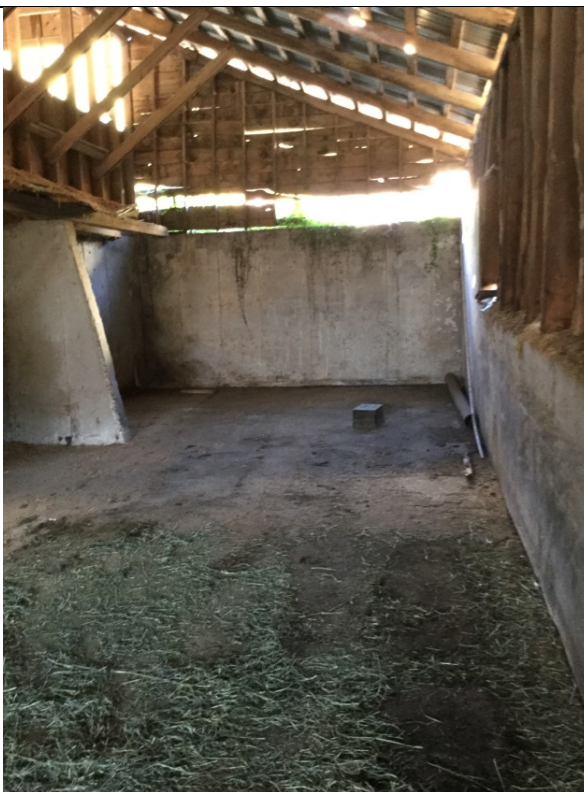
Photo 6

Back end of the manure storage facility showing the concreted in corners, floor and walls.

ACTIONS REQUIRED BY REGULATED PARTY: <div>None</div>	
ADDITIONAL COMMENTS: <div>The next time that the permanent, concrete manure storage facility is emptied it would be advisable to take photos of the base and walls demonstrating that there are no cracks from which leachate can escape through. You may want to consider doing this annually for your own records.</div>
