APD BULLETIN 11

**FRASER RIVER ESTUARY STUDY,
WATER QUALITY,
DRY WEATHER STORM SEWER DISCHARGES**

June, 1981
Victoria, B.C.

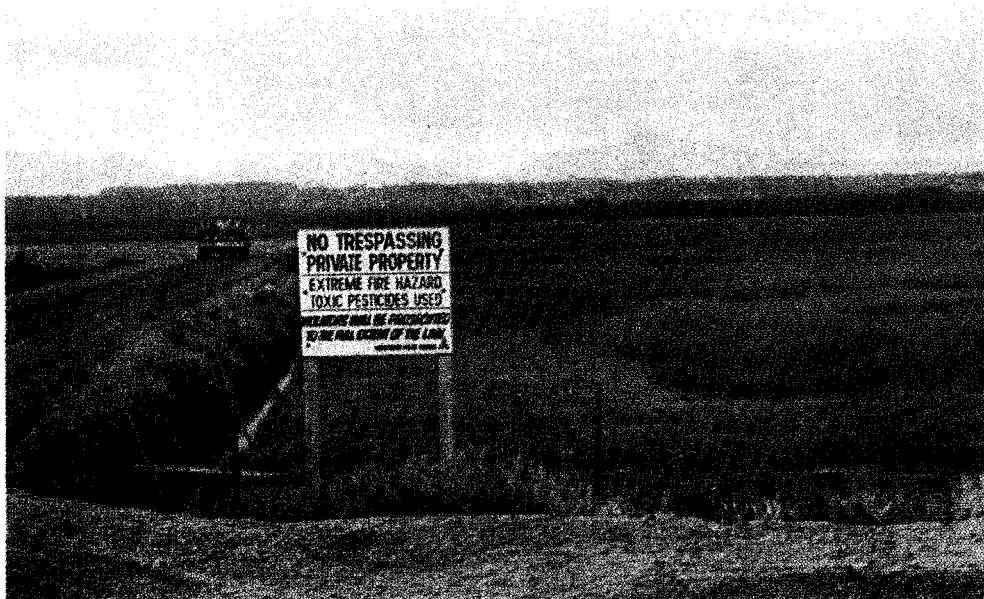
Figure 36
View of the Big Red Cranberry Farm
fields and access roads. Richmond.
79-07-04

Of all the crops grown on Lulu Island, the cranberry fields, occupying approximately 1 000 acres between No. 7 Road, No. 9 Road and the Westminster Highway, use the most water. Vegetables, fresh produce, berries, forage crops and green house operations use the remainder. Irrigation of the cranberry fields begins in mid March as a safeguard against frost. Soil temperature is continually monitored, and ditch water pumped onto the fields insulates the crop when the soil temperature, drops below 0°C . Frost prevention may continue into July and resume again in September until October. During dry weather, irrigation continues at a rate of $19\ 000\ \text{m}^3/\text{day}$ (approximately $19\ \text{m}^3/\text{acre day}$) using water coming from No. 8 Road and Cambie Road ditches. With the permission of the Richmond Drainage Authority, the flood gates for these ditches are kept open to allow Fraser River water to flood in at high tide and maintain irrigated water lost to evaporation and increased demand by developing crops (Figures 35 to 39).

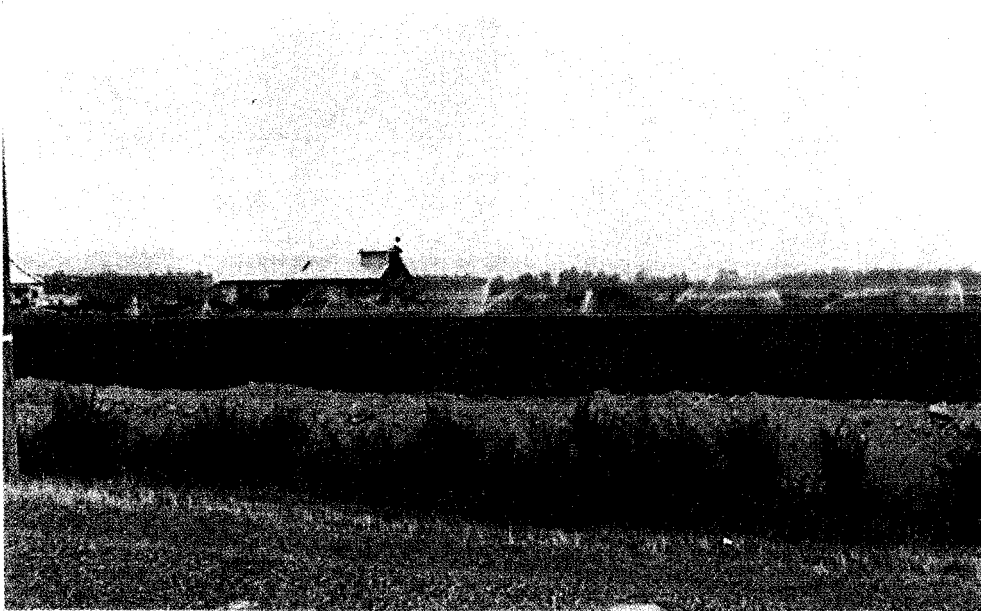
Figure 38

Fraser River water from the Cambie Road
ditch used for irrigation of newly planted cranberry fields
