Sign #5 56th Avenue Eastbound RAILWAY CROSSING STATUS

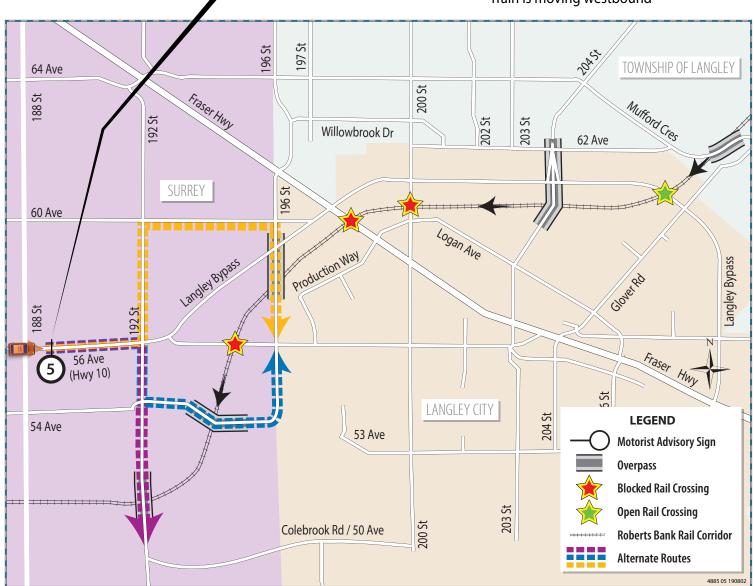
Example message on Sign #5 indicates:

- OPEN Langley Bypass rail crossing is clear
- TRAIN 200th St rail crossing is blocked
- TRAIN Fraser Hwy rail crossing is blocked
- TRAIN 56th Ave rail crossing is blocked
- TRAIN WESTBOUND > > > Train is moving westbound

Driving eastbound on 56th Ave, drivers will see Sign #5. Based on the example message on Sign #5, drivers can choose alternate routes to avoid waiting at the blocked rail crossings ahead.

- From Hwy 10, right onto 192nd St and across the overpass.
- From Hwy 10, right onto 192nd St, left on 54th Ave and across the overpass.
- From Hwy 10, left onto 192nd St, right onto 60th Ave, right onto 196th St and across the overpass.
