Memekay River

Watershed Status Evaluation Report

FREP WSEP Extension Note #1

April 2018

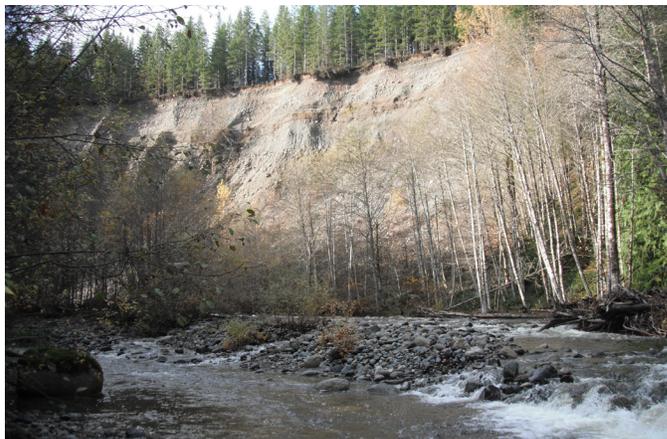
Figure 1. Logged 30–40 years ago, this site (above the mouth of the Middle Memekay) provides an example of a natural erosional process that likely was affected by the type of harvesting practices prevalent before 1995. Ongoing sloughing at this site adds large volumes of fine and coarse sediment to the channel (riparian sample site M306—see Figure 4, page 3).

Many stream reaches surveyed showed the effects of old forest harvesting adjacent to, and upstream of, sample reaches (Figure 5), as well as old mass-wasting events (Figures 1 and Table A2). These impacts have resulted in unstable substrates, channel widening, and atypical wood composition and distribution throughout stream channels. Compounding these factors, many harvested riparian areas are too young to be fully functional, and currently lack the forest structure necessary to supply LWD that would stabilize stream banks and provide habitat complexity. In some situations these conditions were exacerbated where old and second growth harvesting occurred on the same stream reach (i.e., on S4, S5, and S6 streams) because pre-harvest LWD has become degraded with no sources of new functional LWD. Many affected riparian areas do not represent natural conditions (Figure 5), whereas unlogged riparian areas are typically fully functional providing a wide range of processes benefiting stream channel condition (Figure 6).

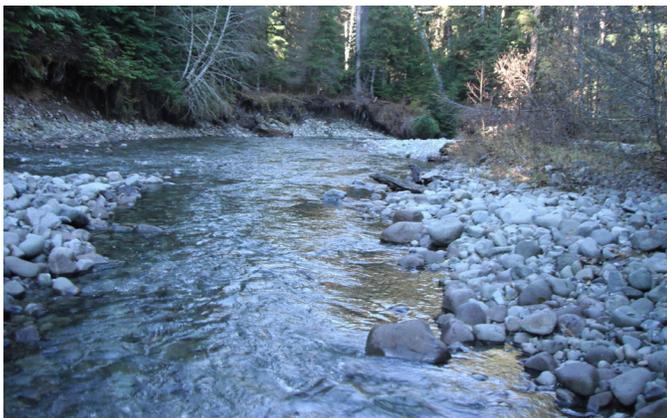
Figure 5. Riparian field survey site M300 – Properly Functioning Condition at high risk (PFC-I). This site is an example of how masswasting upstream has affected the condition of a well-buffered stream reach downstream.

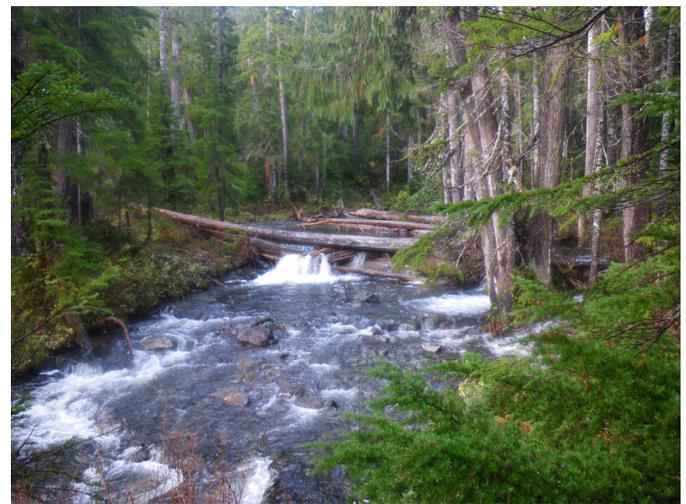
Figure 6. Riparian field survey site M301 – While this sample reach was dropped it is a good example of well managed stream (Properly Functioning Condition (PFC) with riparian buffering, stable banks, sufficient LWD recruitment, etc.) located adjacent to, and downstream of, a series of old cut blocks.

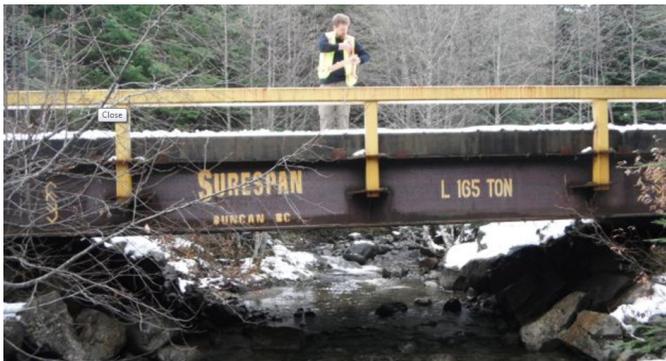
Figure 8. Located in the North Memekay, this small bridge (Crossing ID# 102823) crosses a 3rd order stream that has over 3km of upstream observed and modeled habitat, and is a good example of a crossing that easily passes fish, storm flows and debris.

Analysis of road crossings showed that all crossings on observed fish streams (n=12) passed fish. Of all the passable fish stream crossings for observed and modeled (n=19), 17 used open-bottom structures (Figure 8). Eight of the modeled fish stream crossings (n=15) were assessed to be barriers to fish passage. Modeled habitat suggests the eight crossings have suitable lengths of habitat above the stream crossing and two were located on streams with low gradients indicating a probability of being high quality fish habitat (Figure 9). All eight barrier sites on modeled fish habitat used closed-bottom structures and were located on 1st & 2nd order streams. These should be confirmed as fish habitat and prioritized for restoration suitability.

Management Opportunities – To maintain connectivity and accessibility to fish habitat, continue using bridges, open-bottom, properly embedded closed-bottom culverts, and log box culverts at stream crossing sites with fish presence.

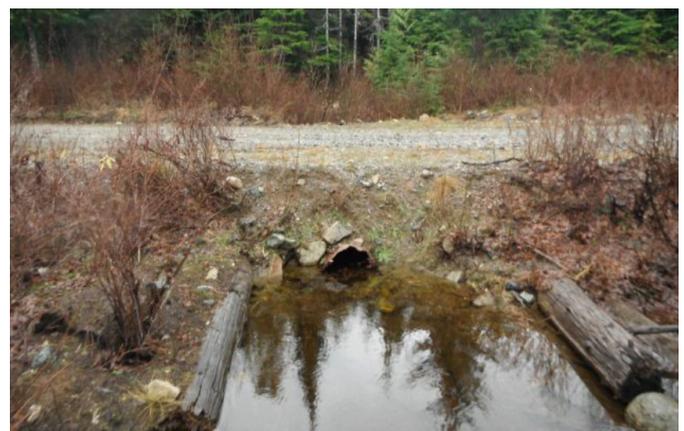
Figure 9. Periodically occupied by beaver, this stream crossing is located in the North Memekay. This site (Crossing ID# 103933), estimated to have >800m of modeled upstream fish habitat, is an example of habitat requiring confirmation of (i) fish values and (ii) restoration. While once a small log bridge, the replacement culvert constricts the channel and encourages beaver dam construction. This, and similar closed-bottom metal culvert crossing-sites, are examples of good candidates for replacement with open bottom structures less prone to beaver blockages (Jensen et al. 2001) and better able to pass storm flows and debris.

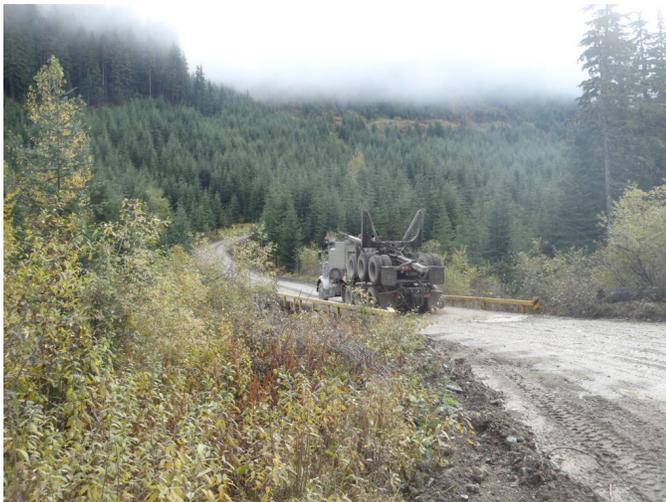
Figure 12. Middle Memekay Bridge, Branch C1000, site #320. Grader berms at this location concentrate road surface drainage onto the bridge where it flows directly into the Middle Memekay River.

Management Opportunities – Maintain sediment control practices. Most sites of concern can be corrected by improving grader operator training, berm management, culvert design, and road location changes.

Site #	Road Use	Fine Sediment Generated (m ³)	Issue
320	Branch	5.4	Remove berms
271	Branch	2	Too close to wetland
273	Branch	2	Remove berms
324	Branch	1.8	Too close to stream
264	Branch	1.76	Remove berms
263	Branch	1.7	Remove berms
270	Branch	1.36	None
321	Branch	1.1	Too close to stream
318	Branch	1.04	Install culvert

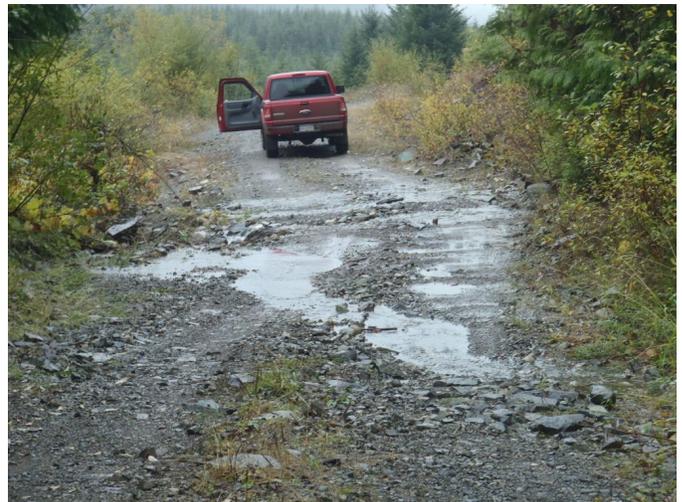
Figure 13. Cooper Main. On some inactive roads, relief ditches capture small streams, directing concentrated storm flows onto otherwise dry hillslopes. These have the potential to form streams with chronic sediment problems.

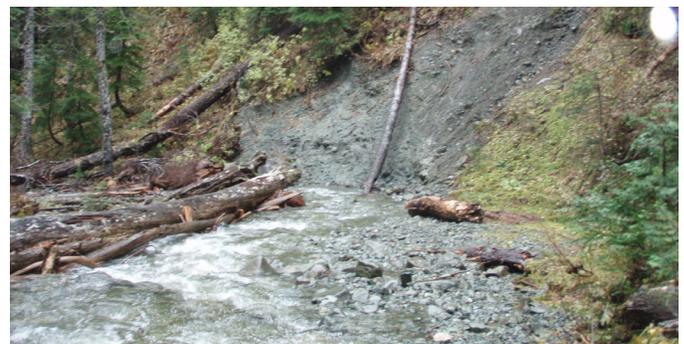
Figure 15. Riparian site M024 – Not Properly Functioning condition (NPF). This naturally occurring slide affected all channel bed and bank attributes, including a portion of the riparian area on this Middle Memekay tributary. While not directly attributed to human activities, this site is indicative of the inherent terrain instability (i.e. sensitivity) in many parts of the Memekay watershed and underlines the need for special management of sensitive characteristics within the fisheries sensitive watershed.
