On May 12, 2016, a Pollution Abatement Order (Order), was made under section 83 of the *Environmental Management Act*, issued to Canyon Road Farms Ltd. pertaining to the abatement of agricultural waste into the environment.

Ministry of Environment Inspection Record

| Inspection Number: 28629 | | Inspection Status: FINAL | |
| Regulated Party: Canyon Road Farms | | | |

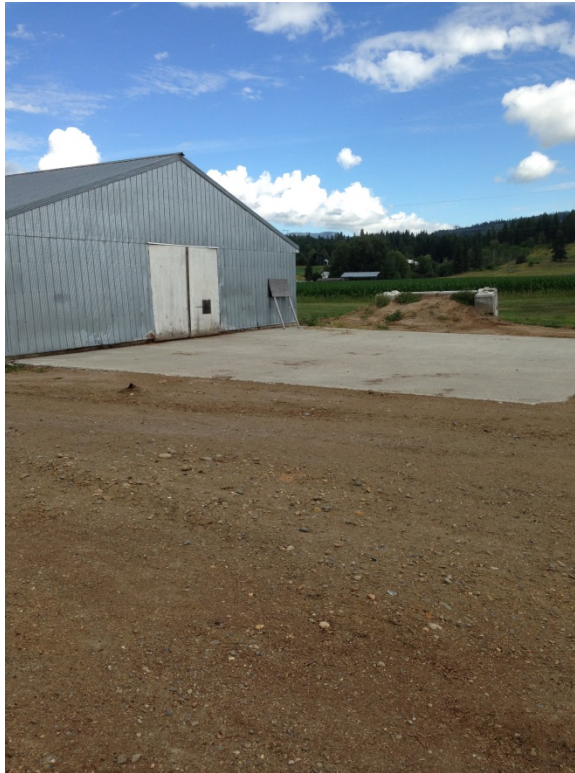
Photo 1

Manure storage pad located on the east side of the northern barn.

Photo facing northwest.

| Details/Findings: <p>The manure storage facilities provide sufficient storage capacity to store all the manure produced at the facility during the time of inspection. As the farm was no longer in operation and there was no intention to continue operating by the current owners, there was no need to consult the farm book to determine compliance with this requirement.</p> <p>If the farm is sold and begins operating again: The storage capacity is sufficient to store all manure produced by the operation. This is based on an approx. 60 cubic metres of litter (manure and bedding) generated per barn per cycle (15,000 birds per barn), requiring 64 square metres storage pad. Currently, the storage pads are approx. 120 square metres.</p> |

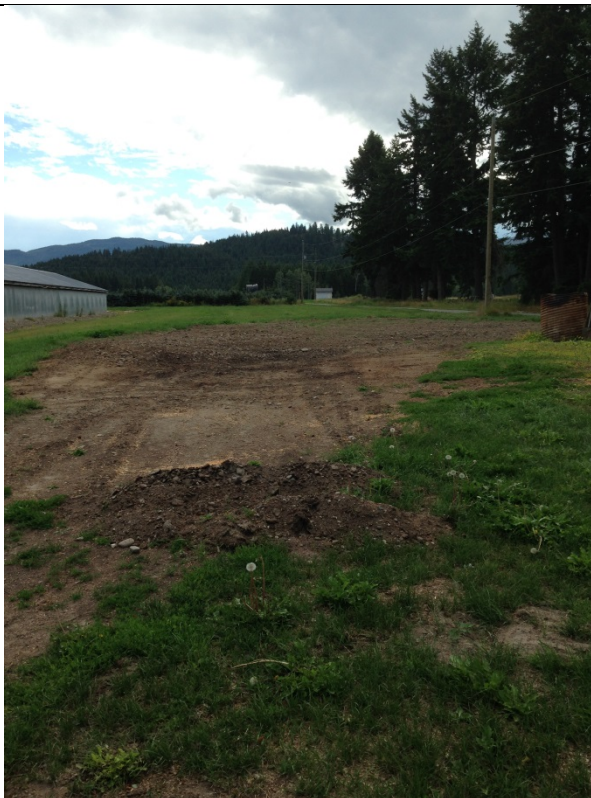
Photo 2

Previous field stored manure has been removed and will no longer be generated. See photo 2.

Location of historic field storage.

Photo facing east along southern property boundary.

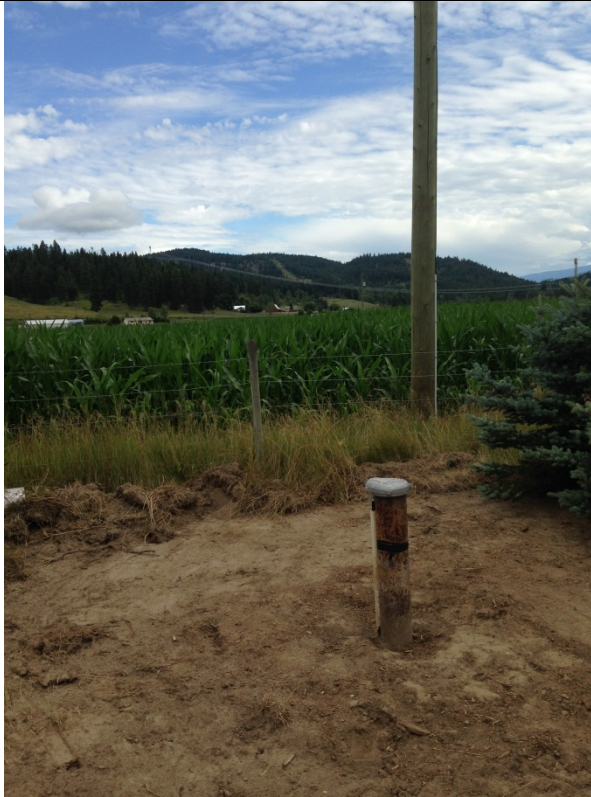
Photo 3

Well located
along north
property line.

Photo facing
north.

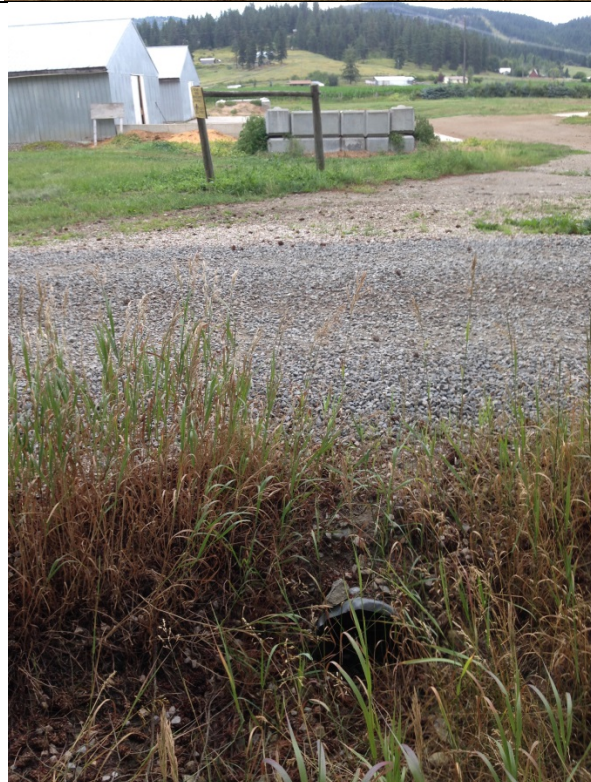
Photo 4

A culvert has been placed beneath the municipal roadway along the southern property line (See photo 4). This culvert directs ditch water, and runoff from the fields to the south across Canyon Road Farm lands, within 0.5 metre from the manure storage pads. As no manure is expected to be generated, since the farm is no longer operational, this drainage issue has been noted, but does not put the owner out of compliance.

Culvert installed
across municipal
roadway in
foreground. Both
barns and
storage pads in
background.

Photo facing
north from
municipal
roadway to the
south of the
property.

| MONITORING AND REPORTING REQUIREMENTS | | | | | |
|--|--|---|---|---|---|
| <p>If the farm is to become operational in the future;</p> <ul style="list-style-type: none"> - covers for the manure storage pads will need to be utilized. A weighted down impermeable tarp over the pile would be sufficient. - the drainage issue created by the placement of a culvert beneath the road to the south of the property would need to be addressed to prevent runoff from flowing within 15m of the manure storage pads. | | | | | |
