CANADA – BRITISH COLUMBIA WATER QUALITY MONITORING AGREEMENT

WATER QUALITY ASSESSMENT OF Columbia River AT NICHOLSON (2003 – 2006)

Prepared by: L. G. Swain, P. Eng. B.C. Ministry of Environment

August 2007

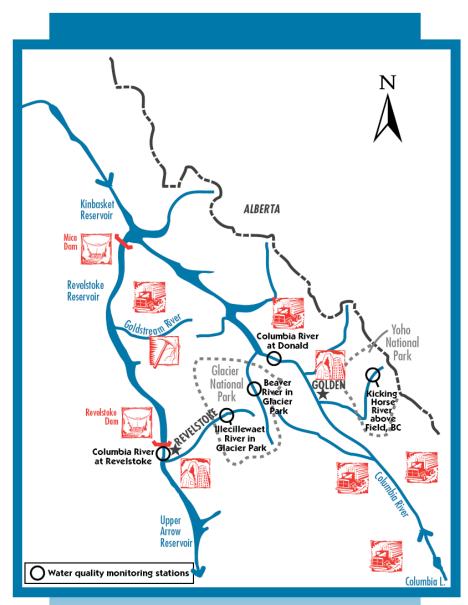
FIGURE 1: COLUMBIA RIVER AT NICHOLSON

The Columbia River watershed is located in the southeast corner of British Columbia. Water quality measurements for the Columbia River at Nicholson are from samples collected from the upstream side of the Nicholson Road Bridge accessed from the exit off Highway 95, 10 km south from Golden, B.C.; site coordinates are 54° 14′ 38" N and 116 ° 54′ 42" W. The drainage area at this point is 6660 km², with the Rocky Mountains to the east and the Purcell Mountains to the west. The river flows in the Rocky Mountain Trench and is used for drinking water, irrigation and industry and supports populations of cutthroat, rainbow, bull, and eastern trout and whitefish. Cirque glaciers in the high Purcell and Rocky mountains that drain to the Columbia River and the glacial silt imparts a gray, muddy colour to the river at times.

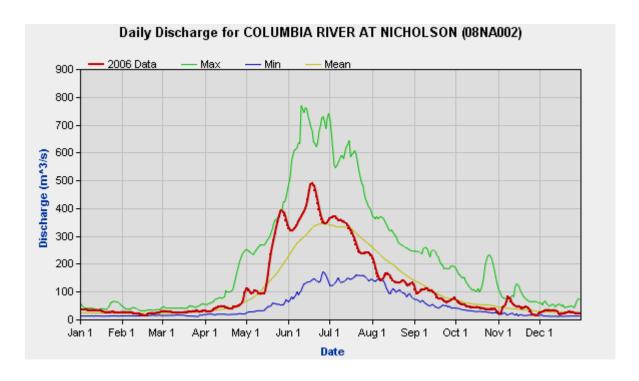
FIGURE 2: WATER SURVEY OF CANADA FLOW DATA FOR COLUMBIA RIVER AT NICHOLSON

Flow (Figure 2) values which are uncontrolled peak during the months from May through August, with lowest flows being recorded in the November through April period. Maximum flows can exceed 750 m³/s.

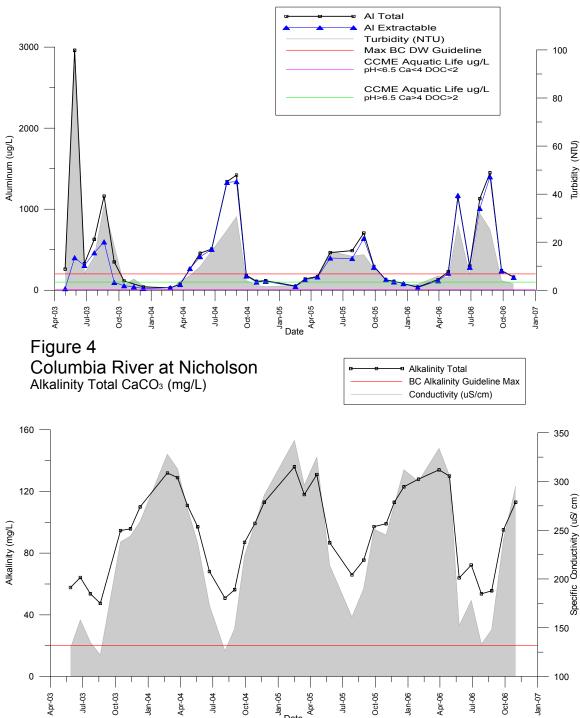
Figure 3
Columbia River at Nicolson
Aluminum Total and Extractable (ug/L)

Total **Aluminum** (Figure 3) concentrations frequently exceed the guidelines for dissolved concentrations; however, these high values were correlated with high turbidity levels which means that the aluminum are likely not biologically available.

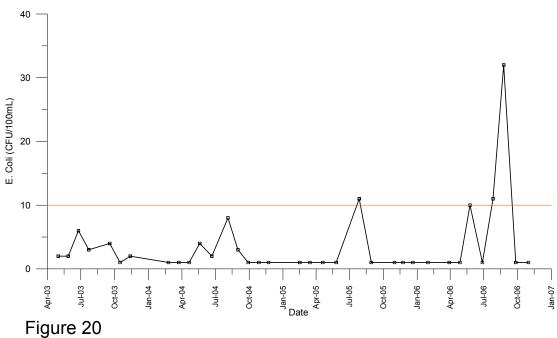
Figure 19 Columbia River at Nicholson Escherichia, Coli

Fecal coliforms (Figure 15), **Escherichia coli** (Figure 19) and **Enterococus** (Figure 20) occasionally exceeded the guideline for drinking water supplies receiving only disinfection. This means that water supplies withdrawn from the Columbia River near Nicholson should receive partial treatment as a minimum, as well as disinfection.

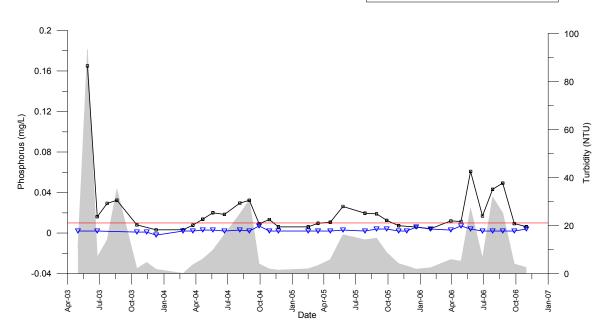
Figure 36 Columbia River at Nicholson Phosphorus Total and Total Dissolved (mg/L)

The following water quality indicators seemed to fluctuate through the year according to turbidity concentrations, but were below guideline values (if guidelines exist) and had no other trends: total arsenic, beryllium, bismuth, cobalt, copper, gallium, lanthanum, manganese, niobium, nickel, rubidium, antimony, selenium, silver, tin, thallium, vanadium and total phosphorus.

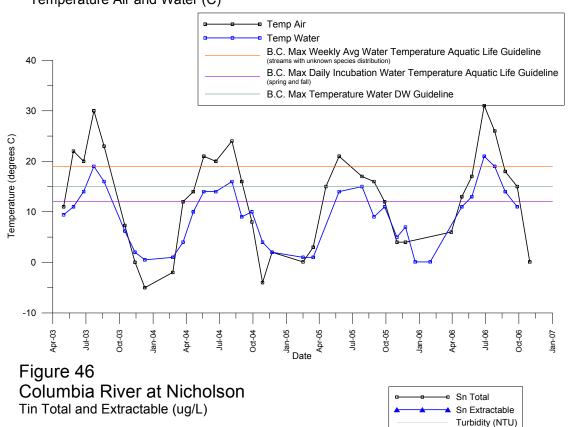
Figure 45
Columbia River at Nicholson
Temperature Air and Water (C)

Water temperature (Figure 45) values occasionally exceeded the guideline for maximum temperatures for streams with unknown fish distributions. These higher concentrations occurred during the warm summer months.
