LOWER FRASER VALLEY DYKE STUDIES

CONSTRUCTION MATERIALS SURVEY

E.M. CLARK, P.Eng.

Vancouver, B.C.
August 1963.

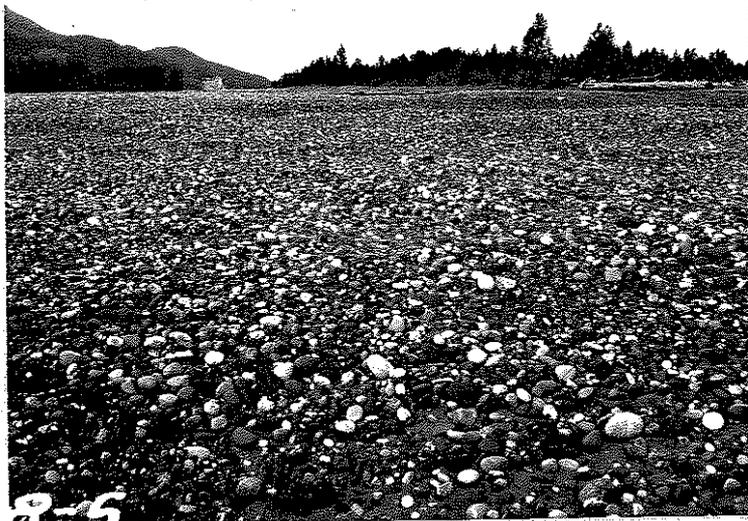
Area 41
Surface material.
Typical of Fraser
River bars.

<u>Pit No.</u>	<u>Volume in c.y.</u>	<u>Ownership</u>	<u>Description</u>	
41	> 100,000	Crown	River bar. Direct access to dyke and some removal of materials during low water. Representative material: poorly-graded gravel-sand mixture, 2" maximum size, clean. <u>GP</u>	Photo #3
42	> 100,000	Private	Abandoned pit, excavated to a depth of 40', now covered by pasture, with mature orchard over the immediately-surrounding area. Pit-run material: poorly-graded sand with gravel to 3", clean. <u>SP</u>	
43	10,000 to 100,000	Private	Undeveloped potential source. Small volume previously removed from a 5' excavation, since overgrown with bush. Representative surface material: poorly-graded gravel to 3", with 25% cobbles and boulders to 8", sandy, clean. <u>GP</u>	
44	> 100,000	Municipal	Operating pit excavated to a depth of 15'. Pit-run material: poorly-graded gravel to 3", with 10% cobbles and boulders to 24", sandy, clean. <u>GP</u>

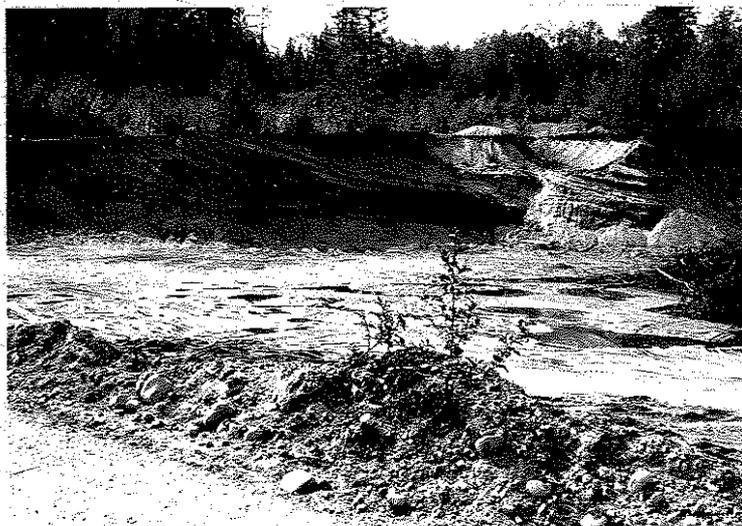
Photo #4

Pit #48
Indicates depth
of excavation.

<u>Pit No.</u>	<u>Volume in c.y.</u>	<u>Ownership</u>	<u>Description</u>	
48	> 100,000	Municipal	Stratified deposit, currently in operation and excavated to an average maximum depth of 20', where impervious material is encountered. Pit-run material: poorly-graded gravel-sand mixture, with 25% cobbles and boulders to 12", sandy, clean. <u>GP</u> Estimated 500,000 c.y. available.	Photos #4 & #5
49	10,000 to 100,000	Crown	Material from Alouette River channel and deposits along banks from channel improvements. Representative material: well-graded gravel to 3", with 30% cobbles and boulders to 8", sandy, clean. <u>GW</u>	
50		Provincial	Rock quarry.	
51	10,000 to 100,000	Municipal and Crown	Material from Alouette River channel removed during low-water period. Representative material: well-graded gravel to 3", sandy, clean. <u>GW</u>	
52	> 100,000	Municipal	Stratified deposit, operated periodically and excavated to a 20' depth. Silt and silty-sand overburden prevails to a depth of 5'. Pit-run material: poorly-graded sand with gravel to 1", clean. <u>SP</u>

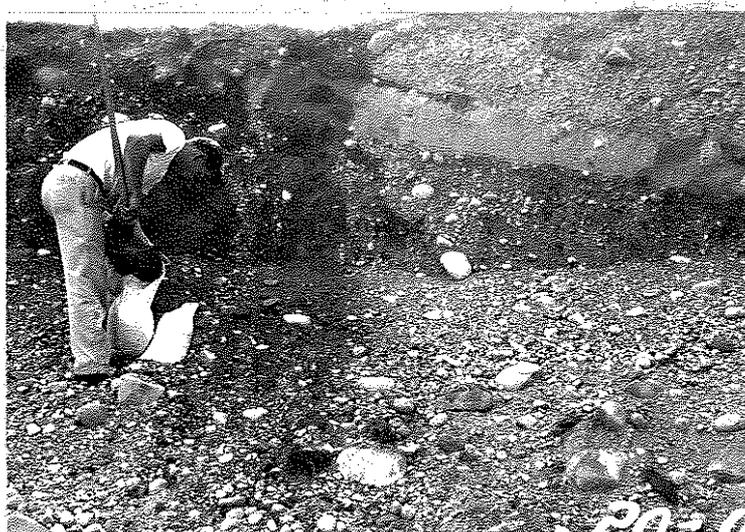
Photo #5

Pit #48
Exposed materials.

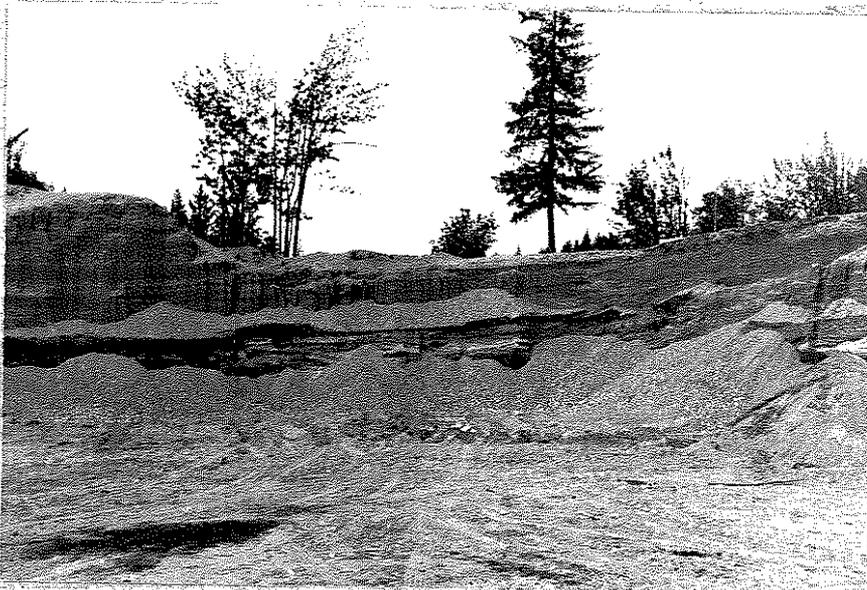
Pit #53 - shows
depth of excavation
and stratification
of deposit.

The largest volume of gravel would be required in the Maple Ridge, Pitt Meadows and Pitt Polder dyking districts. This material could be obtained from pits 52 and 53 where an estimated 1,000,000 c.y. should be available by extending the surface area of the pit and from the vicinity of pit 48 where it is estimated that 500,000 c.y. would be available. An alternative which may not be economic would be to obtain gravels from the large deposits available in pits 55 and 56. Gravel for the Coquitlam district could easily be obtained from pit 57. Depending on comparative costs, the Lulu Island and Delta districts could be supplied either by barge from pit 59 or by truck from pits in the Delta area. Nicomen Island is the only other district which requires an appreciable volume and it could easily be obtained from local pits.

53	> 100,000	Private	Stratified deposit, currently in use and excavated to a 30' depth. Pit-run material: poorly-graded sand with gravel to 2", clean. <u>SP</u> Estimated 1,000,000 c.y. available.	Photo #6
54		Private	Operating rock quarry. Barge-loading facilities available.	
55	> 100,000	Private and Crown	Dry creek outwash and channel deposits. Periodic removal of surface materials. Representative material: poorly-graded gravel to 3", with 30% cobbles and boulders to 12", sandy, clean.

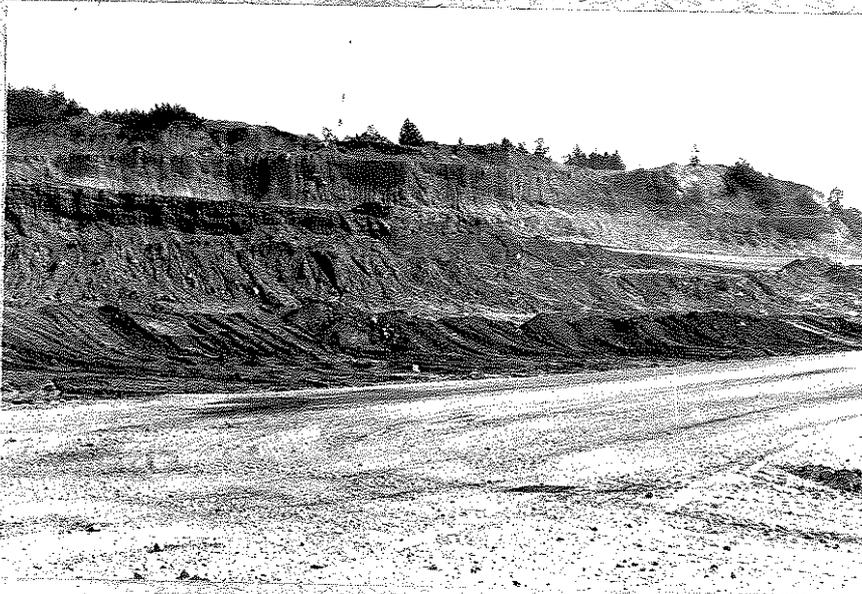
Photo #7

Pit #59 - shows
depth of excavation.

<u>Pit No.</u>	<u>Volume in c.y.</u>	<u>Ownership</u>	<u>Description</u>	
56	> 100,000	Private	Large deposit, currently in use. Has been excavated to a depth of 60'. Pit-run material: poorly-graded sand-gravel mixture, with 20% cobbles and boulders to 16", clean. <u>SP</u>	
57	> 100,000	Private and Crown	Material from approximately one mile of dry channels and bars of the Coquitlam River. Removal and stockpiling of materials in operation. Representative material: well-graded gravel to 3", with 25% cobbles and boulders to 16", sandy, clean. <u>GW</u>	
58	10,000 to 100,000	Crown	Mainly material deposited along banks of Coquitlam River from channel improvements. Representative material: poorly-graded gravel to 3", with 40% cobbles and boulders to 12", sandy, clean. <u>GP</u>	
59	> 100,000	Private	Extremely large deposit, currently in use and excavated to a depth of 100'. Barge and truck-loading facilities available. Pit-run material: poorly-graded gravel to 3", with 25% cobbles and boulders to 36", sandy, clean. <u>GP</u>	Photos #7 & #8

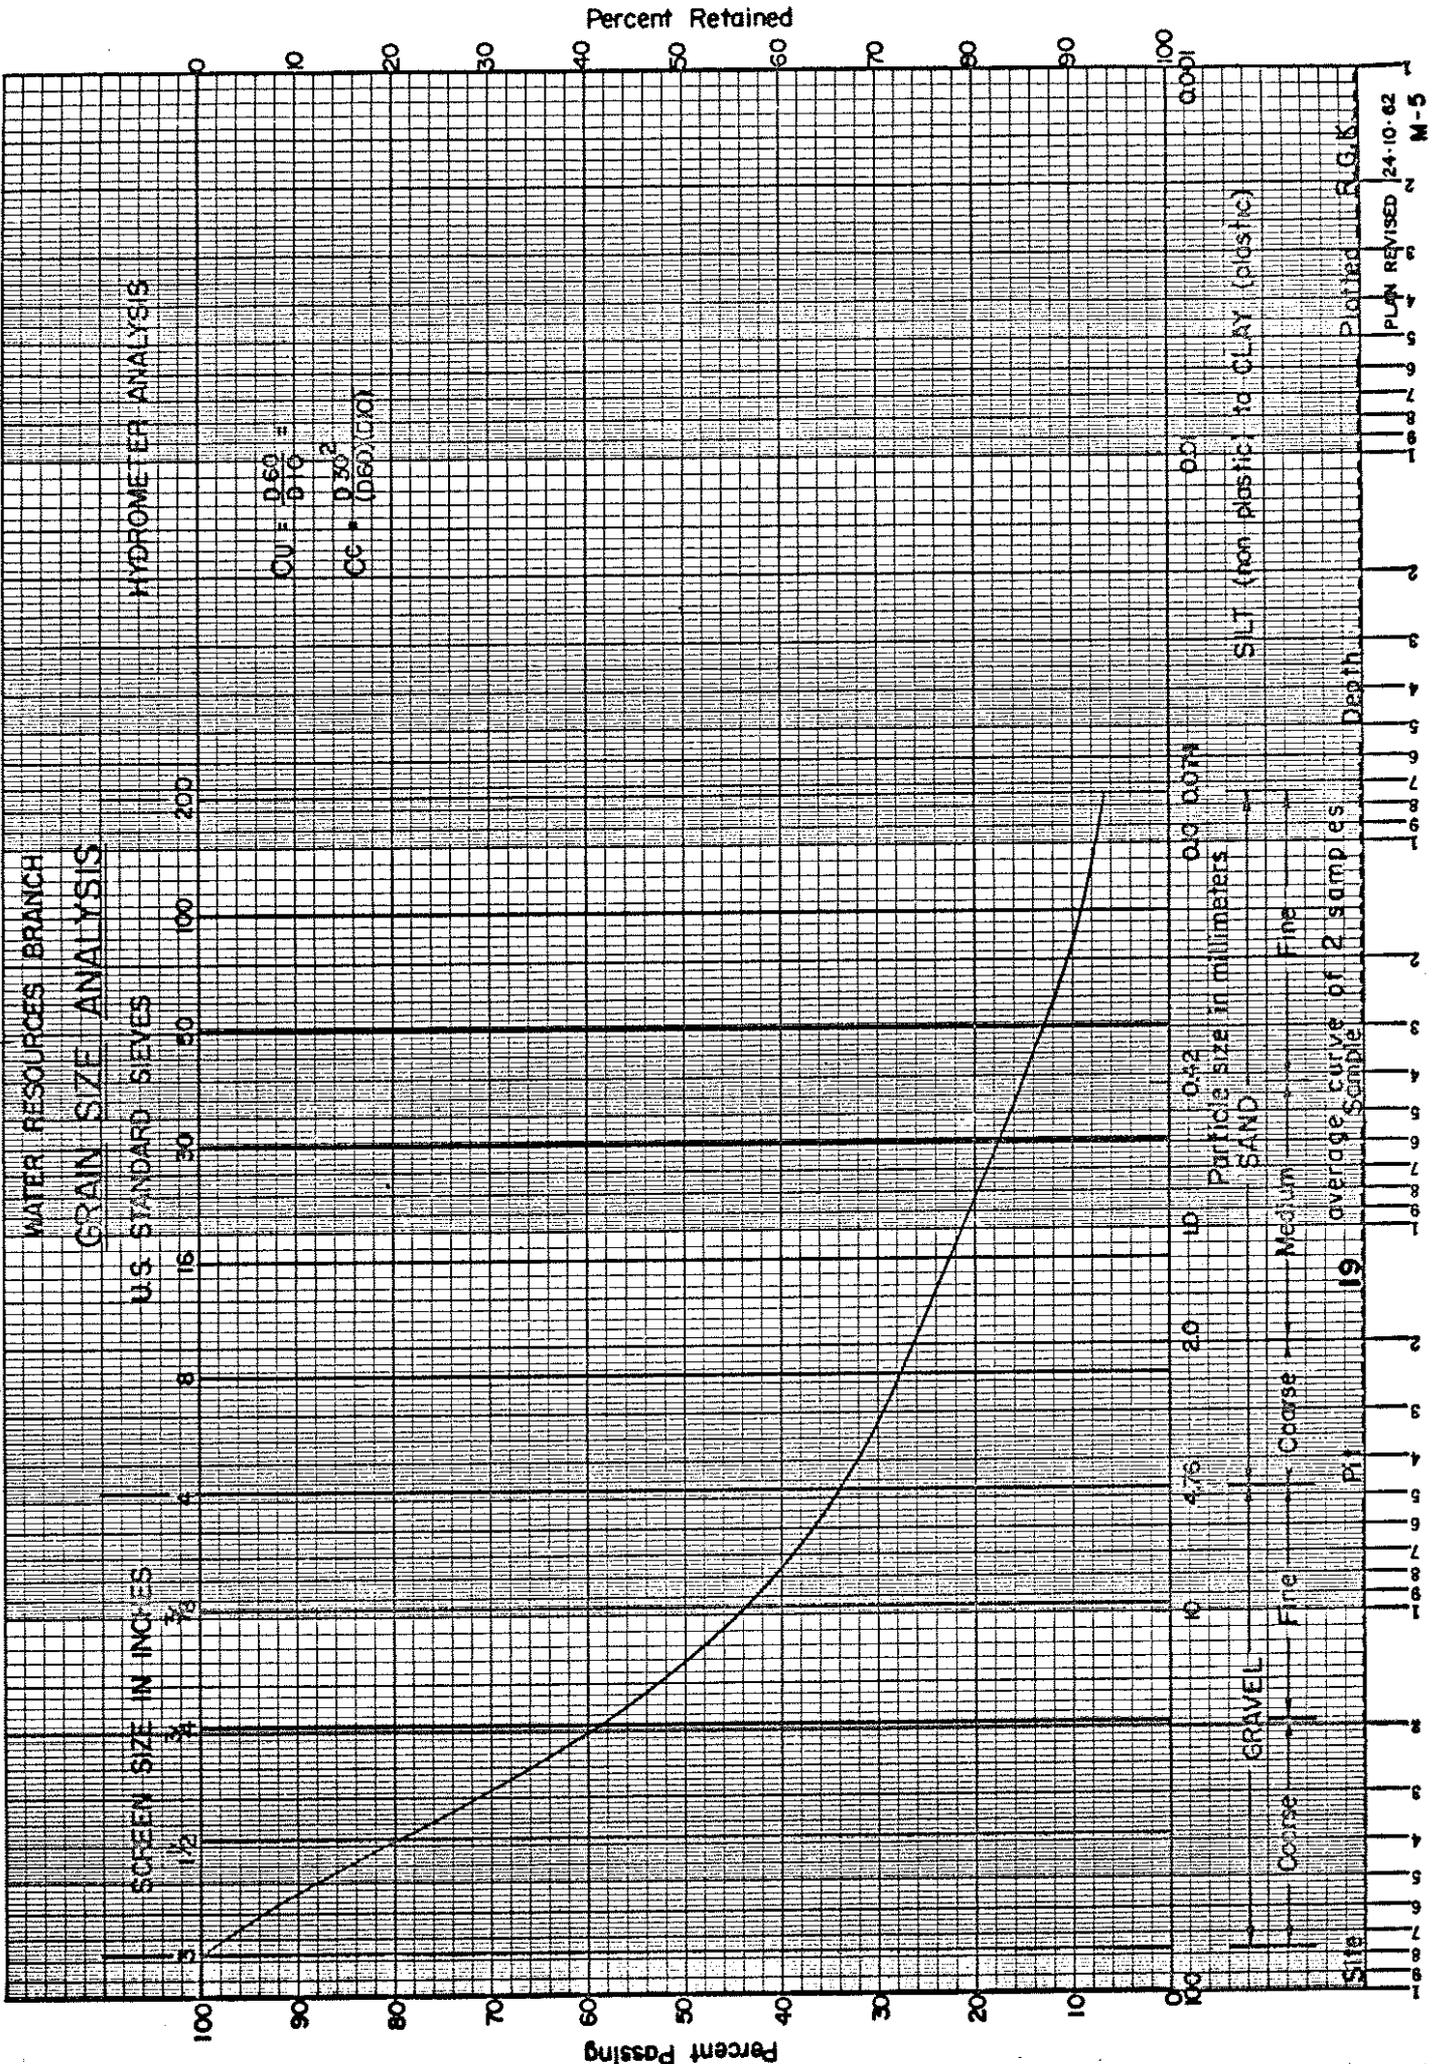
WATER RESOURCES BRANCH
GRAIN SIZE ANALYSIS

average curve of 2 samples

Appendix III. Grain-size curves for twelve typical samples have been included in the same appendix. Test results were used to supplement the field descriptions summarized in Appendix II. Where this has been done, the classification symbol has been shown after the pit description.

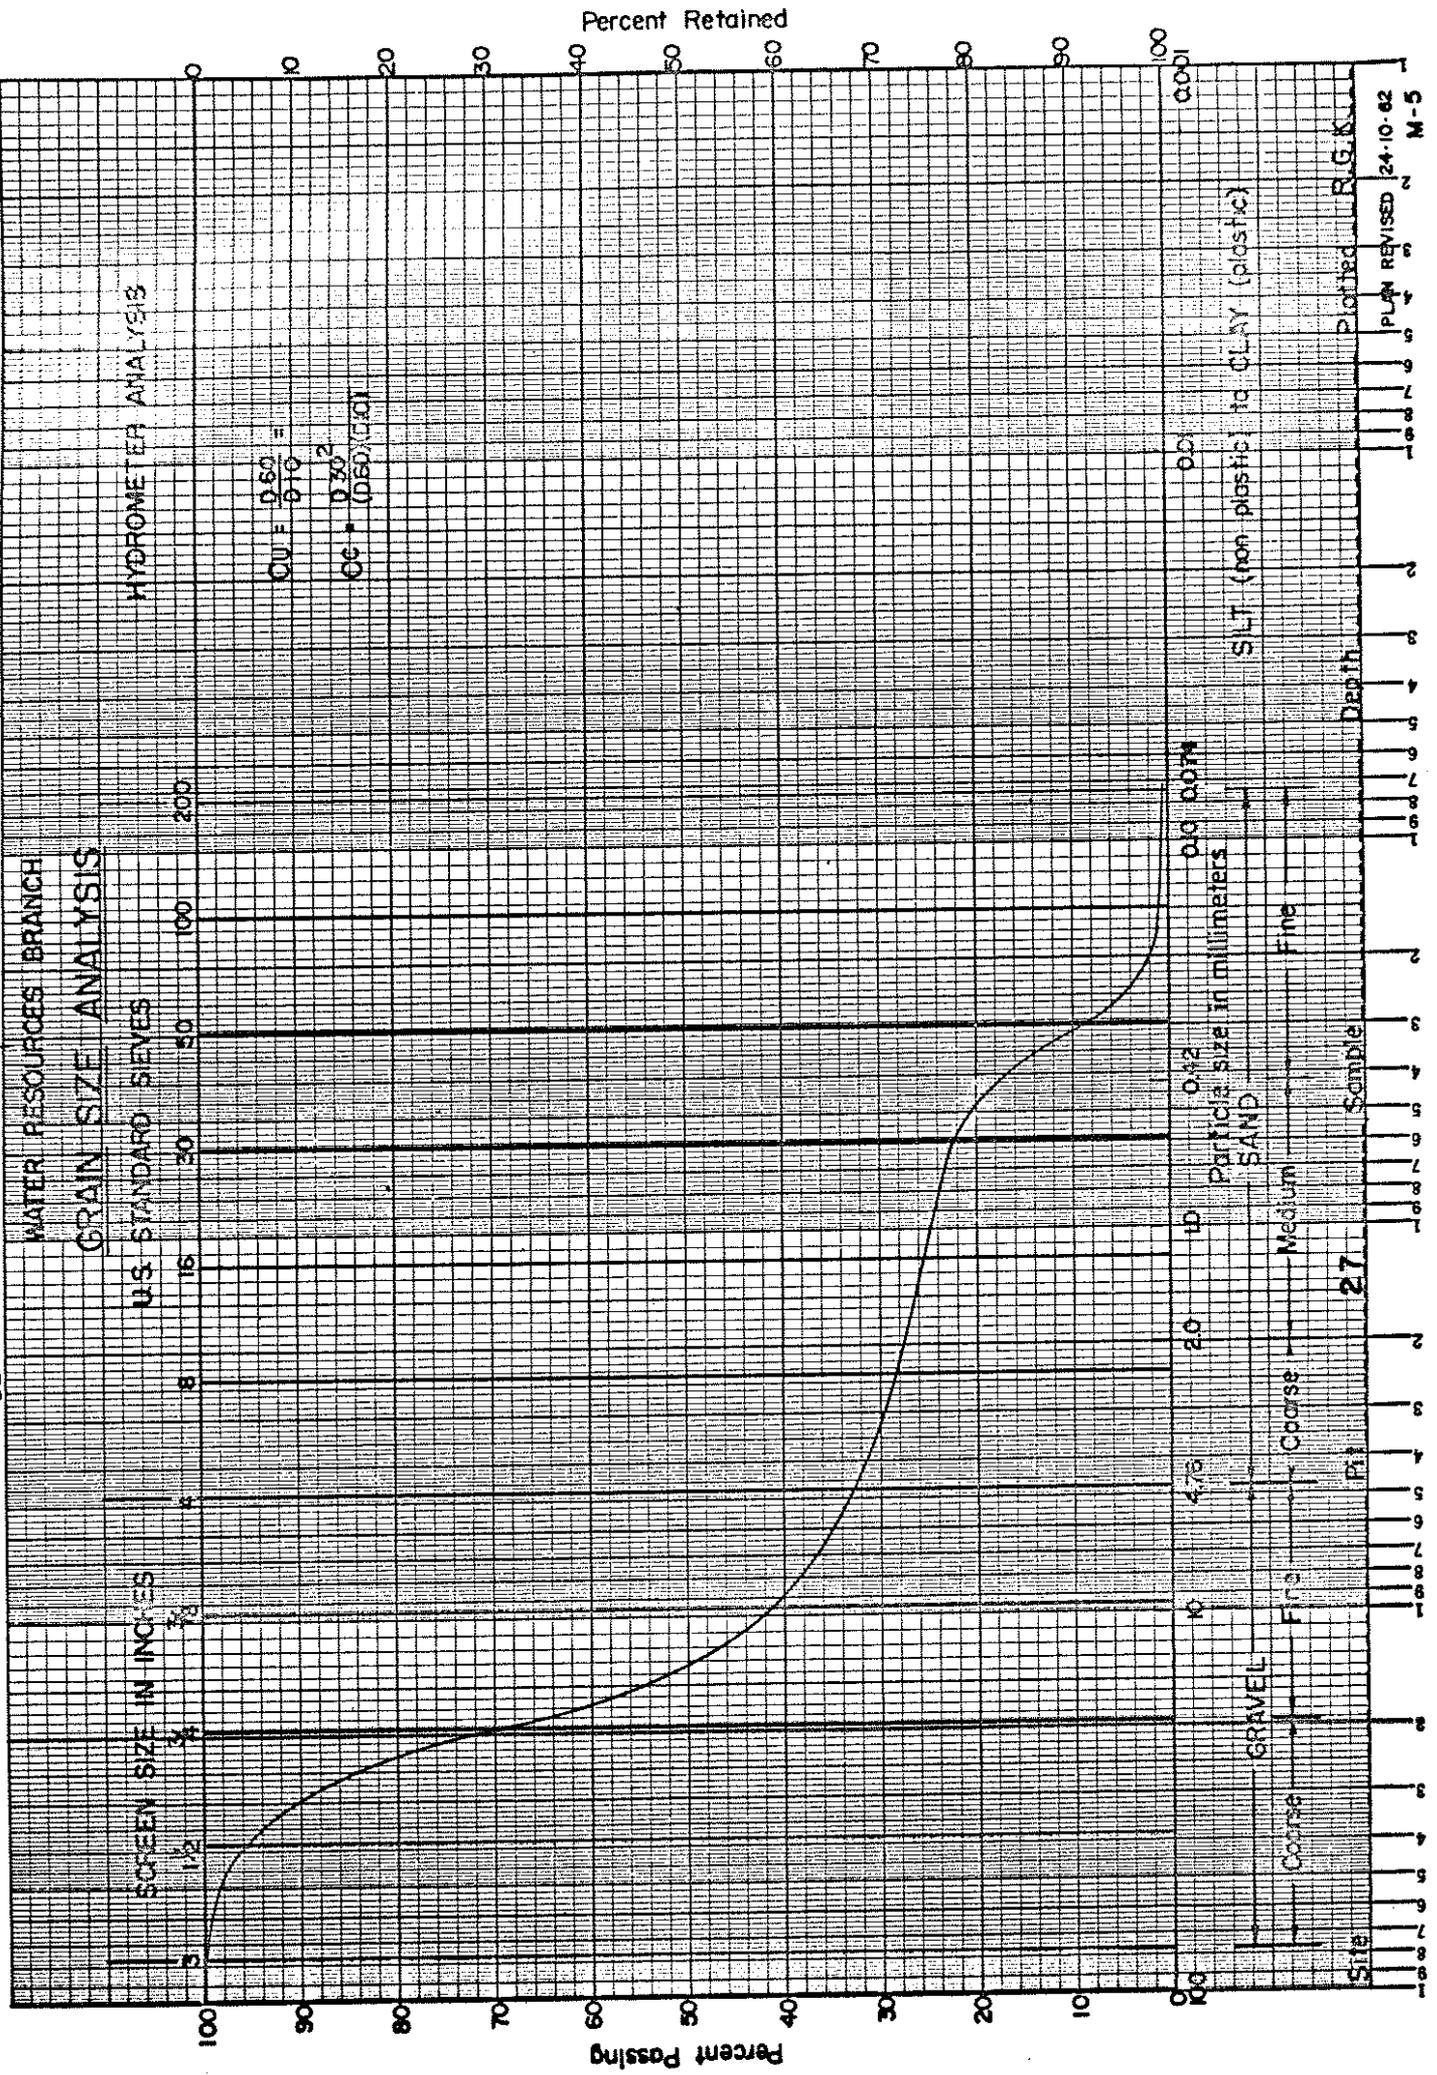
WATER RESOURCES BRANCH
GRAIN SIZE ANALYSIS

$CU = \frac{0.60}{0.10} = 6$
 $CC = \frac{0.70^2}{(0.60/0.075)}$

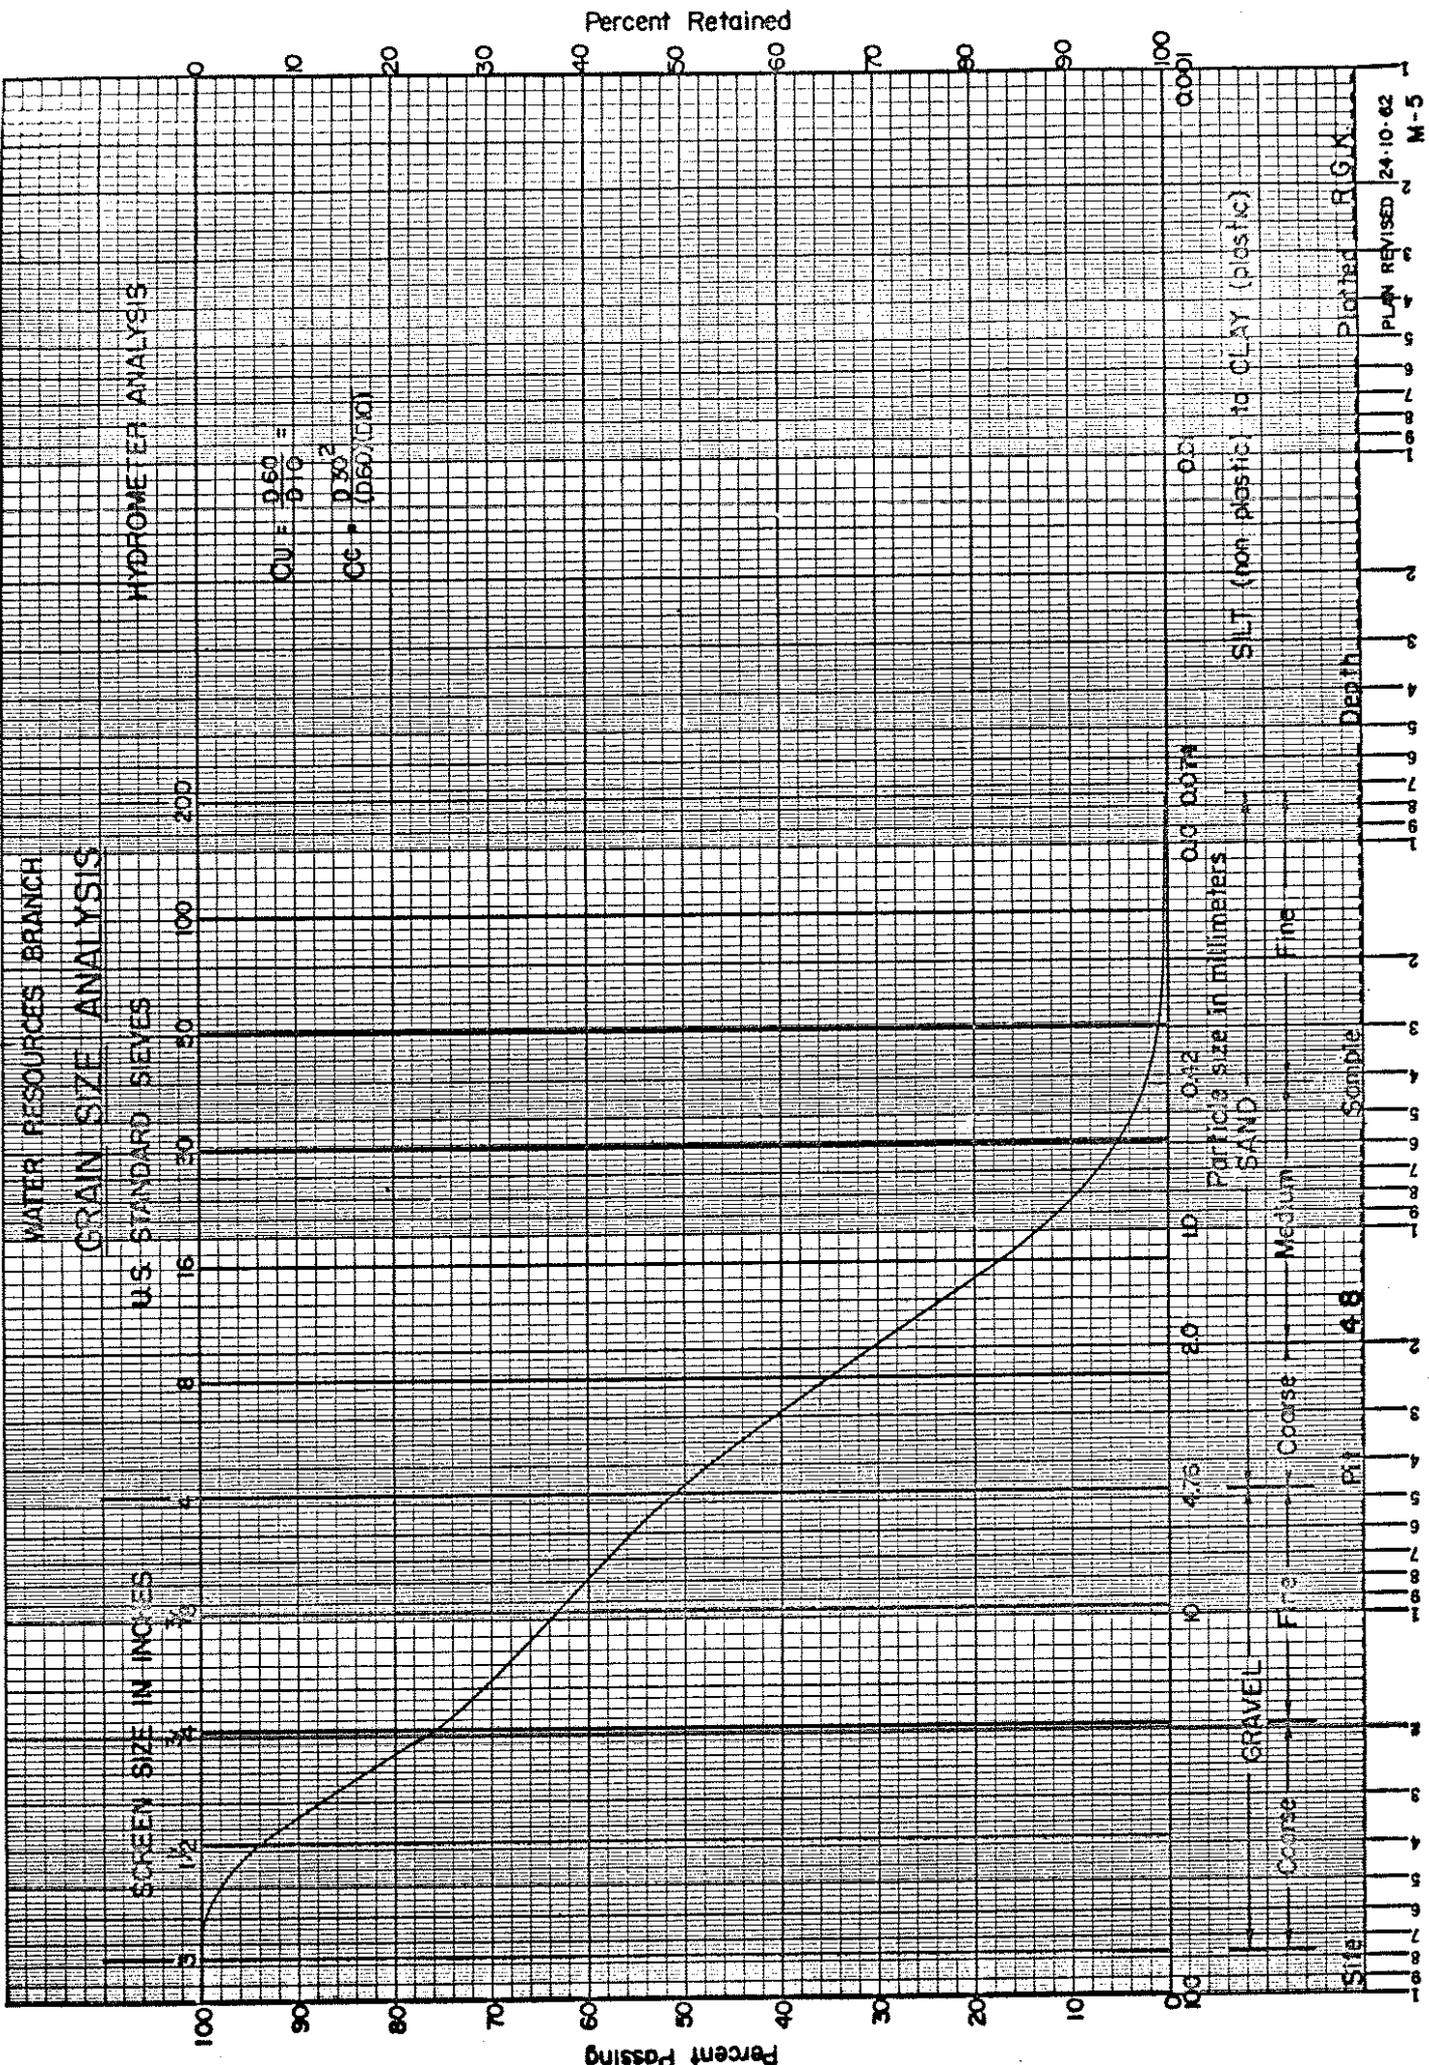
GRAIN SIZE ANALYSIS

$$QU = \frac{0.60}{0.10} =$$

$$CC = \frac{0.30^2}{(0.60)(0.001)}$$

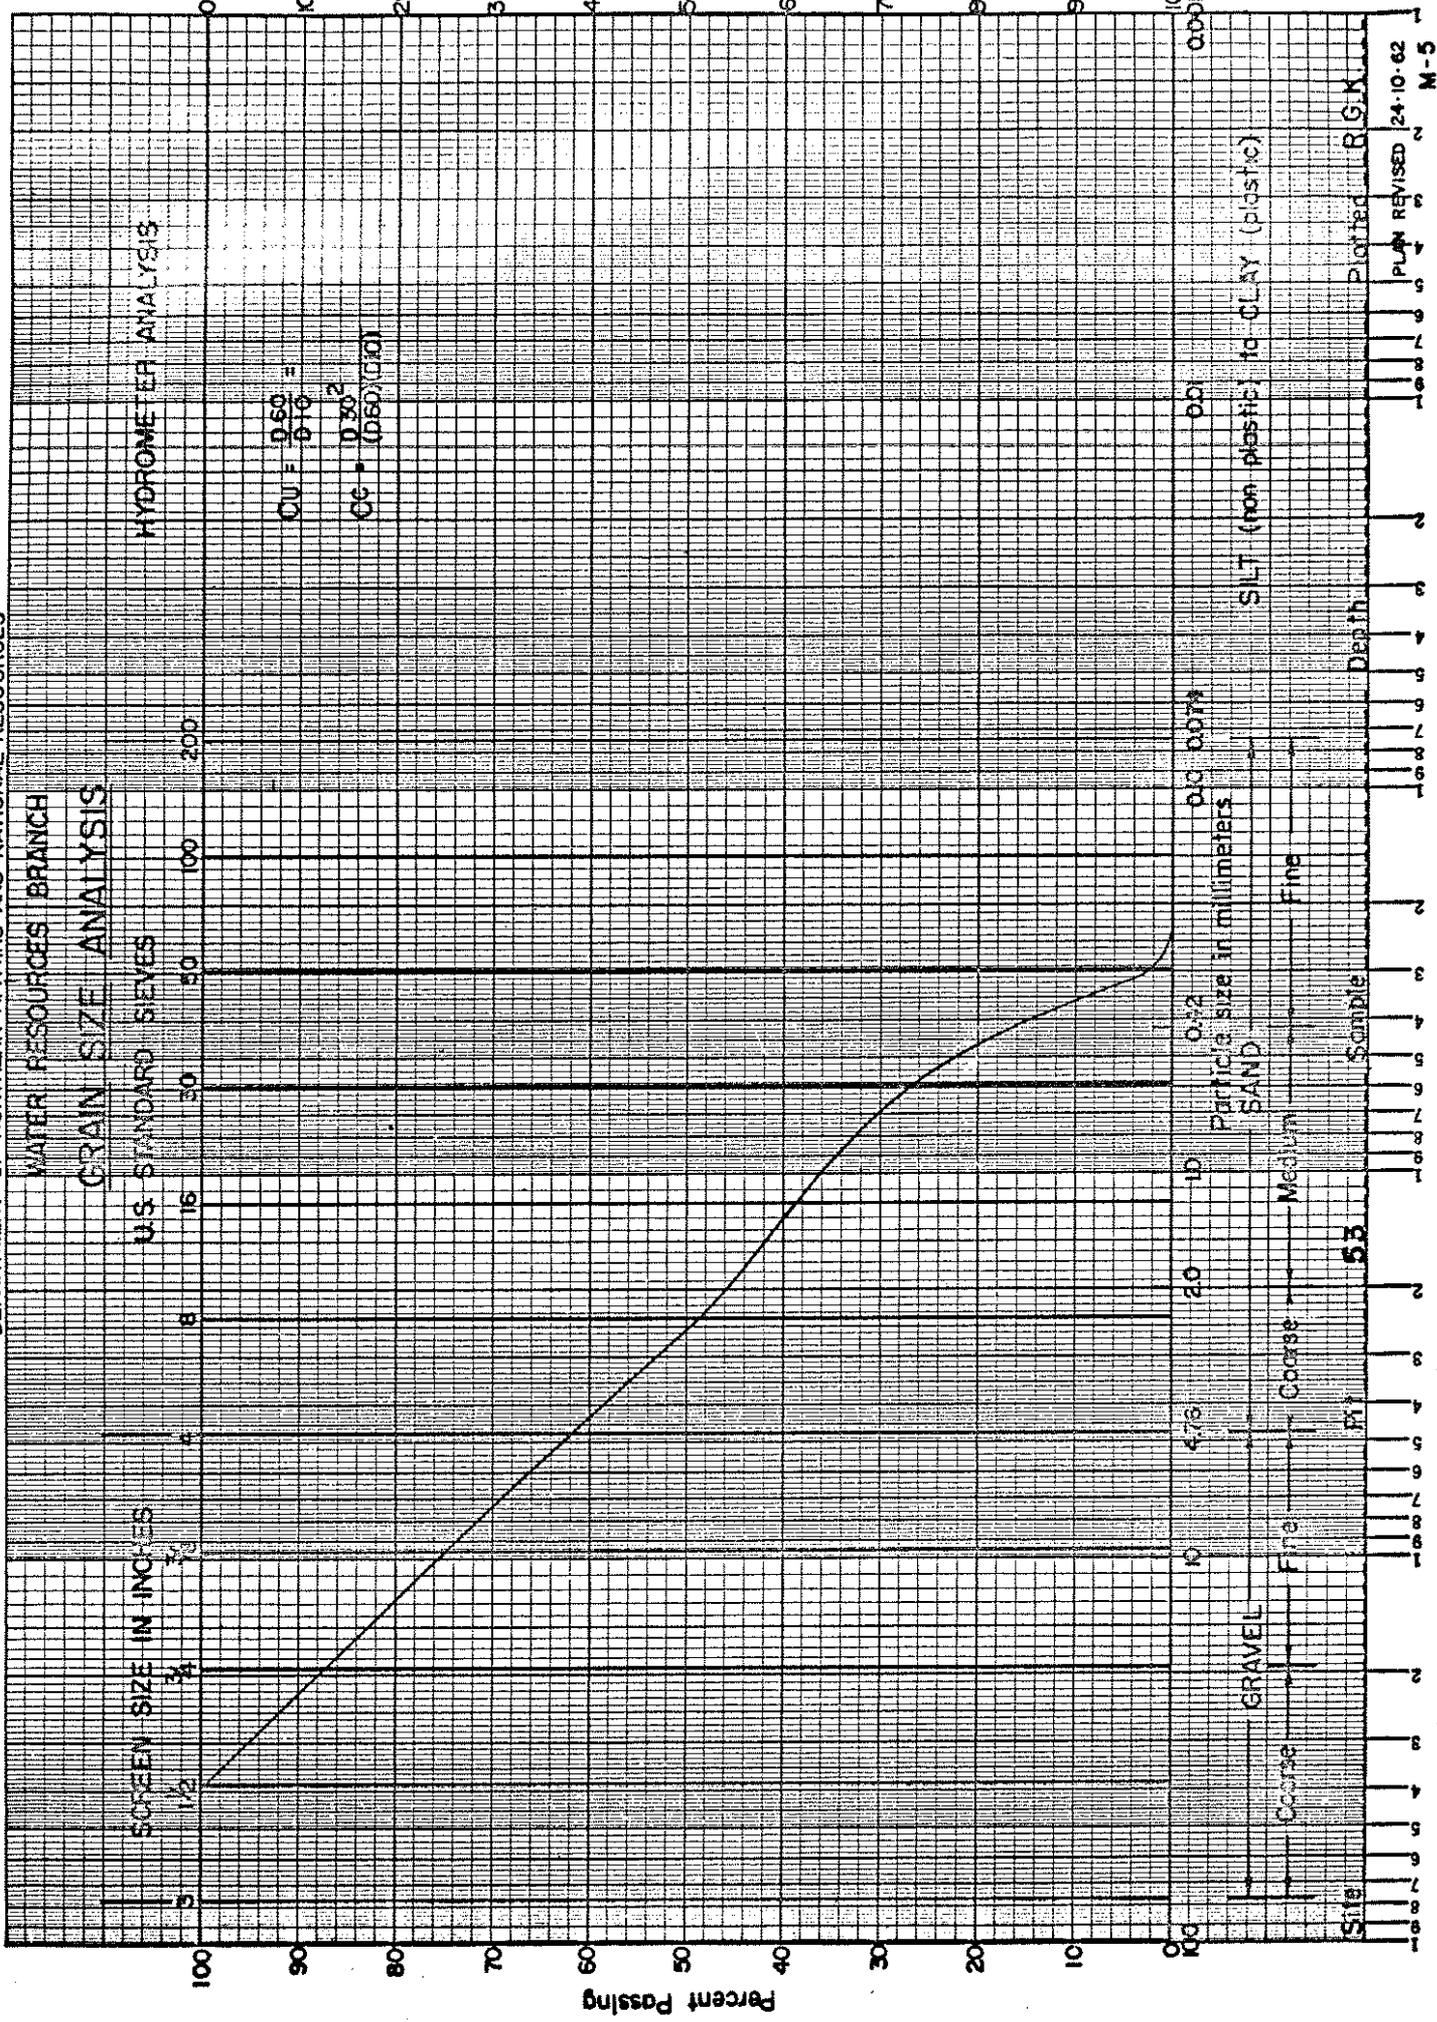
GRAIN SIZE ANALYSIS

$$CU = \frac{D_{60}}{D_{10}} = \frac{0.85}{0.075} = 11.33$$

$$Cc = \frac{D_{30}^2}{(D_{10} \times D_{60})} = \frac{0.425^2}{(0.075 \times 0.85)} = 1.02$$
