Highway 97 / Stickle Road Safety Review FINAL REPORT

McElhanney Consulting Services Ltd.
100-780 Beatty Street
Vancouver BC
V6B 2M1

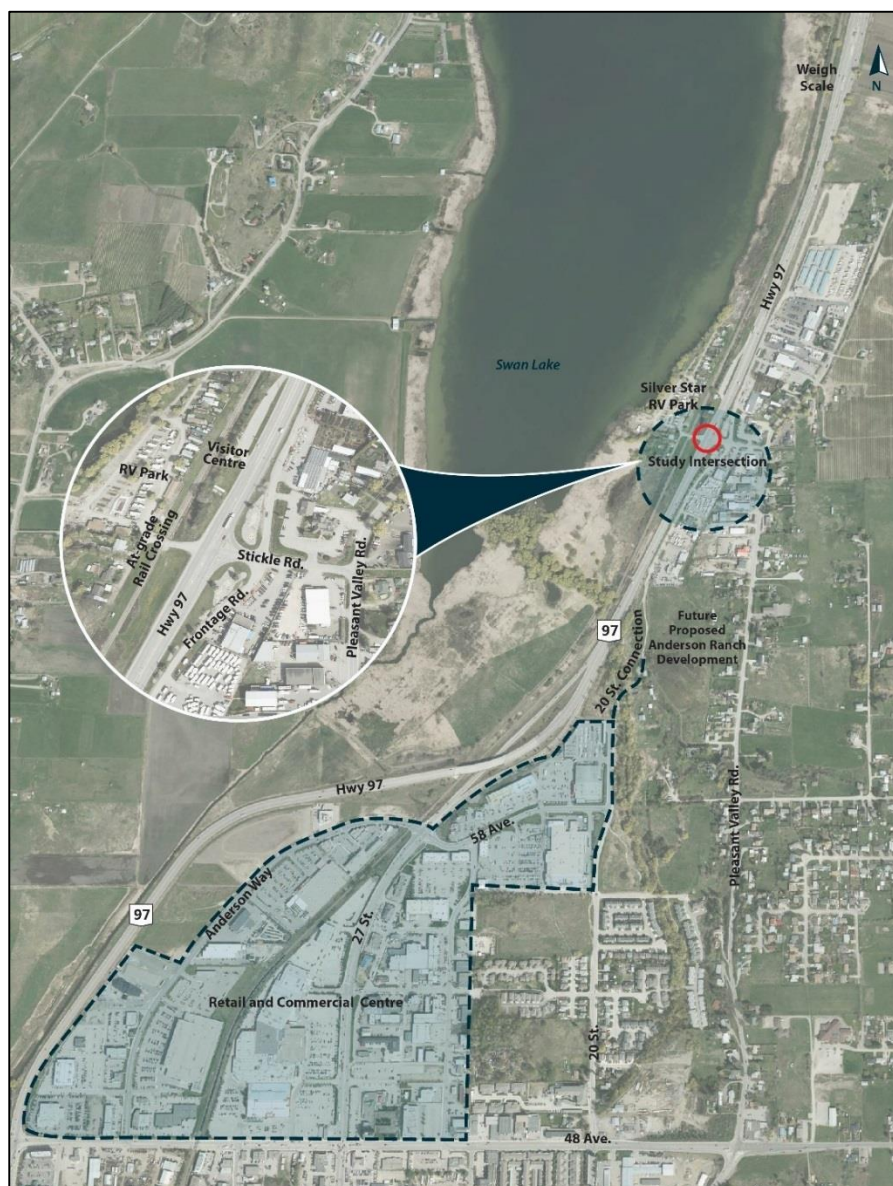
Figure 1. Highway 97 / Stickle Road Intersection Layout and Features

The existing Highway 97 / Stickle Road intersection, shown in *Figure 1*, has the following features:

- A full-movement unsignalized intersection with a two-way stop control on the east-west minor approaches
- The highway within the vicinity of Stickle Road is divided by a raised median, with a combination of open shoulder drainage and asphalt curb and gutter

- A median truck weigh scale for Highway 97 northbound and southbound traffic is located approximately 830 m north of Stickle Road (measured from the centerline of Stickle to the start of the northbound taper to the truck weigh scale).

- The 27 Street interchange is located approximately 560 m to the south (measured from the centerline of Stickle to the gore point of the 27 Street northbound on-ramp), with no median barrier beyond the left turn lane.

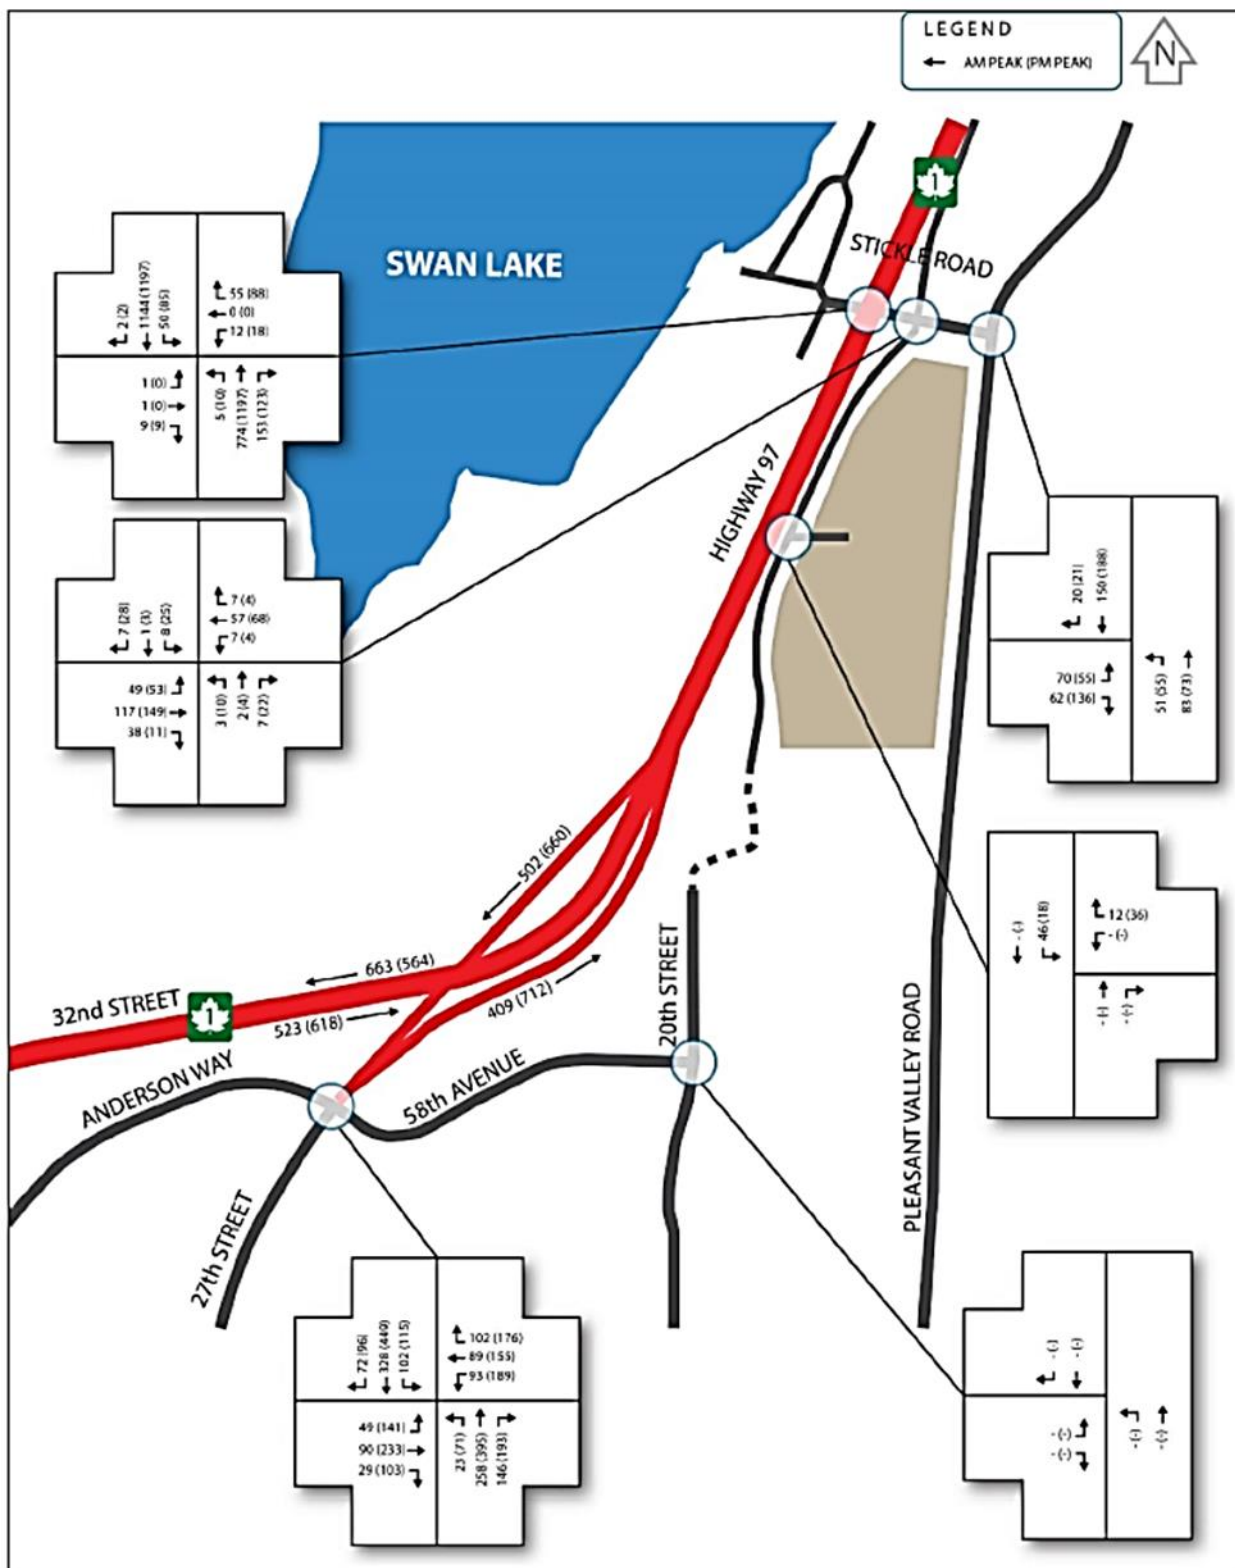
Figure 2. Highway 97 / Stickle Road Summer 2015 AM (PM) Traffic Volumes

Based on the traffic analysis conducted it was determined that under the summer 2015 existing condition the westbound through and left-turn movements currently fail (LOS F) during both the AM and PM peak hours. The eastbound movement also fails during the 2015 summer AM peak hour. The northbound left turn movement is LOS C for both 2015 summer AM and PM periods, while the southbound left turn is LOS B/C (2015 summer AM peak/PM peak respectively). Overall the intersection operates at LOS A during the AM peak and LOS F during the 2015 summer PM peak.

In the 2040 horizon year, it is expected that both eastbound and westbound movements will fail during summer AM and PM peak hours. The northbound and southbound left-turn movements also fail (LOS F) during the 2040 summer PM peak. Although turning movement volumes from Stickle Road are relatively low, even for the 2040 horizon, vehicle delay is significant due to the lack of available gaps in north-south Highway 97 traffic. Overall the intersection operates at LOS F during both 2040 summer AM and PM peak periods.

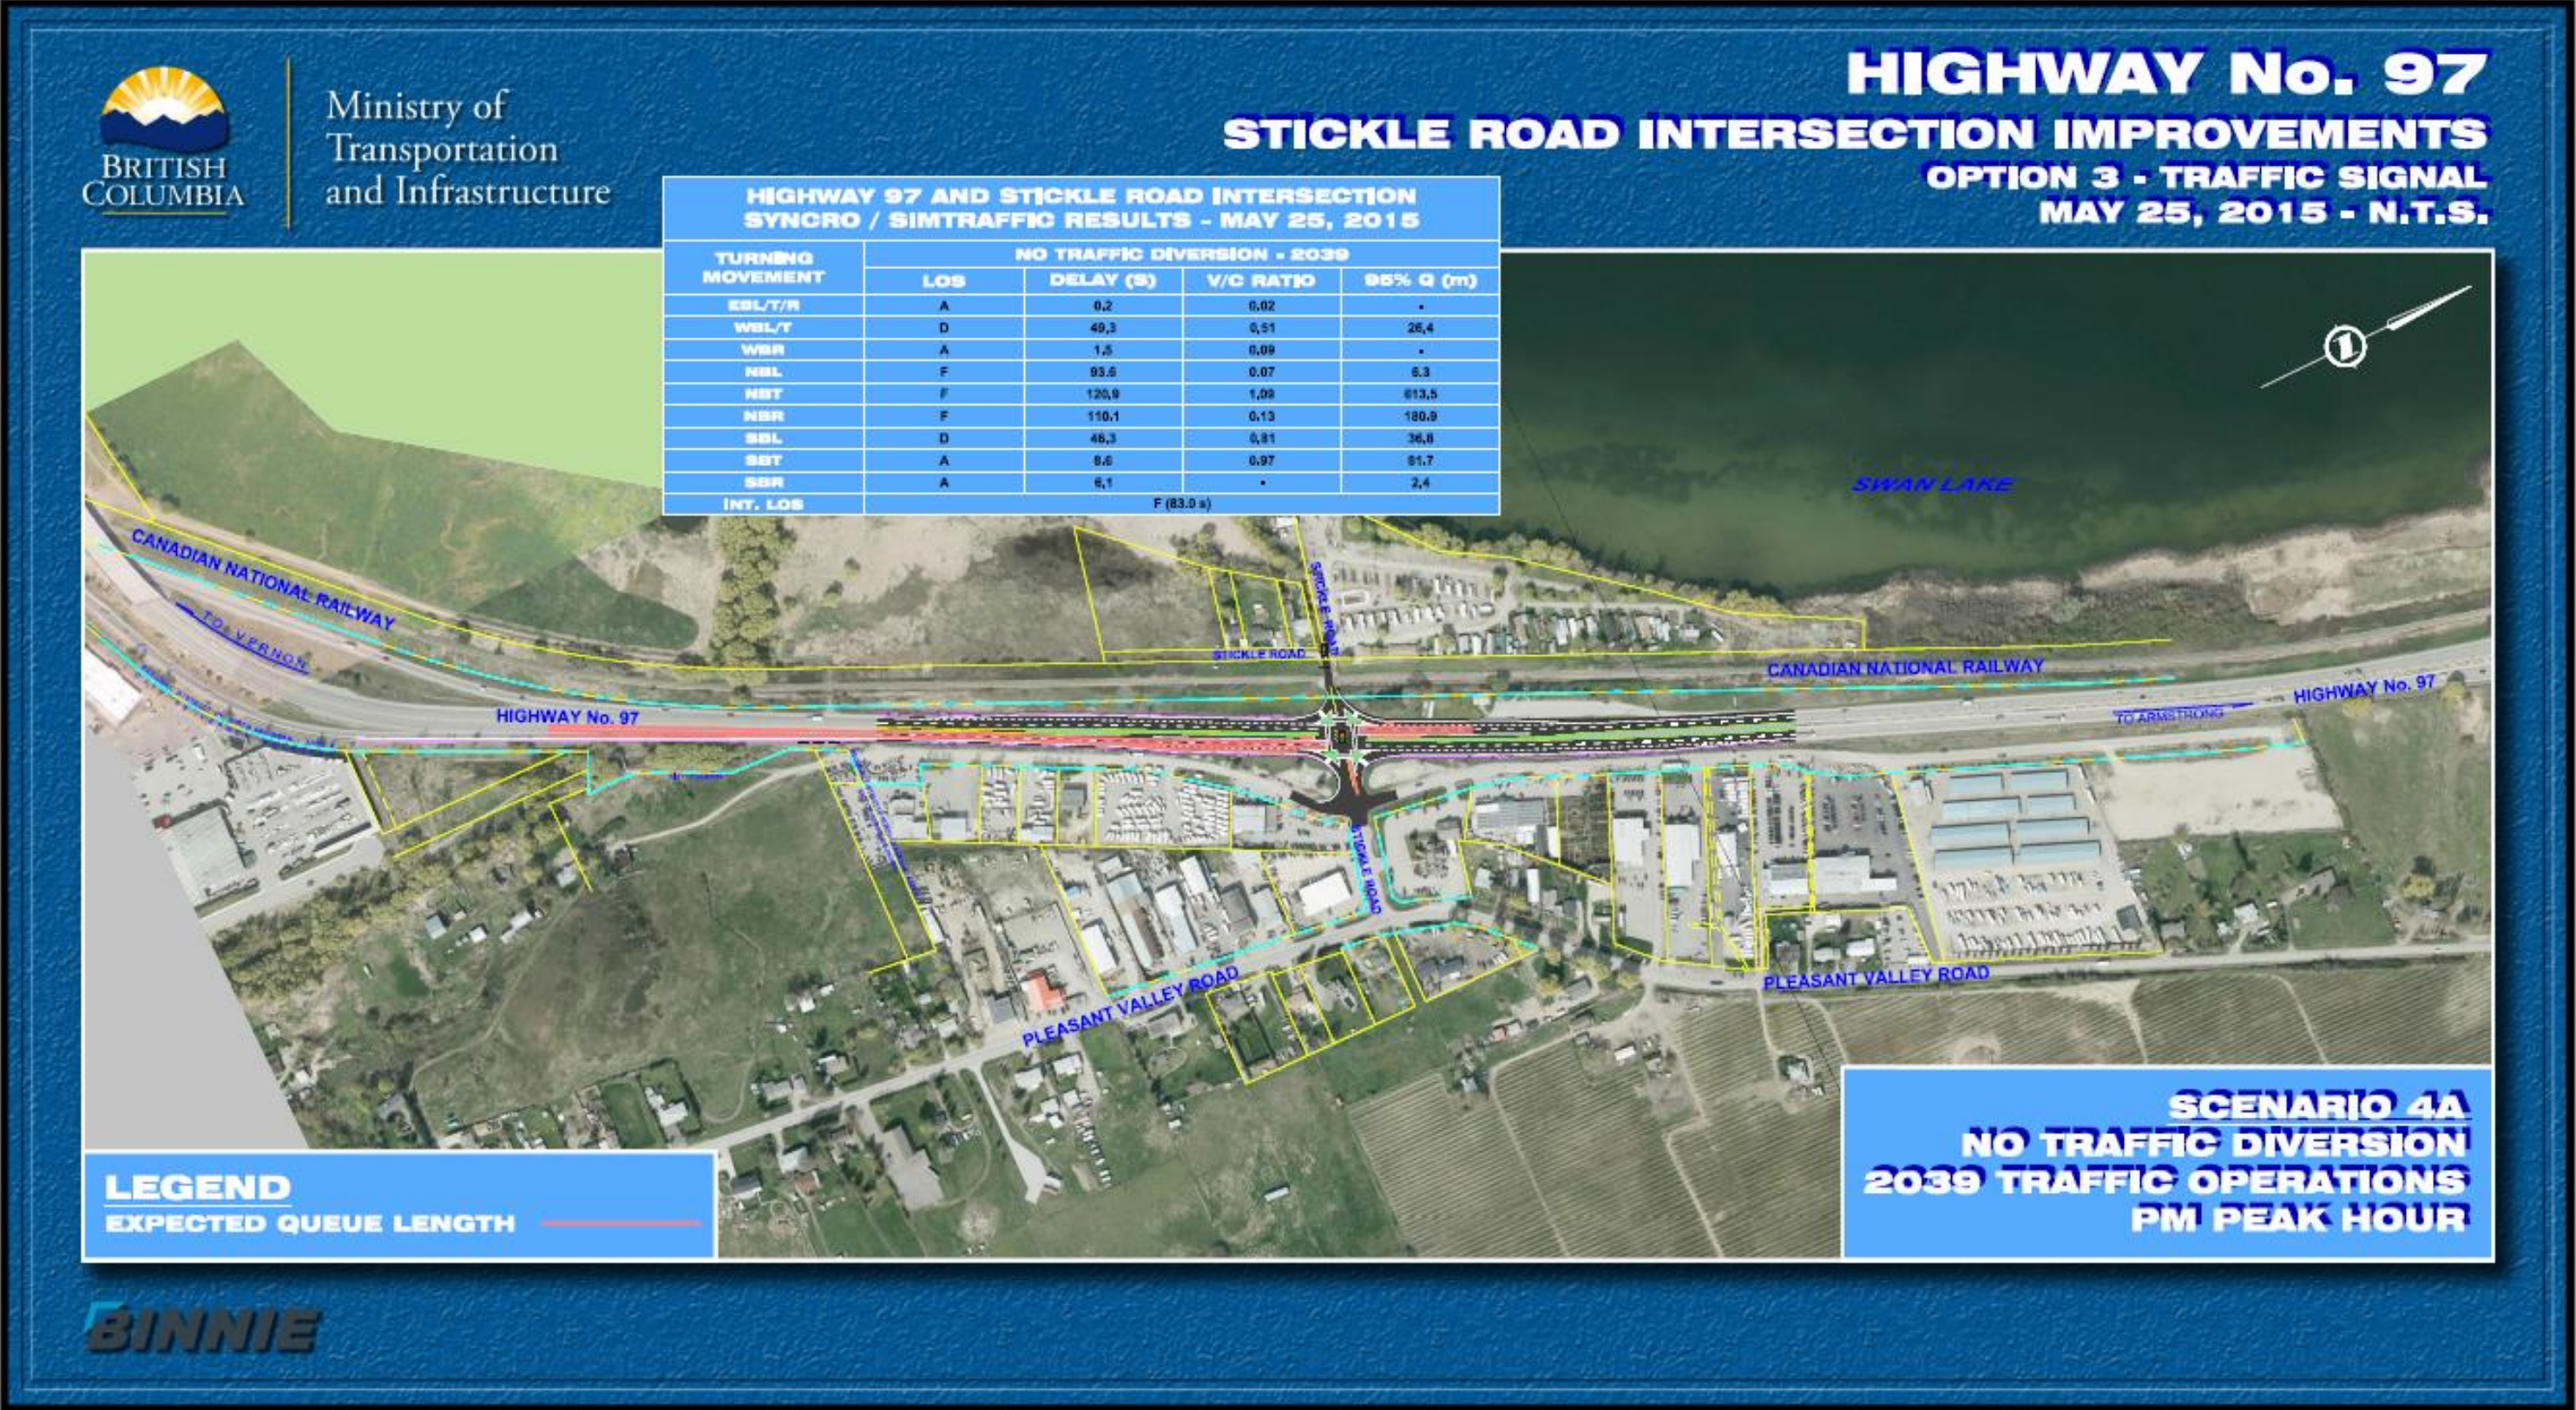
Figure 3. Highway 97 / Stickle Road Queuing for a Signalized Intersection (2039)

By 2039 however, analysis shows significant queuing on the highway even under a no diversion scenario, where northbound traffic backs up to the 27 Street on-ramp. This not only introduces significant delays and idling on the highway, but also increases the risk of rear-end collisions on the on-ramp approaching Highway 97 due to accelerating on-ramp vehicles encountering the back of a traffic queue immediately after the 27 Street on-ramp left-hand curve. These queues are reflected in [Figure 3](#) for the best case, no diversion scenario. The 50% diversion scenario analyses show significantly longer queues on both Highway 97 and 27 Street northbound as well as on Stickle Road westbound, as highlighted by the shaded cells in the table.

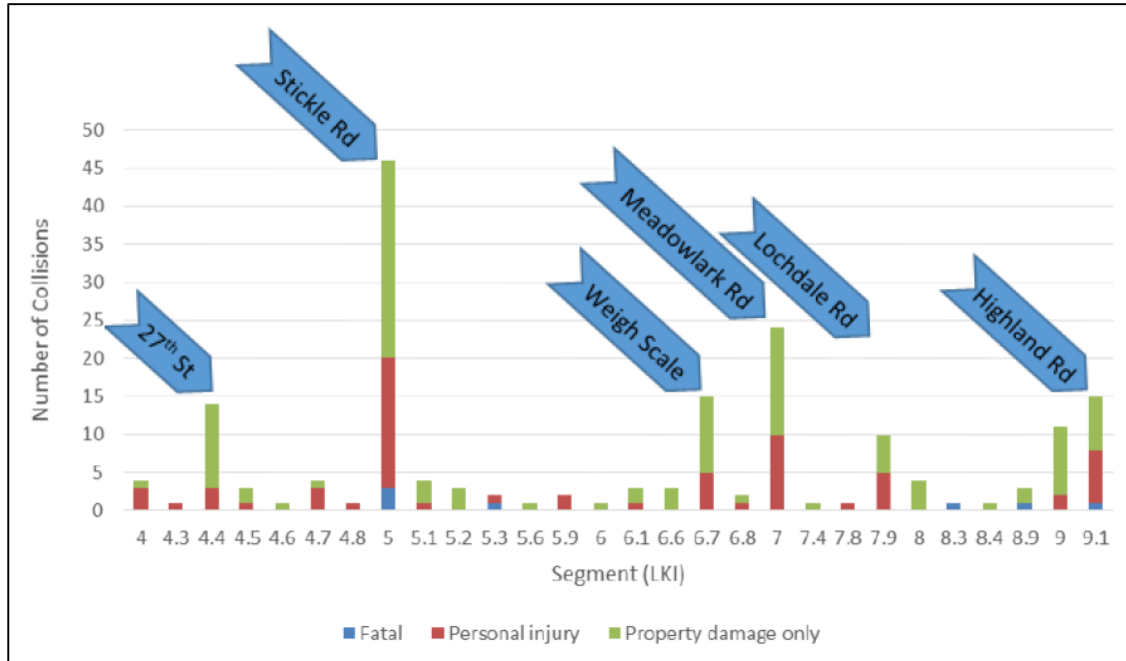
Figure 4. Spatial Distribution of Collisions (2003-2012)

The safety performance indicators show that both the collision rate and severity index are significantly higher than their respective provincial averages at this intersection when compared to similar facilities. In addition, the data shows a predominant spike in collisions at this intersection relative to other intersections in the near vicinity, as seen in *Figure 4*.

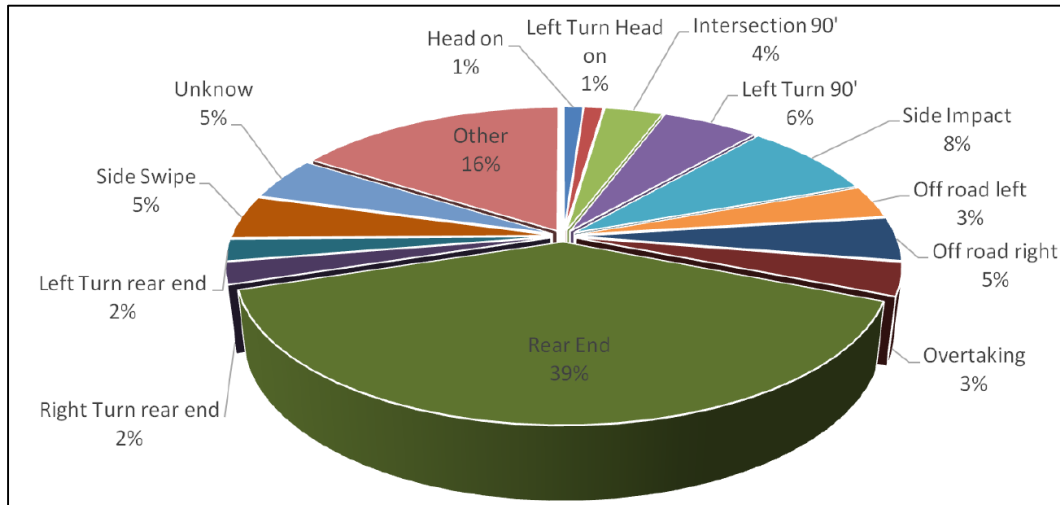
Figure 5. Highway 97 / Stickle Collision Types (2003-2012)

A summary of the primary collision types is shown in *Figure 5*, demonstrating that rear-end collisions, including left and right turn rear-enders account for approximately 43% of all collision types at this intersection. This is a significant finding particularly for a unsignalized intersection that is free-flow for the dominant highway movements (i.e. two-way stop control for minor approaches only).

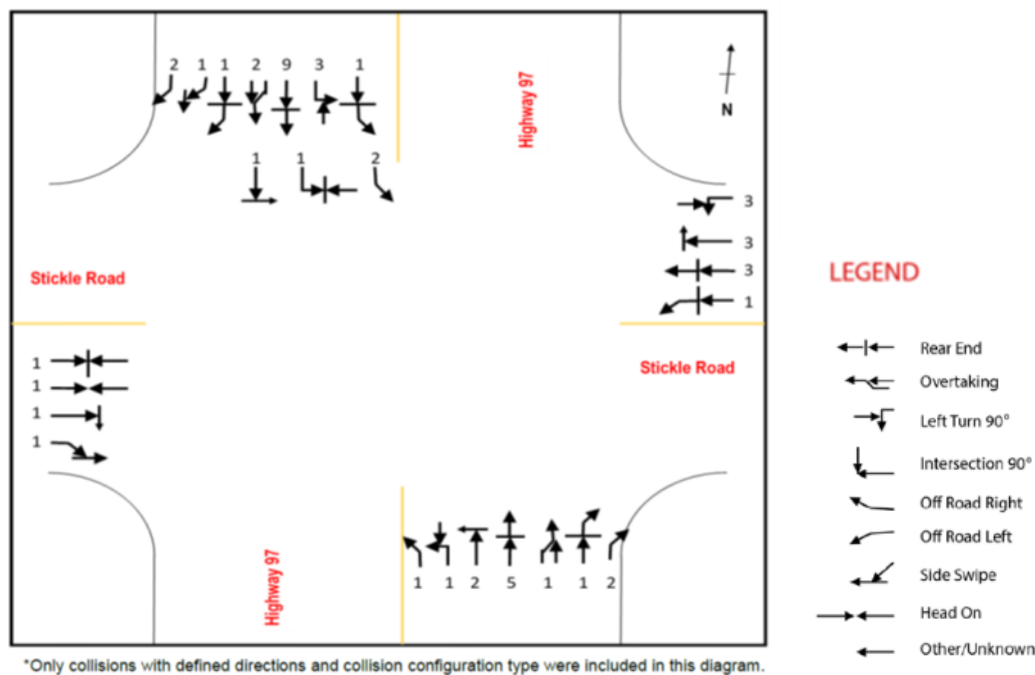
Figure 6. Collision Diagram at Stickle Road and Highway 97 Intersection

The types of collisions that are occurring at the intersection and the directions that vehicles are travelling are reflected in a collision diagram shown in Figure 6. The diagram highlights the occurrence of rear-end type collisions, which appear to be more frequent in the southbound direction. This is supported by the findings of the traffic capacity analysis where traffic exiting Stickle Road likely accepts minimal gaps in Highway 97 north-south traffic to complete the westbound left-out (from Stickle Road onto Highway 97 southbound) turning movement, surprising inattentive highway motorists. In addition, the lack of acceleration and deceleration lanes for entering and exiting traffic likely further contributes to rear-end type collisions, as well as the restricted sight lines at the east leg of Stickle Road.

Note: of the three fatalities recorded at Highway 97/Stickle Road between 2003 and 2012, two involved pedestrians. As a result, these are not shown on the collision diagram. The third fatal involved a motorcycle travelling north making a right turn and a truck with camper travelling east with driver inattentive and failing to yield right of way listed as contributing factors.

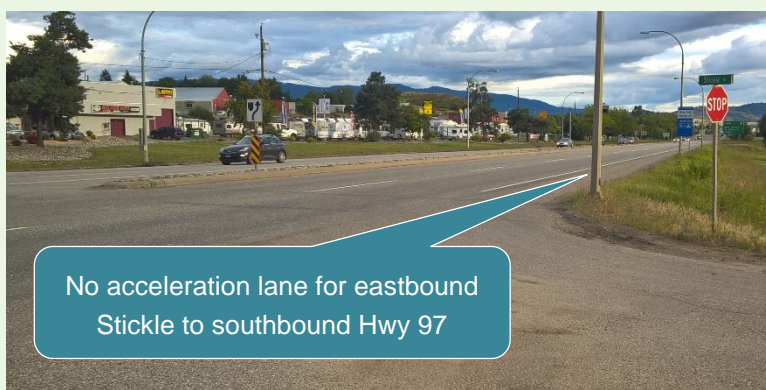
Observation		
Item	Safety Concern	Potential Mitigation Measure
1	Southbound Acceleration Lane An acceleration lane is not provided in the southbound direction on Highway 97 for the eastbound right turn from Stickle Road. Vehicles entering Highway 97 southbound directly into the southbound through movement from the stop position, introducing a risk of rear end type collisions as entering vehicles may not be able to reach highway speeds within available gaps.	Auxiliary Lanes A southbound acceleration lane should be provided in accordance with BC Supplement to TAC to reduce the risk of rear end type collisions in the southbound direction.

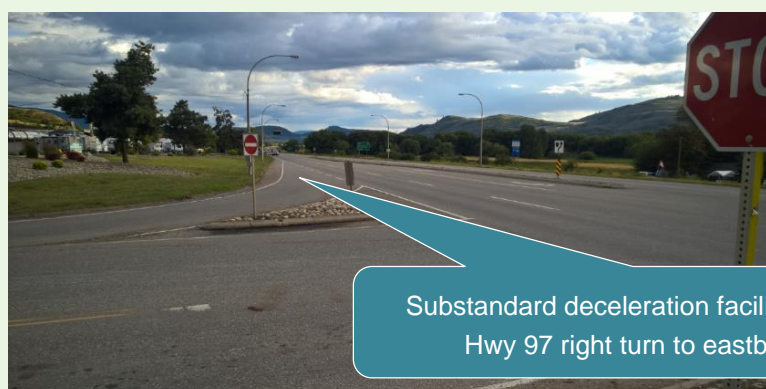
Observation		
Item	Safety Concern	Potential Mitigation Measure
2	Northbound Deceleration Lane The northbound right turn facility from Highway 97 at Stickle Road is a direct taper (i.e. no parallel deceleration lane segment). As a result, there is a risk of northbound rear-end type collisions on the approach to the Stickle Road intersection as well as a risk of northbound right-turning vehicles taking the turn at inappropriately high speeds and crossing the centreline on Stickle Road, resulting in a collision on Stickle Road.	Auxiliary Lanes Provide deceleration lane geometry in accordance with the requirements of the BC Supplement to TAC Figure 710.H Rural Arterial Intersection layout (i.e. 100 m parallel deceleration lane). A northbound deceleration lane will reduce the risk of northbound rear end type collisions, and collisions related to excessive turning speeds to Stickle Road.

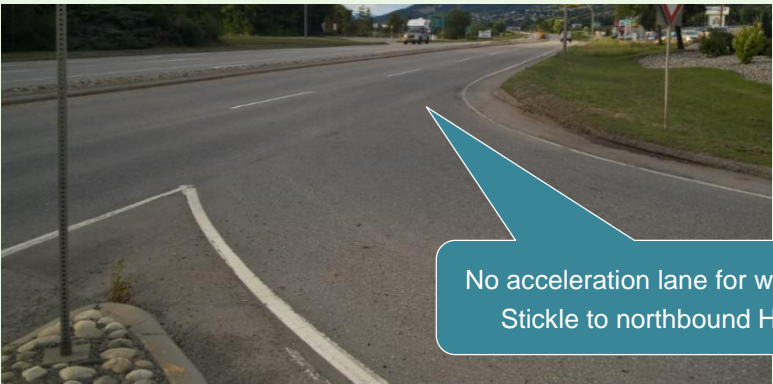
Observation		
Item	Safety Concern	Potential Mitigation Measure
3	<p>Northbound Acceleration Lane</p> <p>There is currently no northbound acceleration lane for westbound right turn movements from Stickle Road. Traffic entering a 90 km/h facility is subject to a yield condition and, therefore enters the highway at a low speed, raising the risk of rear end collisions by inattentive motorists. Similar to the southbound direction, this introduces a risk of rear end type collisions as entering vehicles may not be able to reach highway speeds within available gaps.</p>	<p>Auxiliary Lanes</p> <p>Provide acceleration lane geometry in accordance with the requirements of the BC Supplement to TAC Figure 710.L (i.e. 210 m parallel acceleration lane). A northbound acceleration lane will reduce the risk of rear end type collisions in the northbound direction.</p>

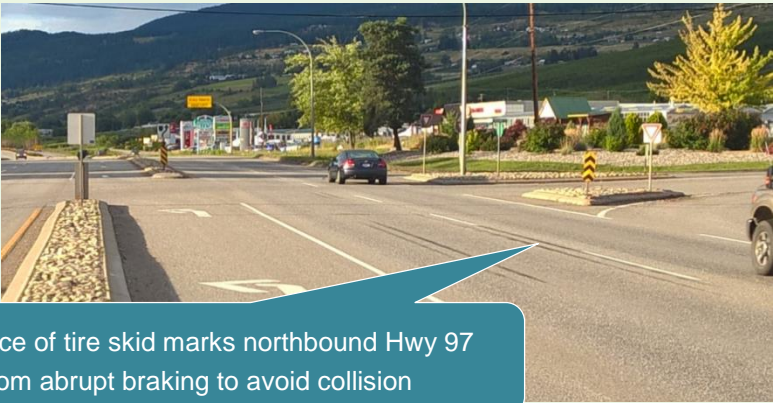
Observation		
Item	Safety Concern	Potential Mitigation Measure
4	<p>Left-out Movement from Stickle Road</p> <p>Evidence of tire skid marks in the Highway 97 northbound fast lane supports documented reports of rear-end and intersection 90 degree type collisions at the Highway 97 / Stickle Road intersection. During the night-time component of the safety review, brake lights on Highway 97 north- and southbound vehicles were observed when vehicles were entering from Stickle Road. This is further evidence of the regular conflict between highway movements and left-out movements from Stickle Road where entering vehicles have insufficient gaps to reach highway speeds increasing the risk of rear-end and left-turn 90° type collisions.</p>	<p>Prohibited Left Turns</p> <p>Although it is not conclusive which vehicle movement conflict resulted in the skid marks, previous collision analysis (McElhanney September 2013 and Urban Systems January 2015) does conclude that rear-end collisions account for 43% of total collisions. Restricting left-out movements from Stickle Road (along and providing acceleration/deceleration lanes) is expected to improve overall intersection safety relative to both the existing condition and signalization option.</p>

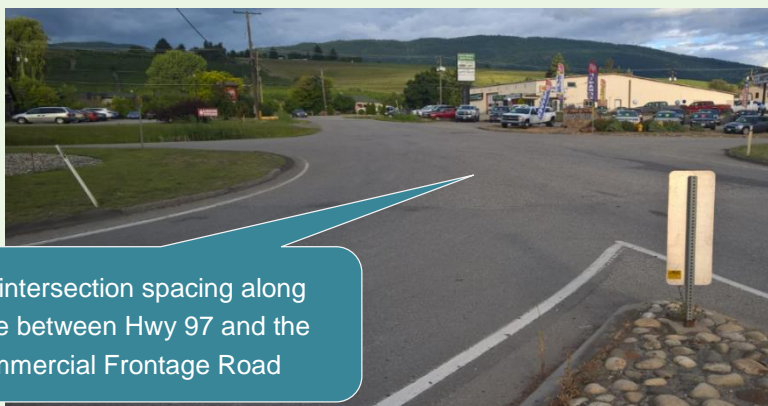
Observation		
Item	Safety Concern	Potential Mitigation Measure
5	<p>Intersection Spacing</p> <p>The spacing between the Frontage Road and the Highway 97 intersection on Stickle Road is approximately 40 m. This results in limited sight distance and perception/reaction time between vehicles exiting at the Frontage Road and northbound right turning vehicles from Highway 97 entering Stickle Road eastbound. Reduced perception/reaction time increases collision risk. Due to the current deficiency in the northbound auxiliary lane (Item 2), this problem is compounded as vehicles leaving Highway 97 to travel eastbound on Stickle are more likely to do so at relatively high speeds.</p>	<p>Sight Distance</p> <p>Provide northbound right turn deceleration laning in accordance with BC Supplement to TAC, and maximize spacing between the Highway 97 and Frontage Road intersections to reduced turning speed of exiting vehicles and provide greater separation between conflicting vehicle movements. W-6 warning signage (intersection ahead) for northbound right turning traffic could also be considered.</p>

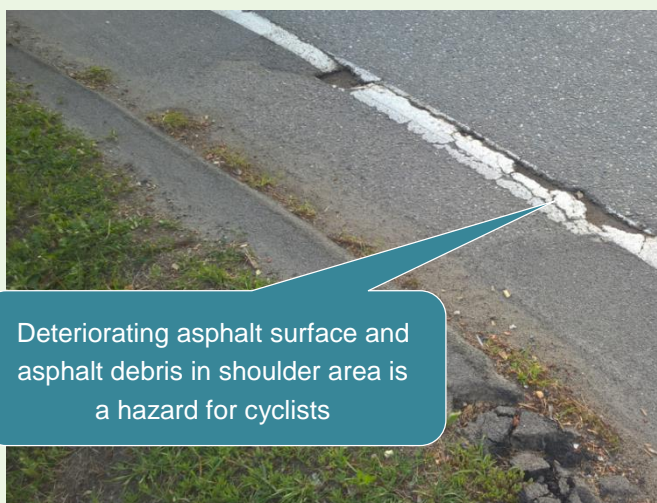
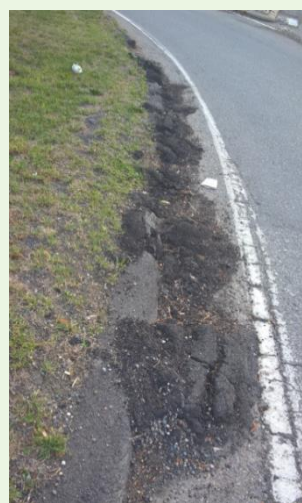
Observation		
Item	Safety Concern	Potential Mitigation Measure
6	<p>Deteriorating Asphalt Surface and Curb</p> <p>Deteriorating asphalt and asphalt curb was observed along the shoulder of the northbound right turn lane. This is considered a hazard for cyclists as it presents unexpected obstacles/uneven surface within the cycling travel portion of the roadway.</p>	<p>Pedestrians / Cyclists</p> <p>Deteriorating asphalt surface should be repaired and asphalt debris removed from shoulders to create a hazard free and even riding surface for cyclists.</p>

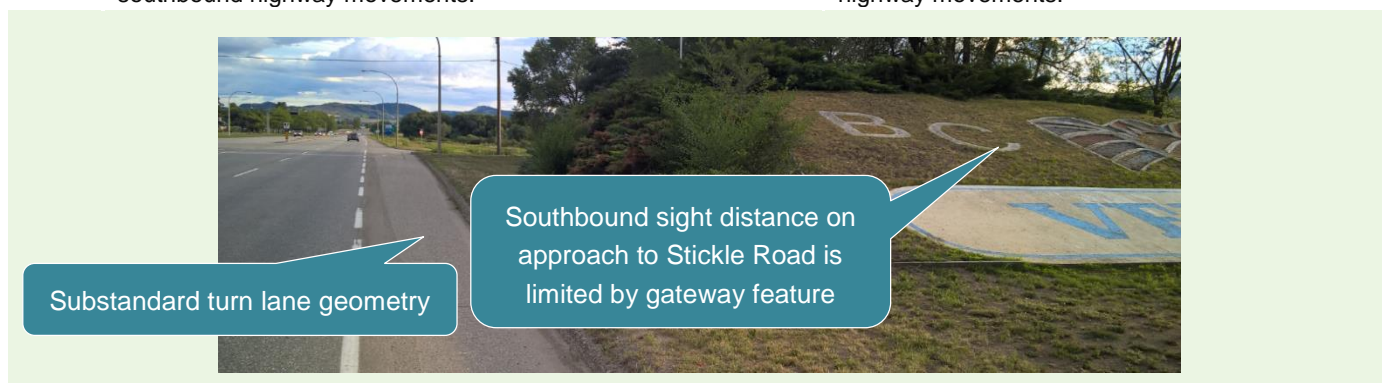
Observation		
Item	Safety Concern	Potential Mitigation Measure
7	<p>Southbound Deceleration Lane and Landscaping</p> <p>The approach to the southbound right turn to Stickle Road westbound has a substandard design: deficient deceleration lane, taper, and lane width. In addition, the west leg of Stickle Road is hidden from southbound Highway 97 vehicles by the landscaped gateway feature entering Vernon. This results in several safety concerns, namely reduced roadside safety through the absence of a standard shoulder (greater risk of southbound right-turning vehicles hitting the asphalt curb), and a reduction in the available turning sight distance for westbound vehicles exiting Stickle Road which may result in conflict with southbound highway movements.</p>	<p>Auxiliary Lanes Sight Distance</p> <p>Provide deceleration lane geometry in accordance with the requirements of the BC Supplement to TAC Figure 710.H Rural Arterial Intersection layout (i.e. 100 m parallel deceleration lane) to improve roadside safety. The landscaped gateway feature should be modified to ensure that adequate intersection and departure sight distance is provided. Providing adequate sight distance from the west leg of Stickle will reduce the risk of collisions between exiting movements and highway movements.</p>

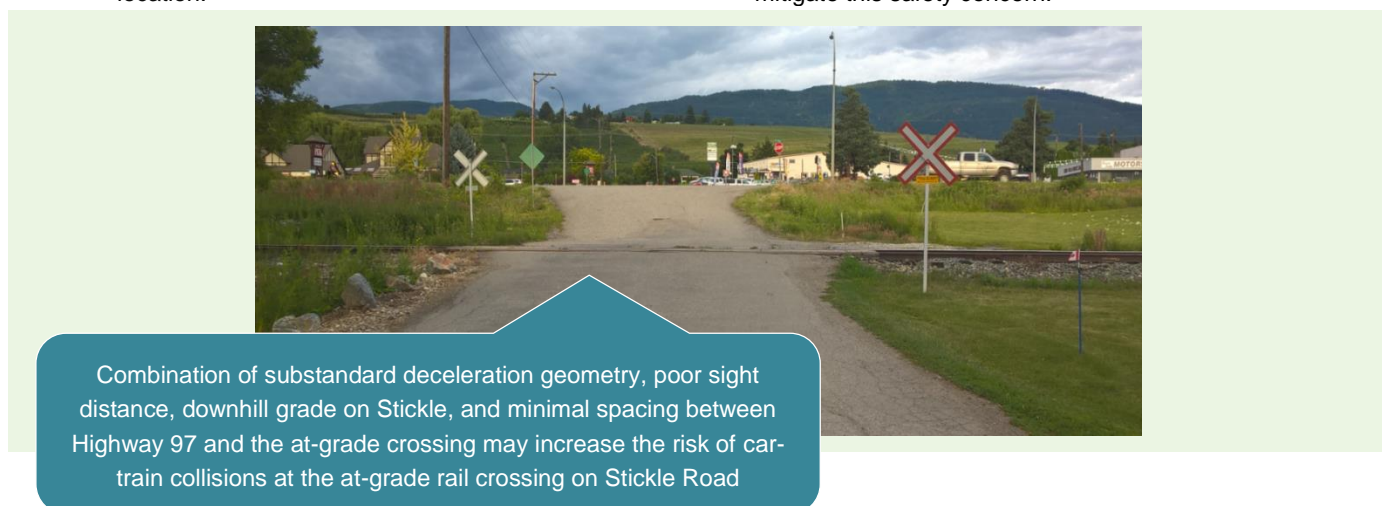
Observation		
Item	Safety Concern	Potential Mitigation Measure
8	<p>At-grade Rail Crossing on Stickle</p> <p>Substandard deceleration geometry for southbound right turning traffic, poor sight distance, minimal spacing between Highway 97 and the at-grade rail crossing, and the downhill grade approaching the at-grade rail crossing (>5%) could result in an increased risk of car-train collisions. Despite this potential risk, we are not aware of any documented vehicle-train incidents occurring at this location.</p>	<p>Rail Crossing</p> <p>At-grade rail crossing lights and bells could be considered in addition to the suggested improvements to the Highway 97 southbound deceleration geometry and sight triangles on the approach to Stickle Road (<i>Item 7</i>). Additional signage on Highway 97 warning motorists of the at-grade crossing should also be considered to improve safety at the at-grade crossing. Signalization is not expected to mitigate this safety concern.</p>

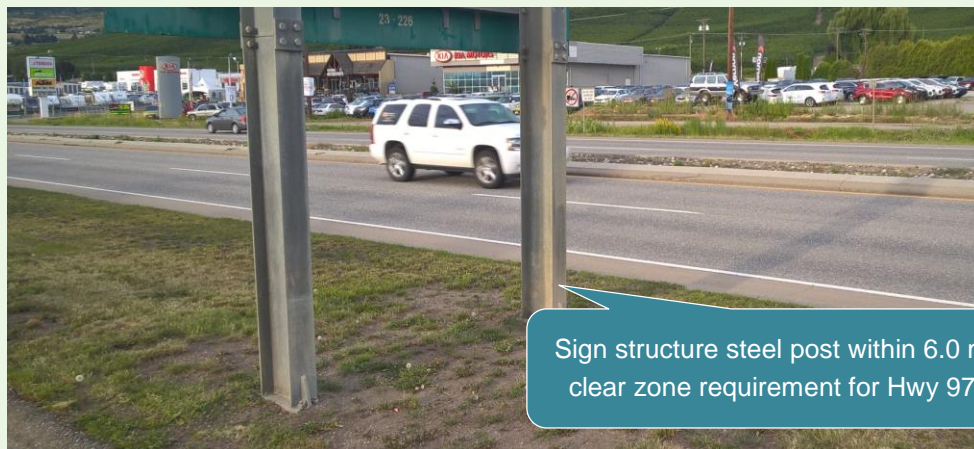
Observation		
Item	Safety Concern	Potential Mitigation Measure
9	<p>Sign Structure within Clear Zone</p> <p>Clear zone violation was observed with a highway sign's steel structure within the Highway 97 southbound clear zone 150m north of Stickle Road. Hazards within highway clear zone compromise roadside safety and could result in increased collision severity should an errant vehicle leave the roadway at this location.</p>	<p>Clear Zone</p> <p>Sign structure should be relocated outside of clear zone. Clear zone requirement for Highway 97 within the vicinity of Stickle Road is 6.0 m based on a 90 km/h posted speed with an AADT over 6000 veh/day (BC Supplement to TAC Table 620.C).</p>

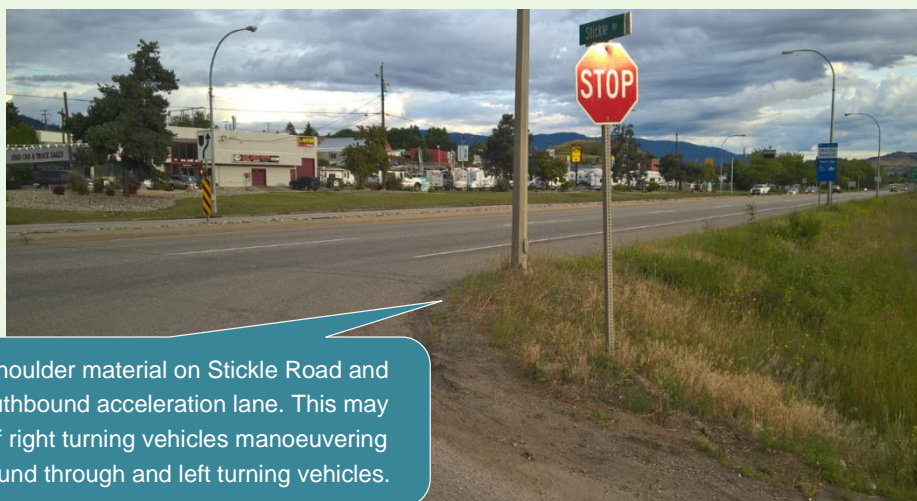
Observation		
Item	Safety Concern	Potential Mitigation Measure
10	<p>Deteriorated Shoulder Gravels</p> <p>Deteriorated gravel shoulders could affect vehicle acceleration performance for the westbound Stickle Road to southbound Highway 97 movement and further contribute to rear-end type collisions by inattentive highway motorists. There is also no Highway 97 southbound acceleration lane at Stickle Road (<i>Item 1</i>). Insufficient asphalt width may lead to compromised vehicle performance (i.e. poor acceleration on gravel surface) which increases risk of conflict with highway movements.</p>	<p>Shoulders</p> <p>In addition to a southbound acceleration lane, consider channelized right turn lane with minimum 1.5 m paved shoulders to accommodate over-tracking of larger RV type vehicles exiting the RV Park.</p>

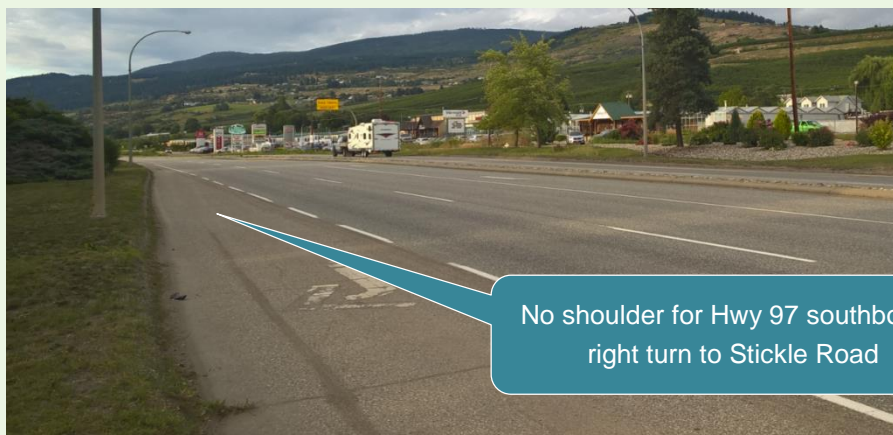
Observation		
Item	Safety Concern	Potential Mitigation Measure
11	<p>Southbound Shoulder on Approach to Stickle Road</p> <p>There is no formal shoulder adjacent to the Highway 97 southbound right turn lane on the approach to Stickle Road. This increases the risk of vehicles leaving the asphalt surface.</p>	<p>Shoulders</p> <p>Provide 1.5 m paved shoulders in accordance with BC Supplement to TAC (refer also to <i>Items 1</i> and <i>10</i>). Standard paved shoulders are a critical component of highway safety.</p>

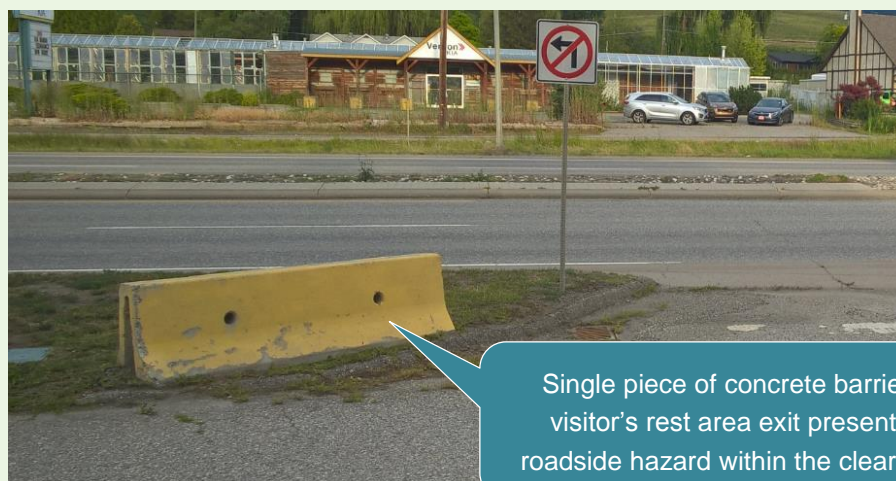
Observation		
Item	Safety Concern	Potential Mitigation Measure
12	<p>CRB within Clear Zone at Visitor's Exit</p> <p>A single piece of concrete roadside barrier (CRB) is positioned within the clear zone of the Highway 97 southbound travel lanes. This presents a hazard within the highway clear zone. For roadside barriers to be an effective safety measure, they must be part of a system with a minimum length, and contain appropriate approach flares. Note: the location of the visitor's exit is considered acceptable as it is positioned north of the start of the taper for the southbound right turn.</p>	<p>Clear Zone</p> <p>This concrete barrier should be removed so that it does not present a hazard within the clear zone. Alternatively, a roadside barrier should be designed in accordance with the BC Supplement with appropriate barrier flares.</p>

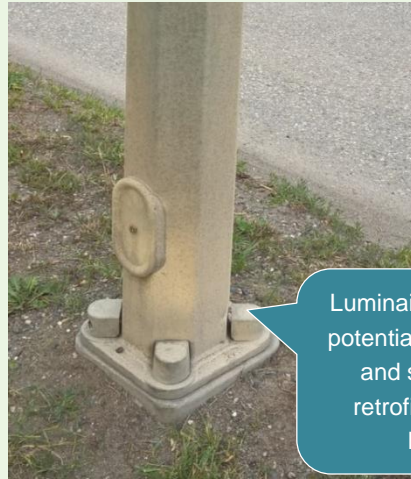
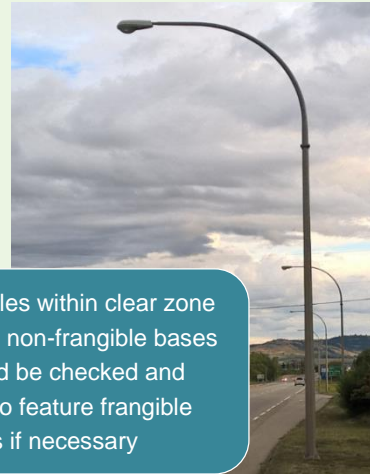
Observation		
Item	Safety Concern	Potential Mitigation Measure
13	Luminaire Poles within Clear Zone Luminaire poles within clear zone are potentially on non-frangible bases. This will increase the severity of a collision if struck by a vehicle.	Clear Zone Luminaire poles within clear zone should be checked to ensure that they are mounted on breakaway or frangible bases. Any poles mounted on non-frangible bases should be retrofitted with frangible bases.

Luminaire poles within clear zone potentially on non-frangible bases and should be checked and retrofitted to feature frangible bases if necessary

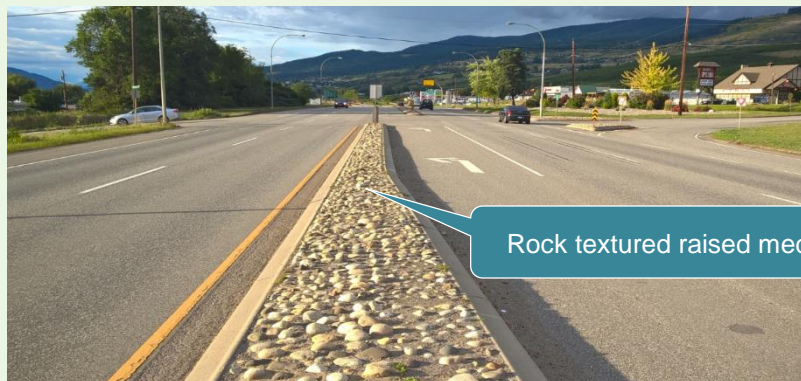
Observation		
Item	Safety Concern	Potential Mitigation Measure
14	Textured Raised Median The existing raised median does not prevent pedestrian crossings, however the rock textured surface presents a tripping hazard for pedestrians that use the raised median as a crossing refuge. Note: Section 180 of the BC Motor Vehicle Act states ' <i>when a pedestrian is crossing a highway at a point not in a crosswalk, the pedestrian must yield the right of way to a vehicle</i> ', and so pedestrians are permitted to cross Highway 97 at Stickle Road under this condition.	Pedestrians / Cyclists Consideration should also be given to better accommodating pedestrian/cyclists crossing movements within the Restricted Left option. This may include an informal pedestrian median refuge to improve pedestrian crossing safety. An informal refuge is suggested as pedestrian movements should not be encouraged at this location (due to high vehicle travel speeds). A formal pedestrian crossing is not proposed, however signage warning motorists of the presence of pedestrians is suggested. Note to designers: provide smooth median surface to mitigate median tripping hazard observed in existing condition.

Rock textured raised median

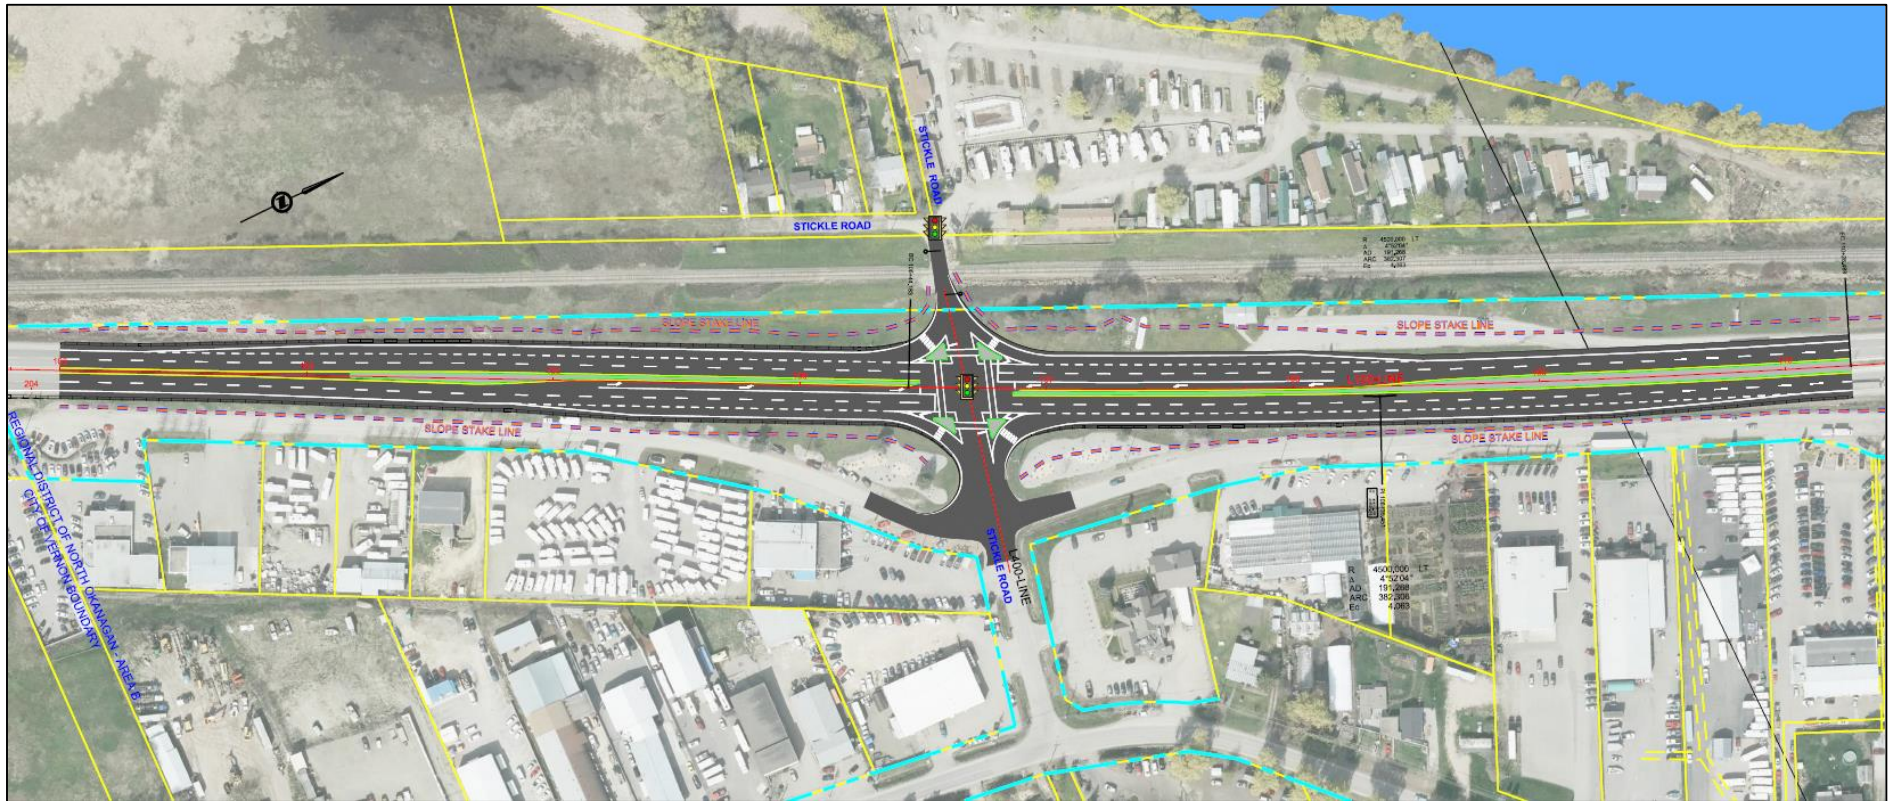
Figure 7. Option 1: Signalized Intersection Improvement

1. A signalized intersection, including improved auxiliary acceleration and deceleration lanes for right turn movements, and deceleration and increased storage for left turn movements off of Highway 97.

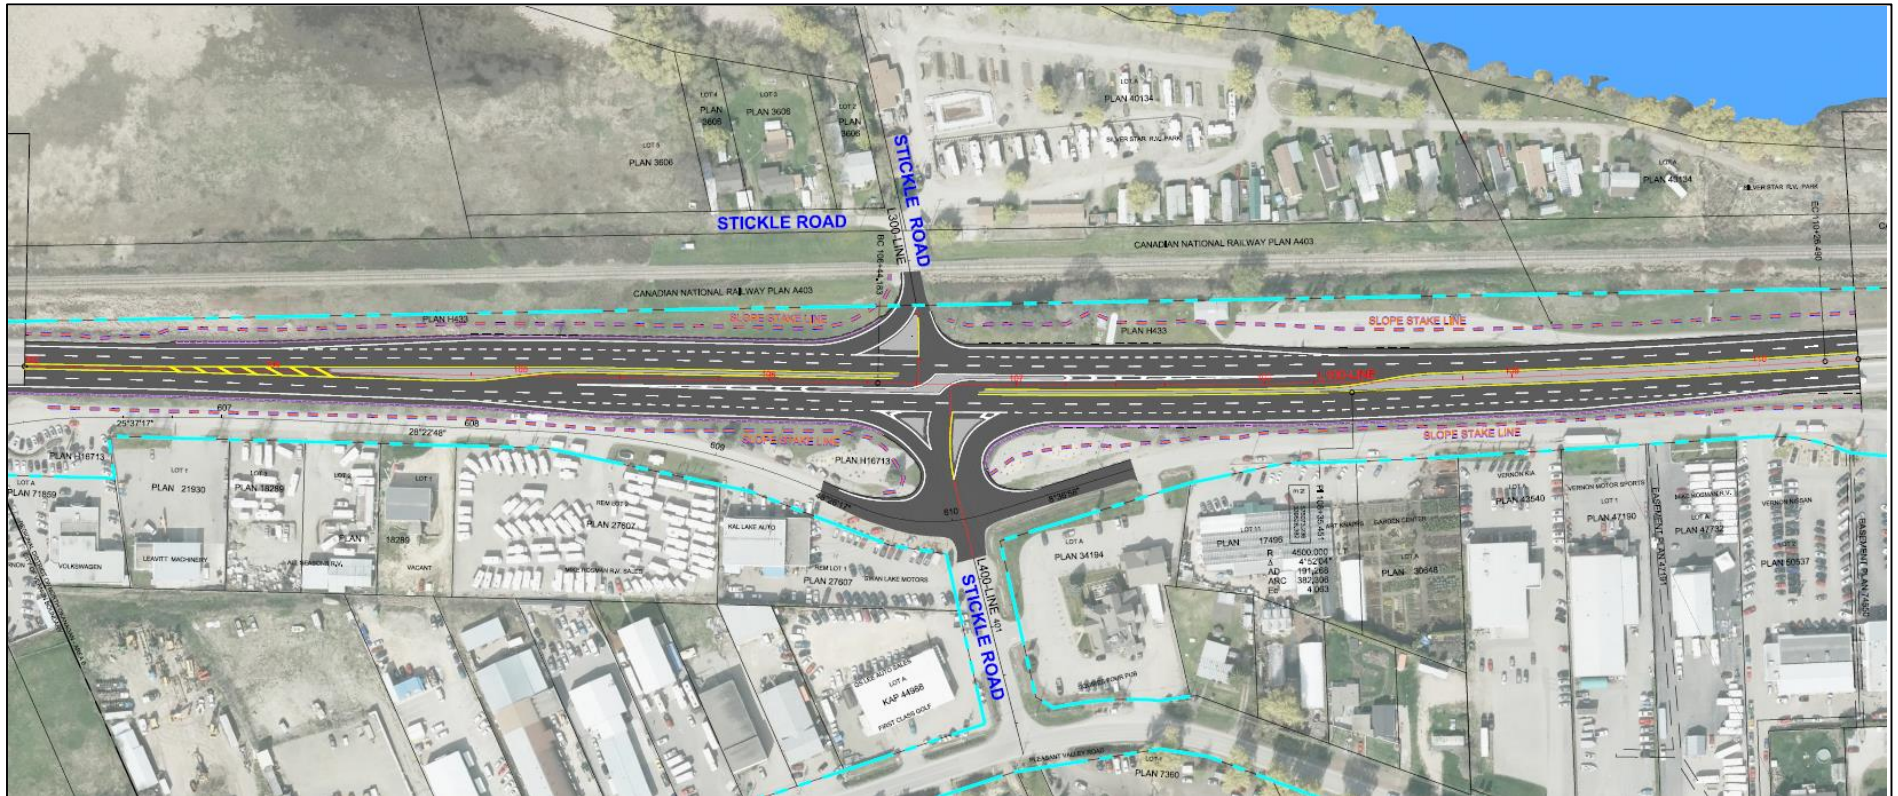
Figure 8. Option 2: Restricted Side Road Left Turn and Through Movement Intersection Improvement

2. An unsignalized intersection with full movements on Highway 97 but prohibits left turns from Stickle Road onto Highway 97, as well as prohibits eastbound/westbound Stickle Road through movements across Highway 97. This option also provides improved auxiliary acceleration and deceleration lanes on Highway 97 for right turn movements, and deceleration lanes and increased storage for left turn movements off of Highway 97. Together with this configuration, a southwards extension of the eastside Frontage Road to 20th Street has been proposed. This 20th Street connection will provide an alternate route for the existing westbound left-out movement from Stickle Road onto Highway 97 southbound. The role and function of this new connection is included as part of this review.
