Highway 97 / Stickle Road Safety Review FINAL REPORT

McElhanney Consulting Services Ltd.
100-780 Beatty Street
Vancouver BC
V6B 2M1

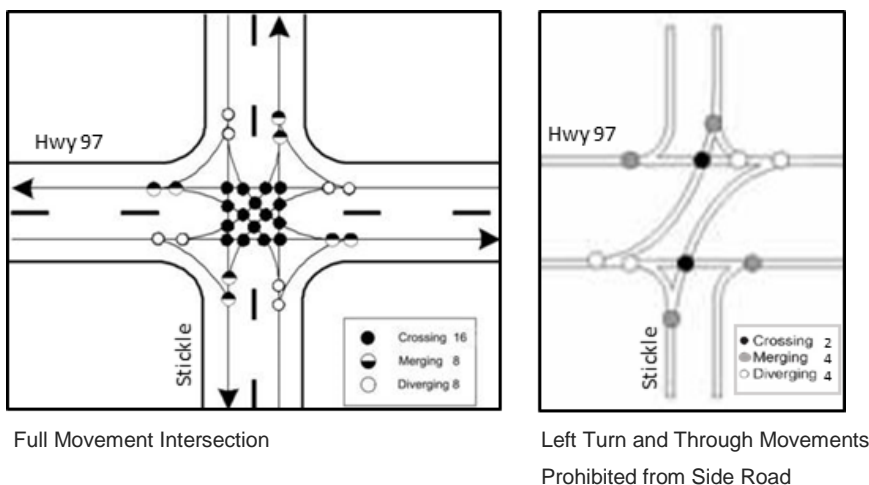
Figure 9. Conflict Points at Intersections

A key indicator of the safety risk at an intersection is the number of conflict points within that intersection when taking into account all allowed turning movements. The greater the number of conflict points, the greater the risk of collisions assuming other factors are kept constant. The conflict points for both the full movement signalized intersection option and the restricted (prohibited) side road left out and through movement intersection option are shown in *Figure 9*, with the number of conflict points summarised in *Table 5*.

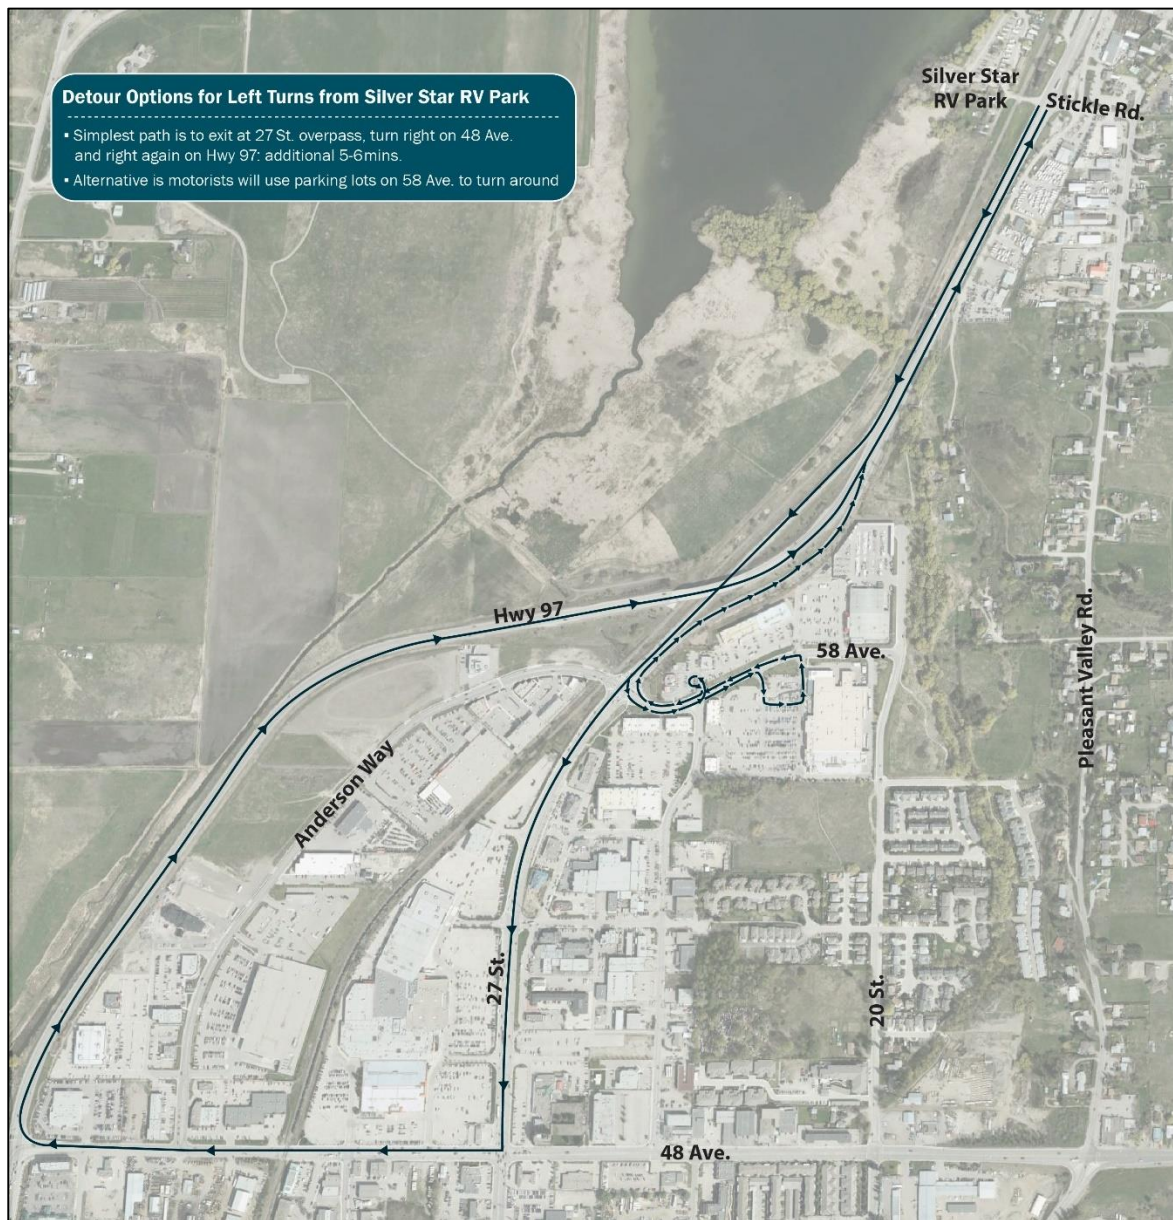
Figure 10. Detour Options for Traffic Wanting to Travel Northbound from the RV Park

A key consideration when evaluating Option 2 is the accommodation of traffic rerouting due to the prohibited left turn movements at Stickle Road. This is aided on the east leg by the construction of the 20th Street connection, with Vernon being the primary travel destination for motorists using Stickle Road. On the west leg however, motorists exiting the RV Park and wanting to go northbound will have a significant detour, which could result in unsafe U-turns on the highway just south of the Stickle Road intersection, influenced by the length of the detour route. An example of a detour route is shown in [Figure 10](#), as well as the alternative whereby motorists use the parking lots with access on 58 Avenue to make a U-turn. It is however, noted that the volume of traffic wanting to go northbound from the RV Park is very low; estimated to be less than 10 vehicles per day based on peak period traffic counts, and one vehicle in the peak hour. This is consistent with the extensive shopping and other destinations in Vernon to the south.
