## **Kicking Horse River Bridges Replacement Project Geotechnical Factual Data Report – Phases 1 and 2**

**Urban Systems Ltd.**

**British Columbia Ministry of Transportation and Infrastructure**

ISSUED FOR USE

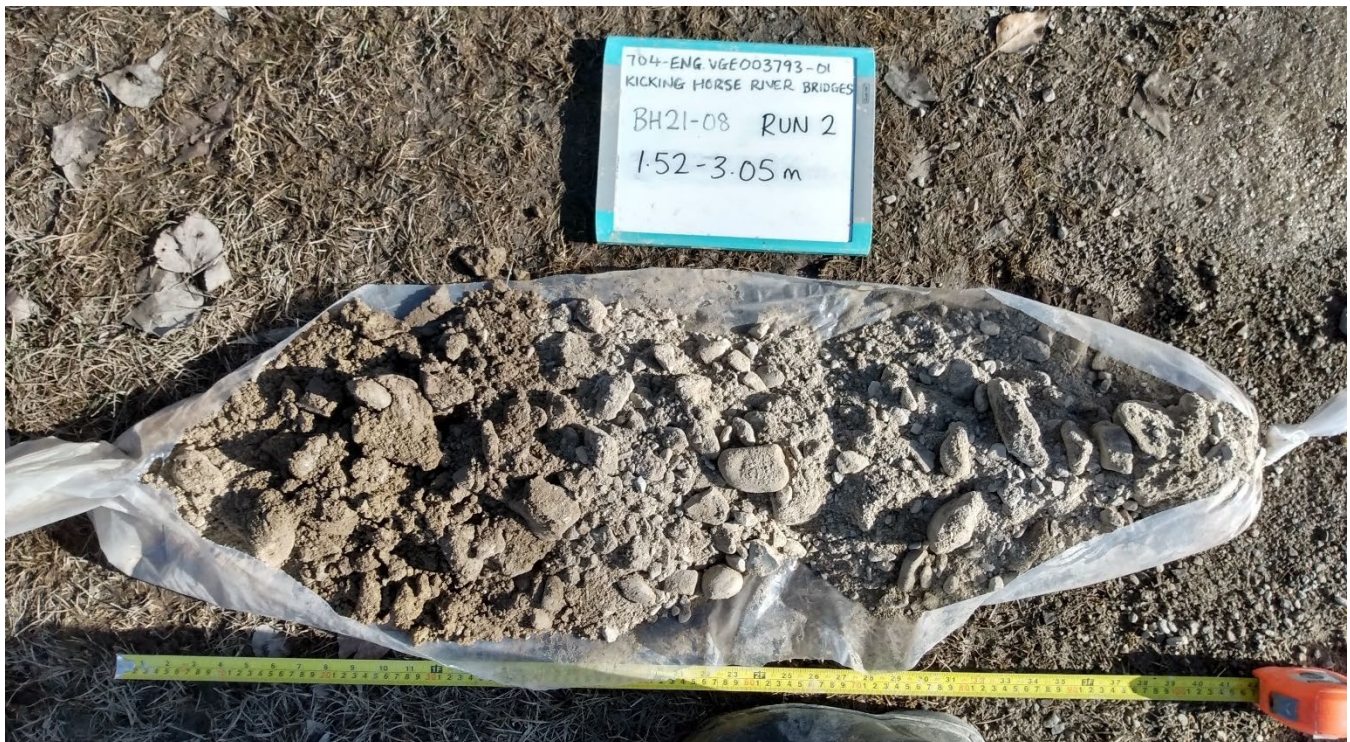
**Photo 24.** BH21-08, Run 2, 1.52 to 3.05 m

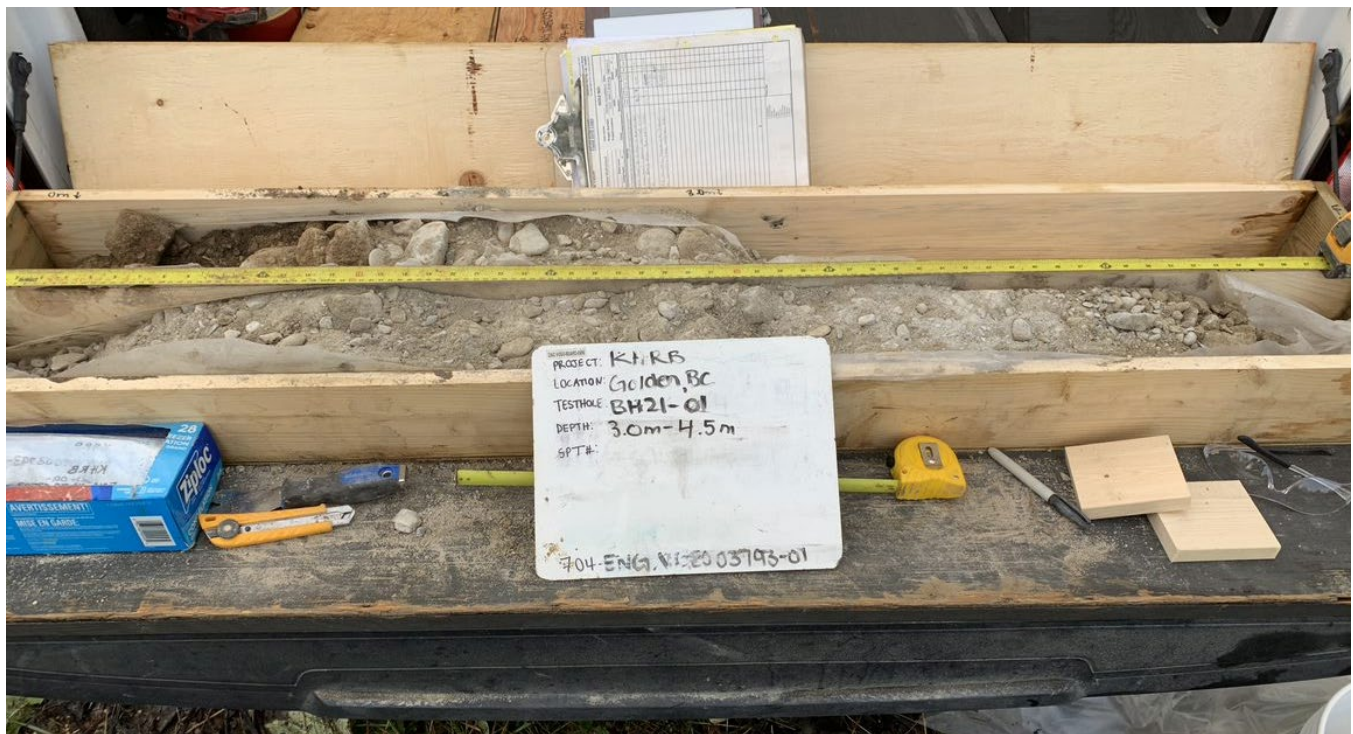
Photo 2. BH21-01, Box 1, 3.0 m to 4.5 m
