Ministry of Environment Inspection Record

Environmental
Protection
Division

MONITORING AND REPORTING REQUIREMENTS					
Inspection Period:					
From: 2016-07-12		To: 2016-07-12			
Requirement Source:					
Pollution Abatement Order					
Activity: On Site		Waste Type: Effluent			
Inspection Summary: <p>On May 12, 2016, a Pollution Abatement Order (PAO) was issued to Canyon Road Farms Ltd., as a result of increasing nitrogen levels in the local aquifer (aquifer 103) which is used to provide drinking water to residents in the Hullcar Valley.</p> <p>On July 12, 2016, Canyon Road Farms Ltd., a poultry producer in Armstrong, BC was inspected by Environmental Protection Officers Devan Oldfield, Compliance Section and Deputy Director Christa Zacharias-Homer, Environmental Protection Division. The inspection was conducted to verify compliance with requirements placed in the PAO.</p> <p>The onsite inspection included two well locations, three manure storage pads, property lines, a compost pile and drainage pathways. A "Farm Book", submitted as a requirement under the PAO was also reviewed as part of the inspection.</p> <p>During the inspection, the farm was no longer producing poultry and no

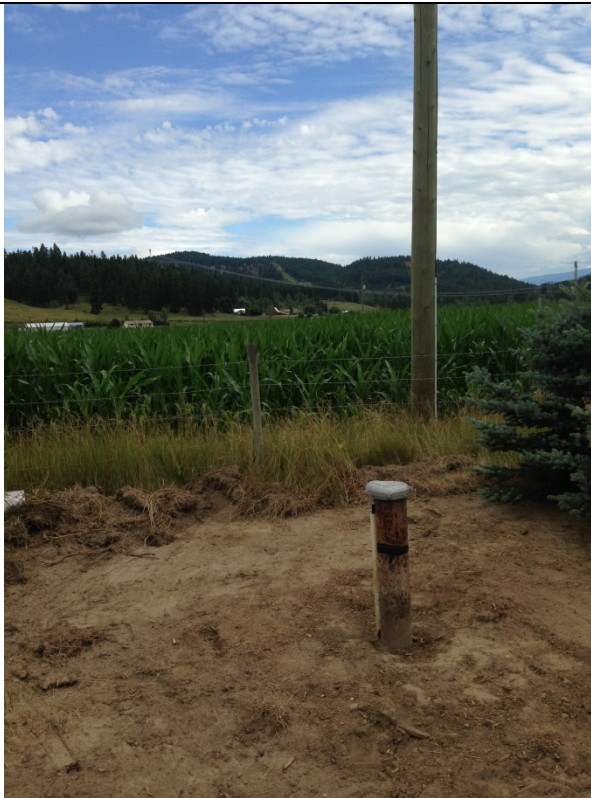
Photo 3

Well located
along north
property line.

Photo facing
north.

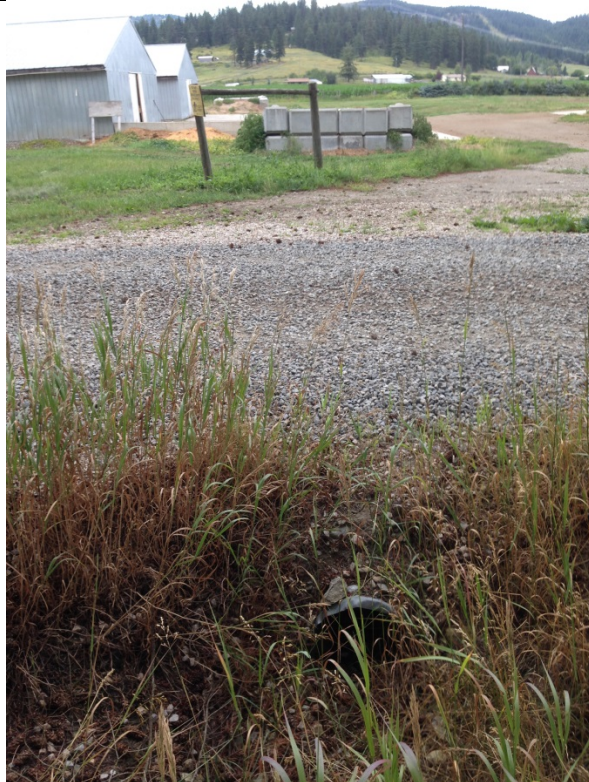
Photo 4

A culvert has been placed beneath the municipal roadway along the southern property line (See photo 4). This culvert directs ditch water, and runoff from the fields to the south across Canyon Road Farm lands, within 0.5 metre from the manure storage pads. As no manure is expected to be generated, since the farm is no longer operational, this drainage issue has been noted, but does not put the owner out of compliance.

Culvert installed
across municipal
roadway in
foreground. Both
barns and
storage pads in
background.

Photo facing
north from
municipal
roadway to the
south of the
property.
