## 4.0 WILDLIFE-VEHICLE ACCIDENT MITIGATION METHODS

### 4.1 Overview

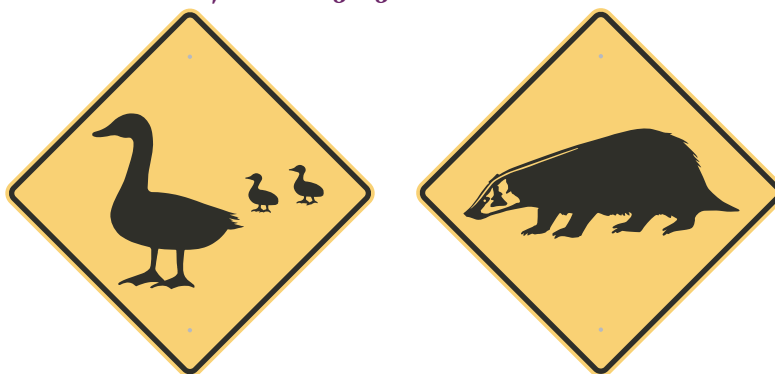
**Figure 4.2 – New BC Wildlife Warning Signs**

New signs are developed by the Ministry as it becomes aware of the need for such signs as part of its ongoing efforts to keep the motoring public aware of potential wildlife hazards as they are identified. In 2003, the Ministry developed signs for ducks and badgers in response to requests by wildlife preservation groups (Figure 4.2). The signs were immediately put into use.

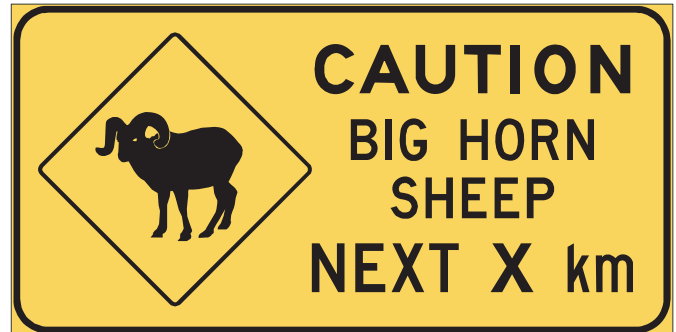
**Figure 4.3 – Standard and oversized signs**

Wildlife warning signs are the Ministry's most commonly used wildlife-vehicle accident mitigation measure because they are the least expensive and easiest to install and maintain. Standard sized signs (75 cm x 75 cm) cost approximately \$150 while oversized signs (244 cm x 122 cm) cost approximately \$550 (Figure 4.3).

75cm x 75 cm

244 cm x 122 cm

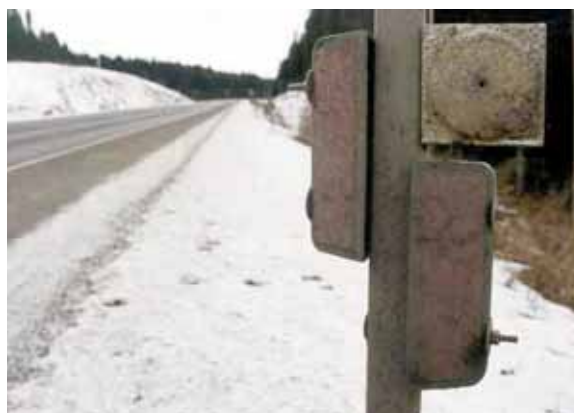
*Reflectors during winter conditions*

Reflectors cost approximately \$10,000/km to install along both sides of a highway. Maintenance costs range in the order of \$500 to \$1,000 annually. Reflectors require regular cleaning and alignment. Reflectors have been the targets of theft and vandalism. Locating reflectors in suitable locations along highways is essential to avoid creating new problems for regular highway maintenance.

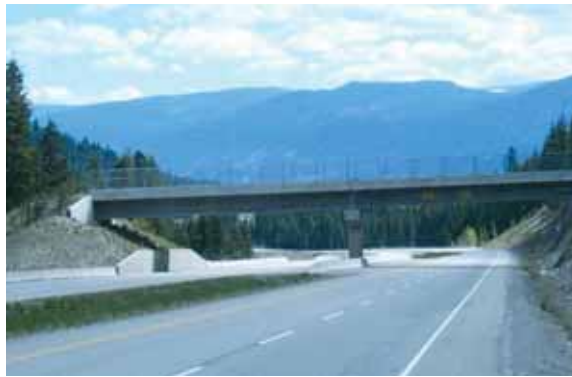
*Trepanier Overpass, 1987*

In 1987, BCMoT constructed the first wildlife overpass in Canada and the second in North America. The Trepanier Overpass on the Okanagan Connector built upon the concept of the first overpass built in Utah. At a cost of approximately \$1 million, the Trepanier Overpass was developed from the design of a pedestrian highway overpass. Structural advancements were required to accommodate the weight of soil and vegetation necessary to create a "natural" environment to encourage wildlife use. Detailed wildlife studies

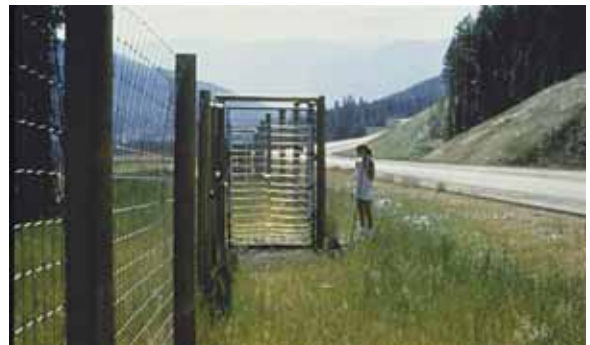
*One-way gate approach*

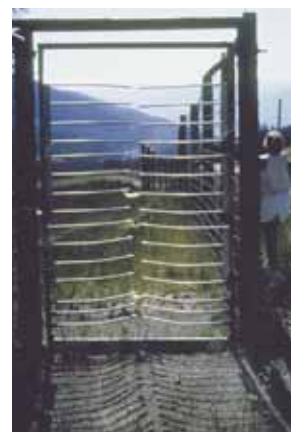
*One-way gate* (Photo: Mike Kent)

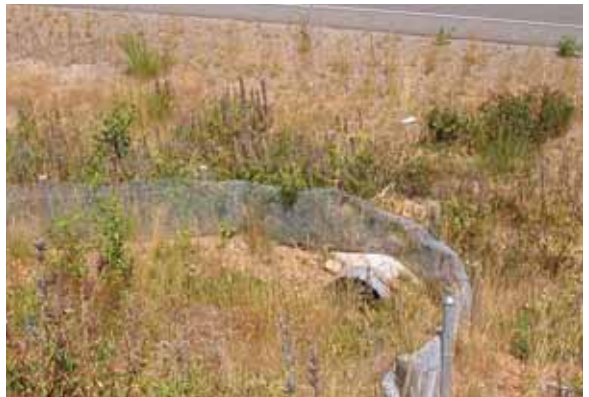
*Amphibian fencing connecting to underpass*

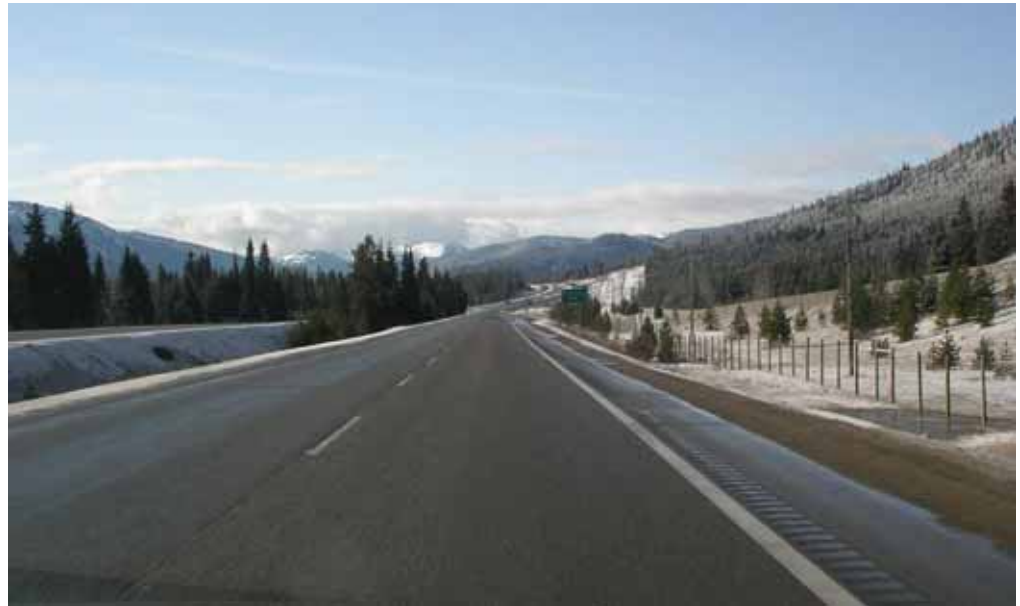
*Wildlife exclusion fencing on the Coquihalla Highway.*

BCMoT initially installed wildlife reflectors in response to these deer-related accidents. When it became apparent the reflectors alone would not be able to reduce the high numbers of accidents on the highway, BCMoT began the design and construction of wildlife exclusion fencing on Phase I of the highway (Figure 4.9).

By improving on the designs originally developed by Public Works Canada for Banff National Park, BCMoT was able to develop effective fencing and one-way gates (Kent, 2005). Wildlife exclusion fencing was constructed for a distance of approximately 70 km (43.5 mi) on both sides of the highway, between the toll booth and Merritt (Figure 4.10).
