# BIG BAR LANDSLIDE UPDATE

FEBRUARY 22, 2021

## -40°C AND CHILLY

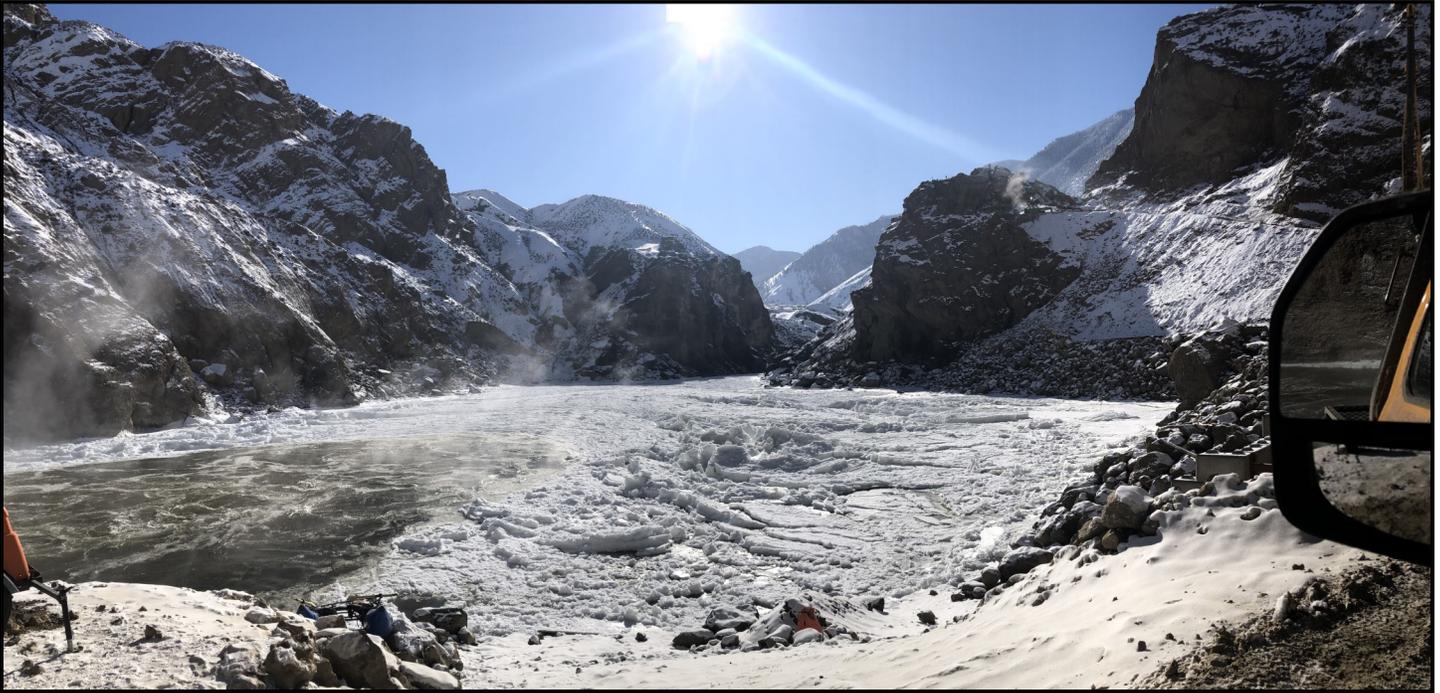
**TOP:** Cold temperatures have resulted in significant ice buildup in the Fraser River, including just south of the Big Bar landslide.

**BOTTOM:** The rock face, after blasting occurred to remove rock from along the path of the permanent fishway for straighter alignment.

On February 13, the team was smiling after a successful blast of the canyon wall to straighten the future path of the permanent fishway. On February 14, crews also completed additional blasting of the Razorback and began excavating various grades of rock required for construction.

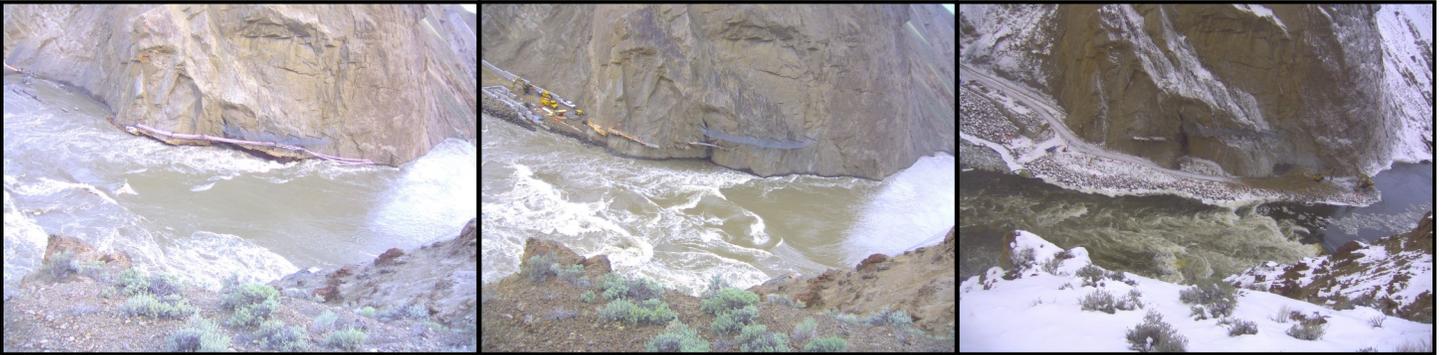
**LEFT:** Water levels exceptionally high, 6,640 m<sup>3</sup>/s, at Big Bar on July 6, 2020.

**CENTRE:** Moderate water levels, 3,750 m<sup>3</sup>/s, at Big Bar on May 6, 2020.

**RIGHT:** On February 16, 2021, water levels were 620 m<sup>3</sup>/s. These low levels facilitate winter works.

Water levels vary considerably in the Fraser River throughout the year. However, the levels have consistently dropped since December and crews have been able to access the river bed and perform in-river work necessary to build the fishway. The brief, critical window between December and April allow crews to finish the winter work before the snow melts and freshet occurs again. Operations will then shift to assisted transport of the early migrating fish that will be blocked by the slide.

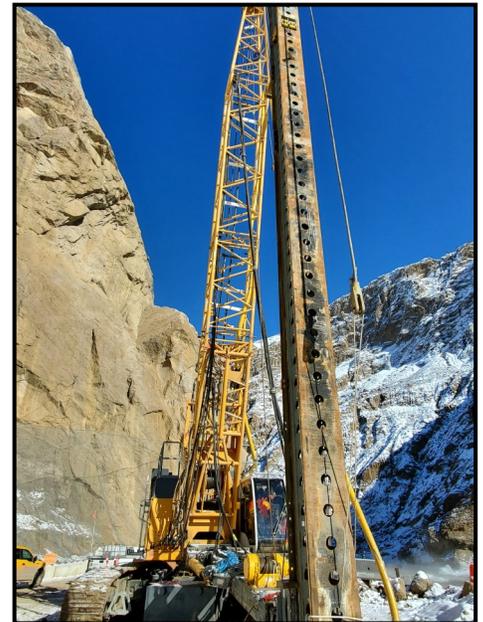
**ABOVE:** The pile installation rig being set-up on the West Beach will be used to drive piles necessary to support the fishway.

Temperatures at site reached -40 C with heavy snowfall and freezing rain causing periodic shutdowns. These interruptions have affected the timeline for some of the cliff stabilization work and the upcoming pile driving for the north end of the fishway. To make up time, the prime contractor, Peter Kiewit Sons ULC, has added double shifts in some areas.

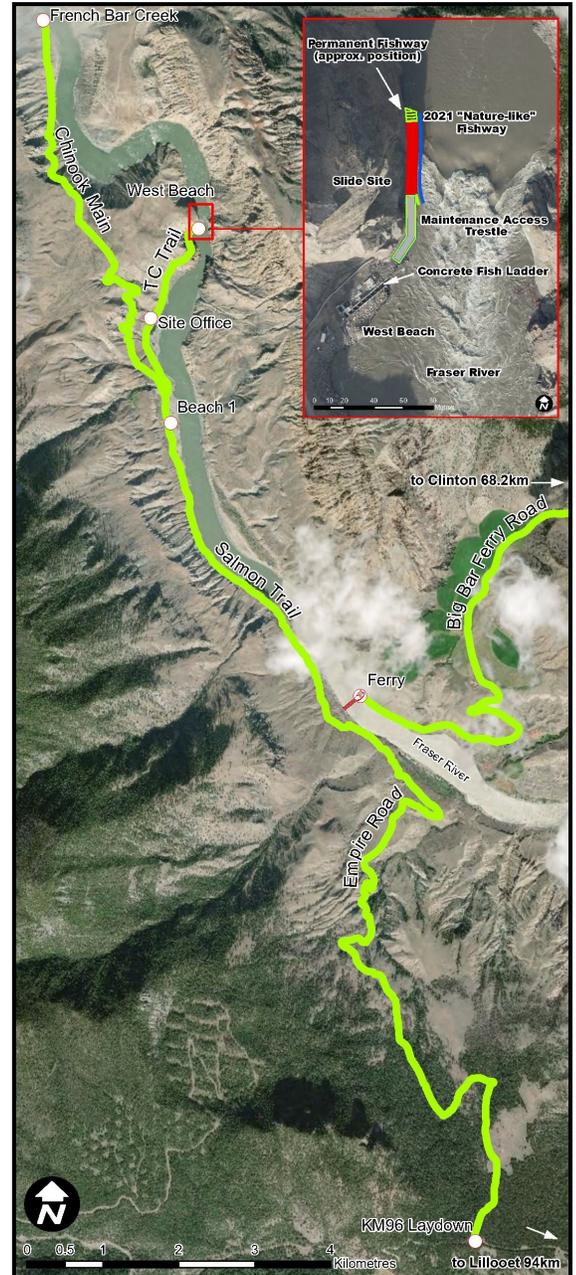
PICTURED: Big Bar site map

In the coming months, based on a FLNR design, PQC will widen and realign the Chinook Main road that connects Beach One to the French Bar Creek area (see map). The improved road will be safer for crews and allow trucks carrying custom 17,000-litre fish tanks to pass during the critical fish “trap and transport” operations.
