**MOUNT POLLEY MINE
Tailings Storage Facility
2011 Construction**

As-Built Report and Annual Review

Mount Polley Mining Corporation,
Likely, BC

30 March 2012

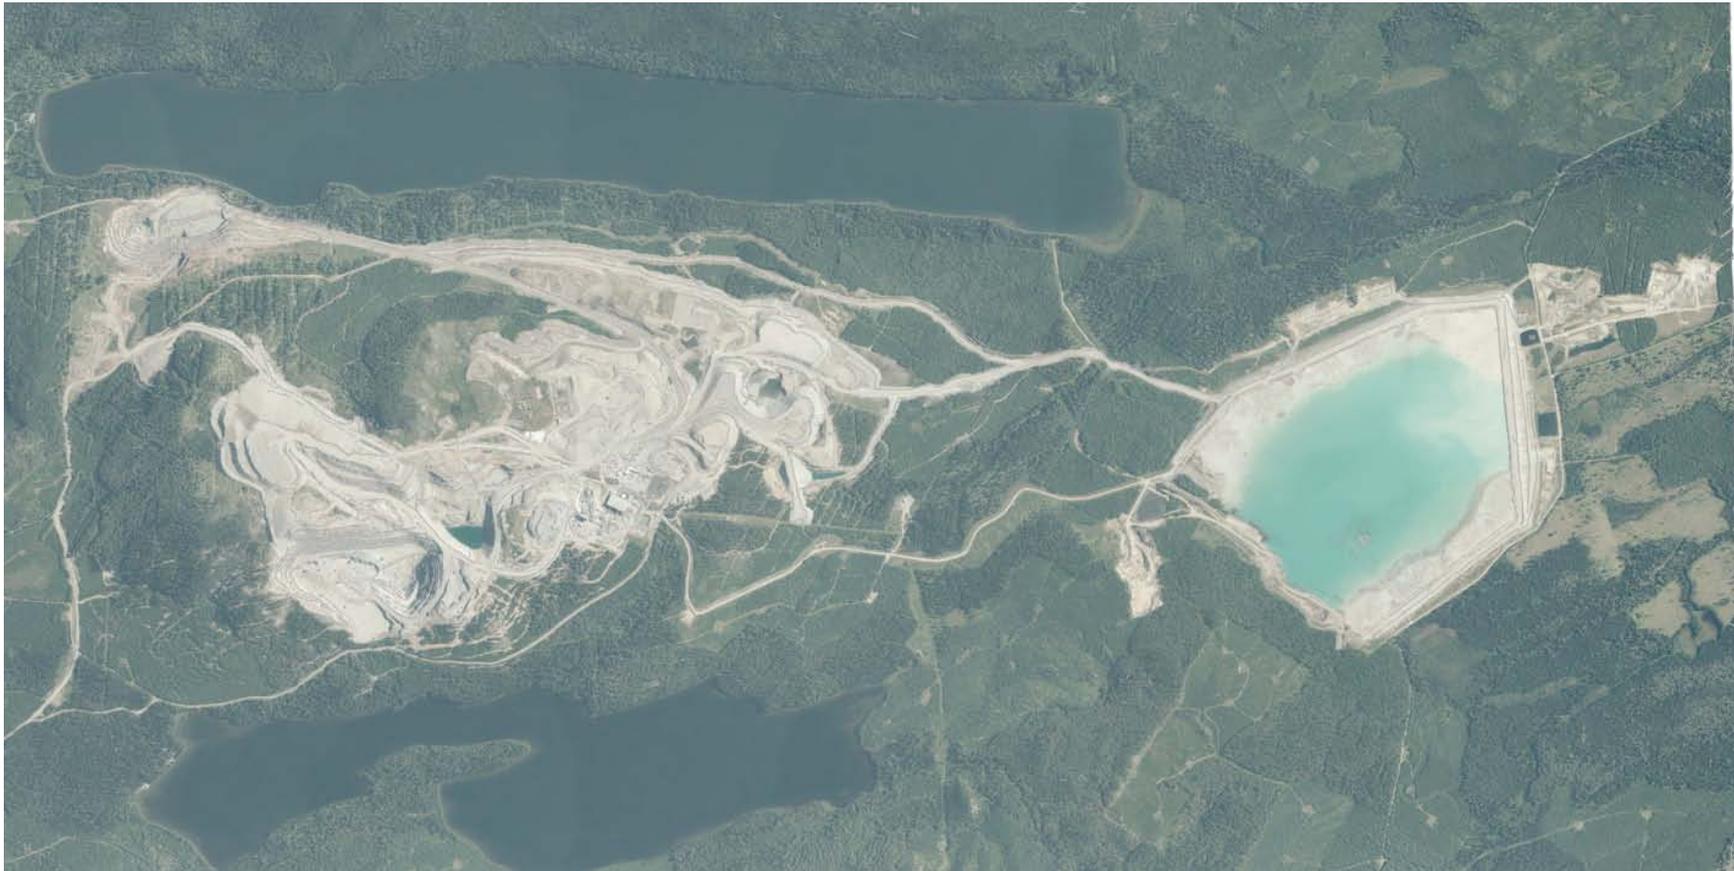
Figure 1.1: Aerial View of Mine Site: 2011

Drawing 2011AB.01 presents a plan of the as-built condition of the Mount Polley Mine site. Figure 1.1 shows an aerial view of the site from 2011.

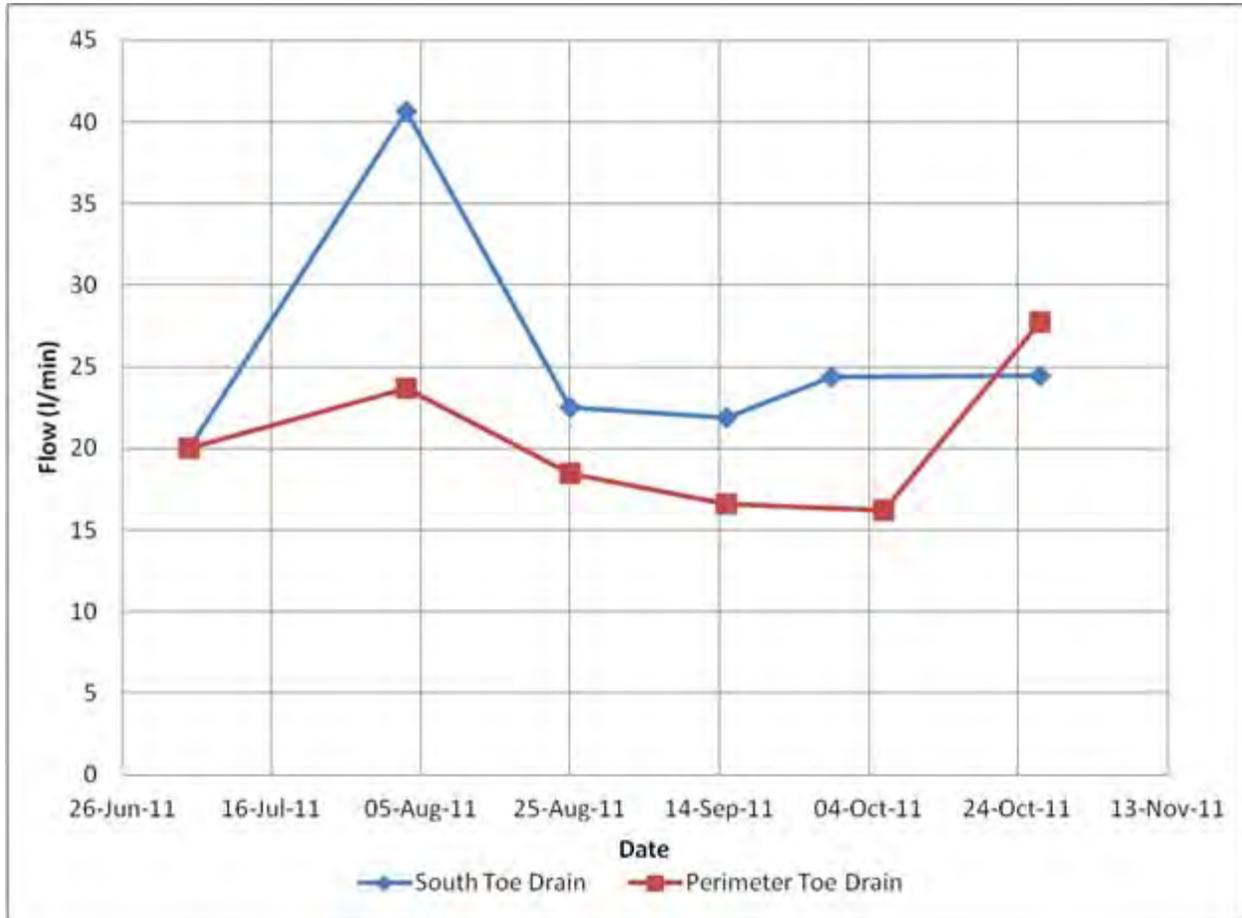
Figure 2.2: South and Perimeter Toe Drain Flow Readings – 2011

Flows from the upstream toe drain and foundation drains of the Main Embankment are measured at the sump located at the Main Embankment seepage collection pond. Upstream toe drains from the Perimeter and South Embankments discharge into ditches which carry the flow to their respective seepage collection ponds where it is measured at the end of pipe. Water from the upstream toe and foundation drains is recycled to the TSF.

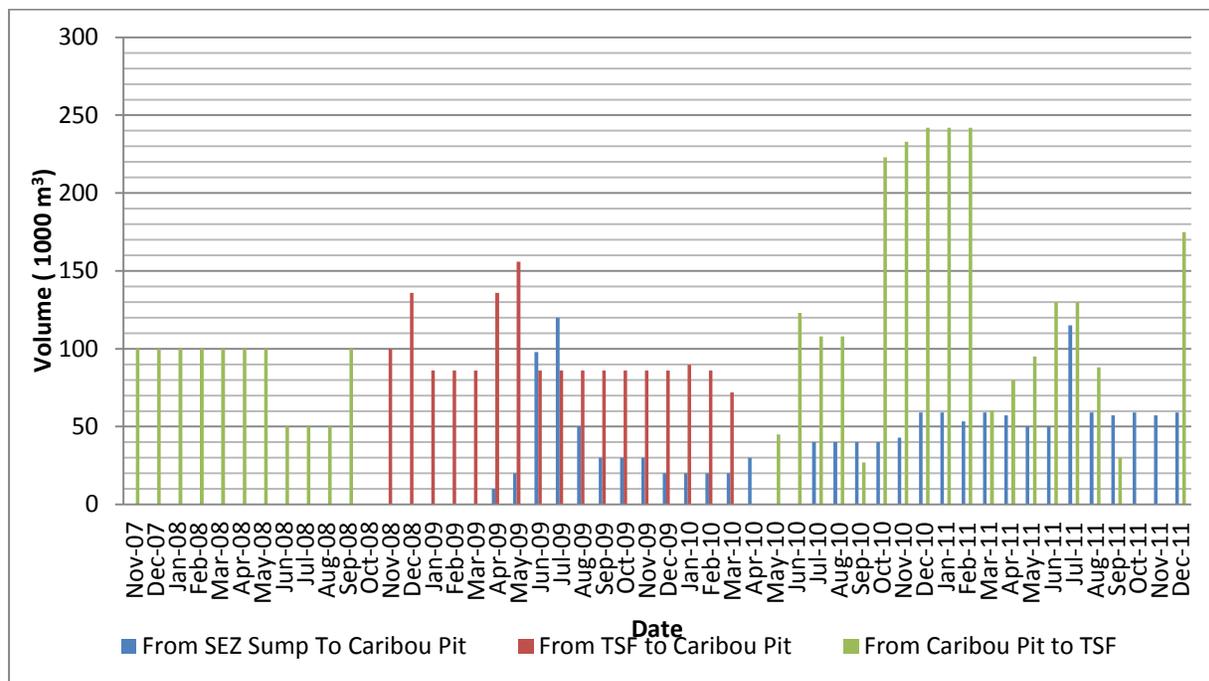
Figure 7.1: Water Transfer

It is AMEC's understanding that currently the total inflow from precipitation and surface runoff exceeds losses from evaporation and storage of water within the voids of deposited tailings. Thus, MPMC mine site is operating under a net annual water surplus condition, with the accumulating surplus being stored in the TSF and the Caribou Pit. MPMC transfers water as needed between the TSF and the Caribou Pit, with the volumes transferred, as provided by MPMC, shown in Figure 7.1.

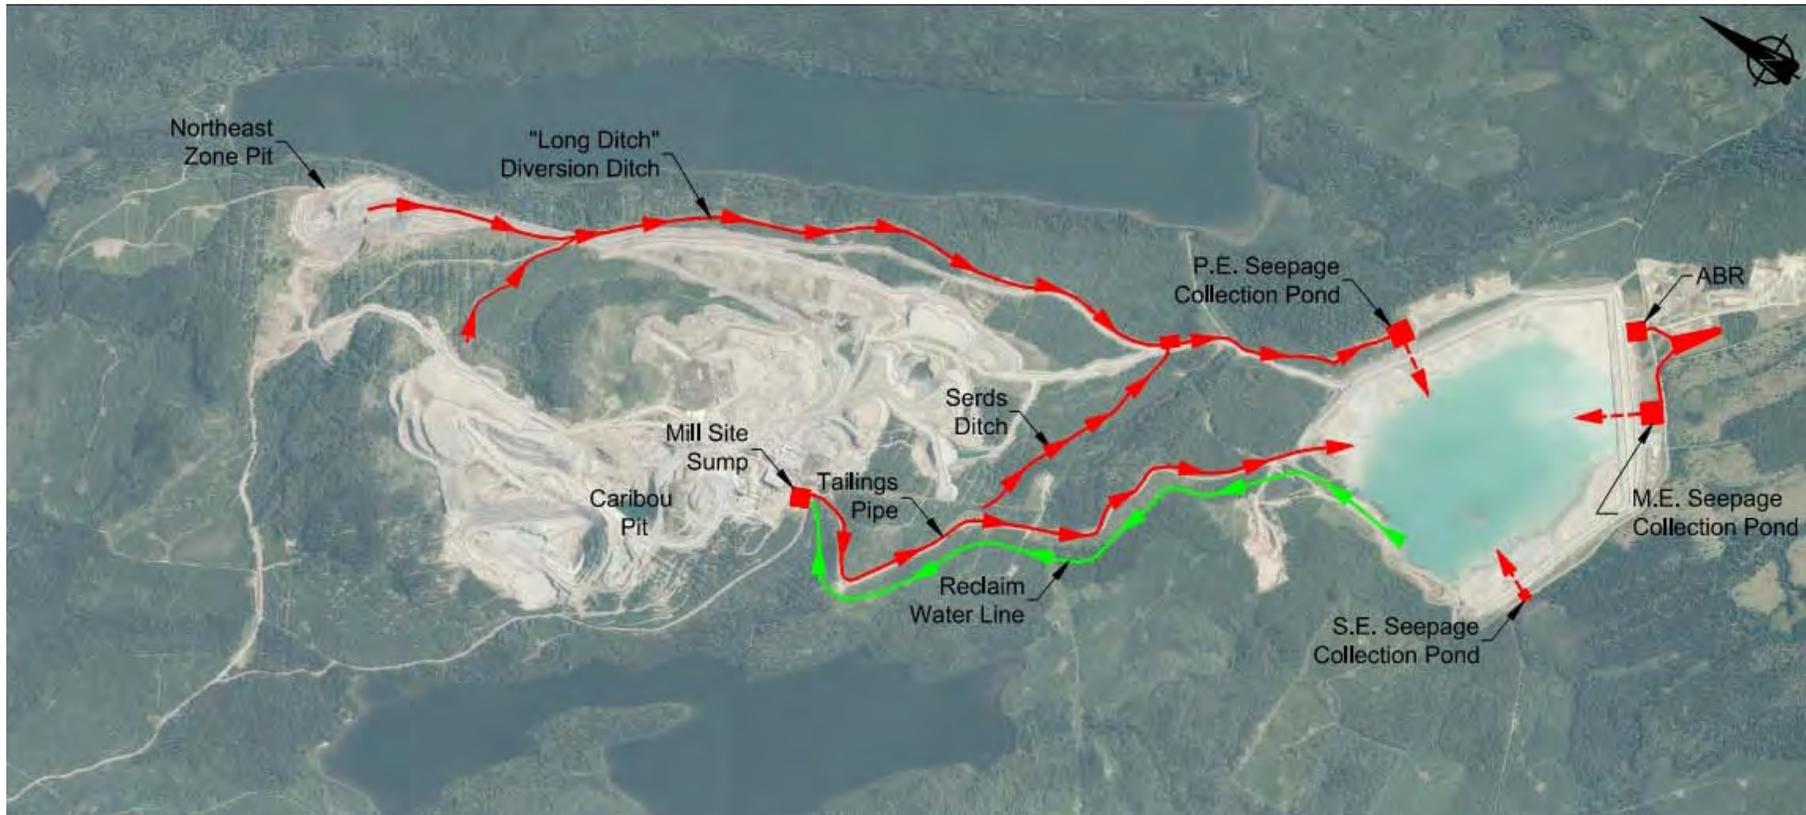
Figure 7.2: Site Water Management Schematic

Site water management is illustrated on Figure 7.2 and is described below:

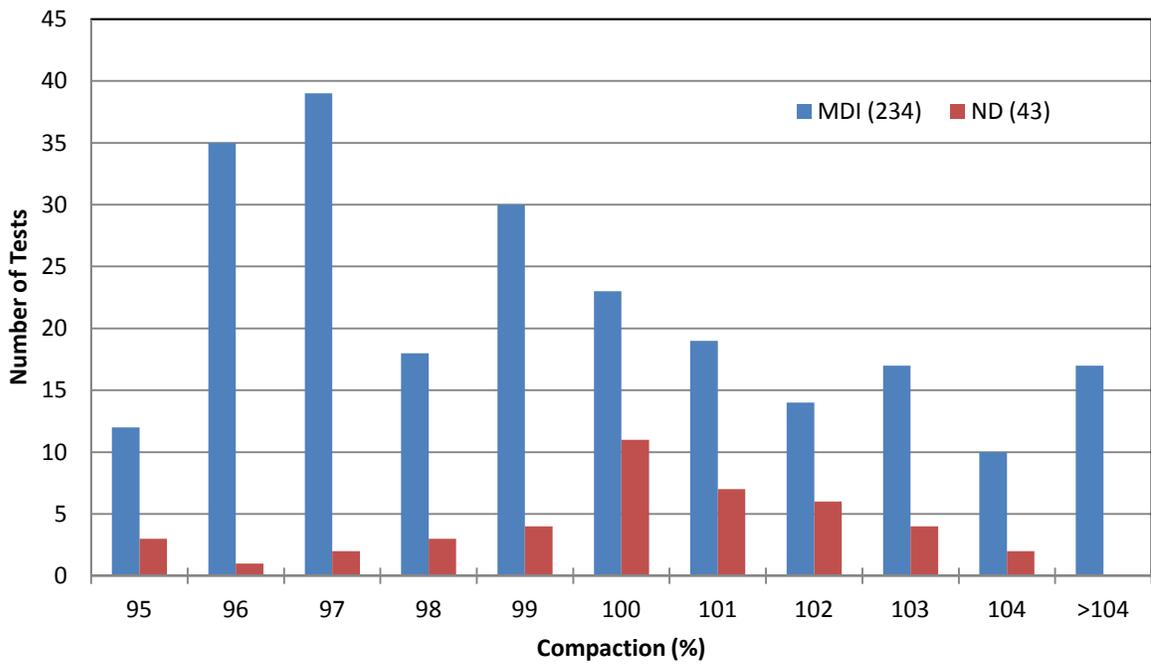
Zone S % Compaction Distribution

Prior to commencement of the 2011 construction season; the MDI testing unit was calibrated as per ASTM 6780-05. In addition, a proctor test was conducted to confirm the maximum density and optimal moisture content as per ASTM D2216-10 of the glacial till to be used for Zone S construction. The in-situ density and moisture content of the compacted fill were determined by performing MDI tests (ASTM D6780-05) by MPMC personnel. AMEC carried out additional QA testing with a nuclear densometer (ASTM D6938-10, ND). Where field test results indicated that the specified 95% Standard Proctor Maximum Dry Density (SPMDD) was not achieved, the

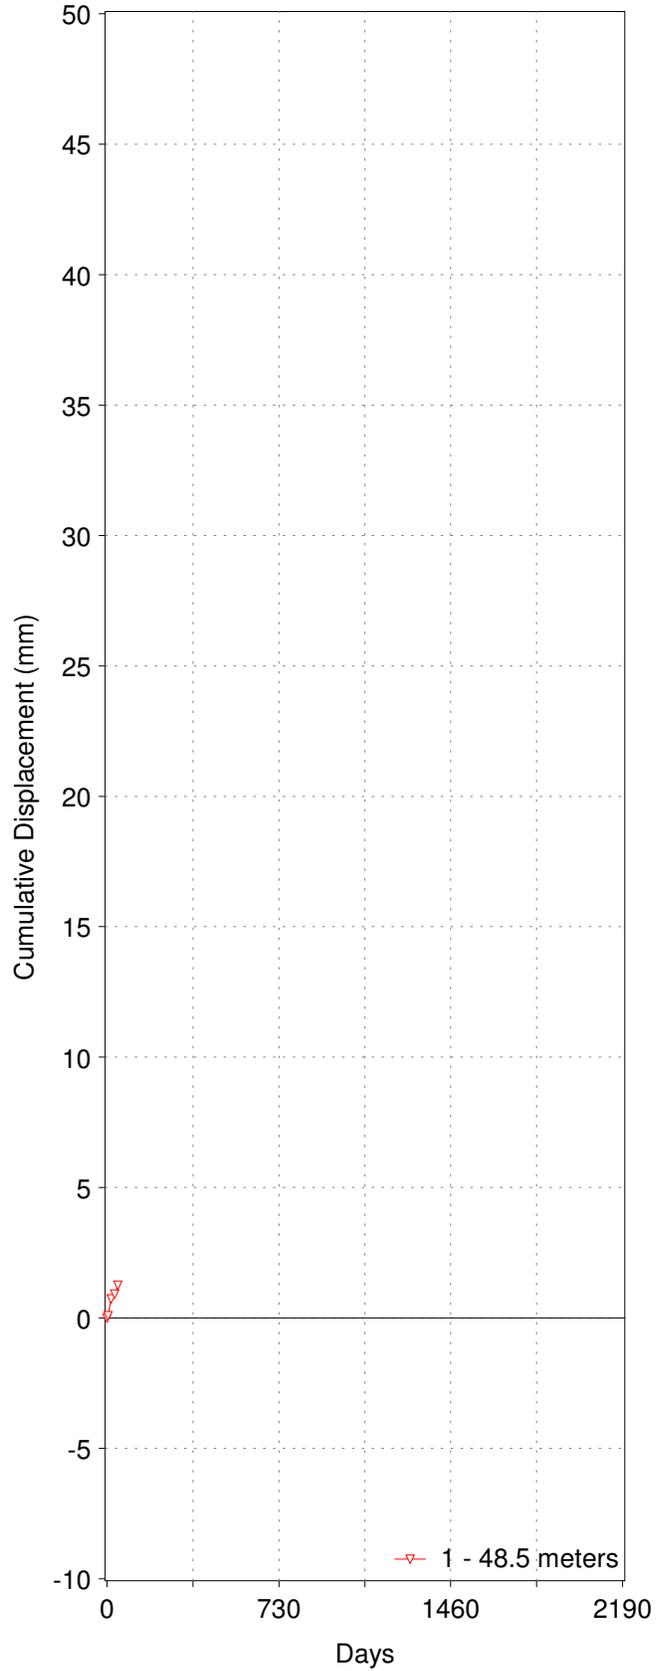
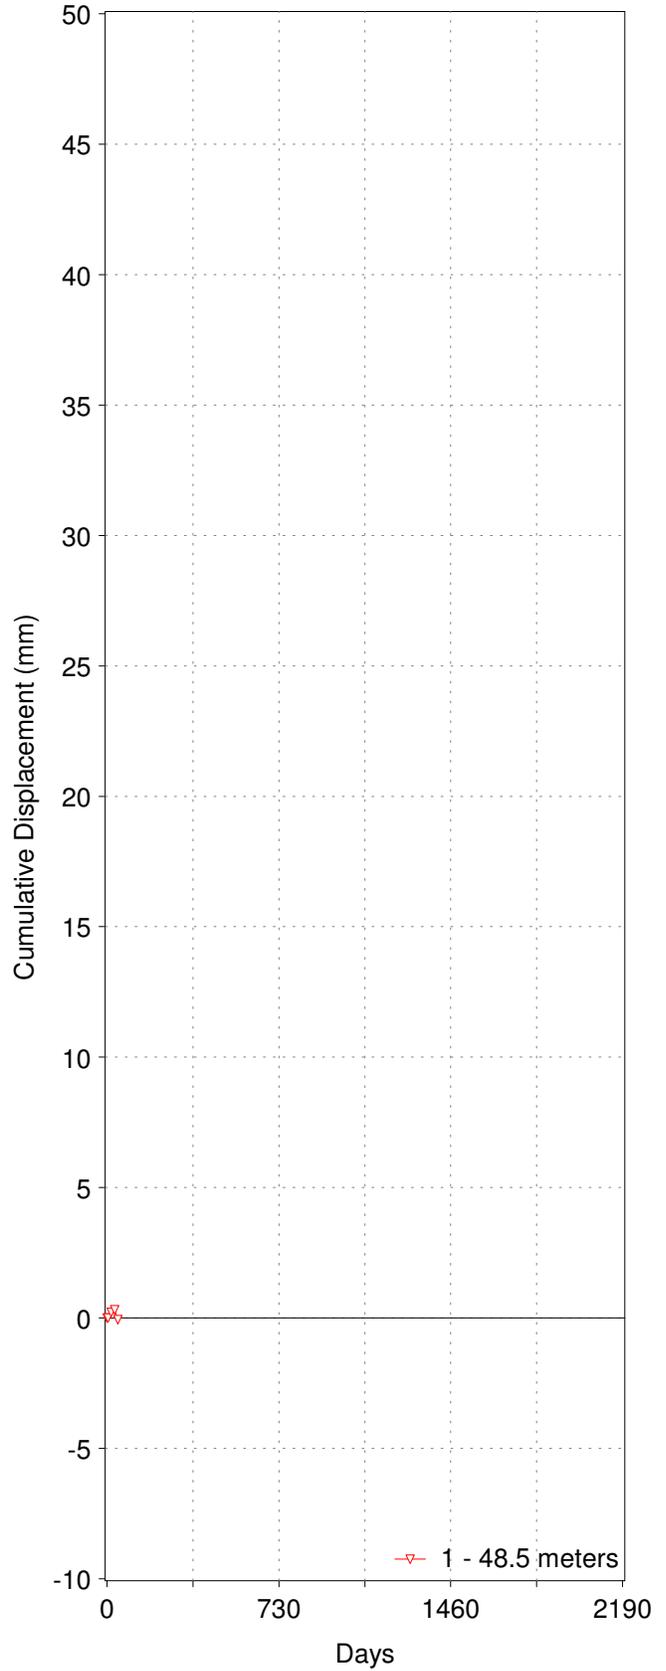
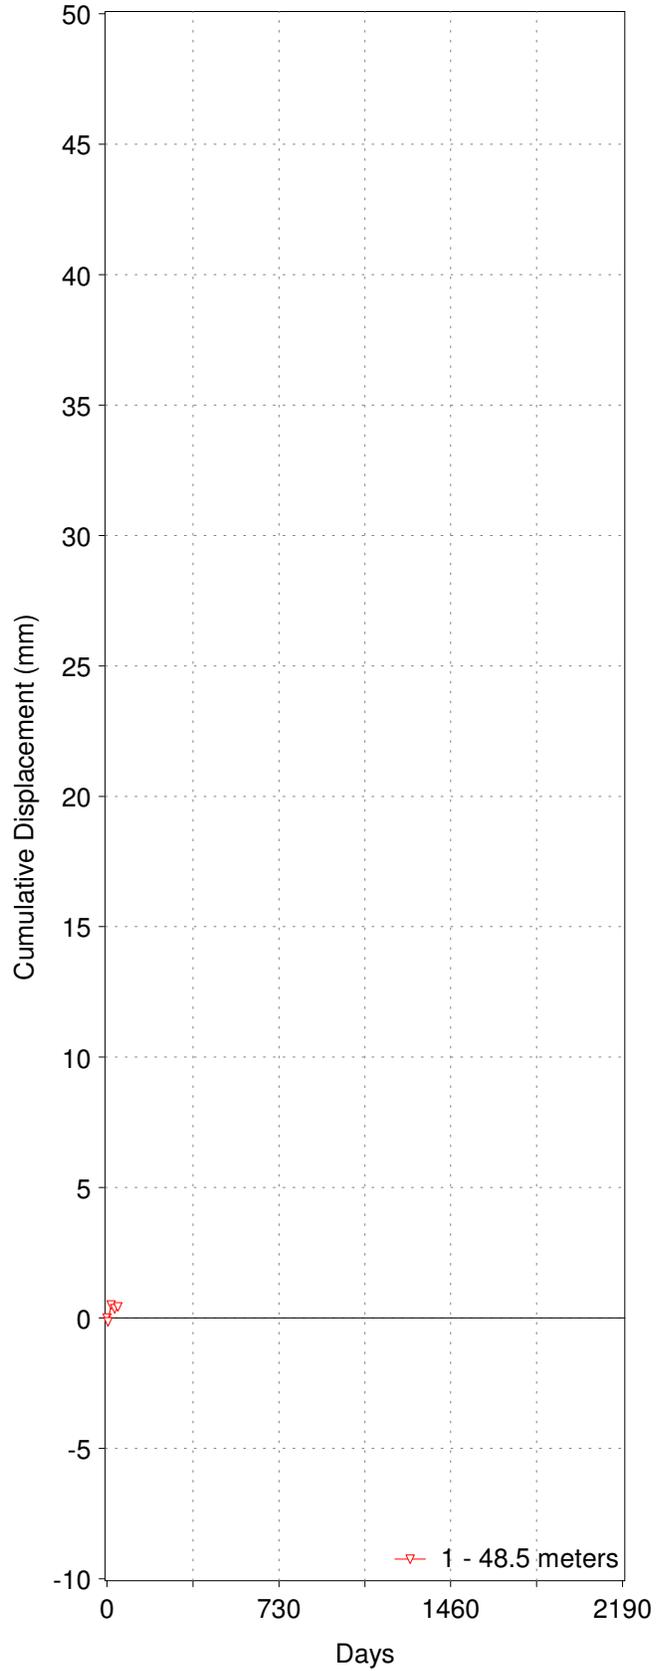
SI11-02 A-Axis

- SI11-02 showed an approximately 5 mm displacement over the course of the entire year. About half of that movement was observed sometime after or near completion of construction. Regular readings were not conducted during construction. The observed displacement is well within tolerable limits.

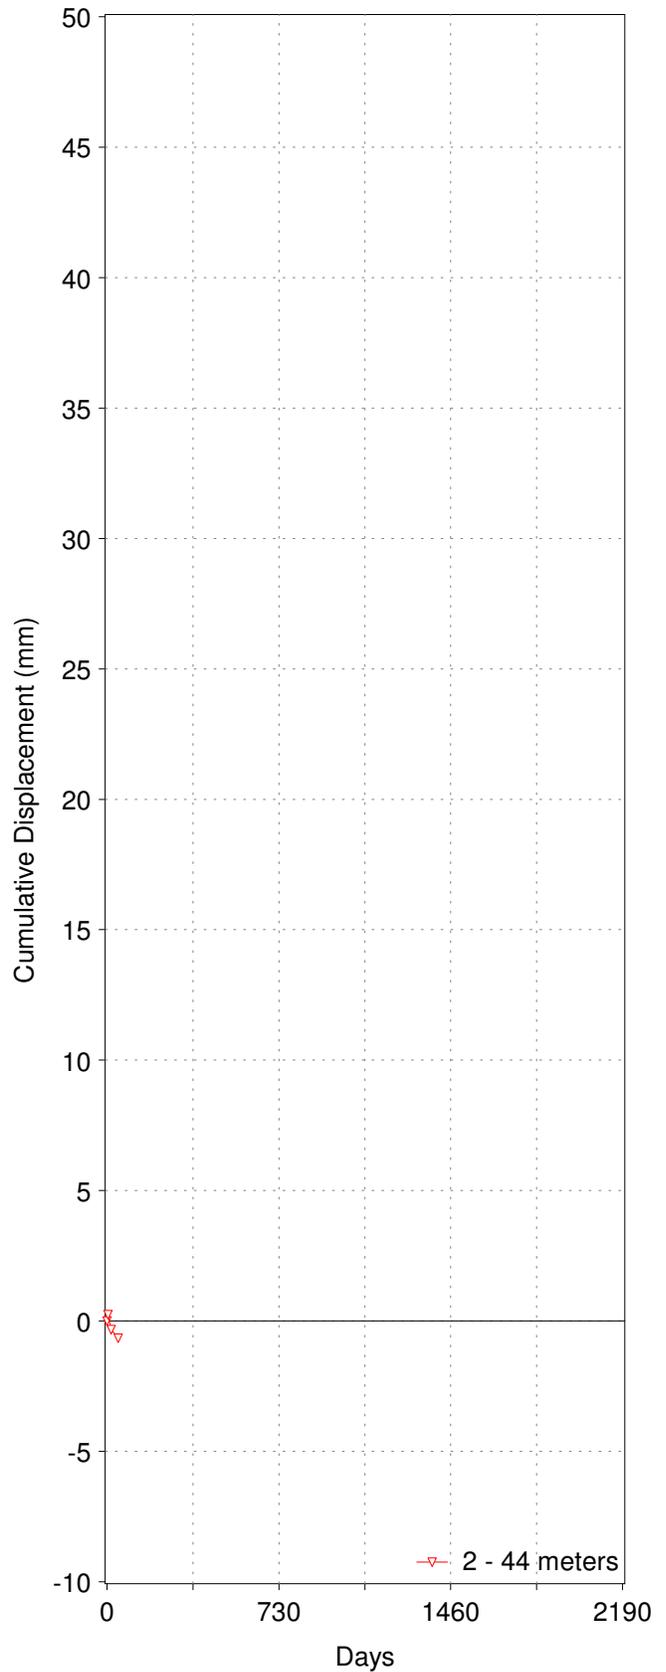
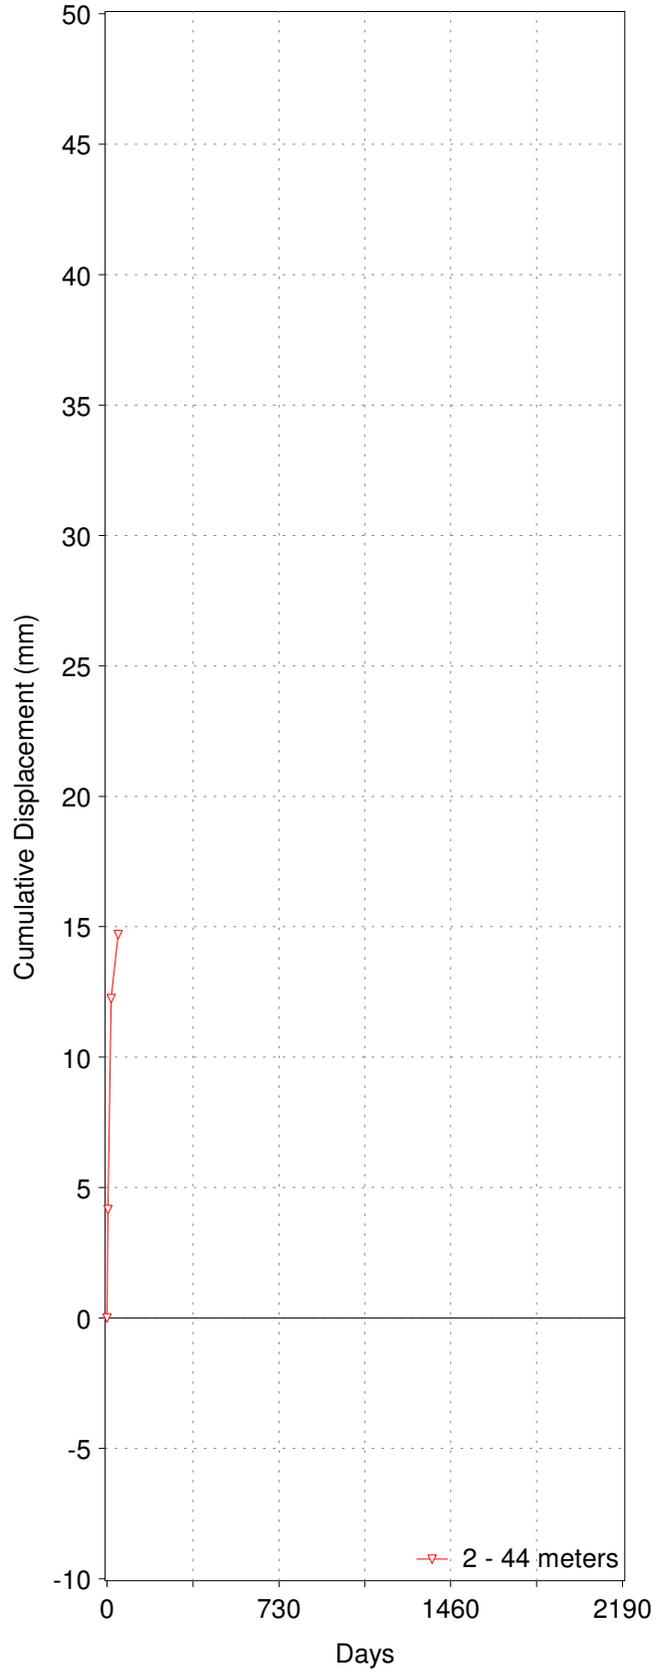
SI11-04 A-Axis

- No notable displacement has been noted on SI06-01, SI11-01, and SI11-02.
- SI11-04 has to date indicated displacement suggestive of compression rather than lateral displacement. Such a pattern of displacement sometimes occurs as a result of the installation process. This slope inclinometer should be reinitialized when the compression displacement stabilizes.

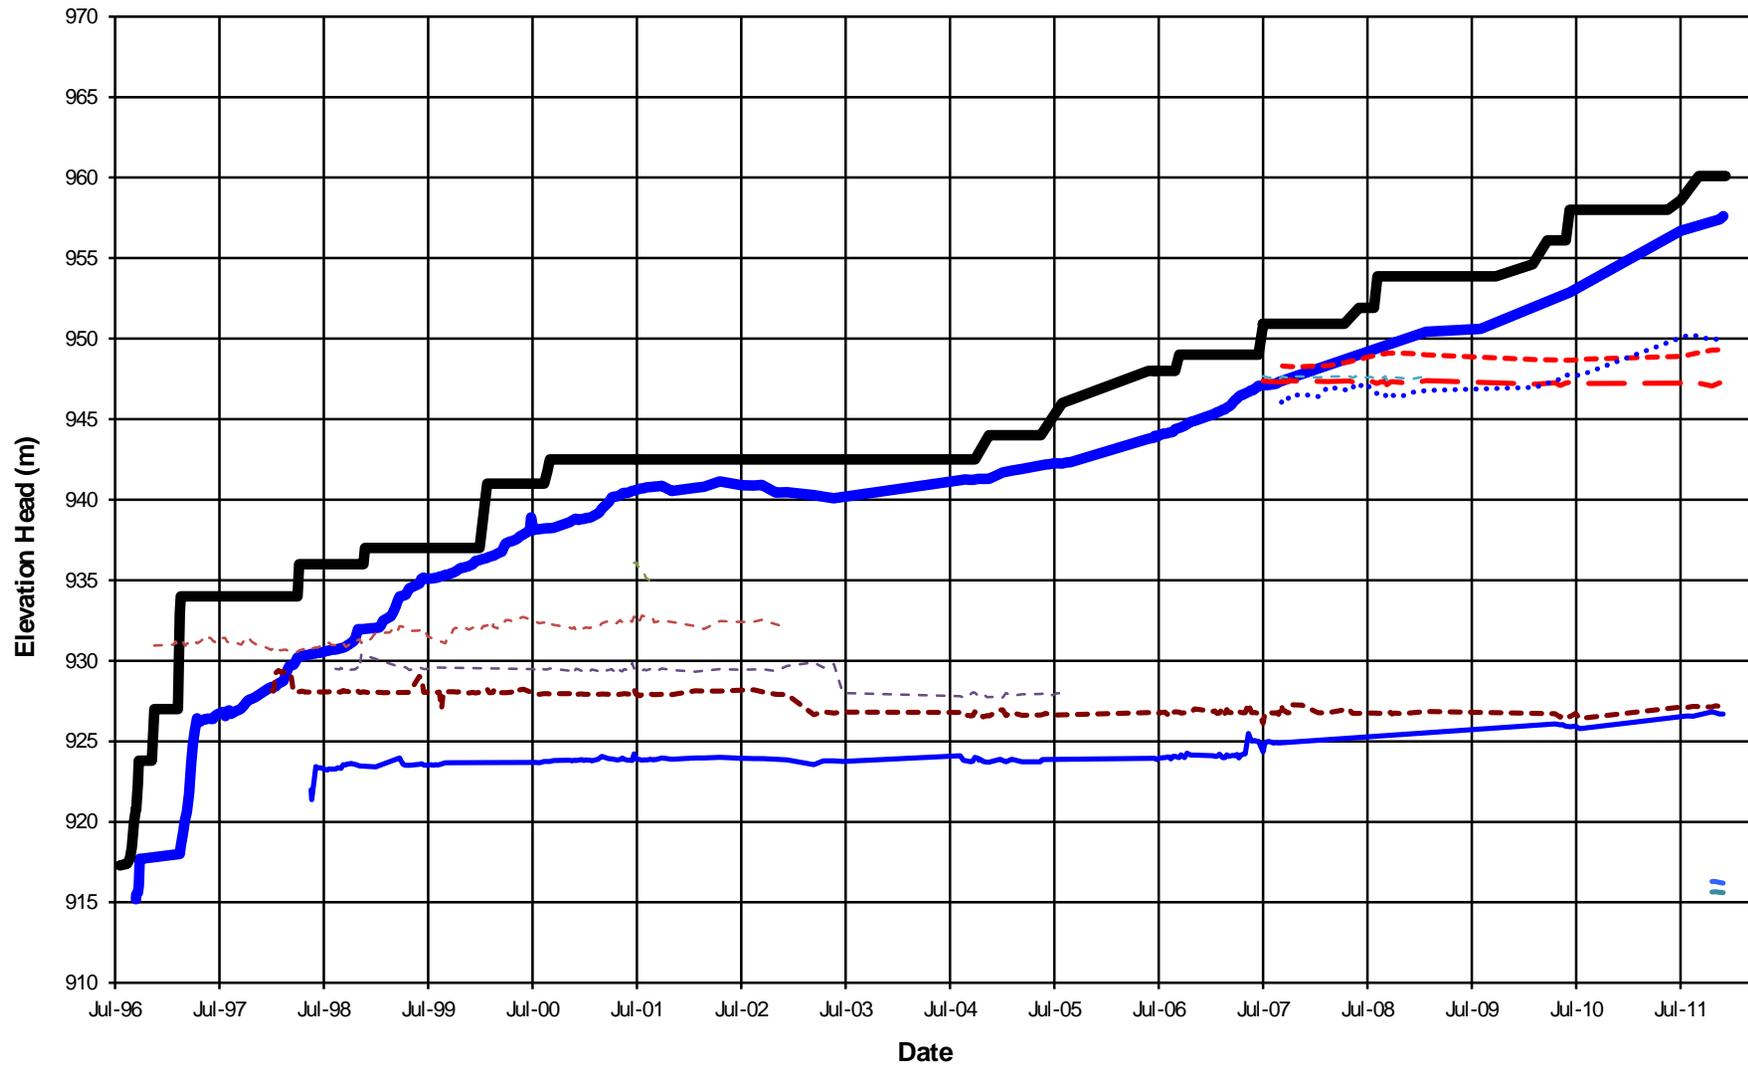
MOUNT POLLEY MINING CORPORATION		
MOUNT POLLEY MINE		
TAILINGS STORAGE FACILITY PLANE D PIEZOMETERS ELEVATION vs. TIME		
PROJECT NO. VM00560	Date. 12/24/11	REV. A
FIGURE D

- Pore pressures in foundation soils in and around the TSF embankment were noted as stable with minor fluctuations, except for D1 where an upward trend is noted. Newly installed piezometers appear to have stabilized but insufficient data has been collected to show any trends at this point.
- Pore pressures in the till core are found to be stable, with a slightly increasing trend in response to the rising pond level.
- Pore pressures in filter and drains remained unchanged throughout the year.
- Pore pressures in the tailings and upstream fill experienced an upwards trend in response to the rising pond level. Piezometers installed at a lower elevation within the upstream tailings experienced lower response relative to the piezometers near the pond elevation, likely the result of proximity to the upstream under-drainage system.

- Pond Level
- - - D3 Filter
- D1 Foundation
- - - DEAD (D1-PE1-03)
- - - DEAD (D2-PE2-03)
- Fill Elevation
- - - D4 Till Fill
- D6 Foundation
- - - DEAD (D2-PE1-01)
- - - DEAD (D2-PE2-01)
- · · D5 Tailings
- D7 Foundation
