Ministry of
Transportation
and Infrastructure

Trans Canada Highway 1 –
Malahat Corridor Improvements

Goldstream Median Barrier Widening

August 2020

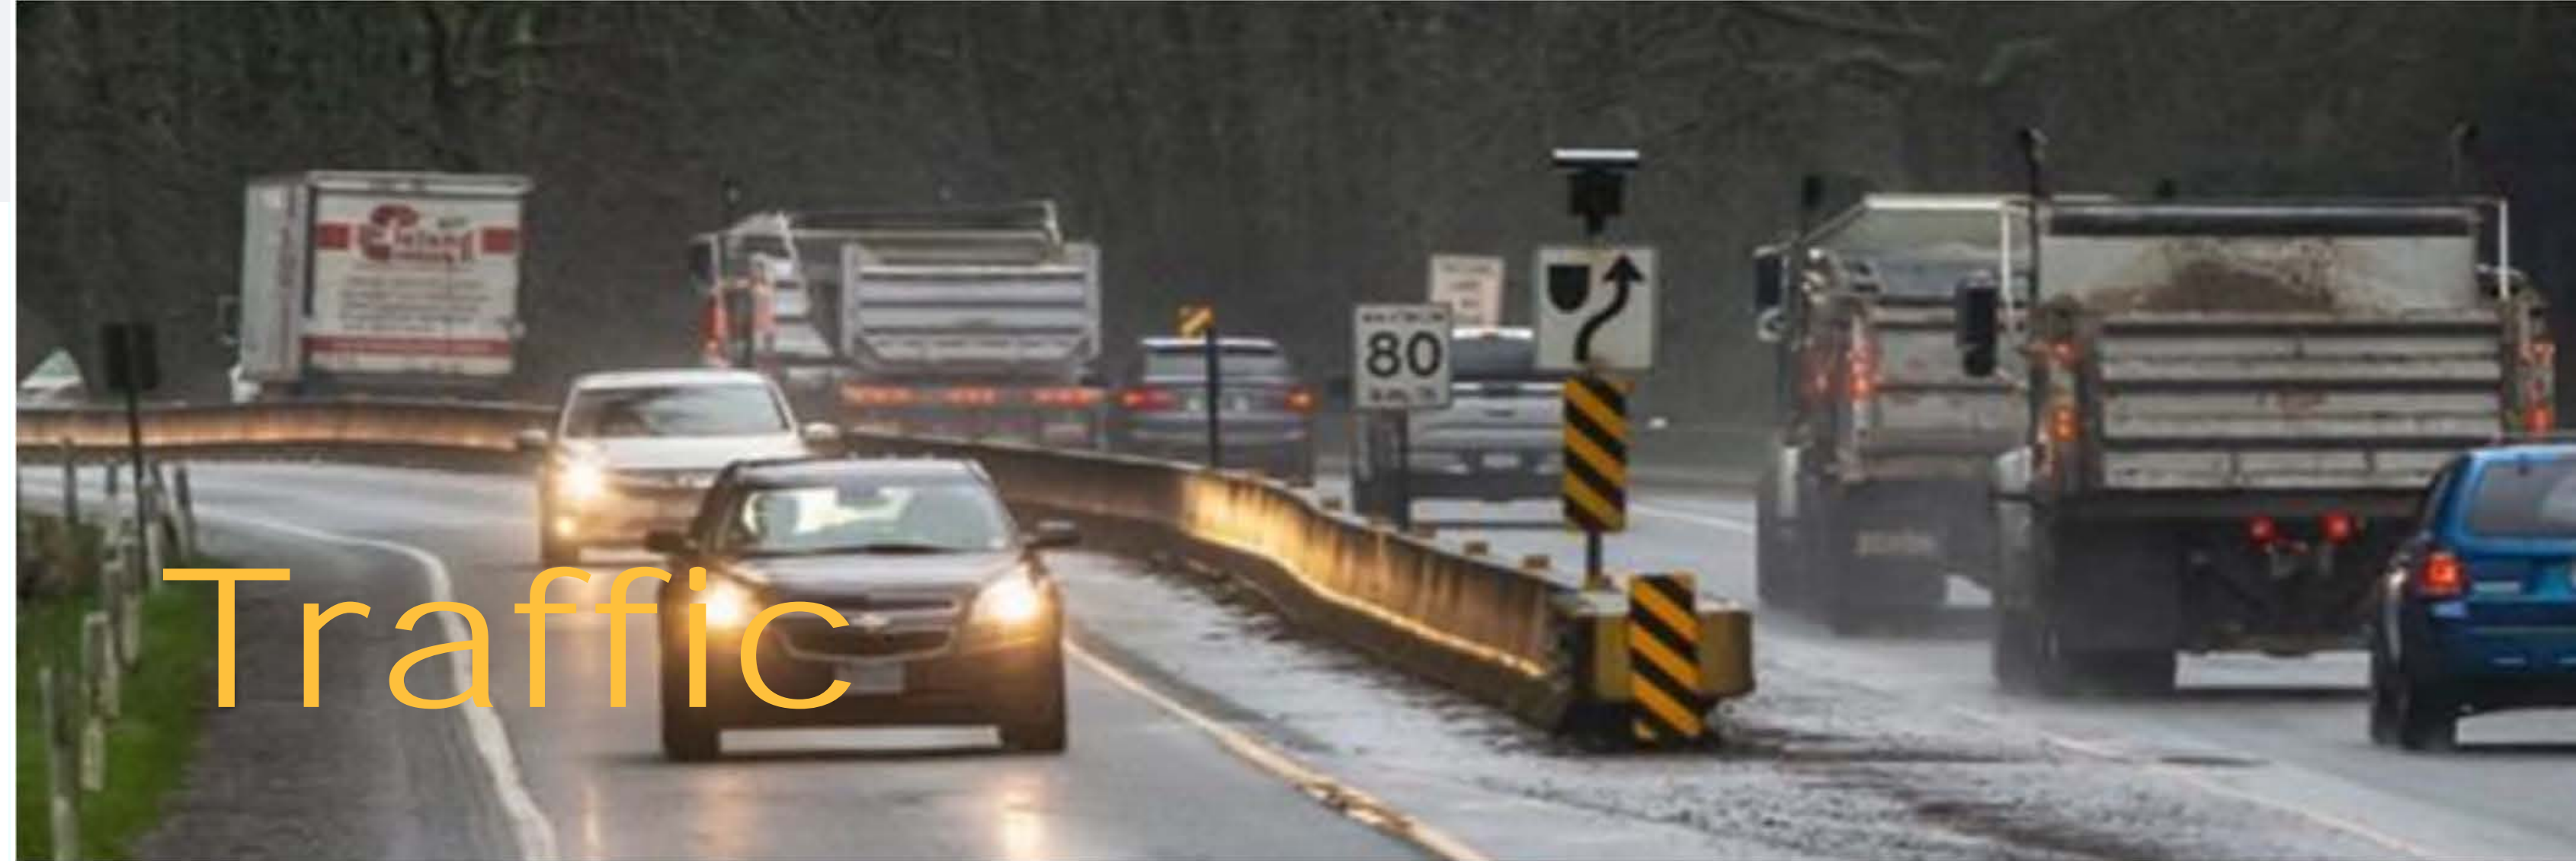
■ Peak hour volumes

AM	PM
NB	360	1,420
SB	1,370	900

- 2019 Annual Average Daily Traffic (AADT) = 25,300
- 2019 Summer Average Daily Traffic (SADT) = 29,400
- Growth ~1.15% annually
- Goldstream is a vital corridor for the movement of goods and services
- Trucks comprise ~10% of traffic volume, including dump trucks that facilitate ongoing south Island development

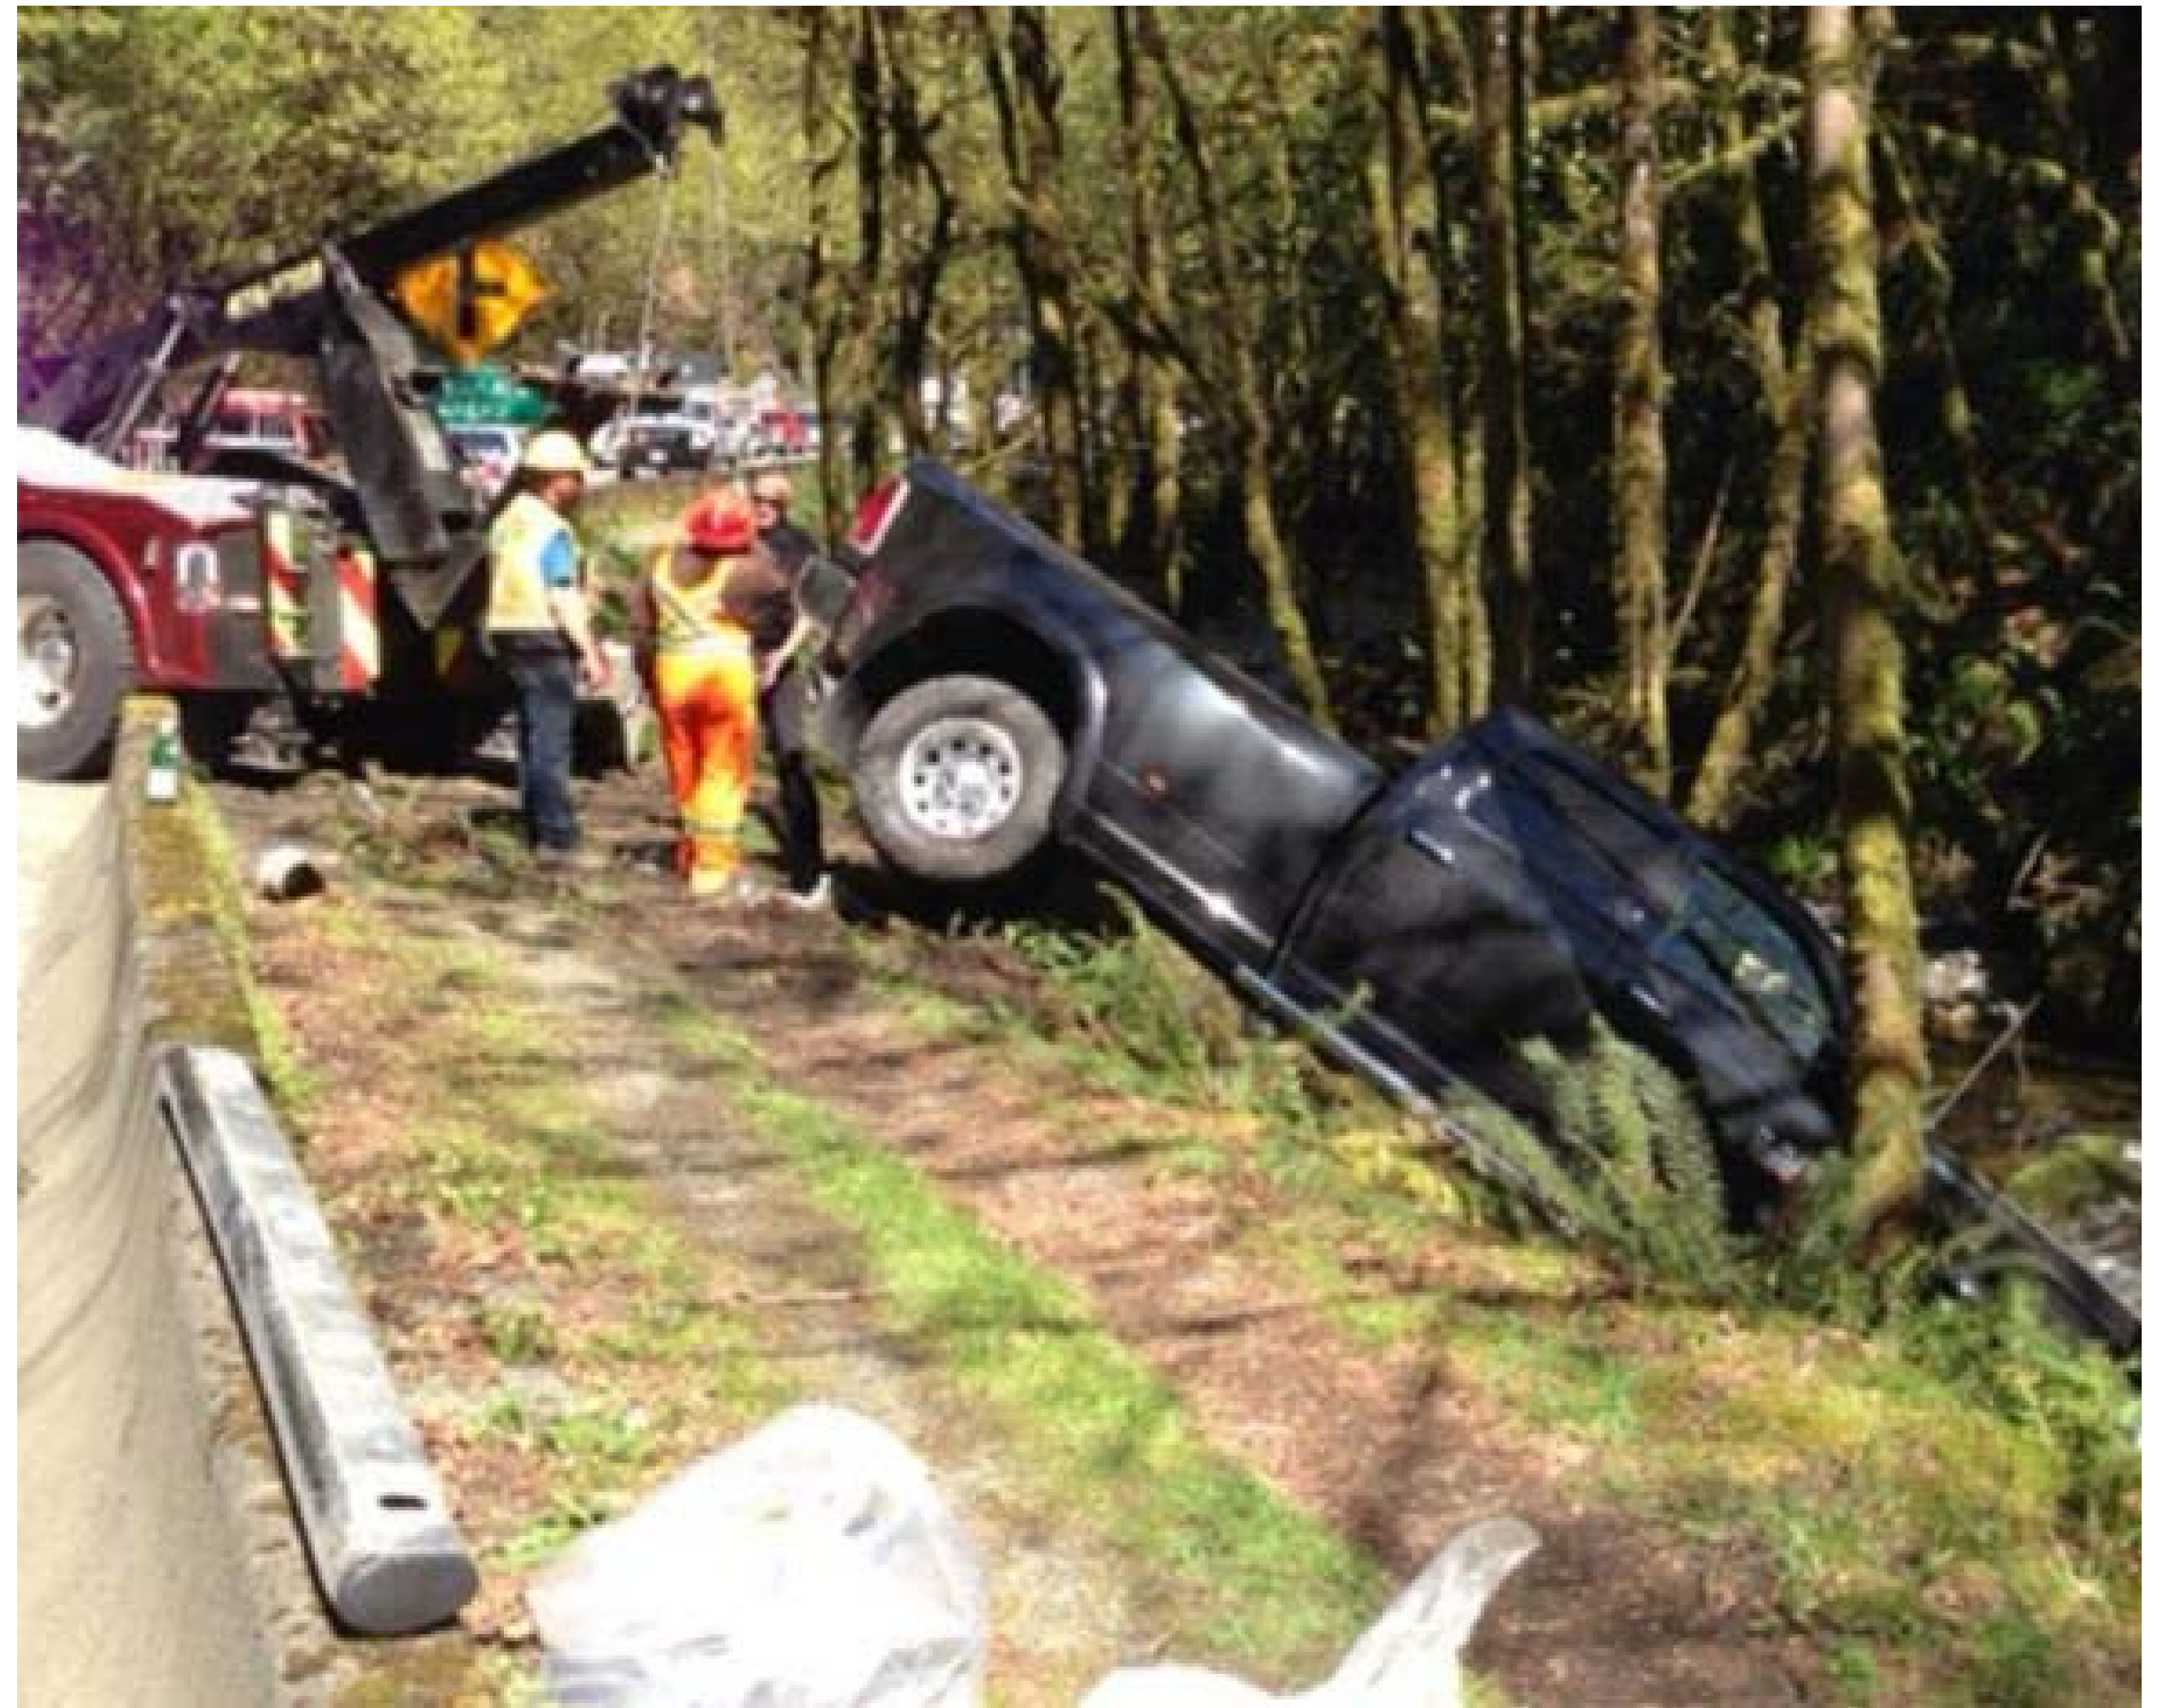
- 45 collisions for the study area in 5 years (2013-2017):
 - 21 Property Damage Only (PDO)
 - 24 Injuries
 - 0 Fatalities
- Collision prone - observed collision rate (0.21 coll/MVK) greater than critical collision rate (0.17 coll/MVK)
- Typical closure durations due to collisions:
 - PDO 0.5 hrs
 - Injury 2 hrs
 - Fatality: 6 hrs

Collisions by Year for Project Segment

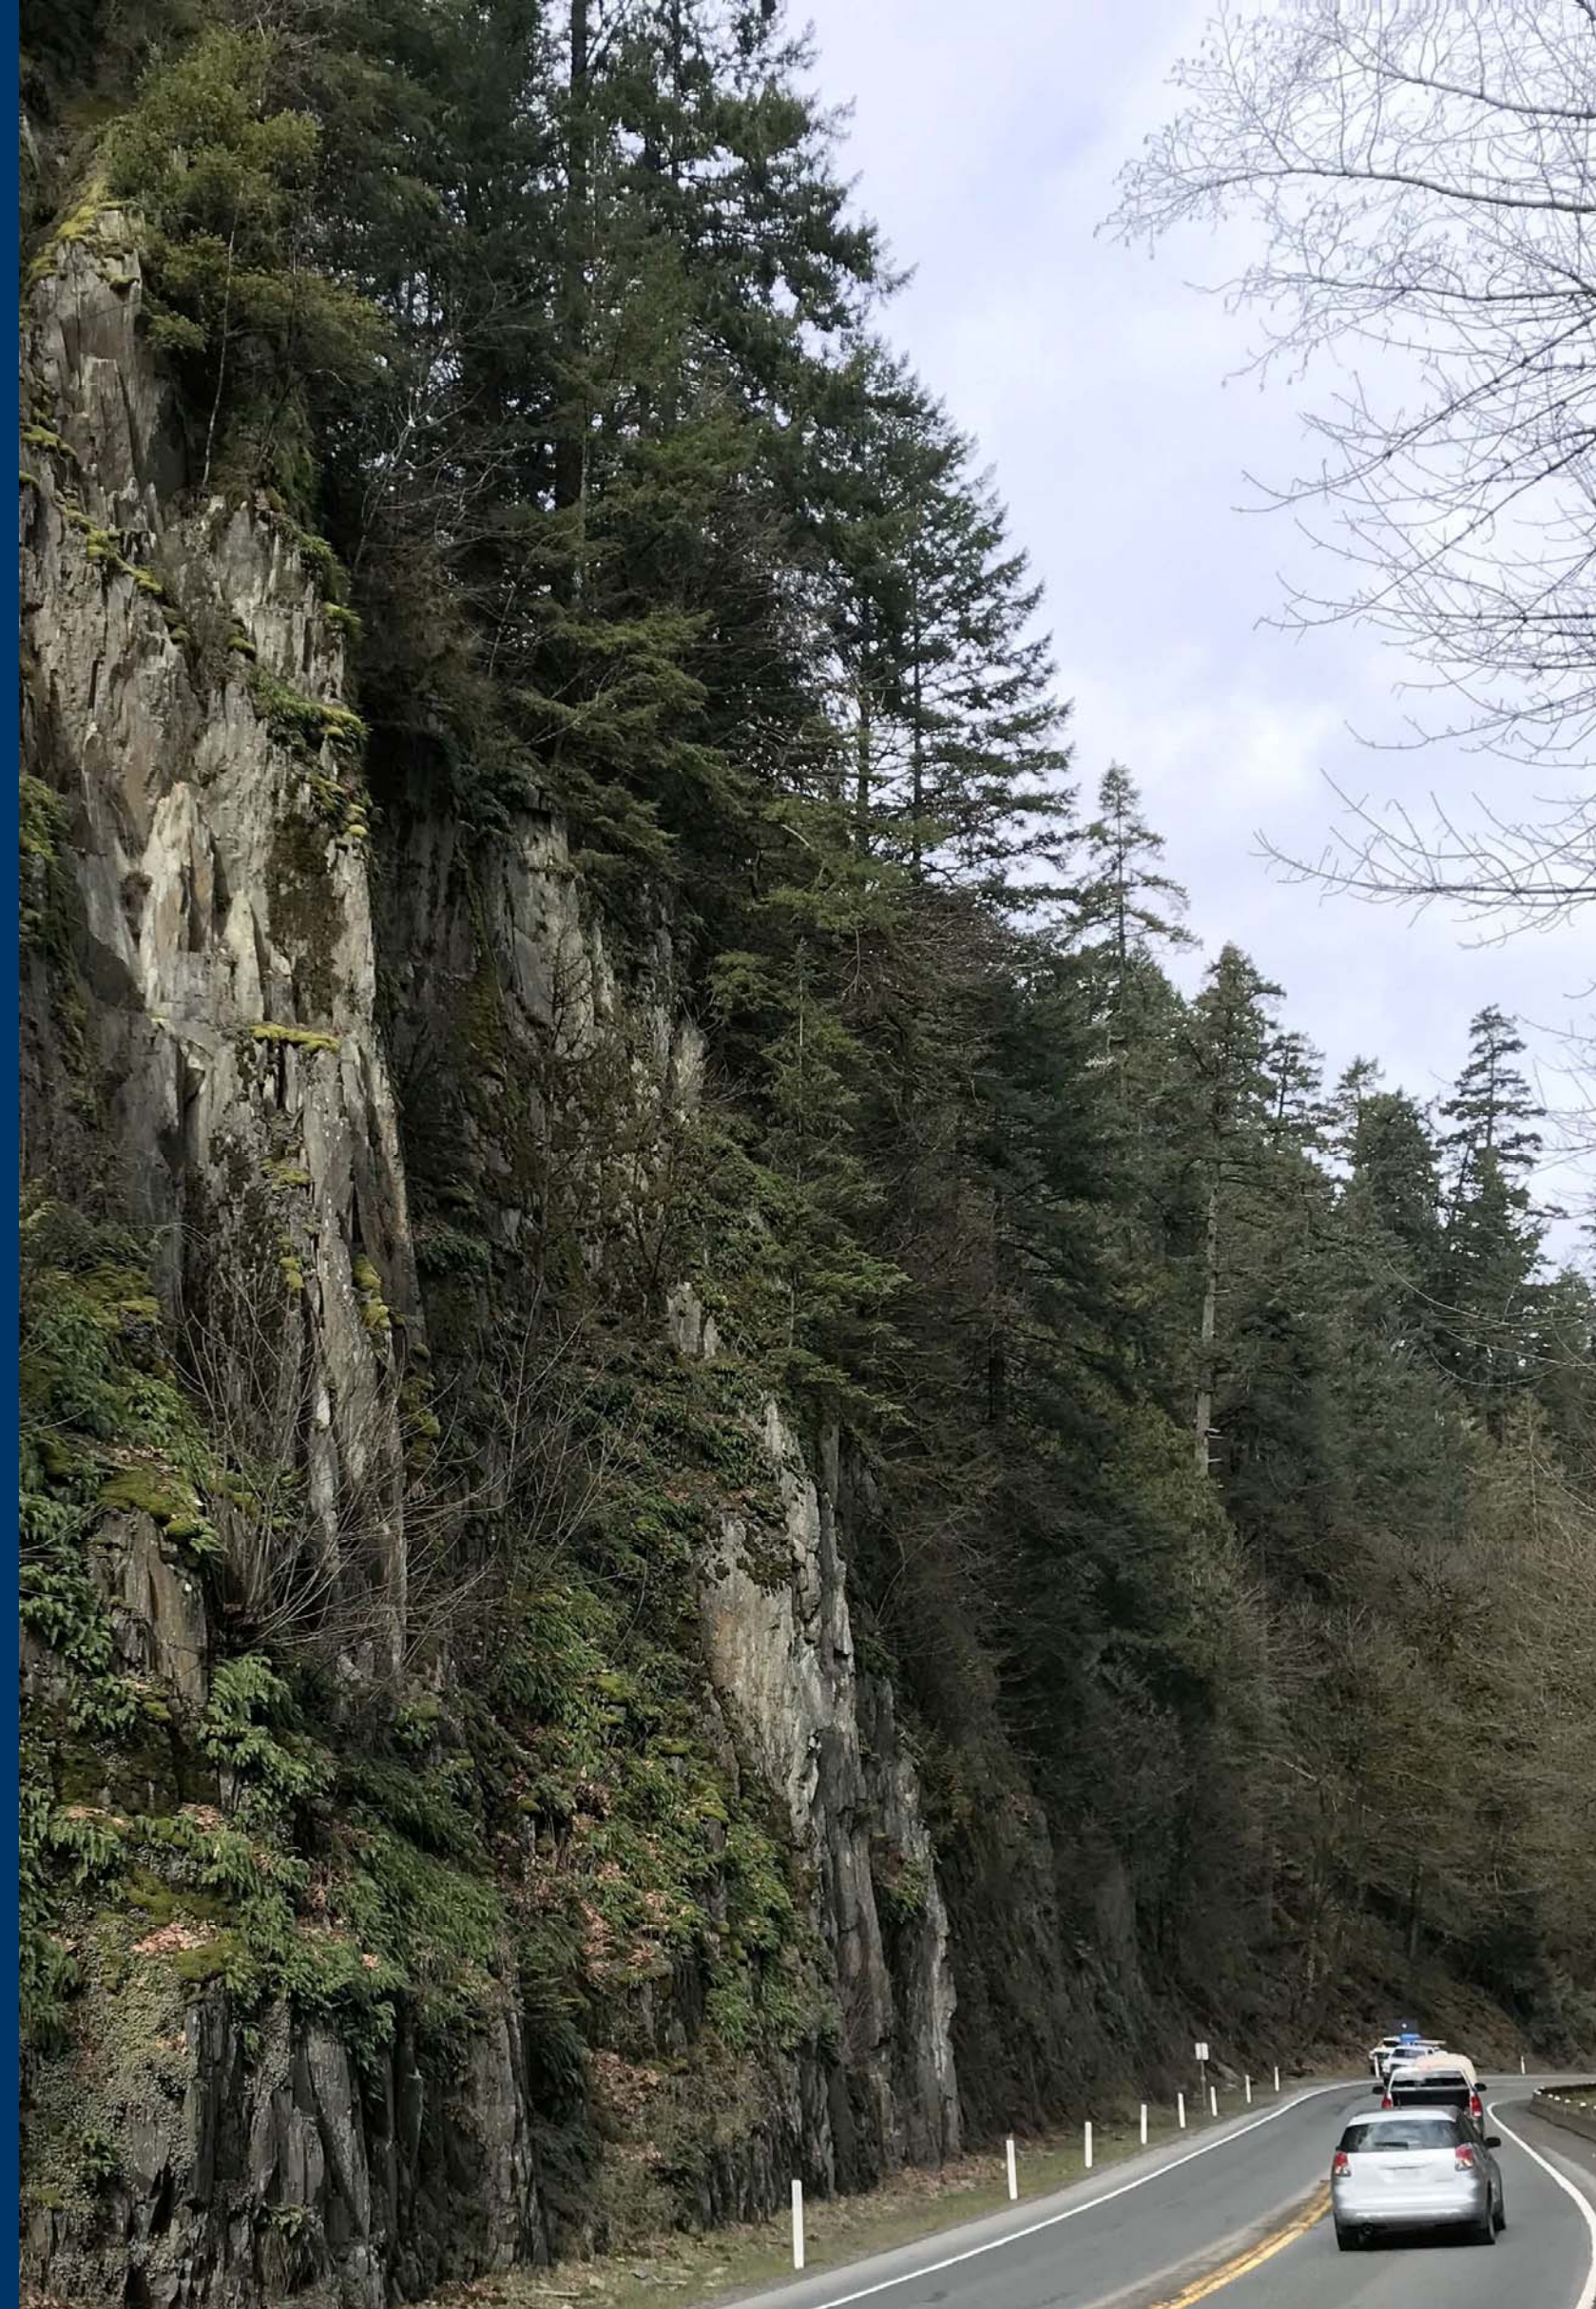
- Existing rock cuts of over 20m height with tops extending into park boundaries.
- Existing drainage infrastructure is limited, with direct outflow into river from highway
- Sensitive habitats and ecosystems, with unique ecological values
- Dry rock-stacked retaining wall currently supporting highway

Steep rock

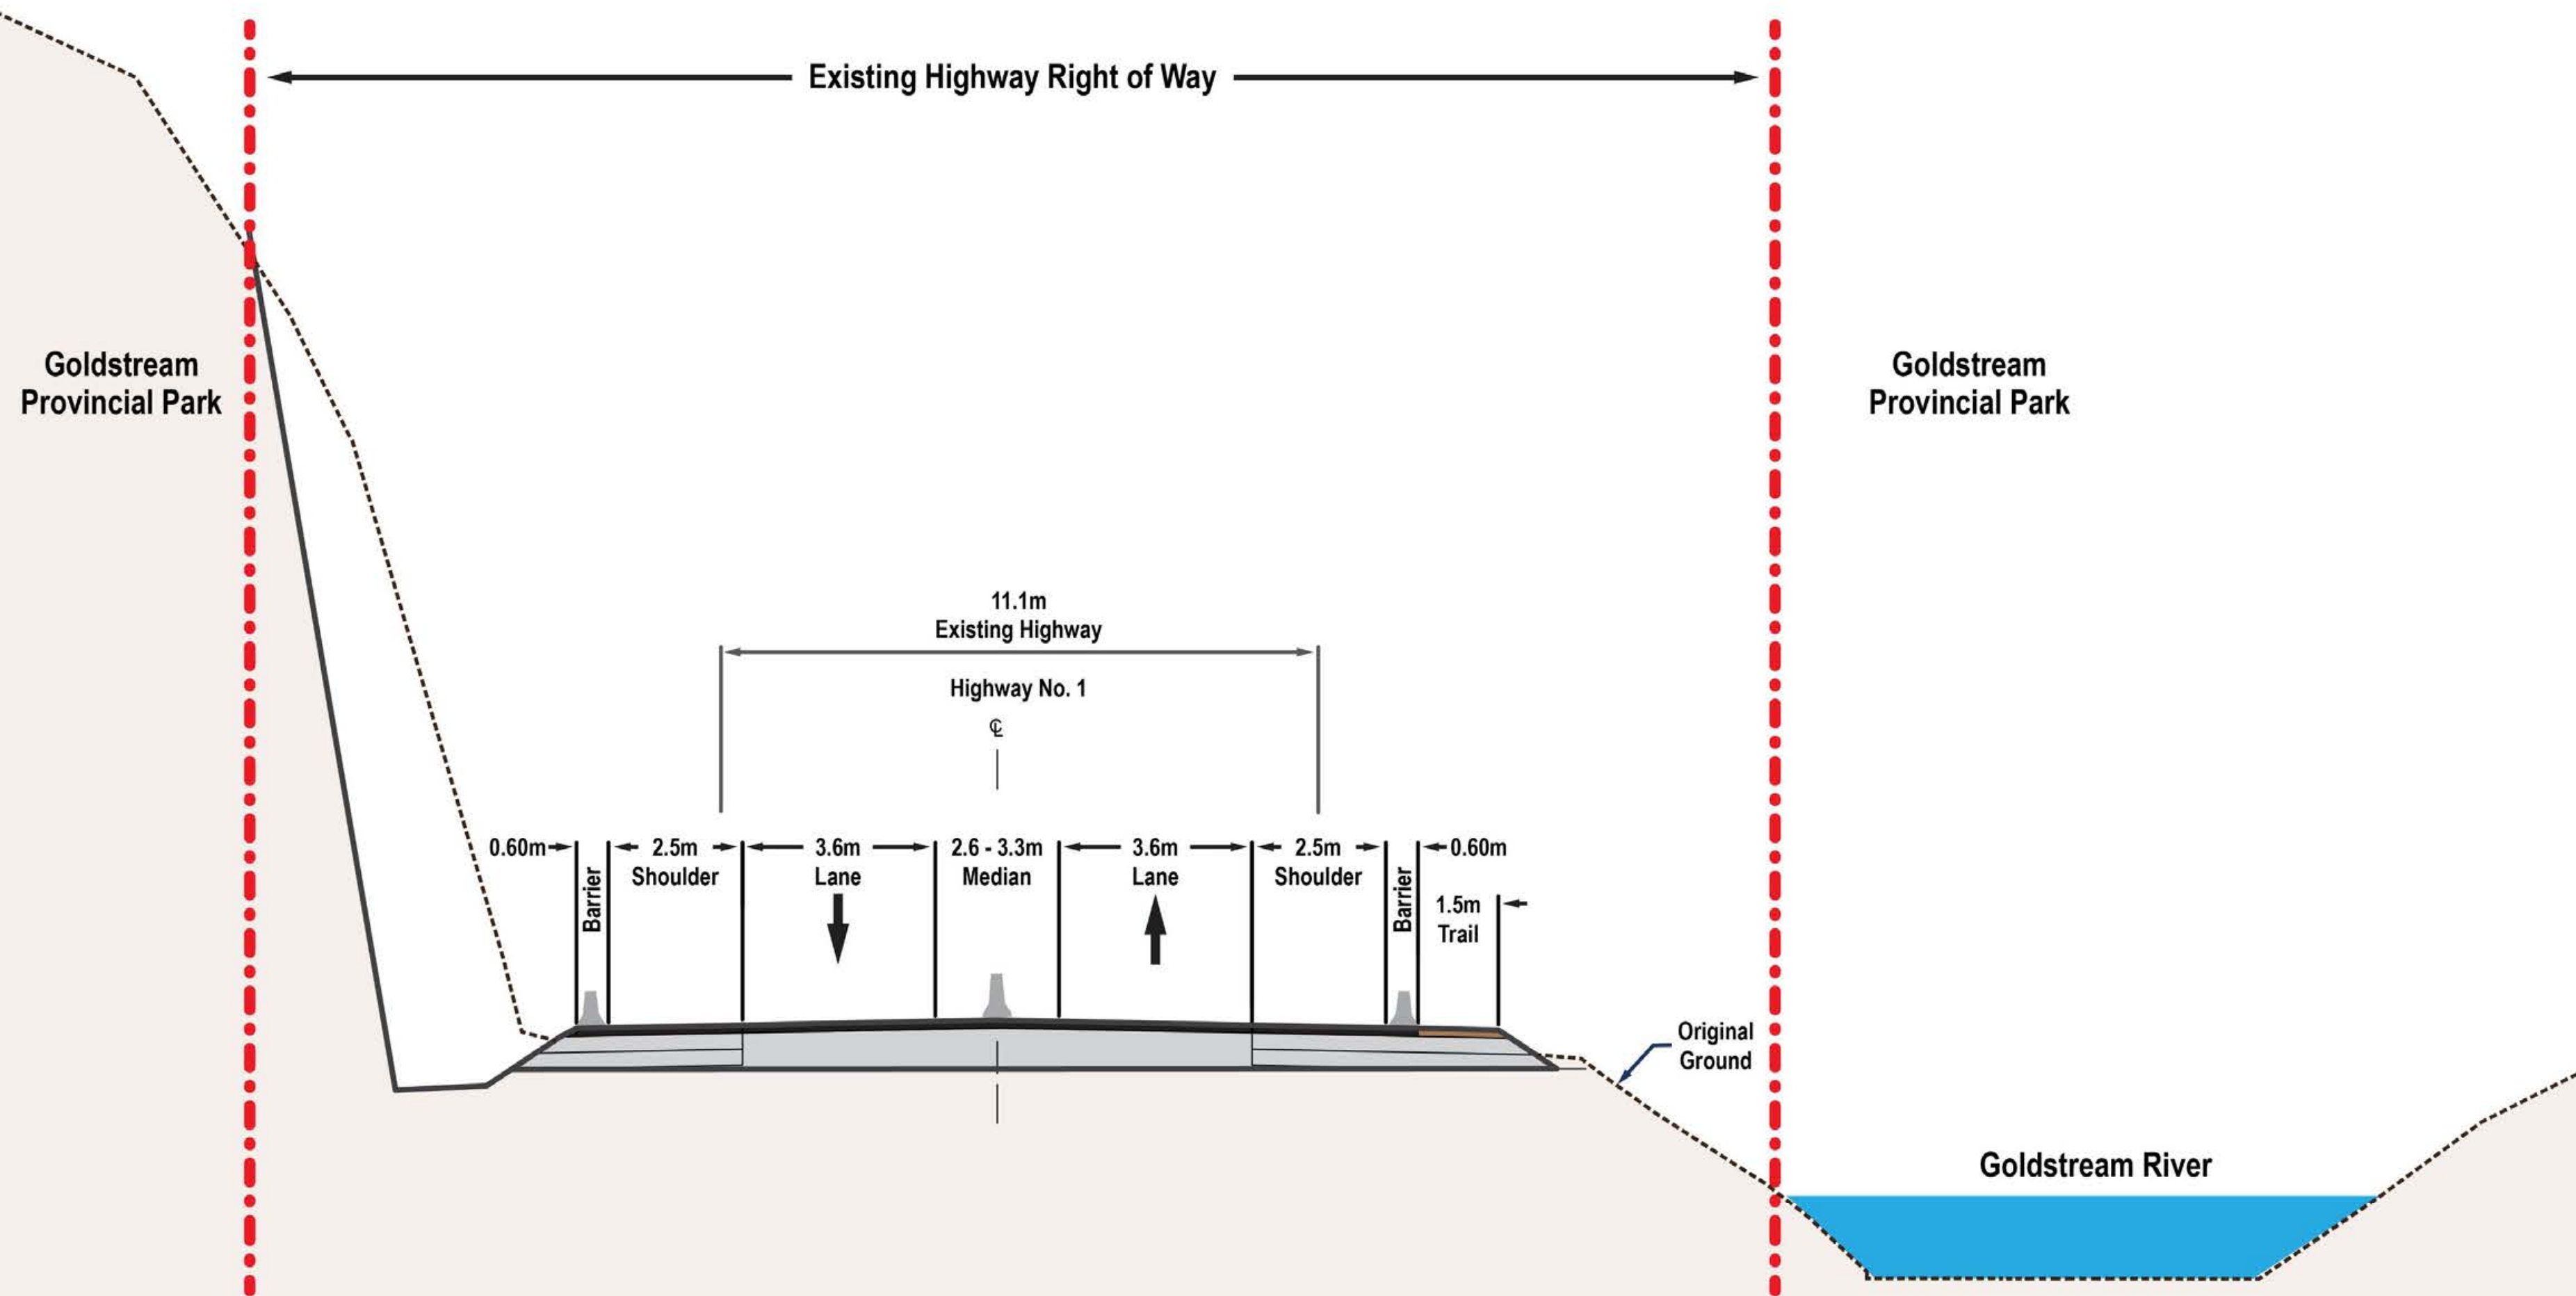
Limited Right-of-way

- Median division and roadside barrier protection can be achieved within existing right of way
- Additional laning would require encroachment into park with extensive and extremely challenging rock cuts
- Retaining walls upslope and downslope as well as a cantilever bridge structure required to mitigate park boundary encroachments
- Temporary construction access within edge of park required adjacent to Goldstream River bridge to access top of rock cut. Rock cut resides within highway right of way.

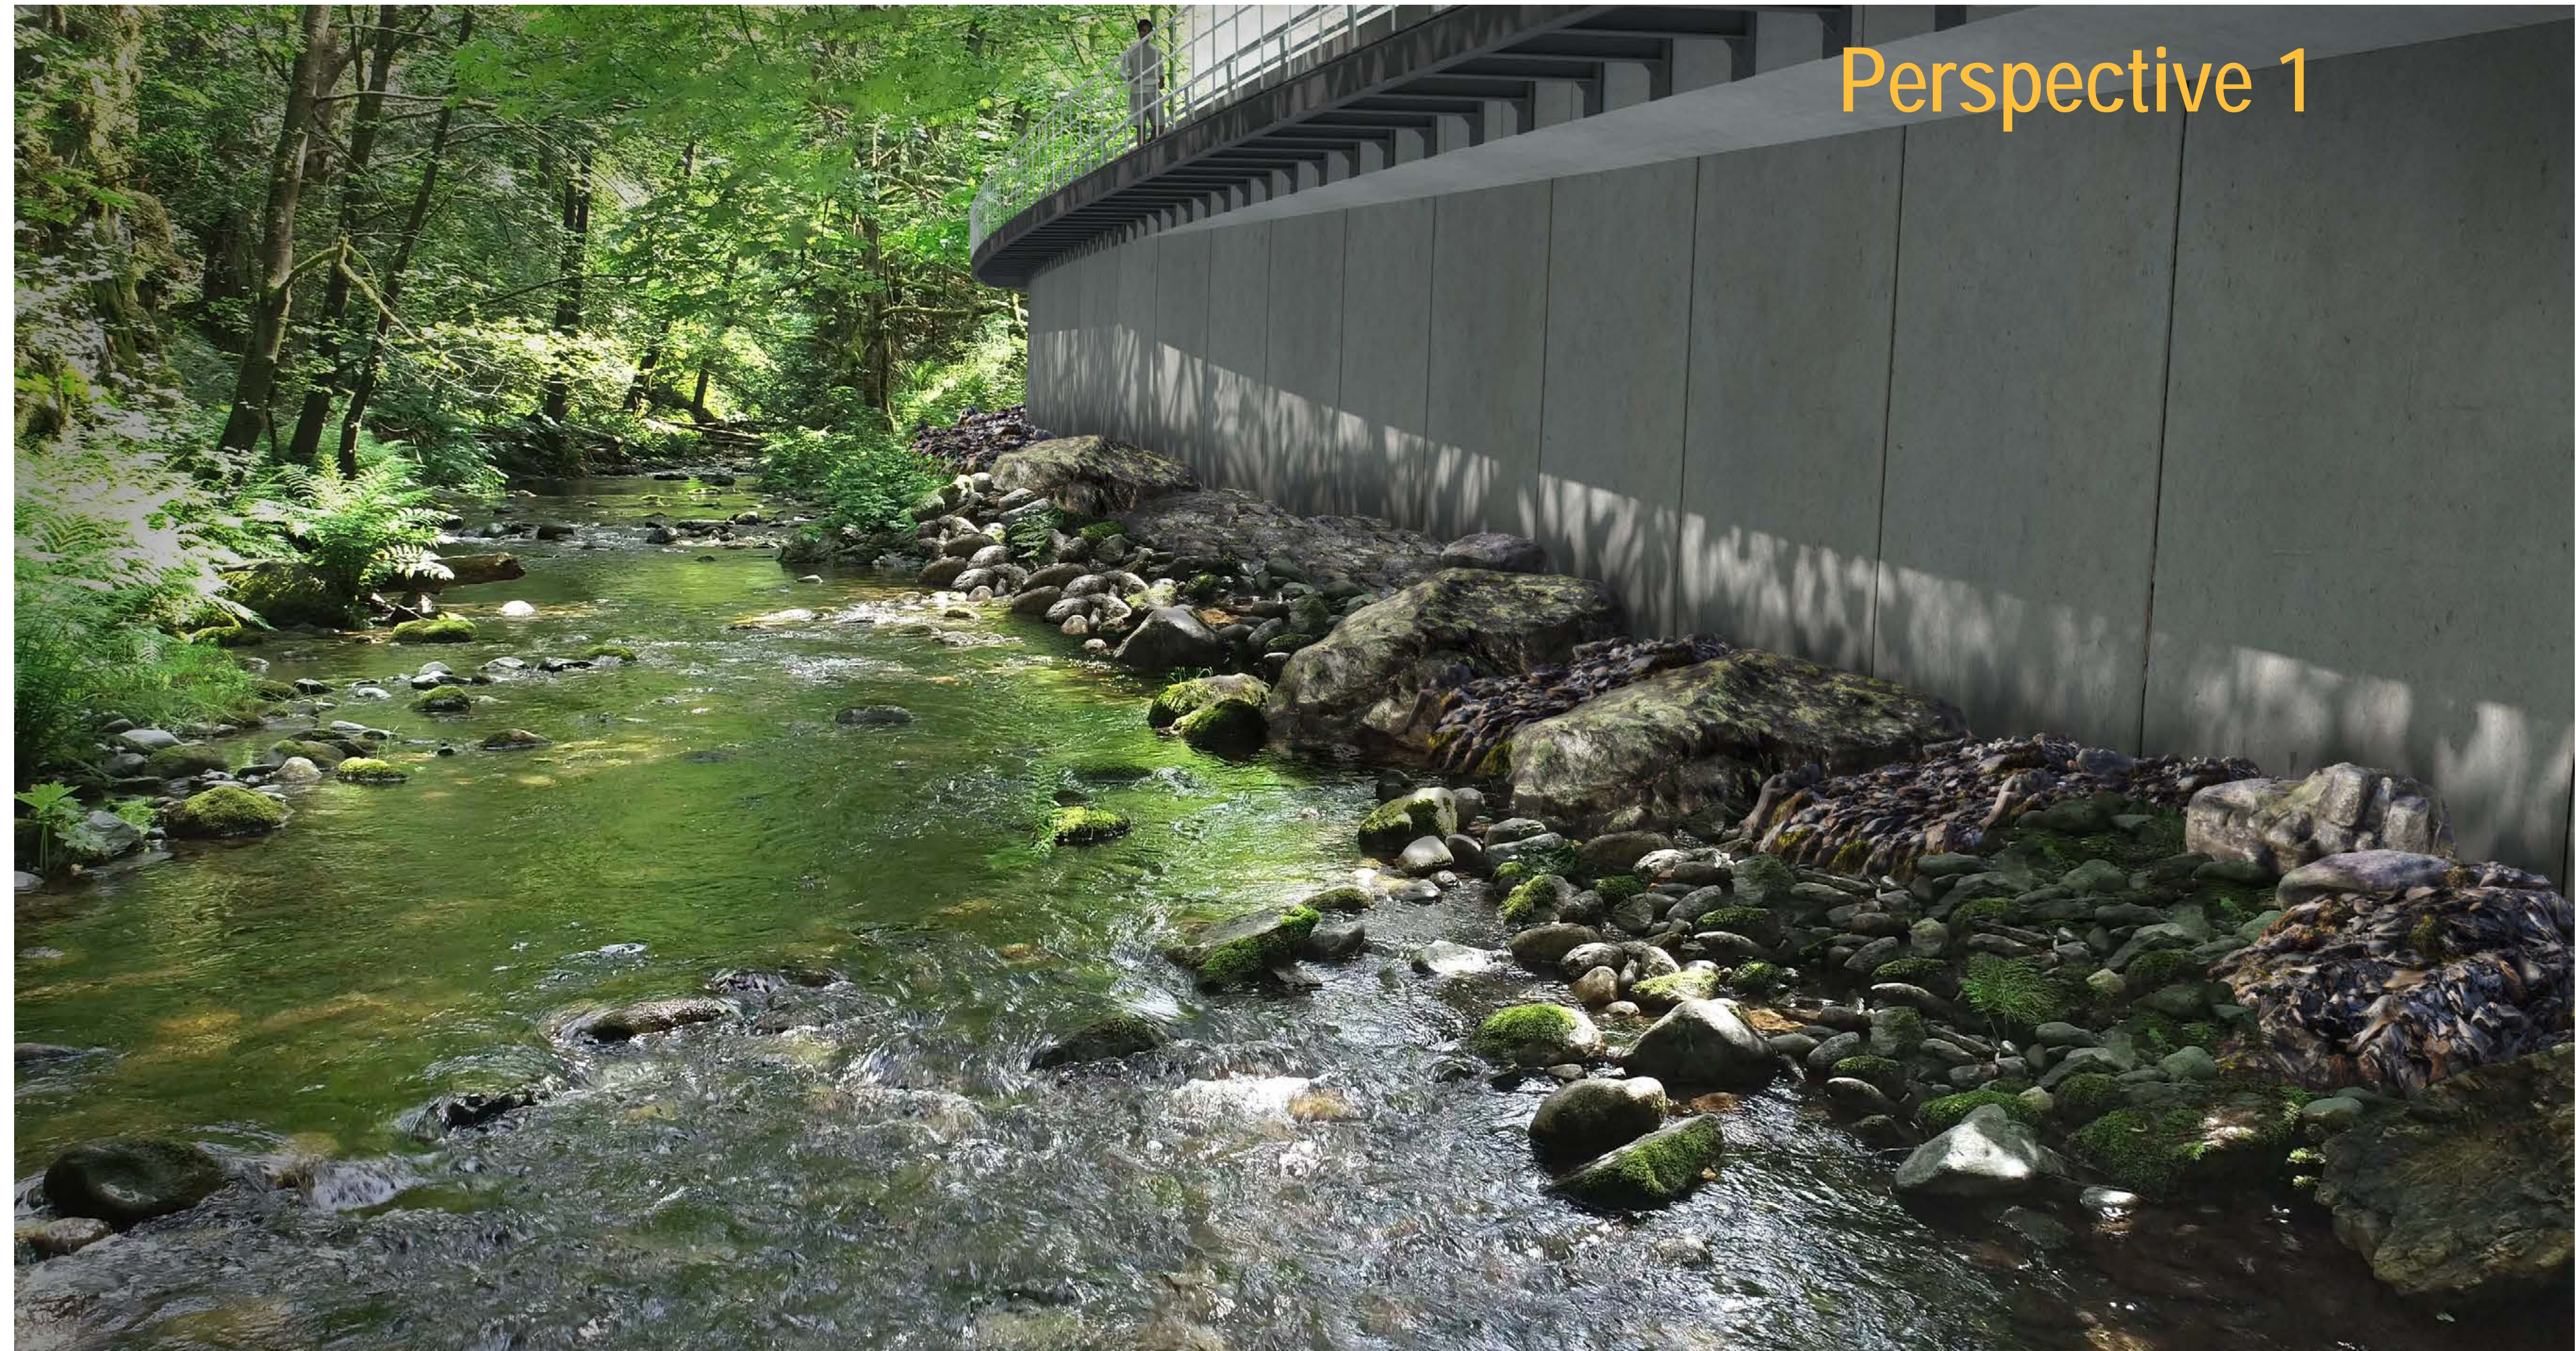
Section B

Retaining Wall

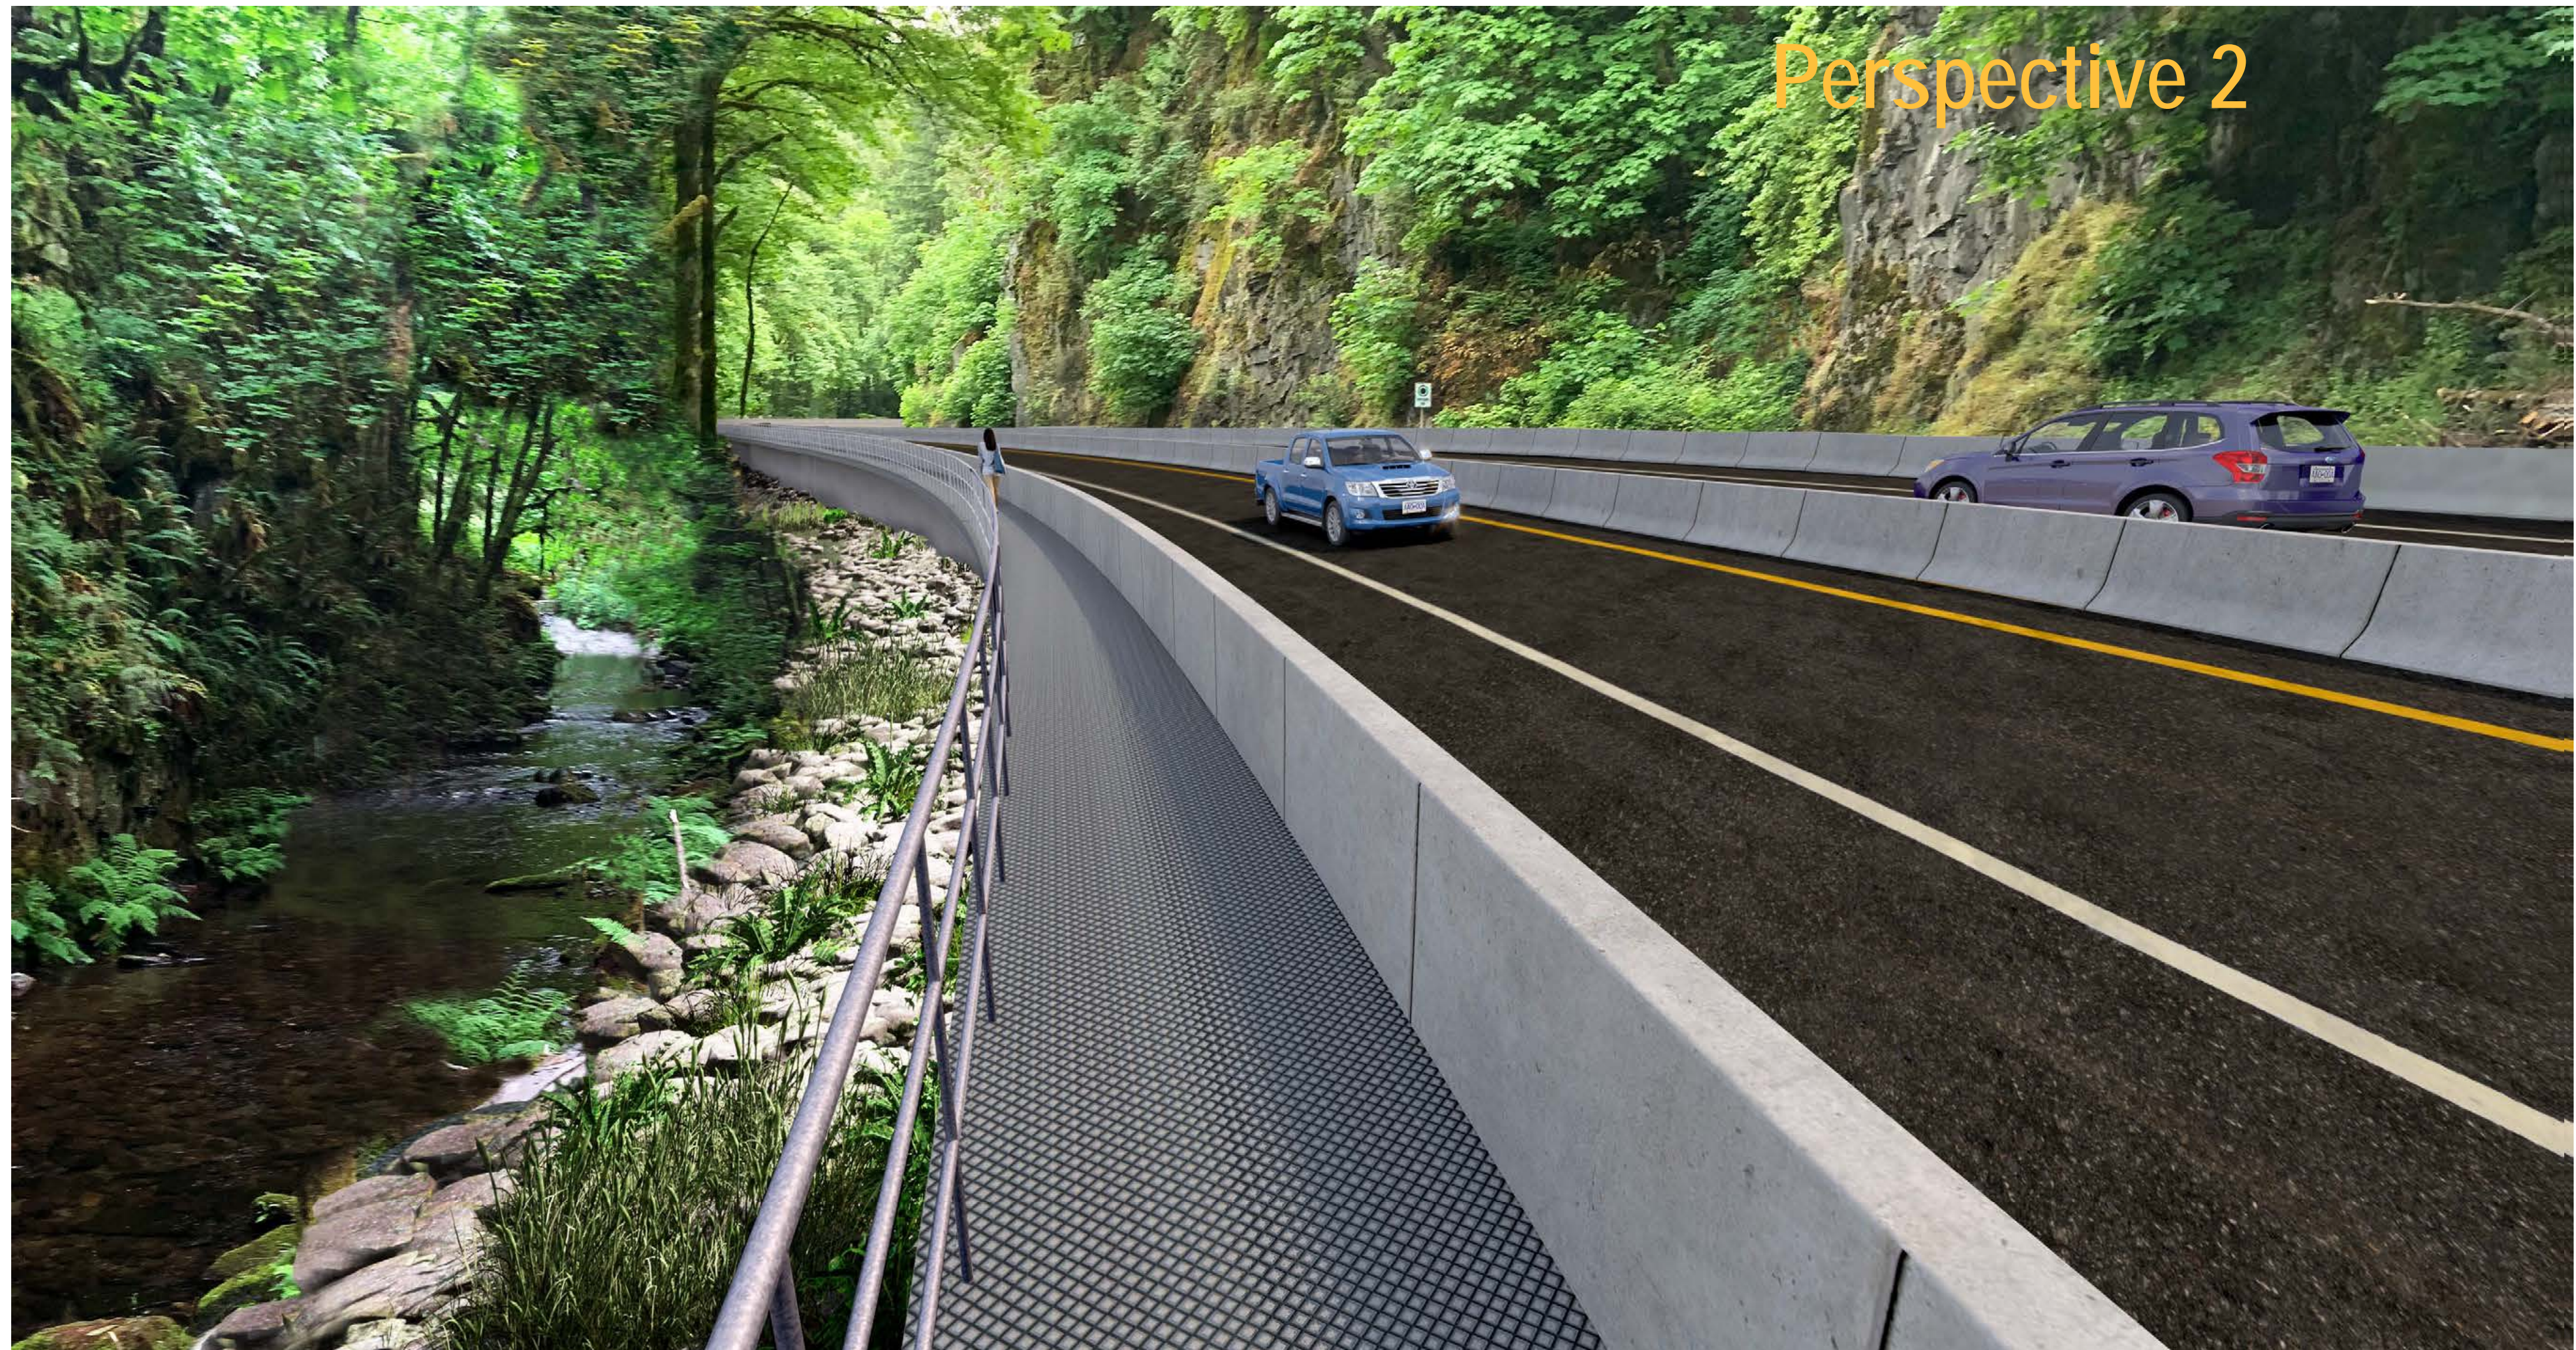
Perspective 3

Retaining Wall
