Ministry of
Transportation
and Infrastructure

Trans Canada Highway 1 –
Malahat Corridor Improvements

Goldstream Median Barrier Widening

August 2020

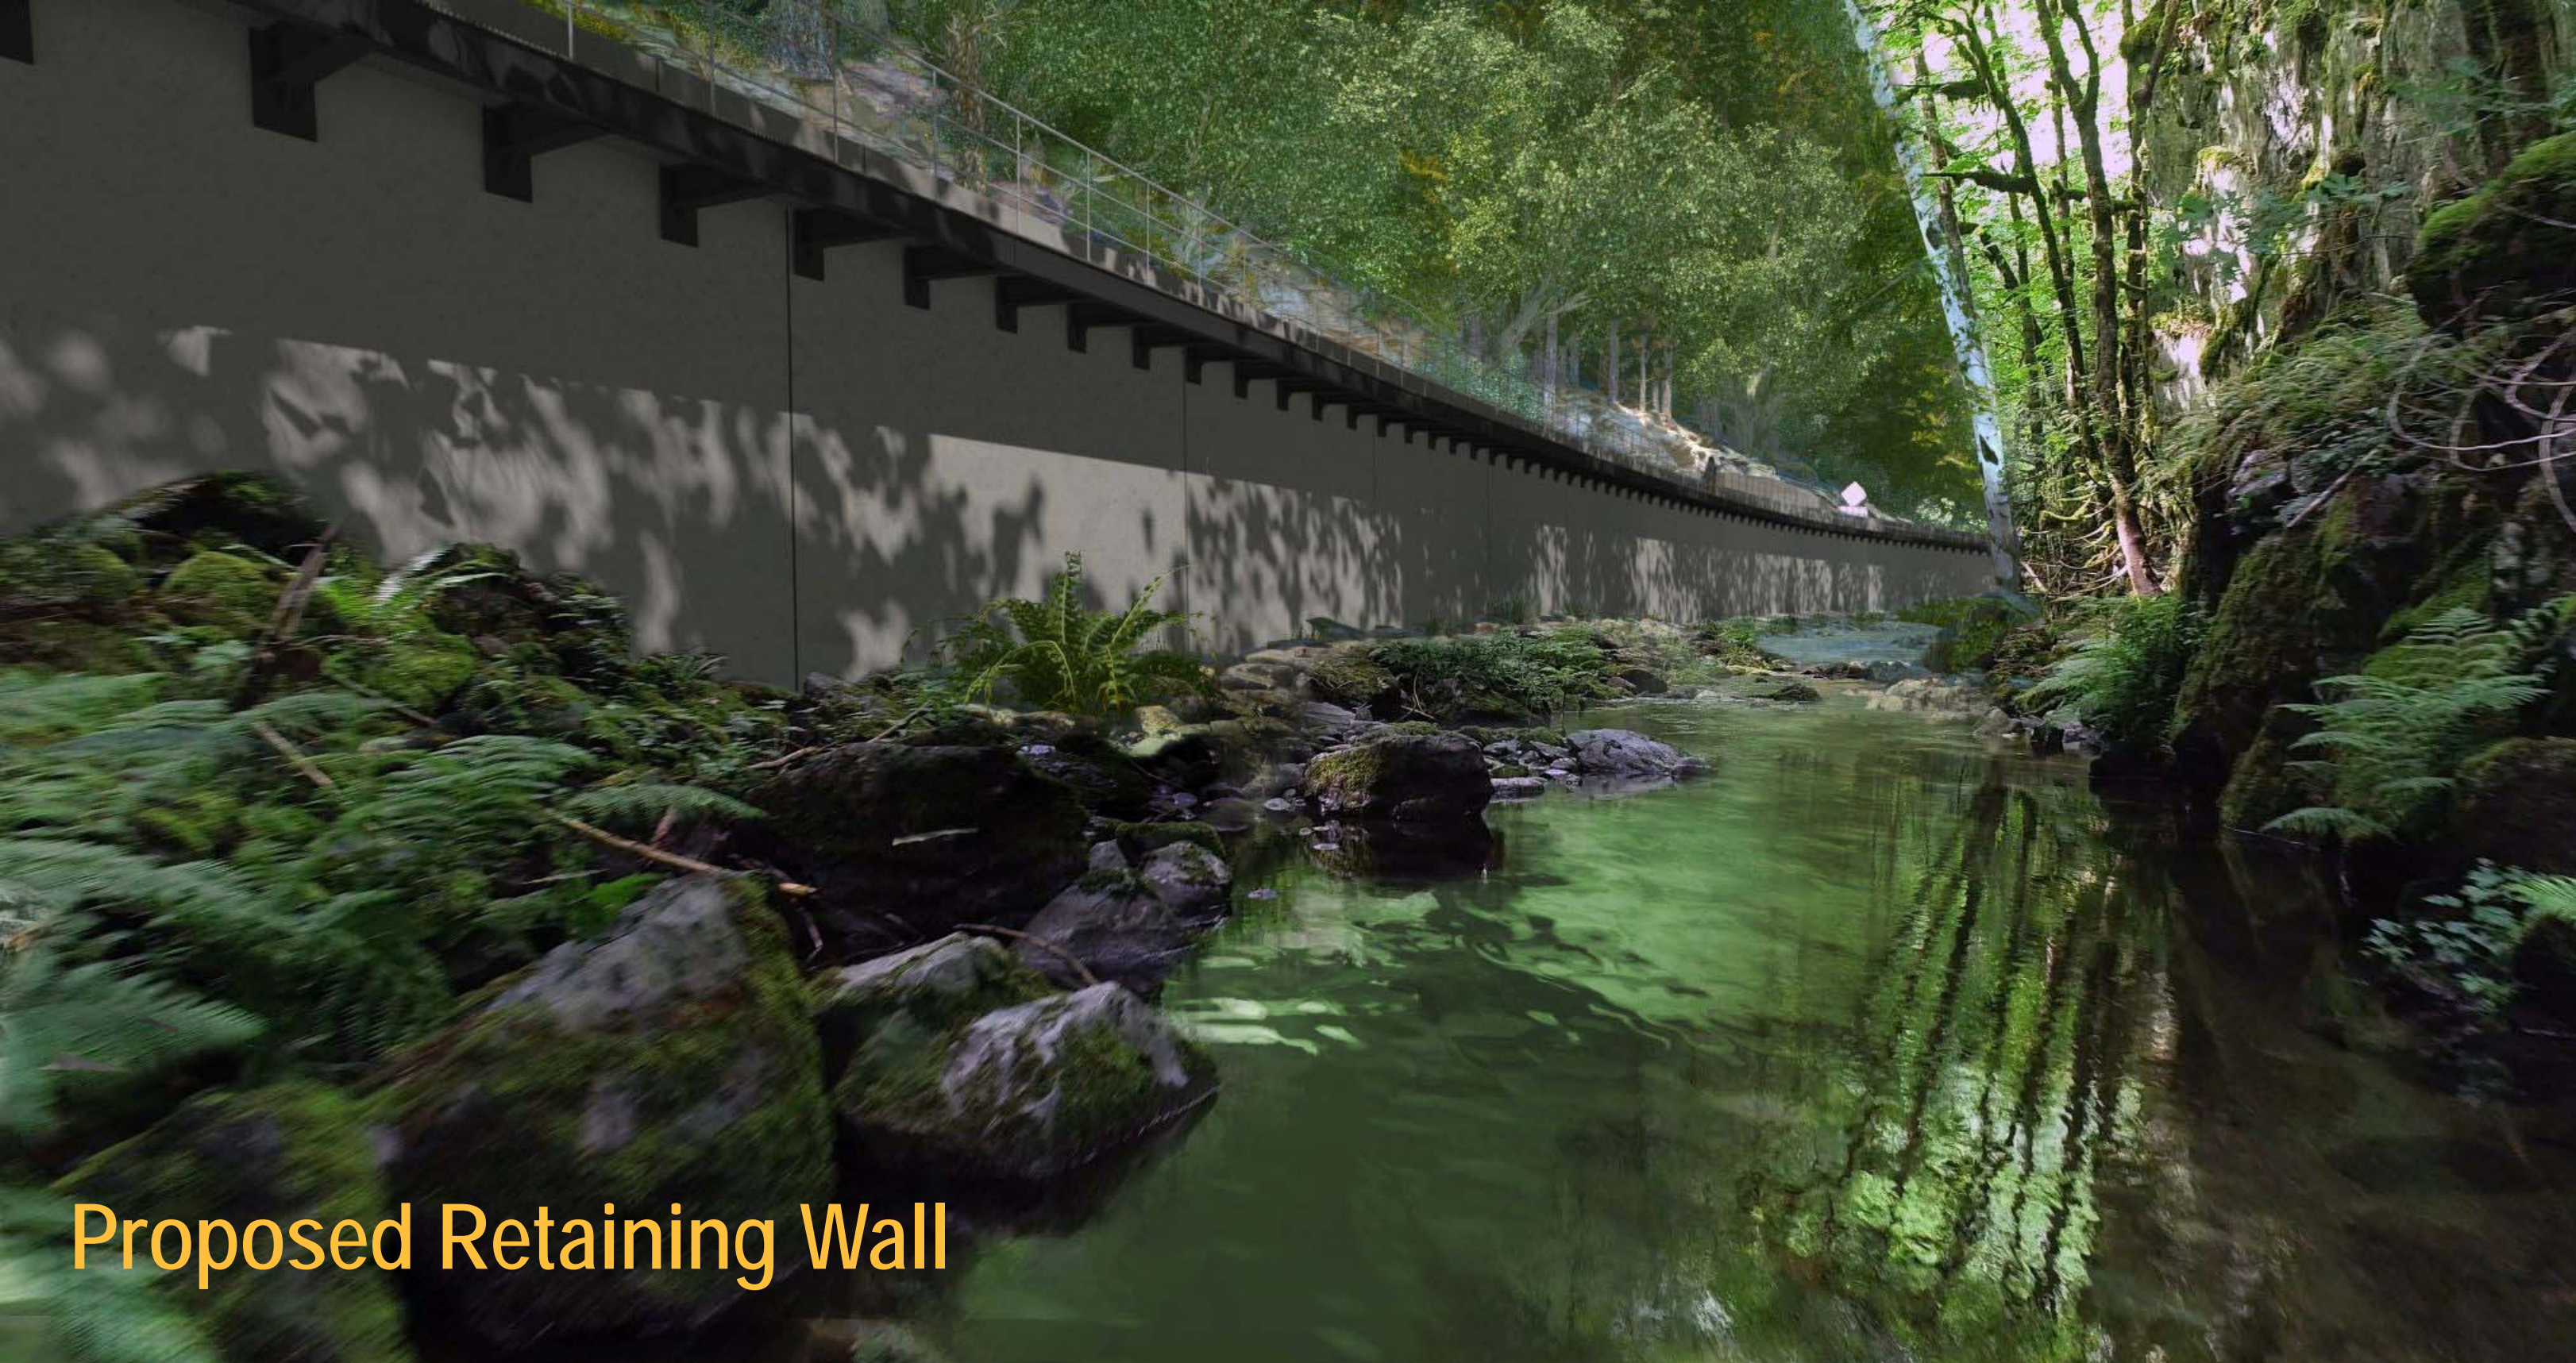
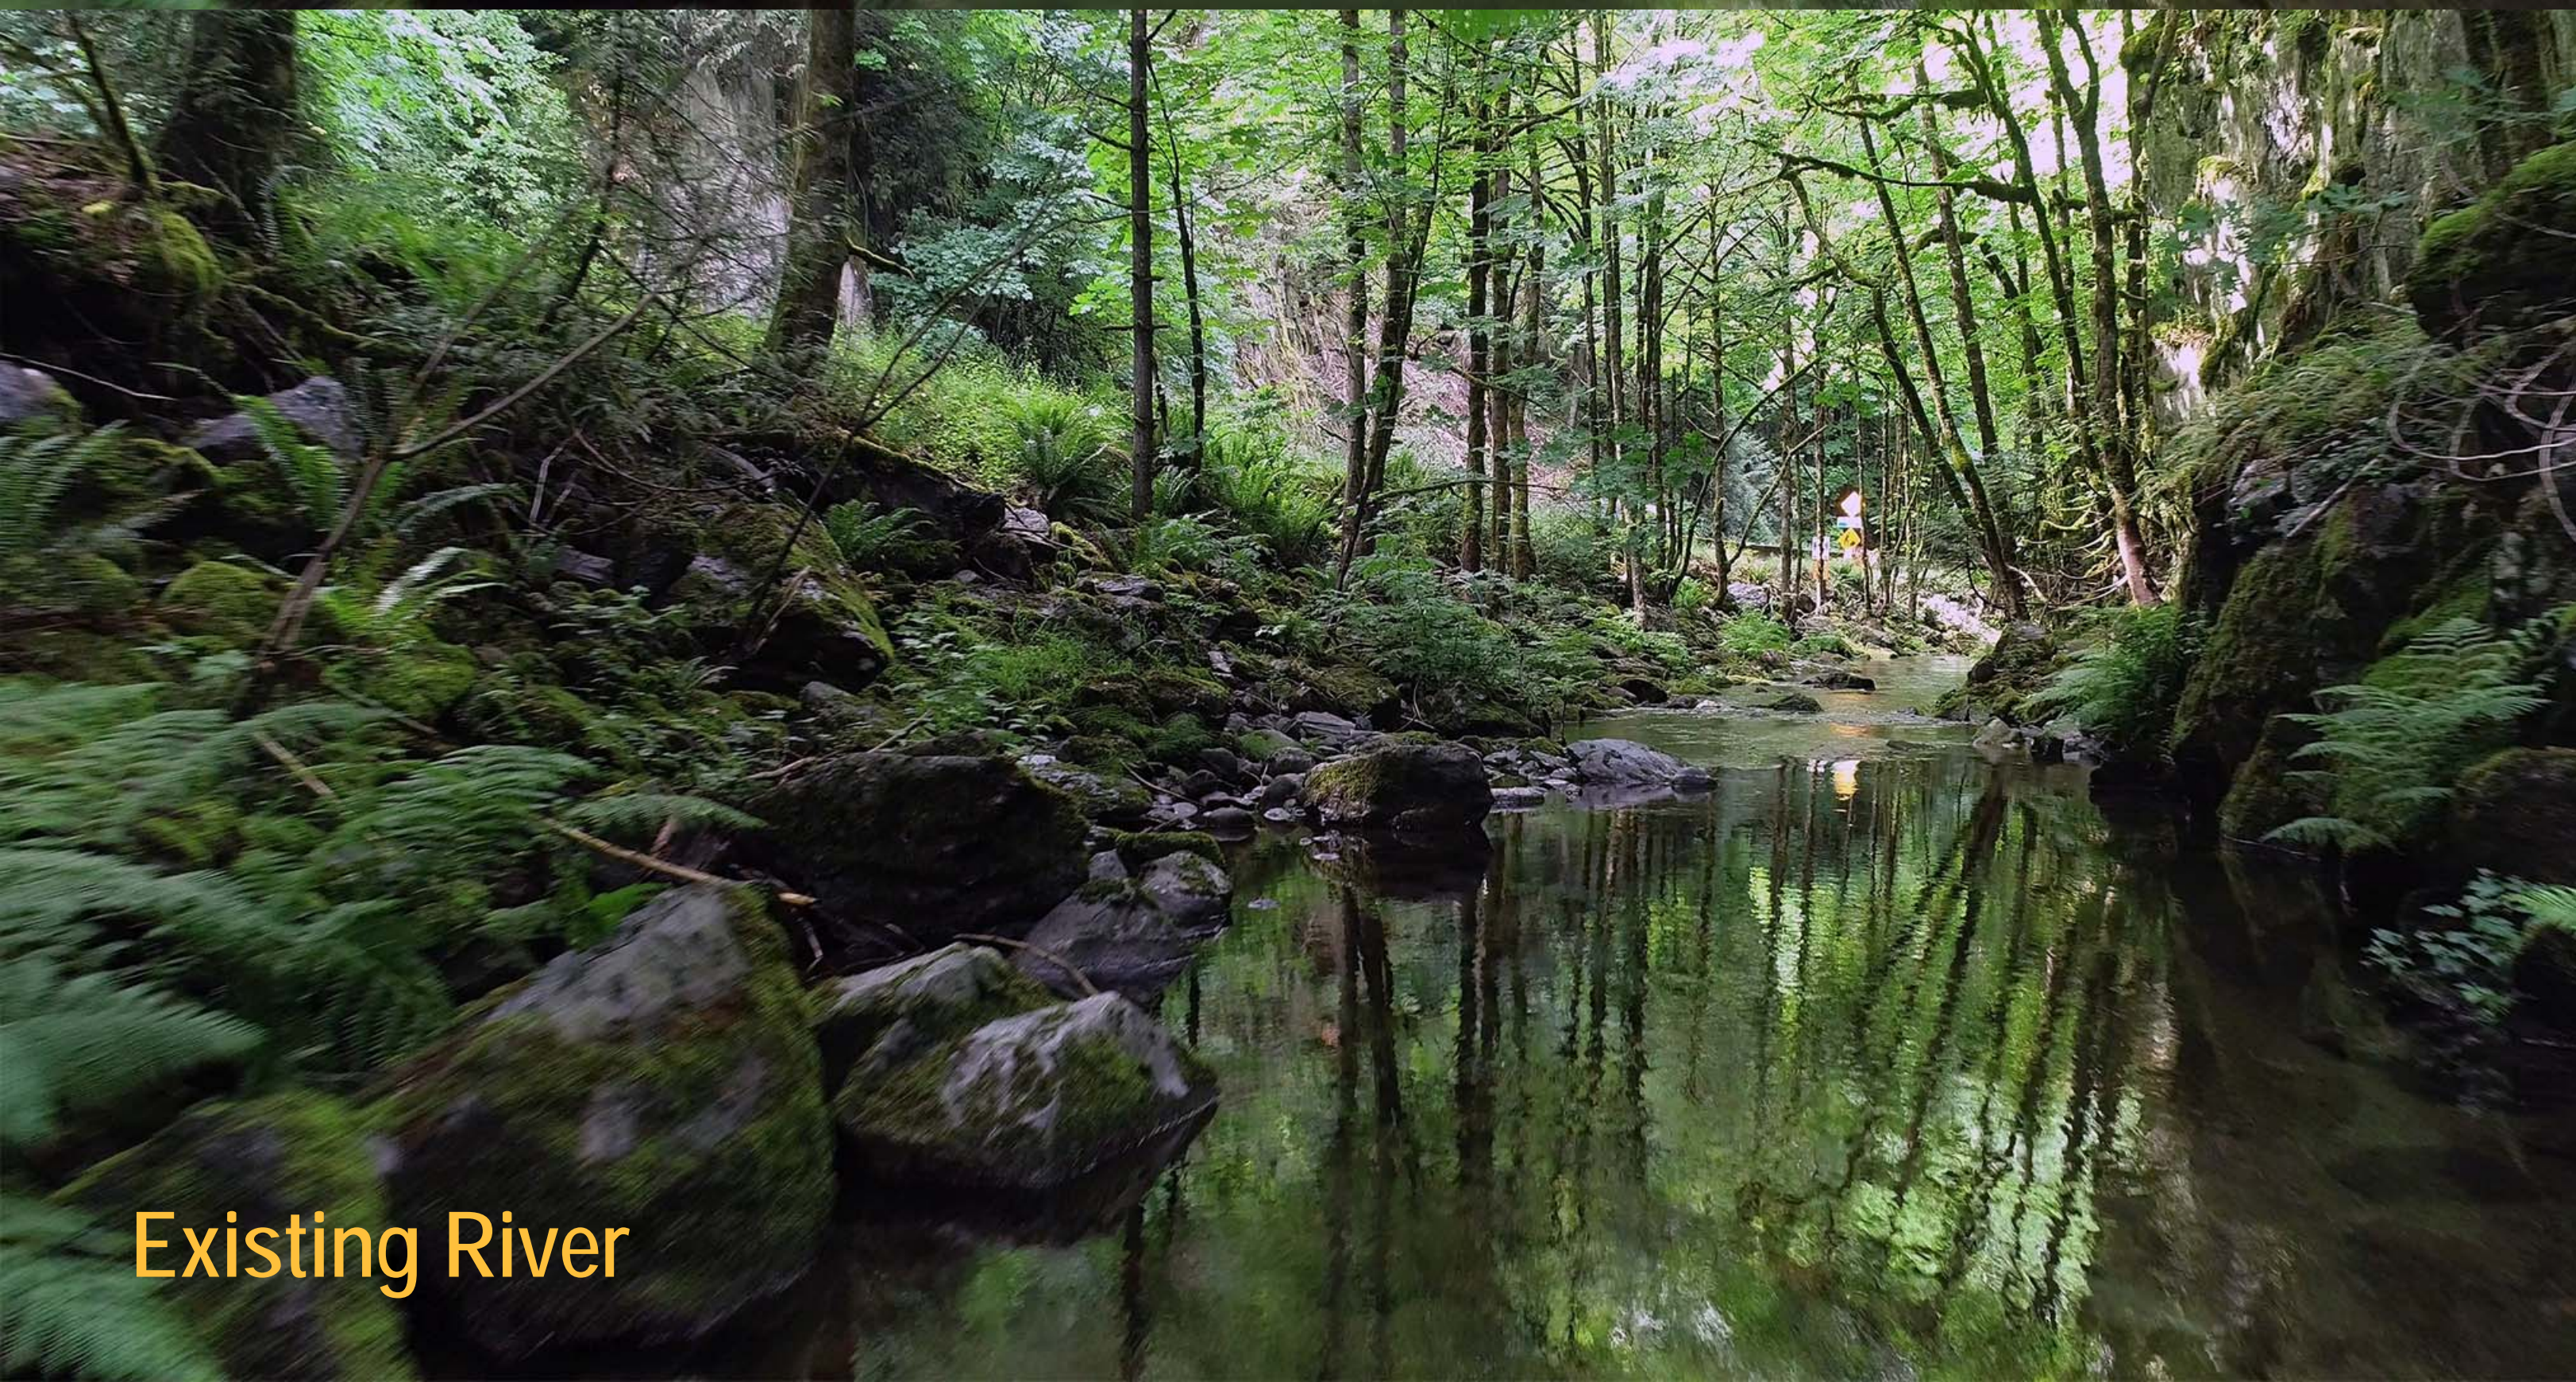
Proposed Retaining Wall

Existing River

- Retaining wall limits intrusion into river
- Vegetation retained or replaced
- Walkway above river provides safe, unobstructed overhead viewing of salmon spawning
- Retaining wall and walkway provide shade for fish

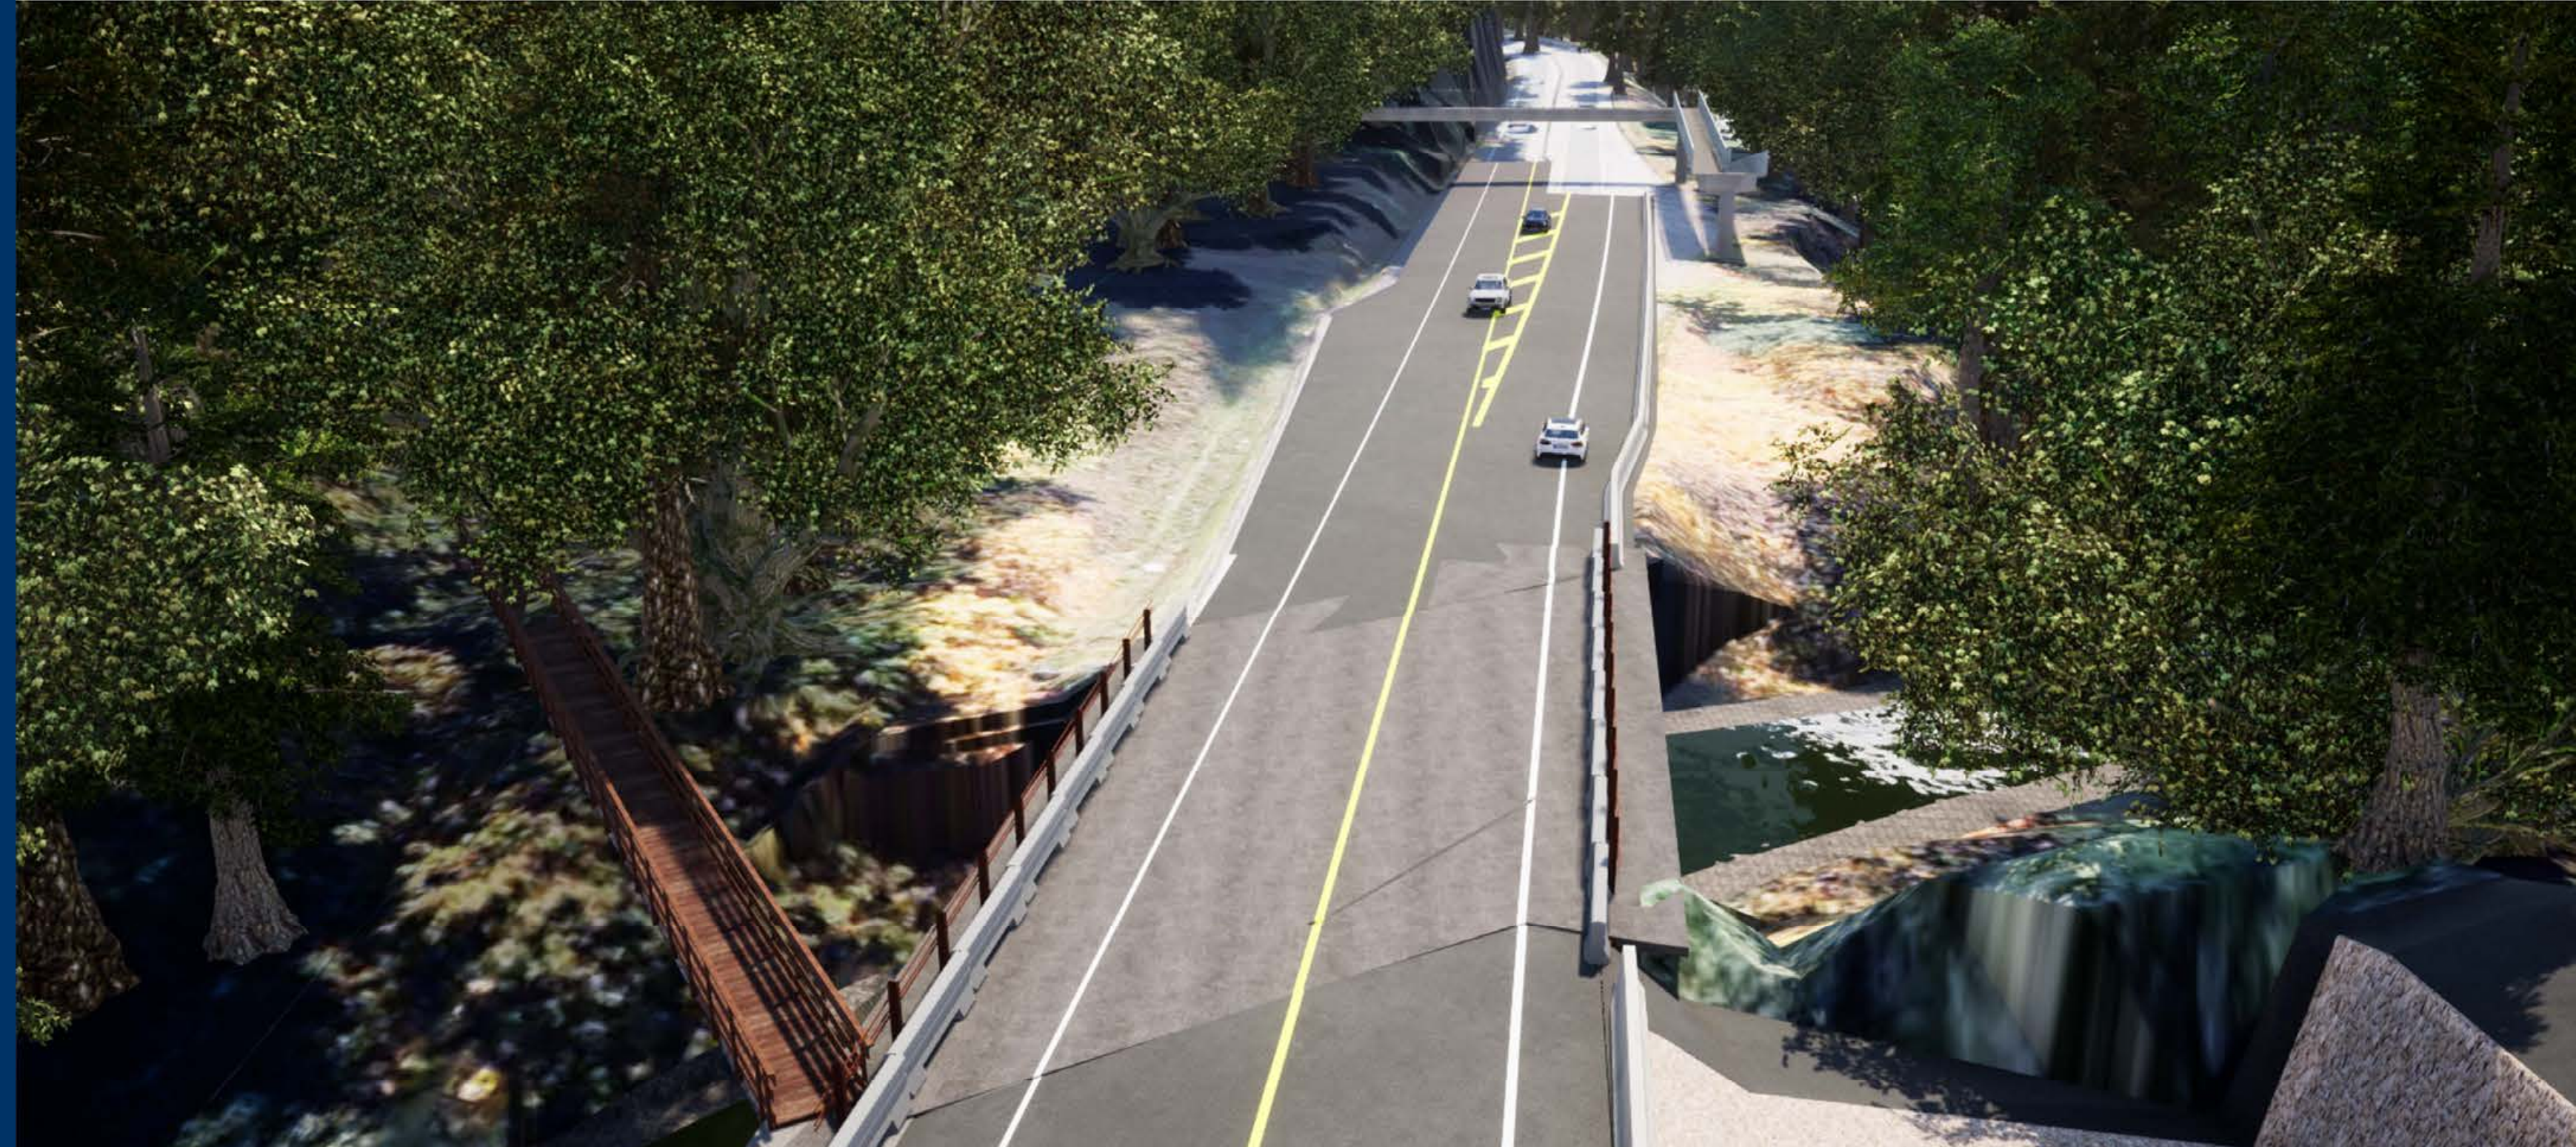
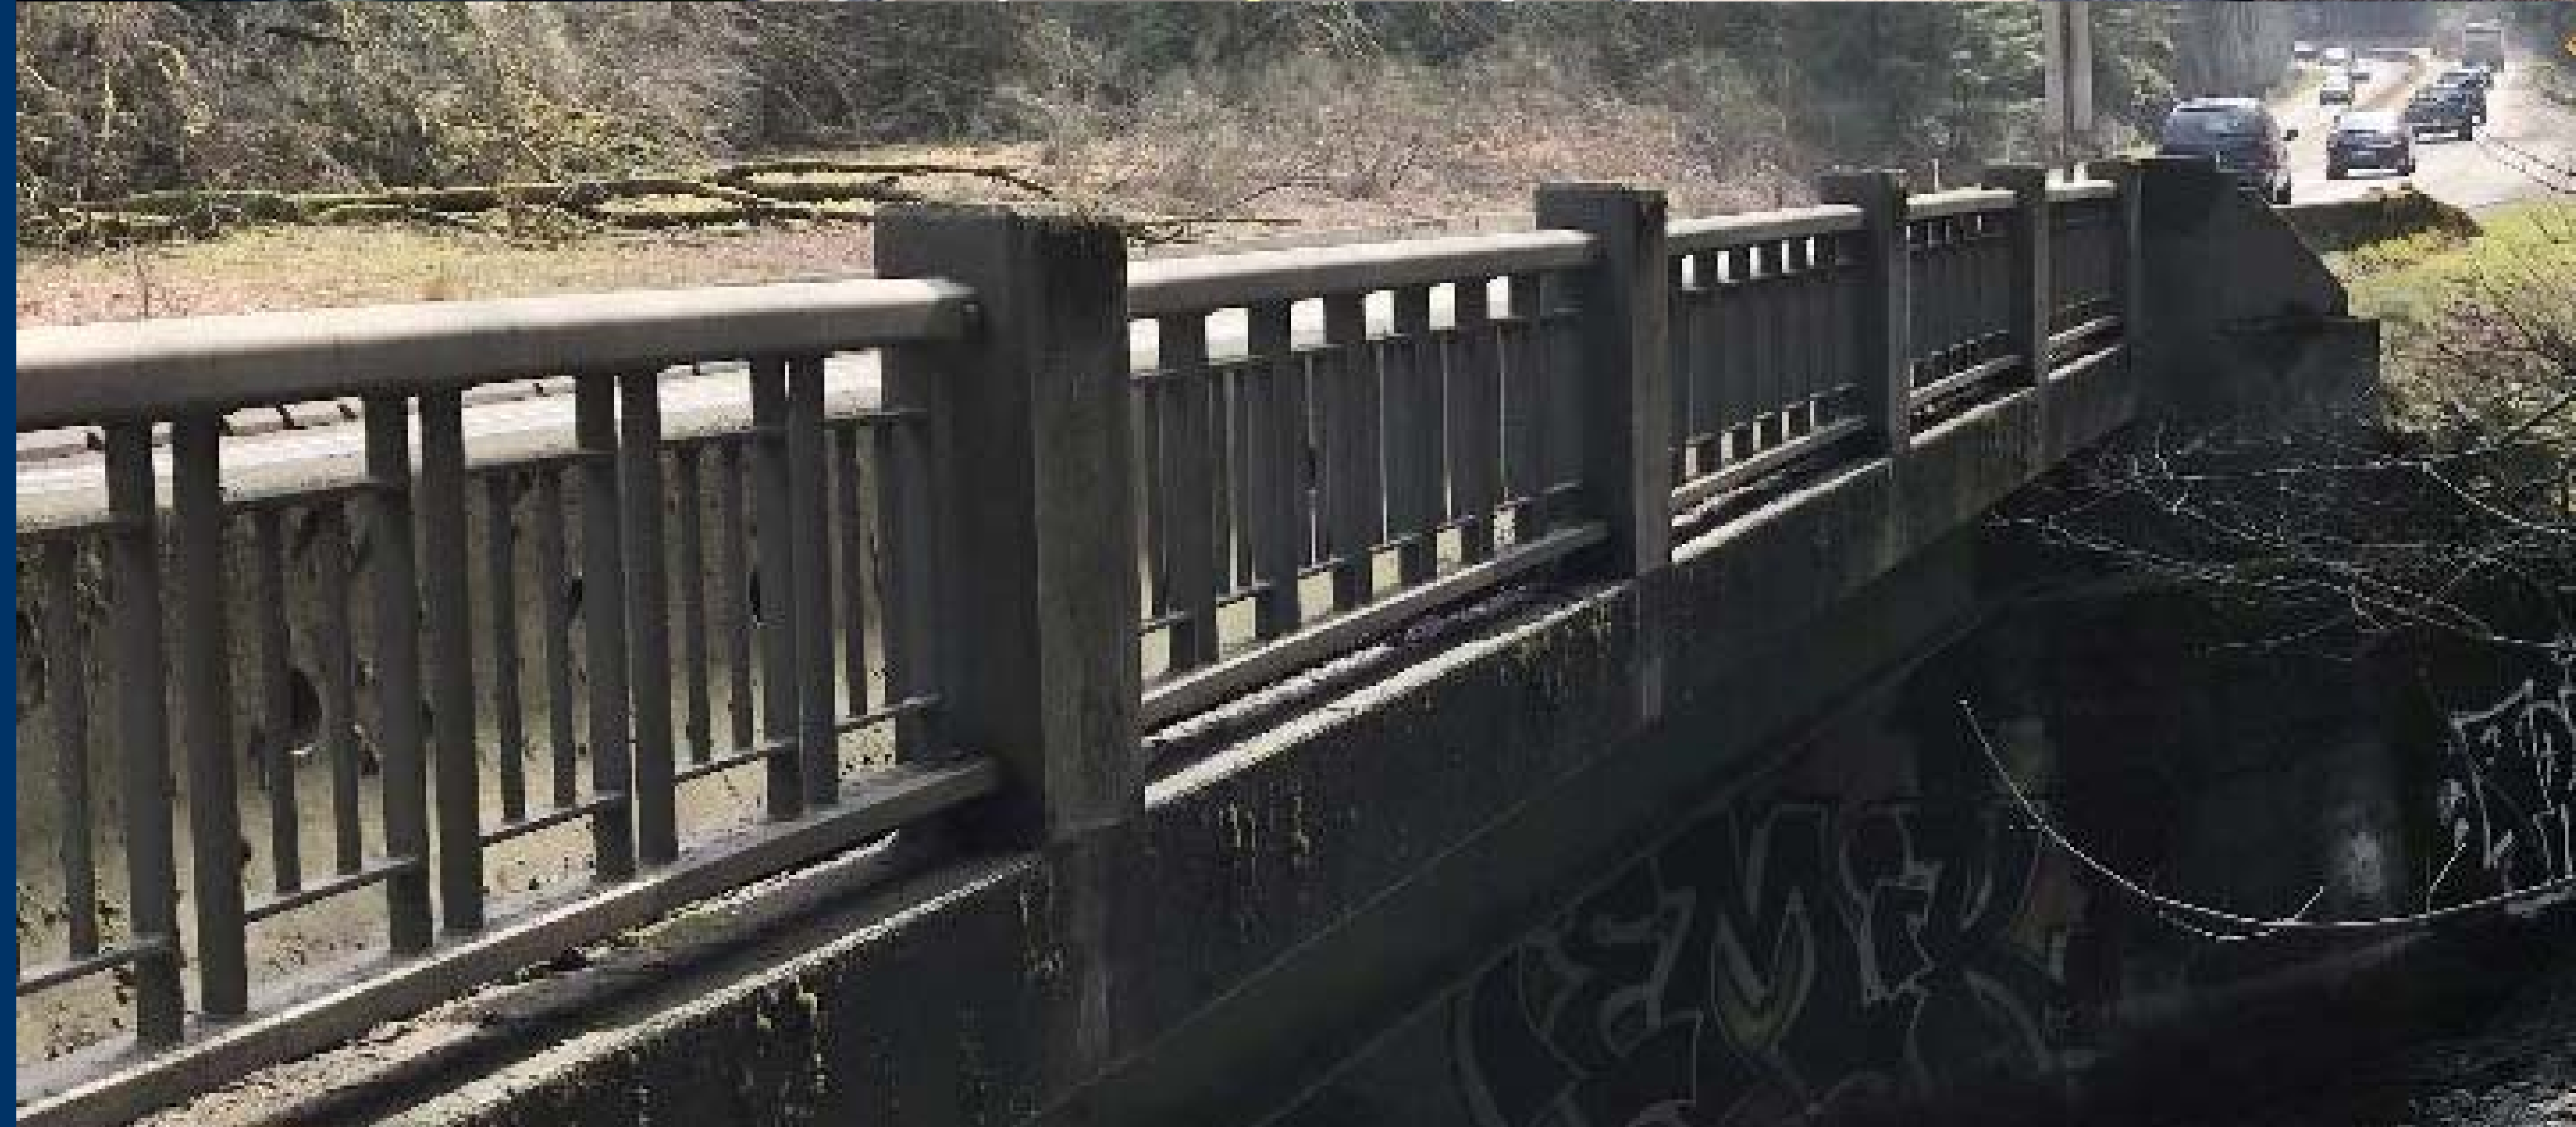
Goldstream River Bridge

- Bridge was constructed in 1936 and widened in 1956
- Minor structural and barrier changes are included in project to extend bridge life and provide wider shoulders
- Additional widening to accommodate a median barrier would trigger need for full bridge replacement
- Deck and immediate highway approaches will remain divided by picket delineators only
- Gap in median barrier will facilitate emergency cross over point as in past median projects within the corridor
