Ministry of Transportation and Infrastructure

Geotechnical and Materials Engineering

Ben Hynes Pit No. 1102

2023 Technical Information Report

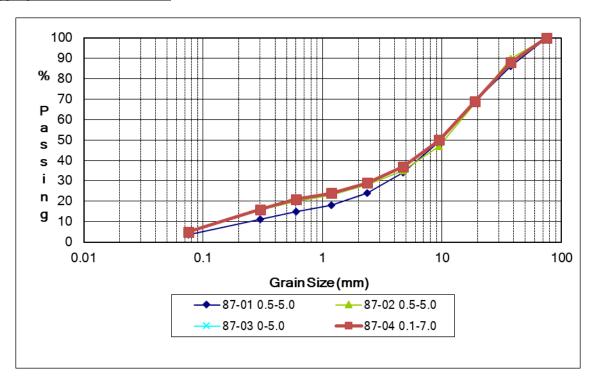
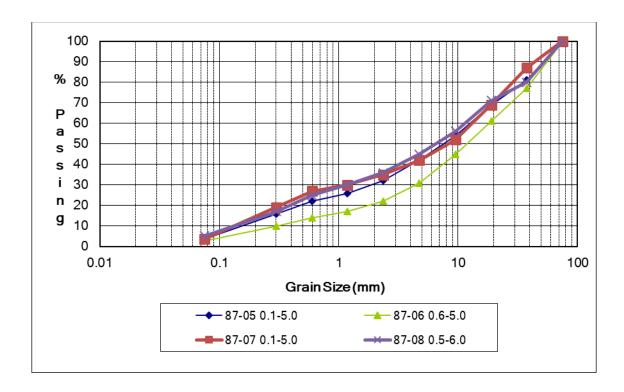
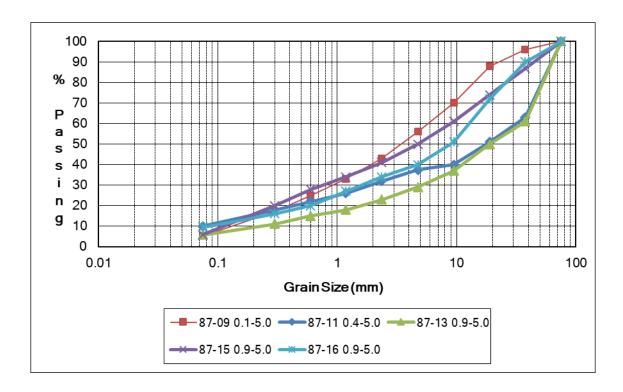
Aggregate Gradation Charts:

The average and range of laboratory samples as well as oversize rock field estimates for material (within the suitability areas) from the 1987 testing program at Ben Hynes Pit are as follows:

It was deduced from historical information that the samples tested in 1987 were a combination of the two differing subsurface layers (as recorded in the test pit summaries as GP-GM and GP).

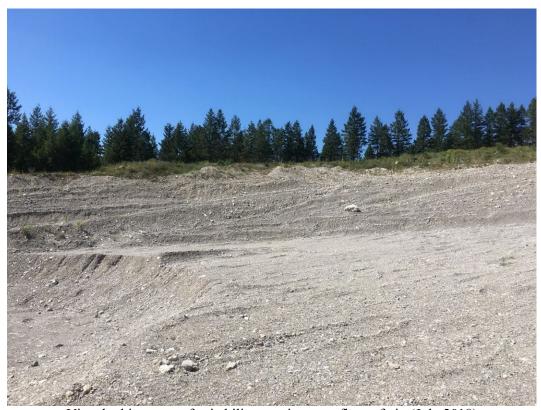
View looking west of suitability area in upper floor of pit. (July 2018)

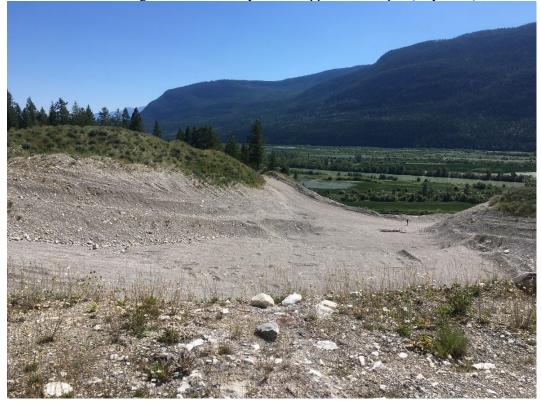
View looking south from edge of developed pit face onto crusher floor setup area, upper floor (July 2018)

- The crusher is recommended to be located on the higher floor as identified on the Pit Development Plan, with mining proceeding in an eastern direction as indicated. The asphalt plant should be located on the lower floor of the pit as indicated in the Pit Development Plan.

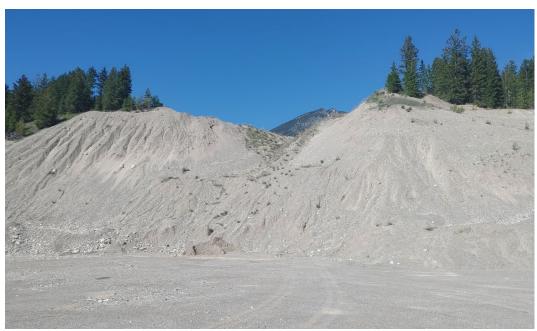
View of main pit face, facing northeast (June 2023).

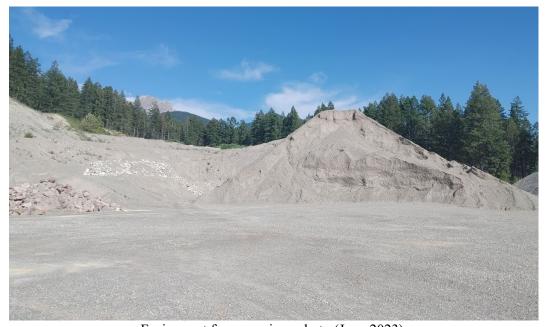
Facing east from previous photo (June 2023).

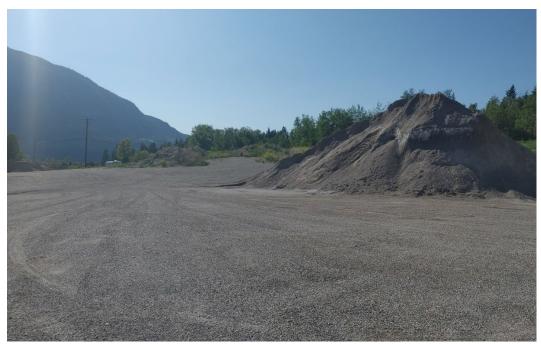
View toward access road, crusher setup and stockpile space is available in the main pit floor area (June 2023).

- The access road running from North to South at the west end of the pit needs to be maintained and/or restored post-production.
- Processed aggregate may be stockpiled in the upper portion of the pit, or where space permits
 on the lower floor should some of the previous existing aggregate stockpiles have moved or
 been utilized.
