Ministry of Environment
Diver Lake 2008
Water Quality Monitoring Program
(September 2011)

The Importance of Diver Lake and its Watershed

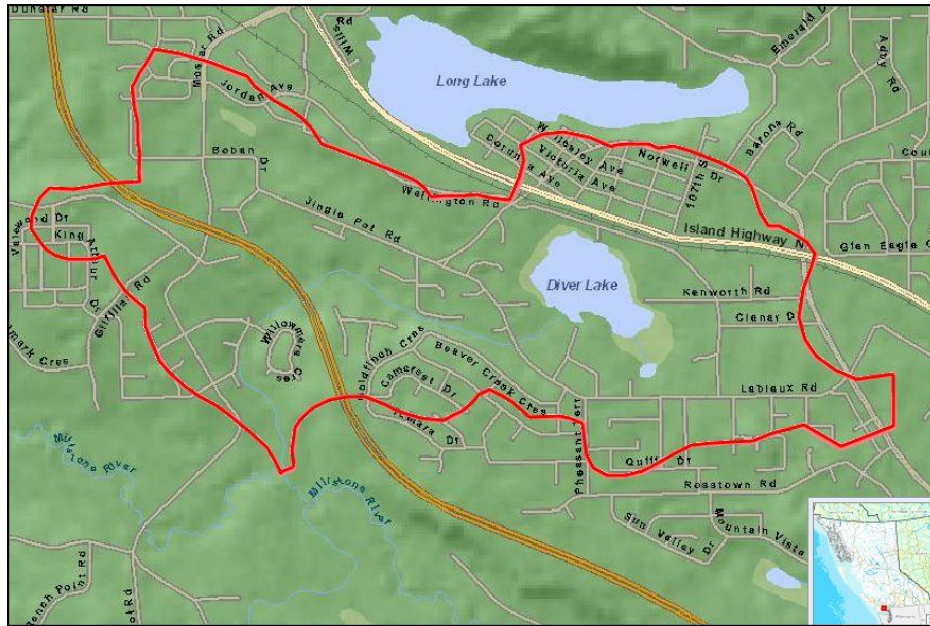
Figure 1. Diver lake with its watershed outlined in red (2011).

According to the Freshwater Atlas (GeoBC, 2011), Diver Lake's watershed (defined as the entire area of land that moves water it receives to a common water body) drains an area of 3.42 km² (Figure 1). Watersheds are a crucial component in the hydrological cycle and, when intact, support proper maintenance of ecosystem functions. Water is continuously cleansed and recycled as it moves through watersheds and other hydrological compartments. The quality of the water resource is largely determined by a watershed's capacity to buffer impacts and absorb pollution.

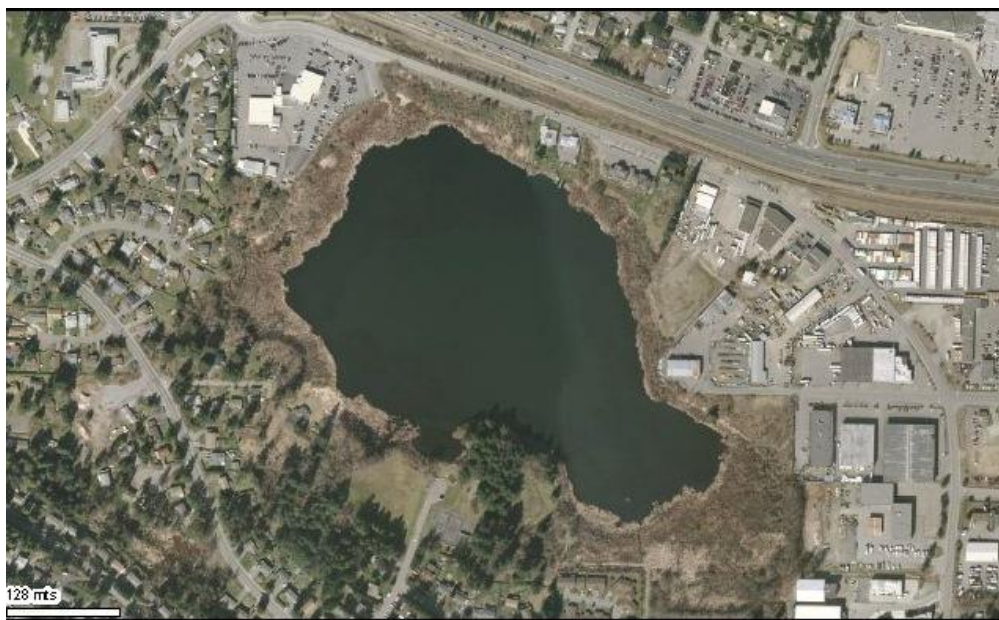
Figure 3. Aerial view of Diver Lake, (2004).

Diver Lake is surrounded by residential housing, commercial and industrial facilities, and a heavily used highway (Figure 3), making urban pollution and encroachment a constant threat to the health of the lake and the integrity of its watershed. Conserving the remaining fish and wildlife habitat within the watershed is another considerable challenge. Preventing excessive nutrient loading and pollution from entering Diver Lake is important for supporting good water quality and preserving the lake's biological community. This may become particularly challenging given the lake's urban surrounding, small size and shallow depth that make it more susceptible to inputs of nutrients, pollutants or sediment.

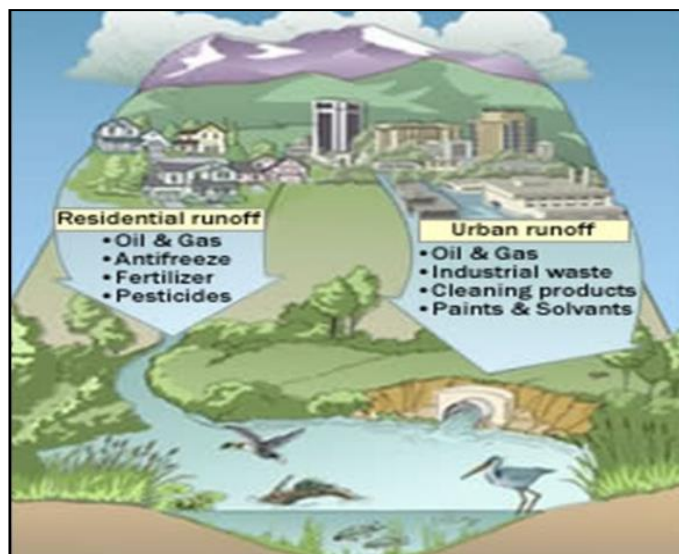
Figure 4. Non-point sources of pollution in a watershed.

One of the most detrimental effects of NPS pollution is phosphorous loading to water bodies. The amount of total phosphorous (TP) in a lake can be greatly influenced by human activities. If local soils and vegetation do not retain this phosphorous, it will enter water courses where it will become available for algal production. Watersheds have the ability to buffer against pollution in time but the ability is impeded with landscape modification and/or significant increases in pollution.

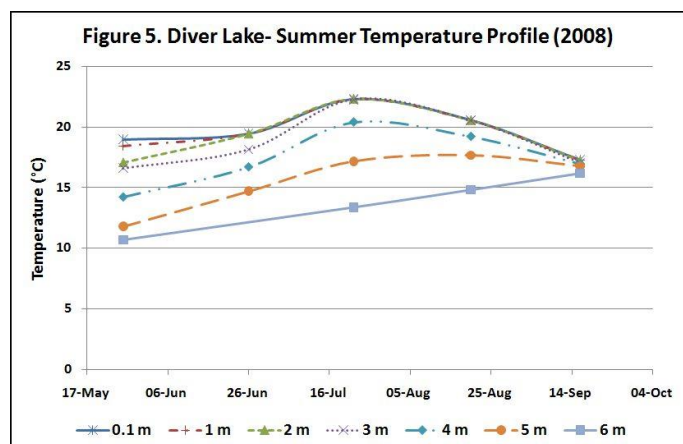
The absorption of solar radiation and its conversion into heat have profound effects on the thermal structure, stratification and circulation pattern of lakes (Wetzel, 2001). Based on a 2008 seasonal temperature profile (Figure 5 (n=34)), Diver Lake began to weakly stratify by late May.

Stratification became relatively stable on July 22nd, with temperatures of 20.40, 17.18 and 13.39 °C measured at 4, 5 and 6 m deep, respectively. A maximum temperature of 22.32 °C was also recorded on July 22nd at 1 m deep. In 2008, the lowest recorded temperature at Diver Lake was 10.70 °C, measured at 6 m deep on the 26th of May.

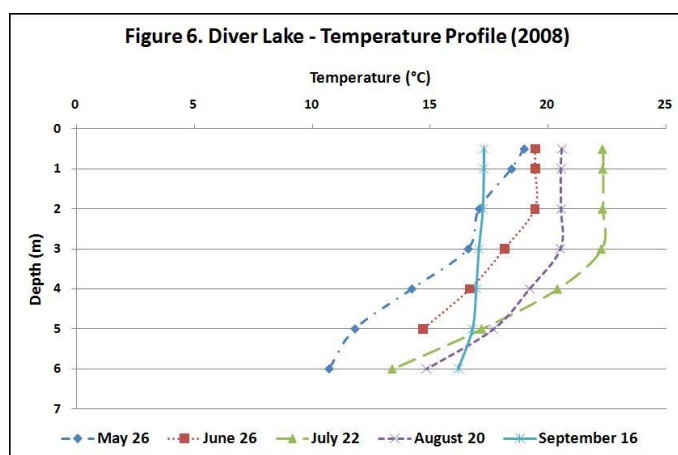
Diver Lake became isothermic (its temperature relatively uniform from top to bottom) by the fall of 2008, with surface and bottom temperatures of 17.28 and 16.19 °C, respectively, on September 16th (Figure 6). Surface temperatures began to drop dramatically in September due to the cooler seasonal temperatures and less exposure to solar radiation. Bottom temperatures, however, stayed relatively stable because, although solar radiation became less intense into the late summer and fall, the available sun light could now penetrate deeper into the clearer water column as algal blooms died off and receded. This caused Diver Lake to become isothermic in the fall, with surface and bottom temperatures separated by only 1.09 °C on September 16th, represented by the vertical nature of the solid line in Figure 6.

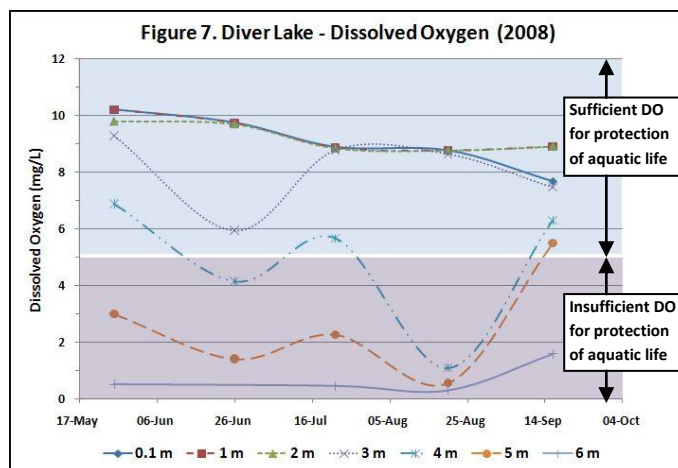
Multi-Depth DO data was collected once a month at Diver Lake from March to September, 2008 (Figure 7). A maximum DO value of 10.21 mg/L was recorded at depths equal to or less than 1 m on May 26th and a minimum value of 0.29 mg/L was recorded at 6 m deep on August 20th. From late spring to early fall, sufficient DO levels (≥ 5 mg/L) could only be found at depths of 3 m or less. At 4 m deep, otherwise anoxic during mid-late summer, there is a brief increase in DO in late July to just above the recommended instantaneous minimum. This is likely due to an algal bloom approximately 4 m deep that supplied the water with oxygen produced through photosynthesis and corresponds with the warmest average water temperature during the sample period of 20.02 °C on July 22nd.

Comparing summer DO levels to temperature patterns in Diver Lake shows the effect stratification can have on the chemical properties within the lake. On June 26th, 2008, temperature was relatively uniform from surface waters to 2 m deep (0.5 m = 19.46 °C, 1 m = 19.45 °C, 2 m = 19.44 °C), and so, with adequate mixing occurring between these depths, DO values were also similar (0.5 m = 9.75, 1 m = 9.73, 2 m = 9.70 (mg/L)). As depth continued to increase temperature dropped more sharply, from 19.44 °C at 2 m to 18.15, 16.69 and 14.70 °C at 3, 4 and 5 m, respectively. The mixing that had

occurred in the epilimnion (the upper layer of the water column) contributing to similar DO concentrations was facilitated by uniform temperatures. The cooler, denser layer at 3 m exhibited a much lower concentration of DO (5.95 mg/L), as it was unable to mix with the epilimnion to receive oxygen from wind agitation.

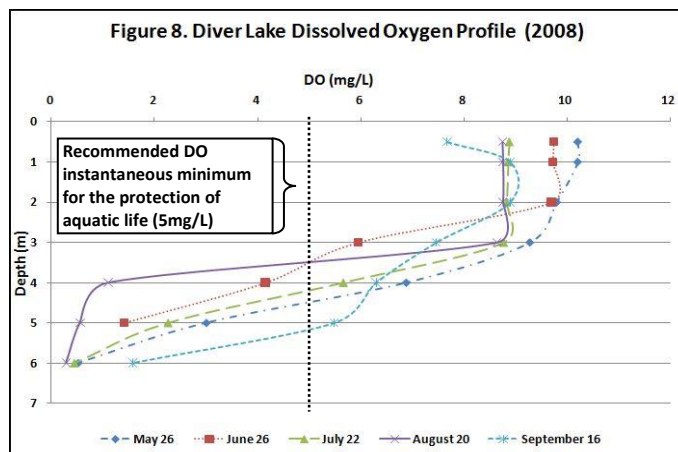
For all sample dates in 2008, DO begins to drop at 3 m depth, steadily diminishing towards insufficient levels for the protection of aquatic life. In June, depths of 2 m or less have relatively high DO levels (Figure 8), likely from wind agitation and biological activity that was confined to warmer, more shallow waters due to less intense incoming solar radiation.

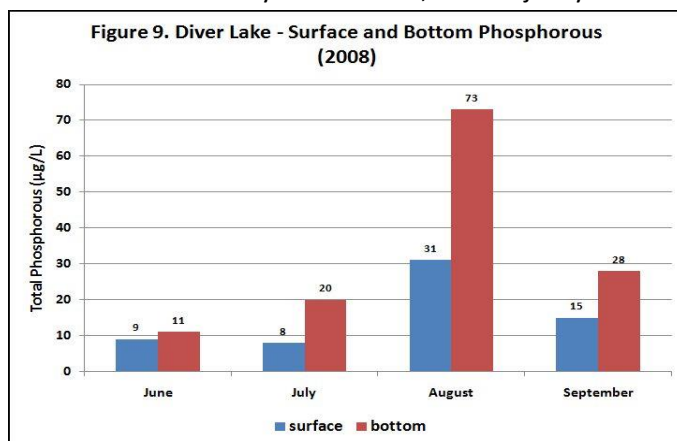
Total phosphorous (TP) data was collected for Diver Lake once a month in 2008 from June to September. Figure 9 separates TP into surface and bottom concentrations. In general, the levels of bottom phosphorous are far greater than those at the surface, indicating that during the summer and early fall of 2008; the majority of total

phosphorous in the lake was a result of internal nutrient loading. The largest recorded concentrations for both surface and bottom concentrations were measured in August, with surface values reaching 31 µg/L while bottom levels measured 73 µg/L.

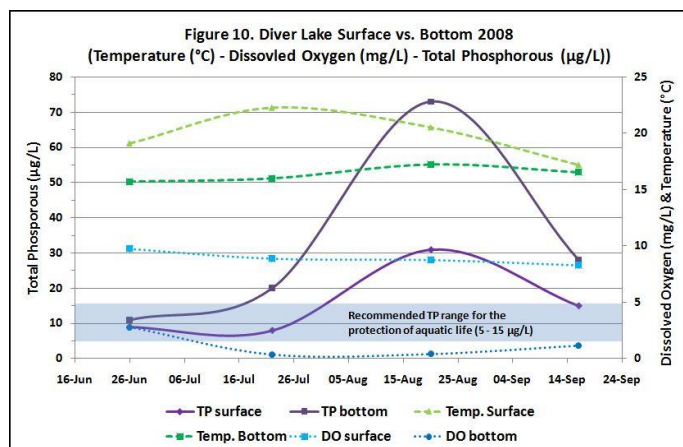
In June, TP levels in the hypolimnion began to increase, likely due to temperature stratification and algal die off. Comparing TP measurements to the average temperature of the hypolimnion (the bottom layer, ≥ 4 m deep) indicates that the warming of bottom waters initially decreased the concentration of DO in the hypolimnion and stimulated a chemical reaction in the

substrate of Diver Lake. The result was the release or remobilization of phosphorous formerly trapped in bottom sediments (Figure 10) and a much sharper increase in bottom TP into July and August. Although surface values also rise during this time, the increase is relatively modest as temperature stratification prevents internally loaded bottom nutrients from mixing with the epilimnion (surface layer). Furthermore, biological uptake during this time was continually removing phosphorous from shallower water. By late August, TP and temperature throughout the water column began to decline. Surface concentrations of DO also decreased slightly, largely the result of algal die off. Conversely, bottom DO concentrations rose slightly as the lake began to cool, decreasing aquatic organisms' metabolic demand for Oxygen.

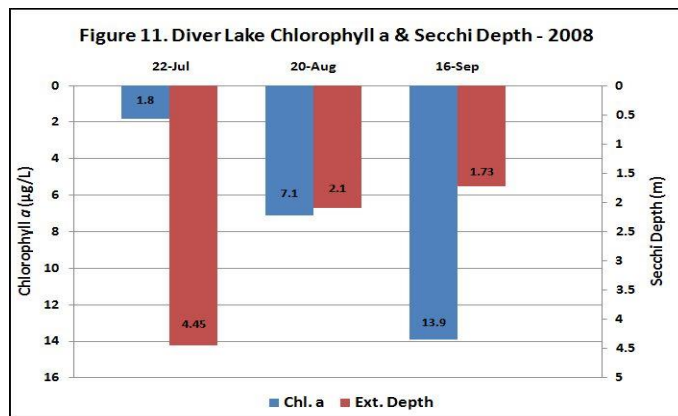
Generally, Secchi depth displays a negative correlation to concentrations of chlorophyll *a* because algal blooms reduce water clarity. In June, biological uptake in Diver Lake was limited and chlorophyll *a* concentrations were relatively low (1.8 µg/L). With low chlorophyll *a* levels, the lake was fairly clear, indicated by a secchi depth reading of 4.45 m. As summer progressed, warmer

temperatures increased biological activity, perpetuating algal blooms and by late July, chlorophyll *a* concentrations had increased nearly fourfold (7.10 µg/L), in turn obscuring the water and decreasing the secchi depth reading to 2.10m.

In the fall, biological activity peaked and chlorophyll *a* was measured at 13.9 µg/L on September 16th. As biological activity accumulated over the late summer, chlorophyll *a* values almost double from August 20th to September 16th. The mounting biological activity in Diver Lake corresponds with a decrease in secchi depth from 2.1 m to 1.73 m over the same time span.

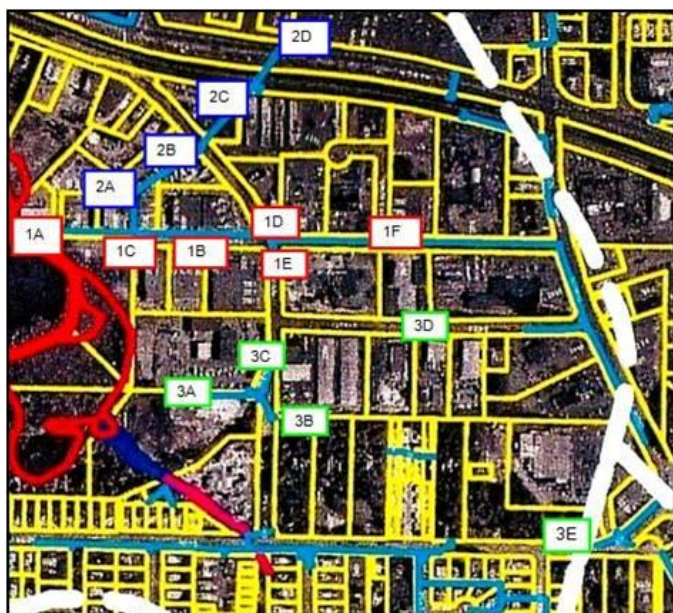
Figure 12. Sample sites for NALTs Water Quality Data Report (2003).

Considering Diver Lake's relatively small size along with its close proximity to sources of metals and PAHs, there is potential for the health of the lake to be degraded by such toxins and chemicals. In 2003, in conjunction with the Better Management Practices program, NALT performed an assessment that measured levels and attempted to identify possible sources of metals and PAHs within the industrial area of Diver Lake's watershed. The previously listed metals, along with PAHs including; Anthracene, Benzo(a)anthracene, Benzo(a)pyrene, Fluoranthene, Phenanthrene and Pyrene, were measured along storm drains which flowed into the lake (Figure 12).

The resulting report, *Water quality data report (2003): Diver Lake tributary (Kenworth Road)* (Bonar, 2003), identified aluminum, cadmium, copper and zinc as metals with relatively high concentrations which exceeded background levels. Likewise, Fluoranthene and Pyrene concentrations were found to exceed background levels at several sites. Although the report does recognize the presence of these potentially harmful substances within Diver Lake's watershed, determining their environmental affect requires follow up.
