WATERSHED REVIEW

HUGUENOT CREEK WATERSHED

Draft March 23, 2012

BIOPHYSICAL AND LAND-USE CHARACTERISTICS OF THE WATERSHED

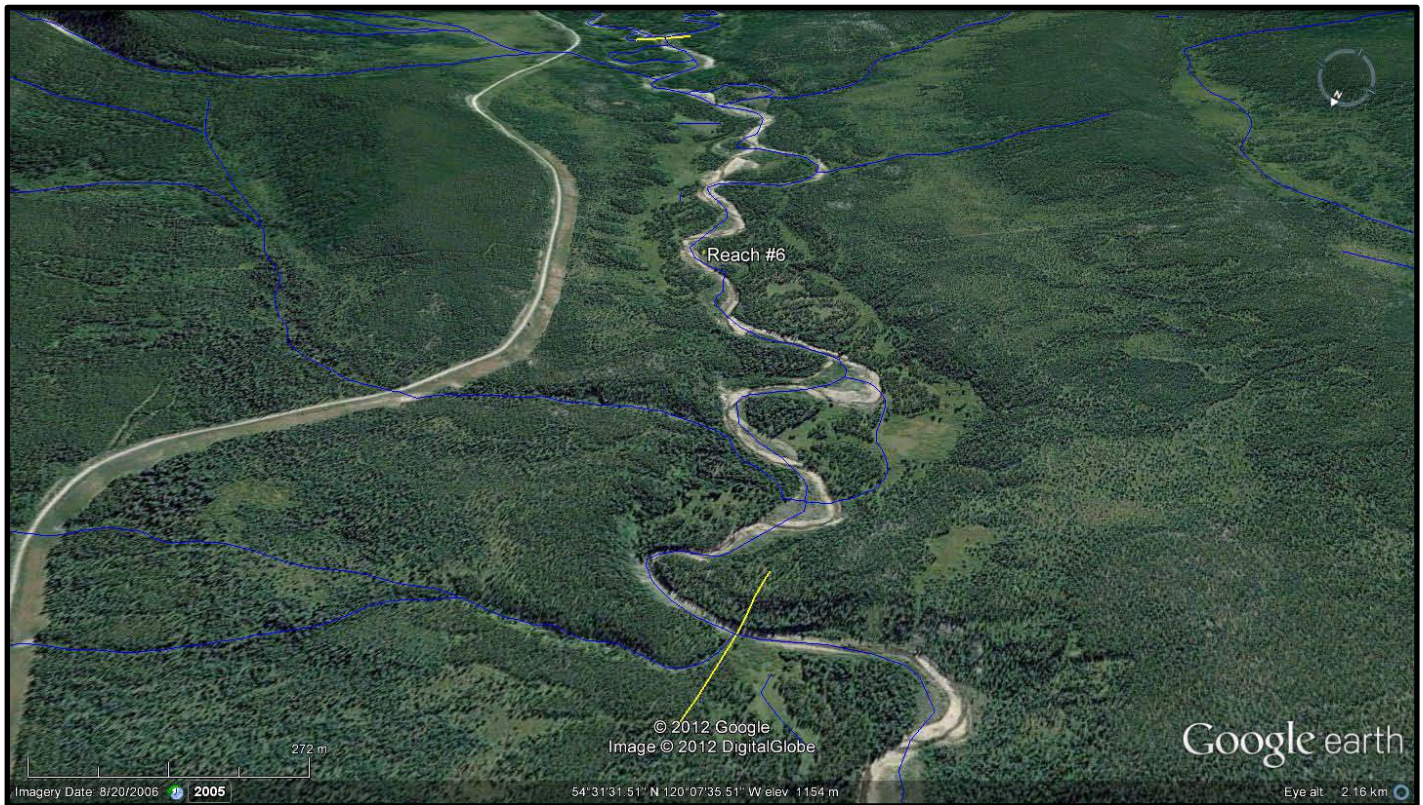
Figure 7. Google Earth image looking upstream along Reach #6 of Huguenot Creek.

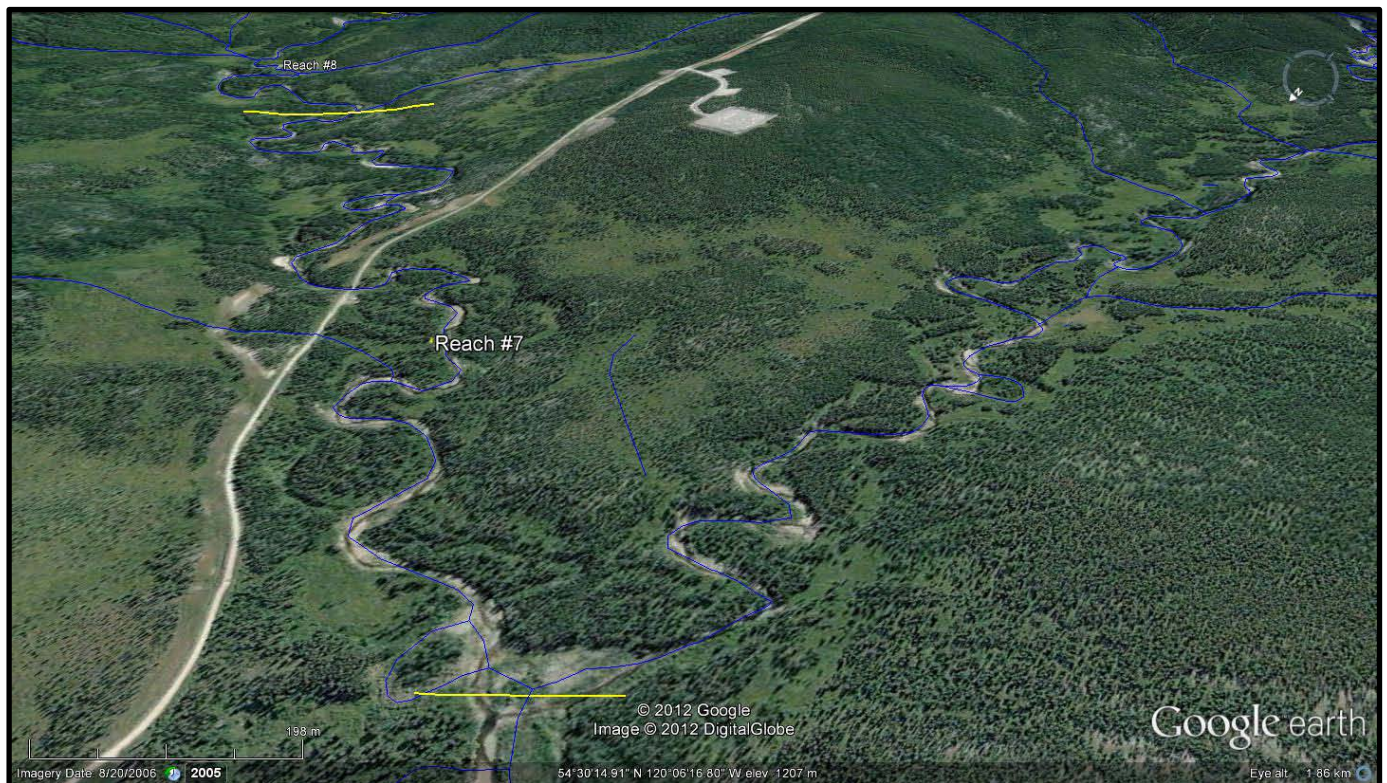
Figure 8. Google Earth image looking upstream along Reach #7 of Huguenot Creek.
